Site Accessibility Evaluation

**L. Ron Hubbard Way to N.
Catalina Street
East Hollywood, CA 90027**

CASp Evaluation

Inspection Date: 02/27/2025

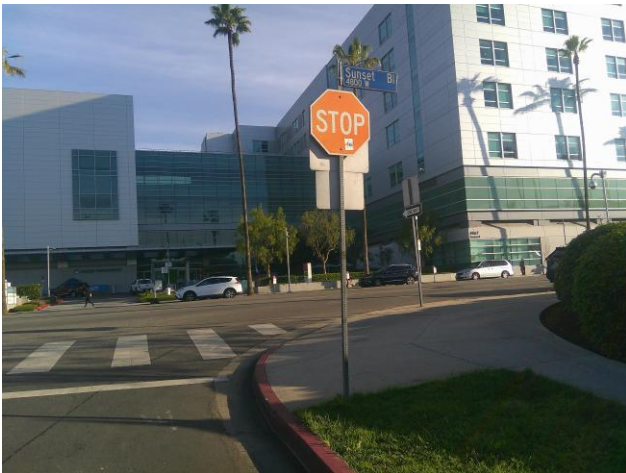
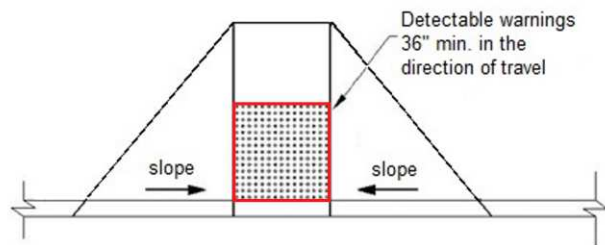
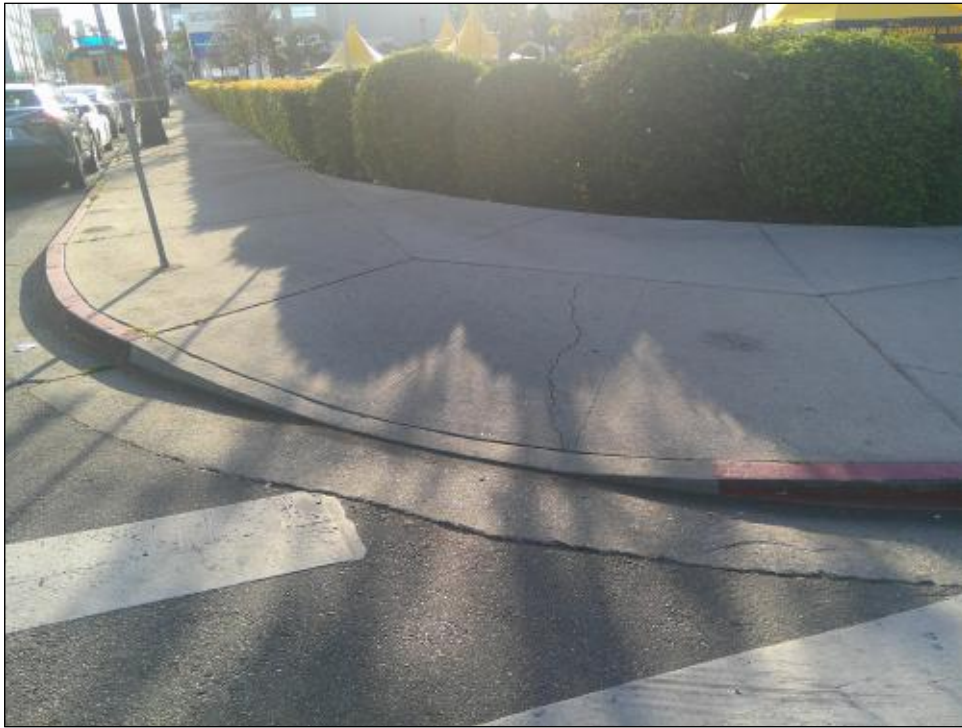
Finding: 1

Detectable warnings at curb ramps shall extend the full width of the curb ramp excluding any flared side and 36 inches in the direction of travel.

Detectable warnings shall extend the full width of the turning space at the flush transition between the street and the sidewalk less 2 inches maximum on each side.

2022 CBC 11B Section: 11B-705.1.2.2

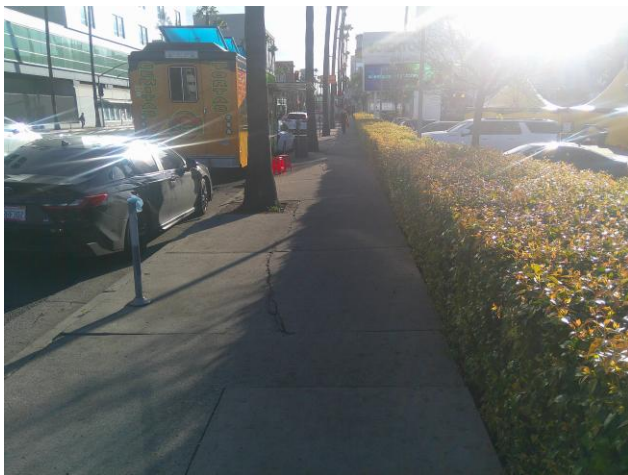
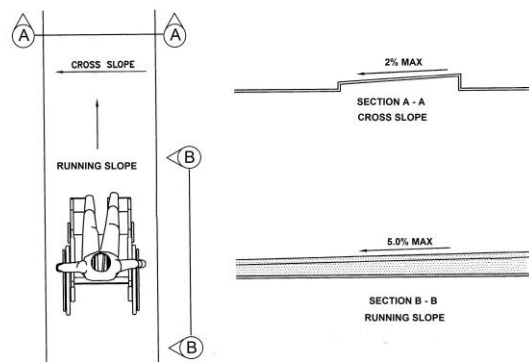
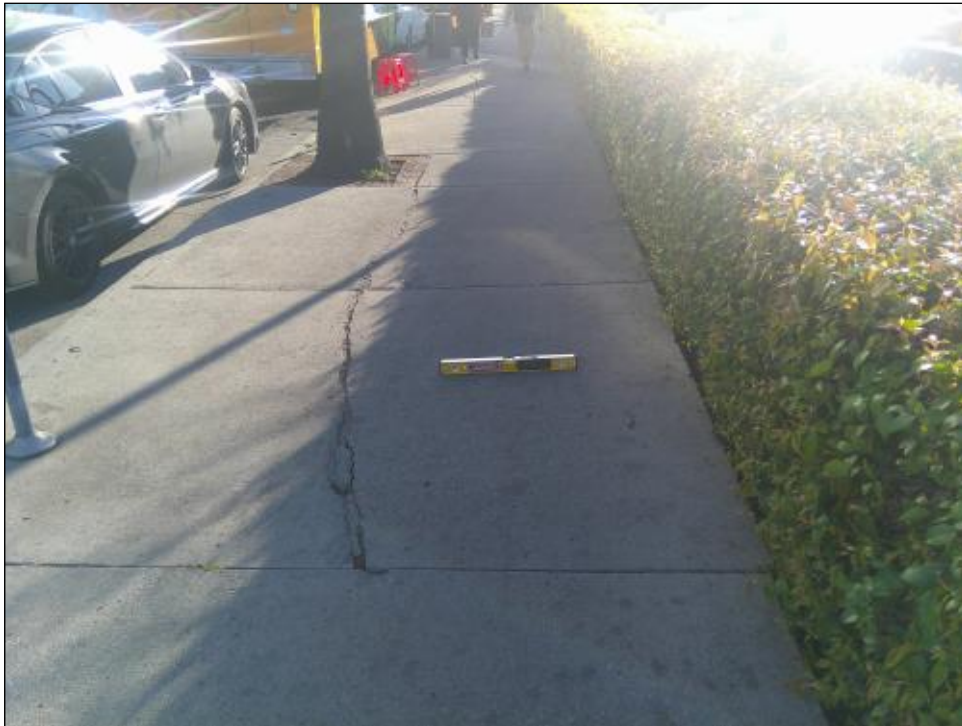
Finding: 2

The accessible path of travel has cross slopes greater than 2%.

2010 ADAS Section: 403.3

2022 CBC 11B Section: 11B-403.3

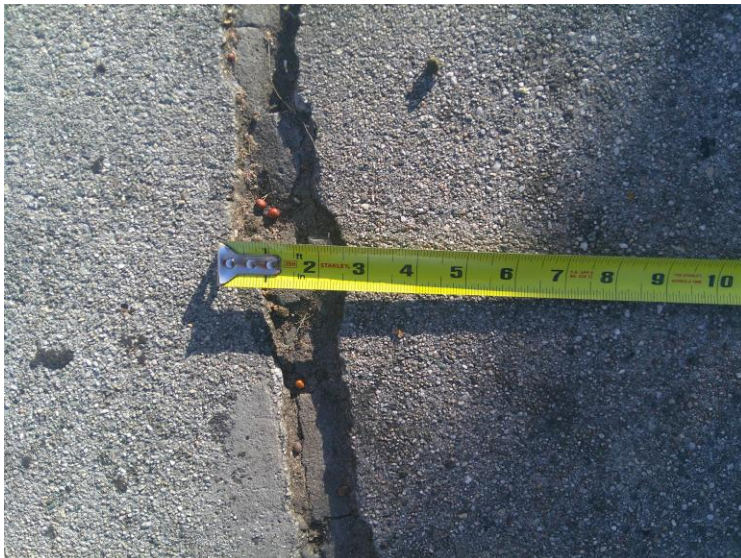
Finding: 3

The route contains openings greater than 1/2 inch.

2010 ADAS Section: 302.3

2022 CBC 11B Section: 11B-302.3

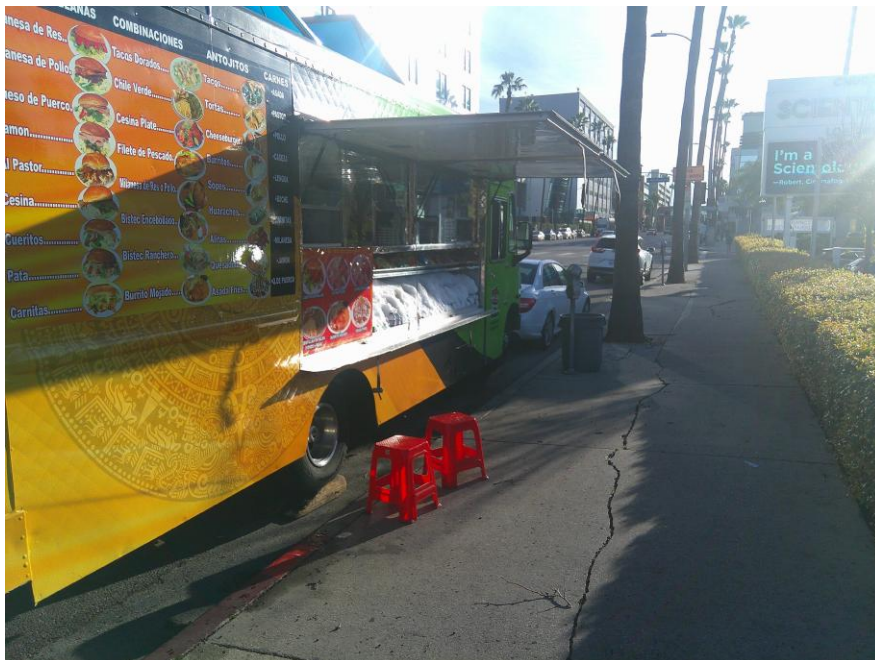
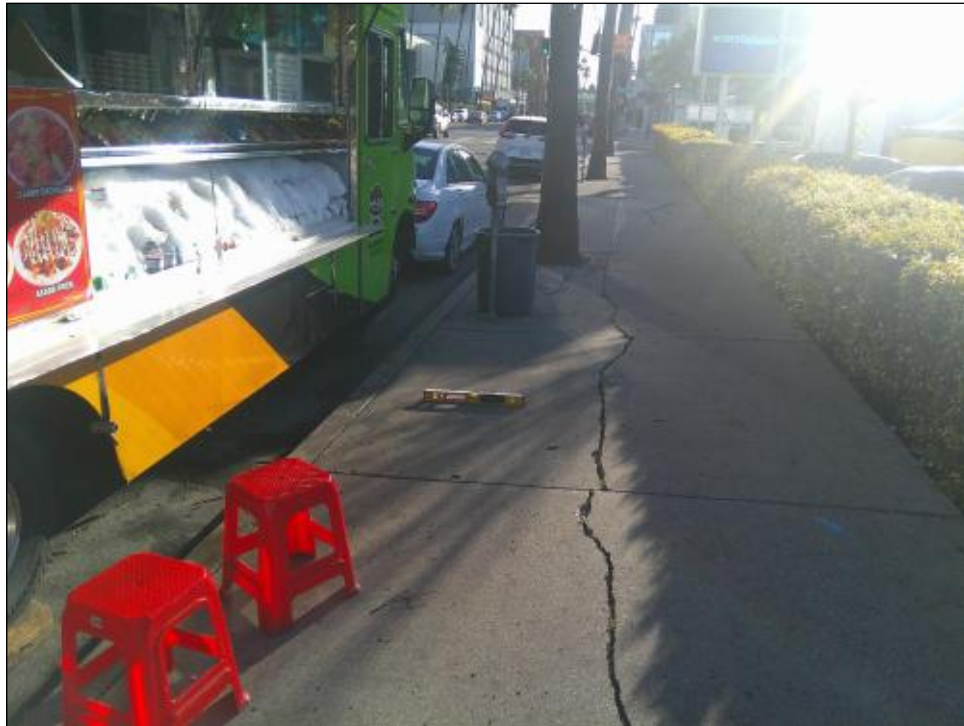
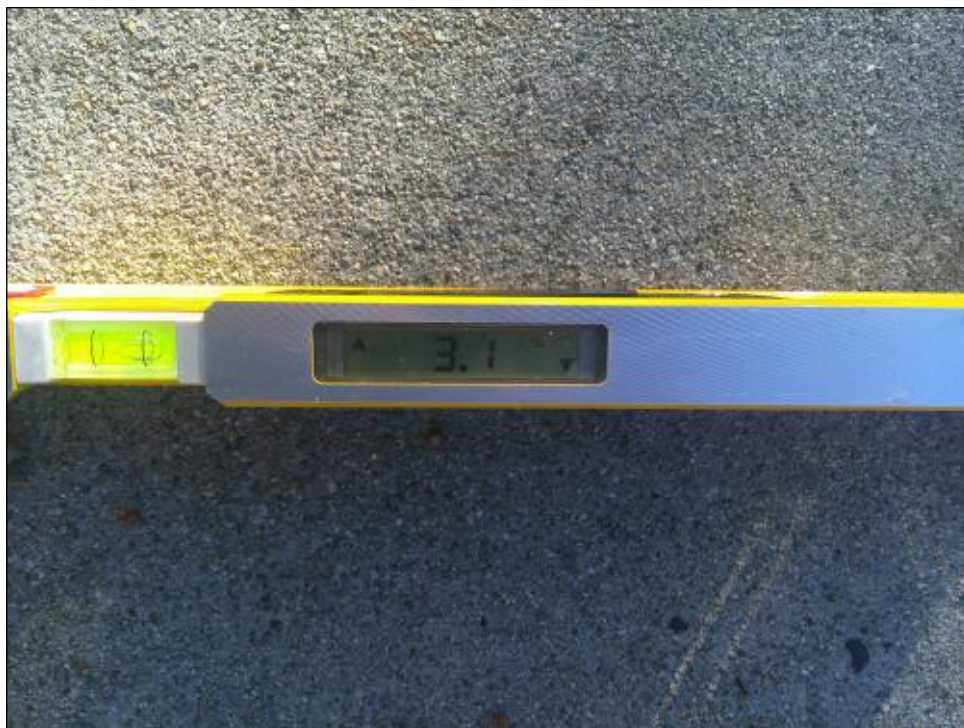
Finding: 4

The clear floor space required at the element is not flat (2% or 1:48 maximum slope) in all directions.

2010 ADAS Section: 305.2

2022 CBC 11B Section: 11B-305.2

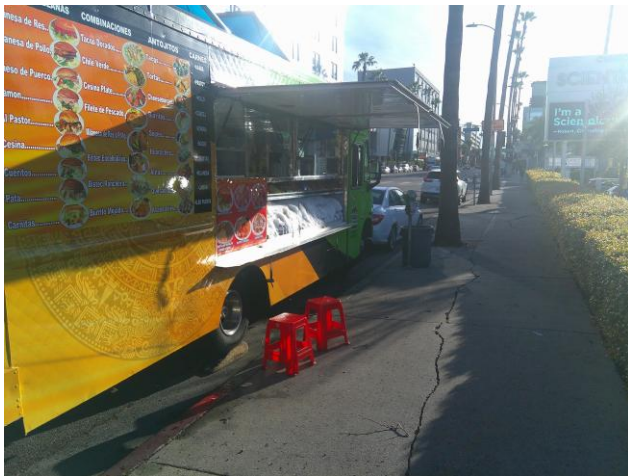
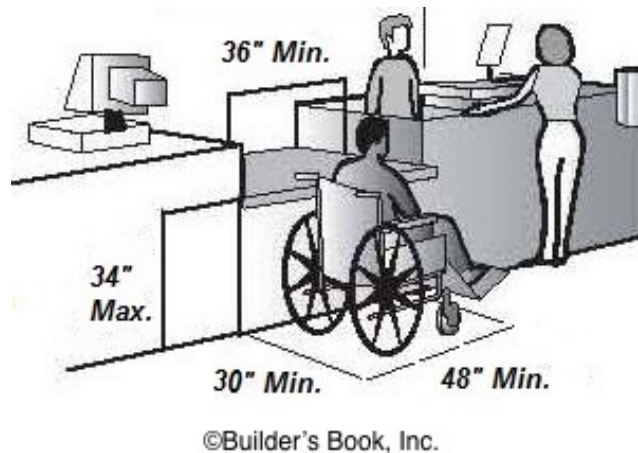
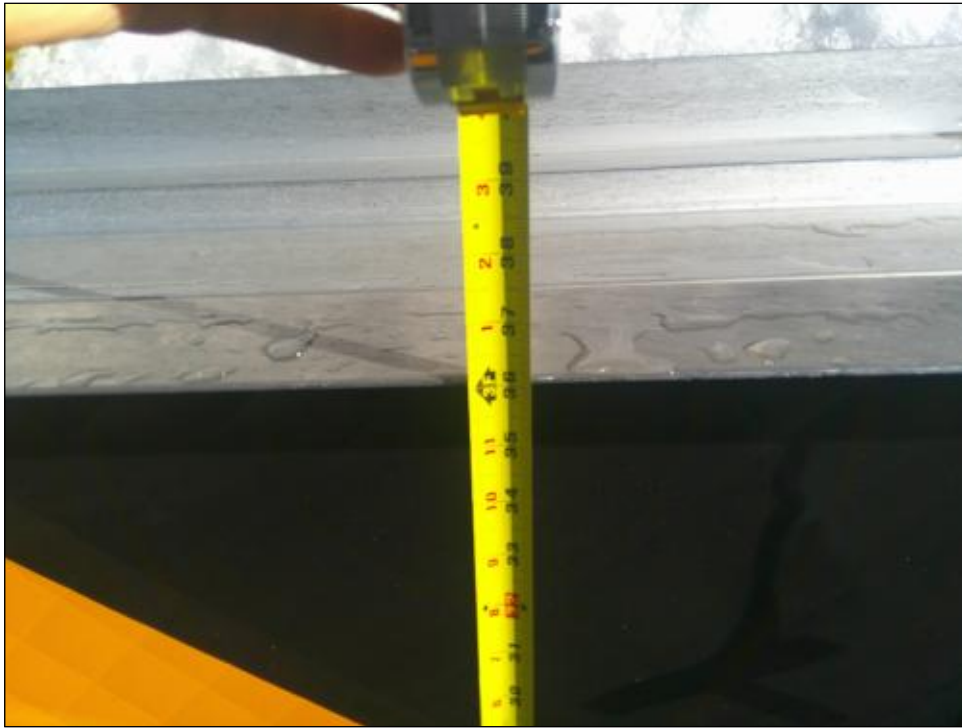
Finding: 5

The transaction counter provides for a parallel approach and is not within the required height range.

2022 CBC 11B Section: 11B-904.4.1

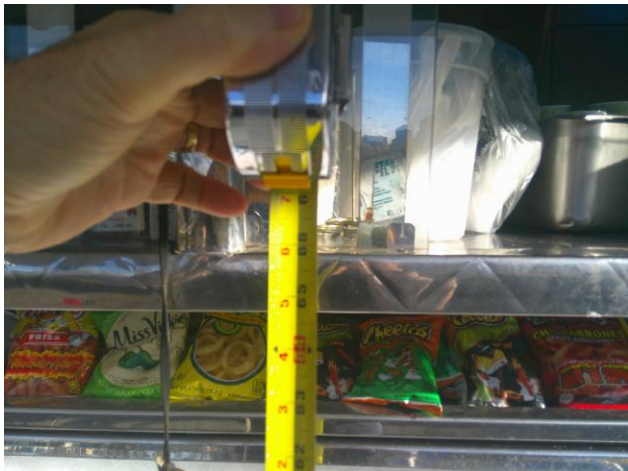
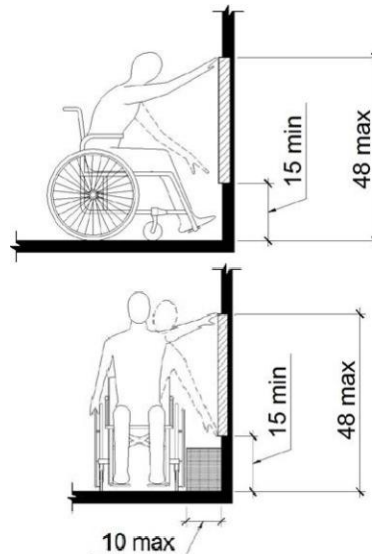
Finding: 6

The order and receiving food window is positioned too high for either a side or front approach.

2010 ADAS Section: 308.1

2022 CBC 11B Section: 11B-308.2.1

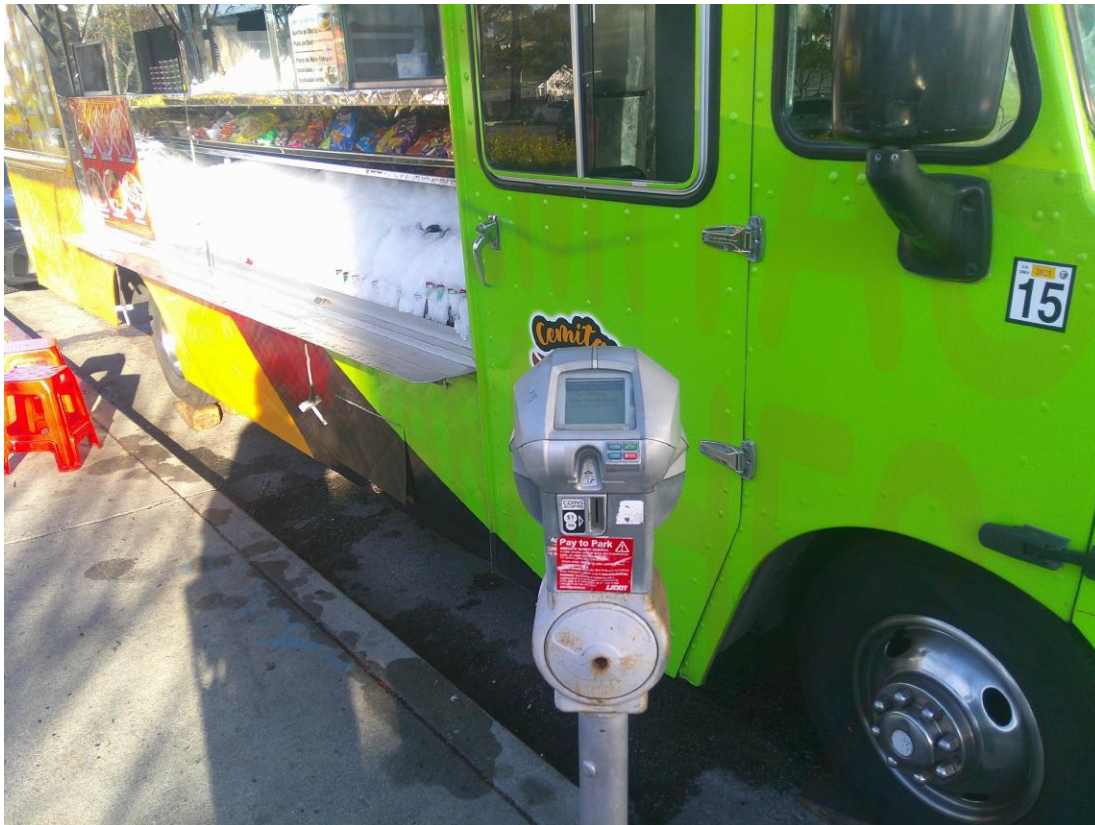
Finding: 7

The Food Truck is serving the public therefore, it must comply with accessibility.

The manager of the Food Truck stated the city granted them permission to sell here.

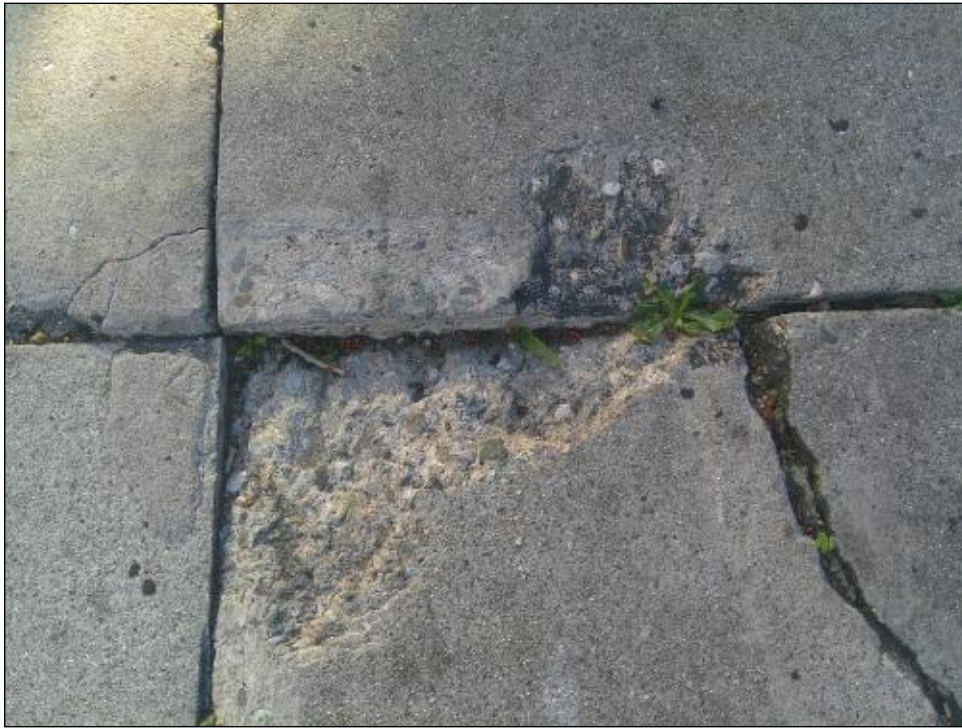
Finding: 8

The walkway contains abrupt vertical edges and/or variations over 1/4 inch.

2010 ADAS Section: 303.3, 303.2

2022 CBC 11B Section: 11B-303.2, 11B-303.3

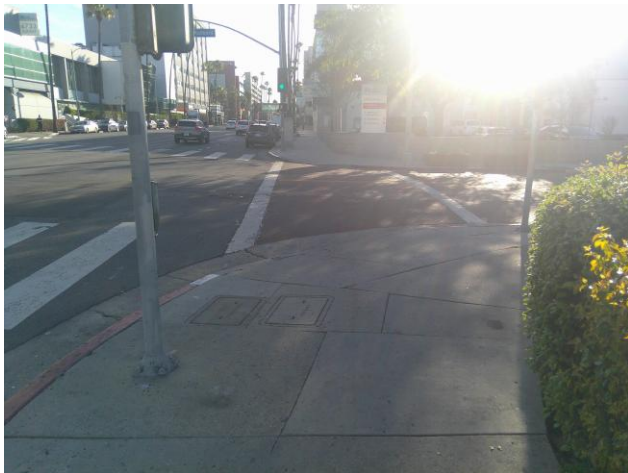
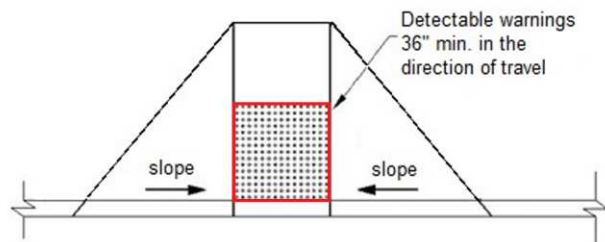
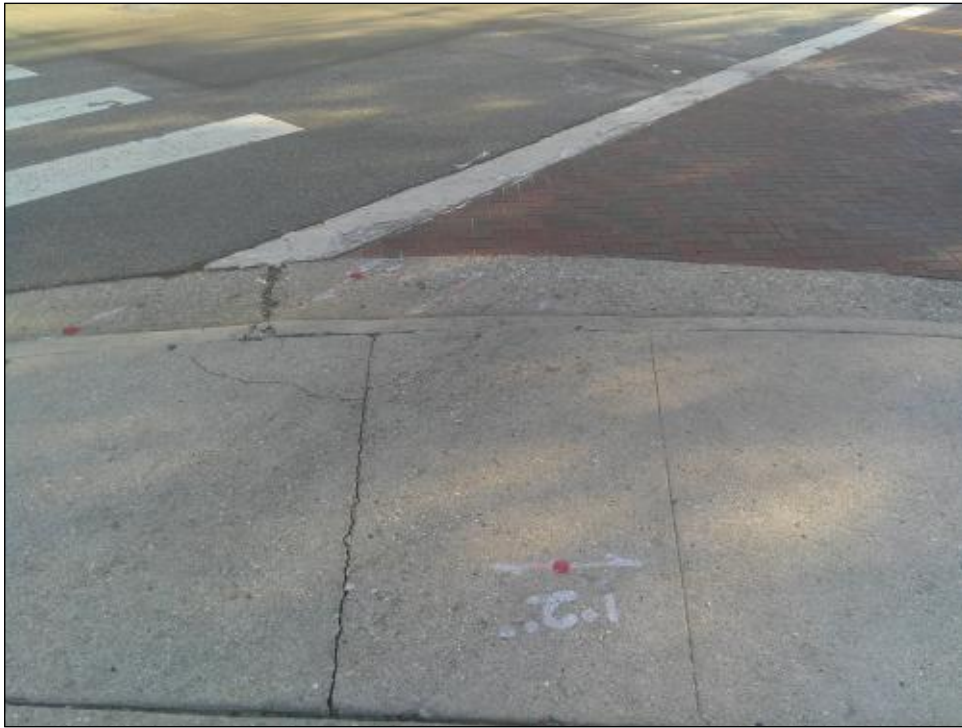
Finding: 9

Detectable warnings at curb ramps shall extend the full width of the curb ramp excluding any flared side and 36 inches in the direction of travel.

Detectable warnings shall extend the full width of the turning space at the flush transition between the street and the sidewalk less 2 inches maximum on each side.

2022 CBC 11B Section: 11B-705.1.2.2

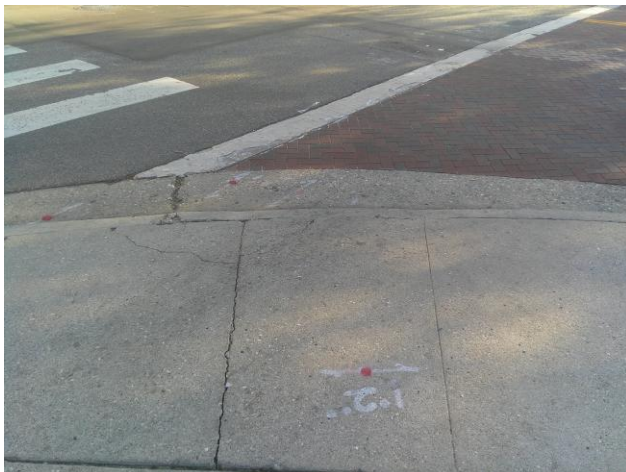
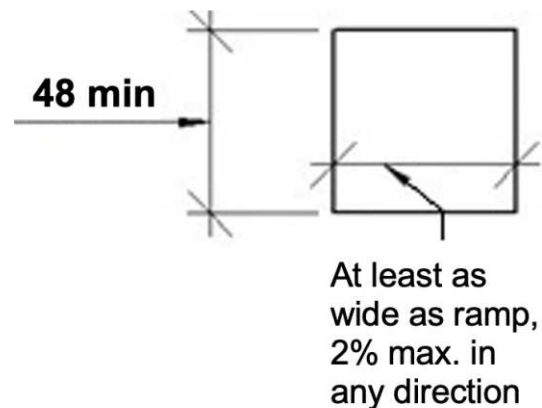
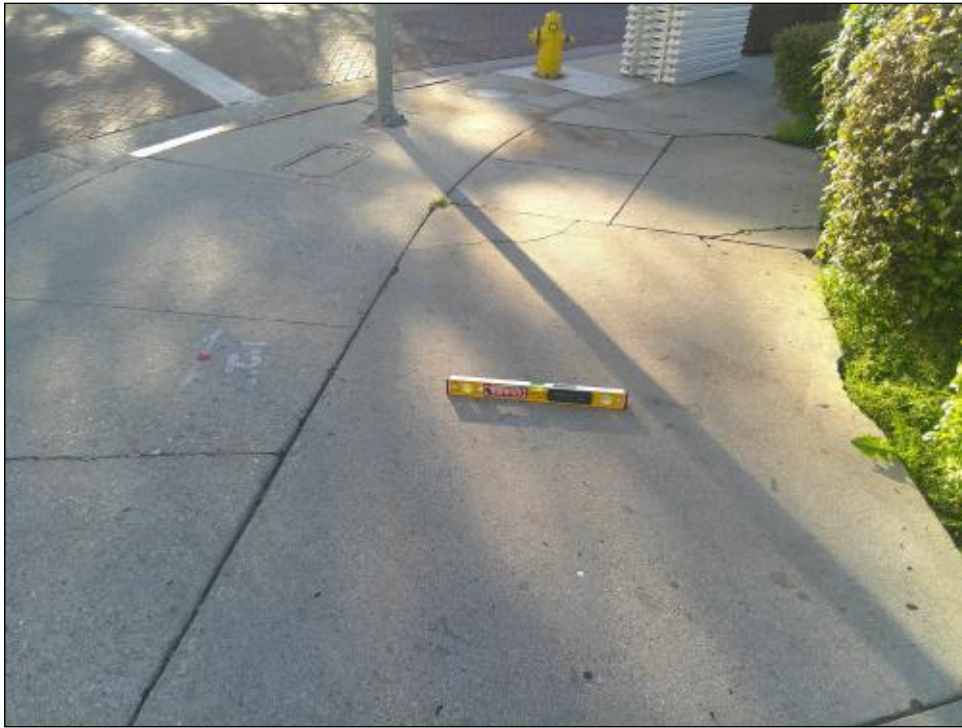
Finding: 10

The top landing for the curb ramp is not level and exceeds a 2% slope.

2022 CBC 11B Section: 11B-406.5.3

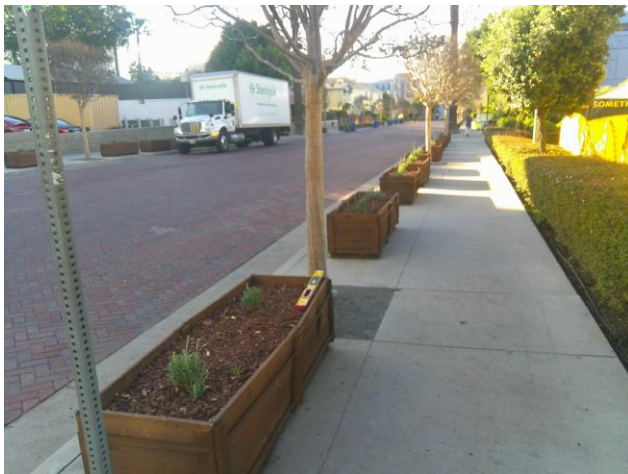
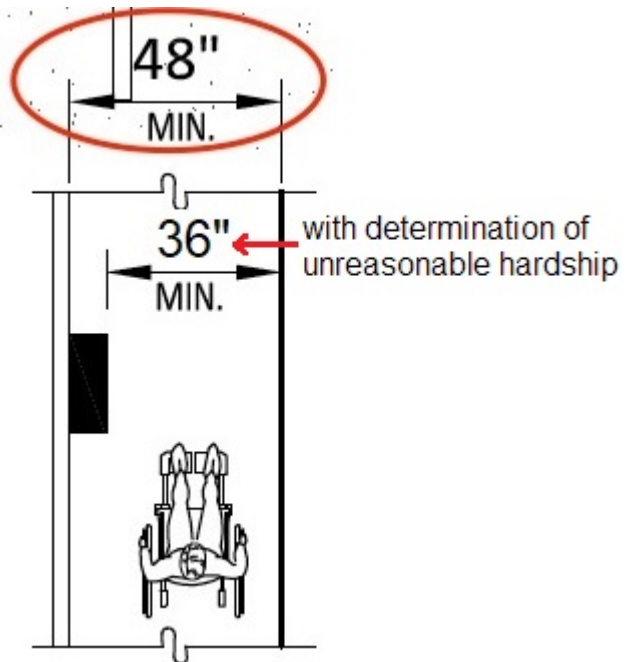
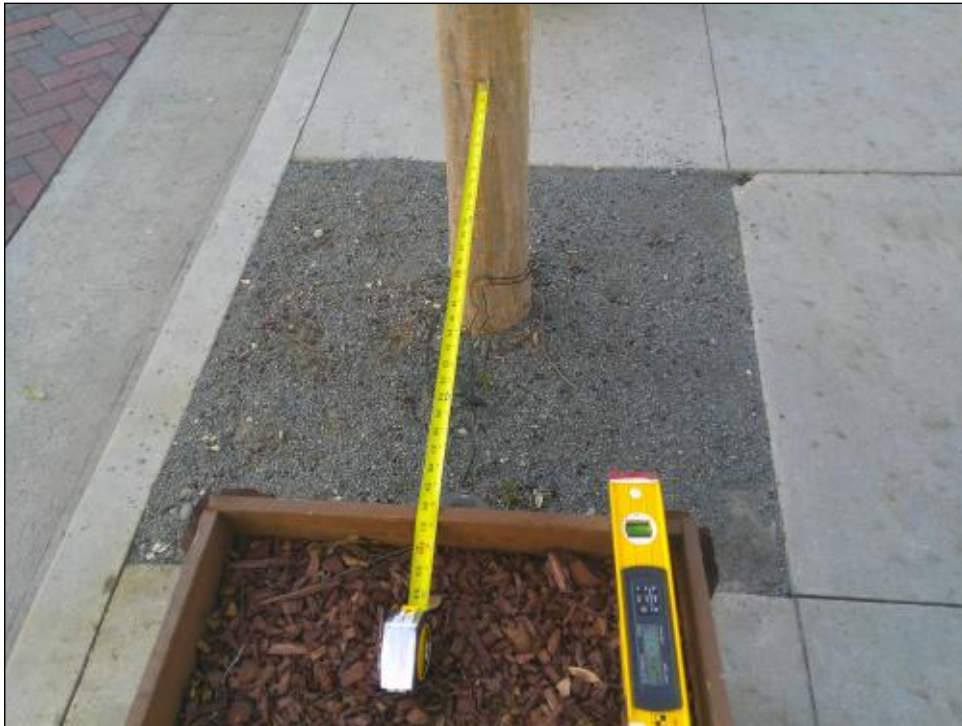
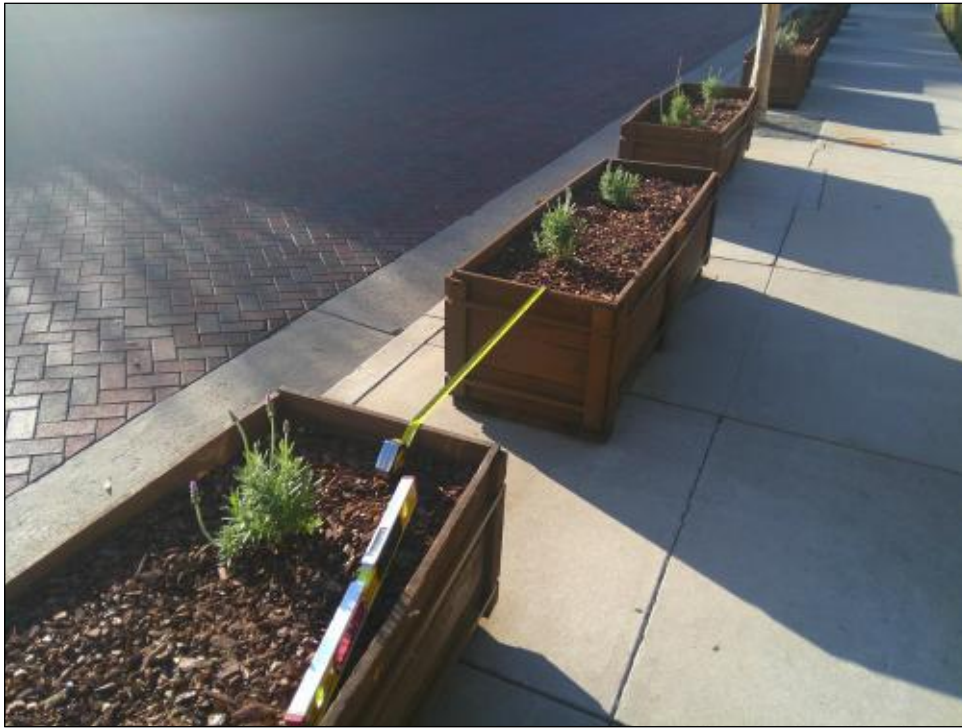
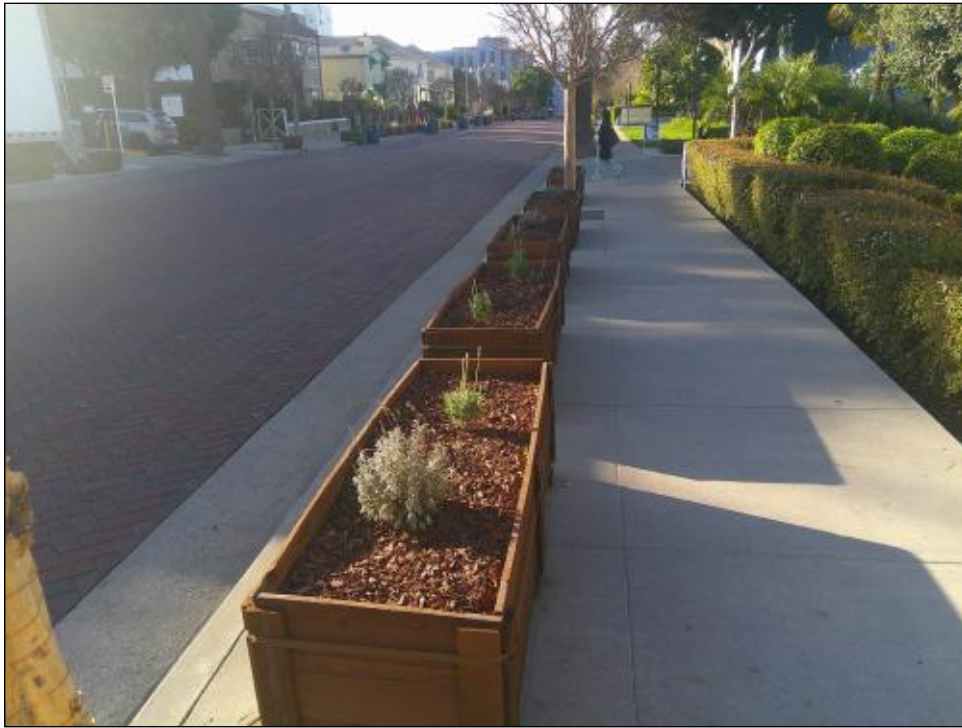
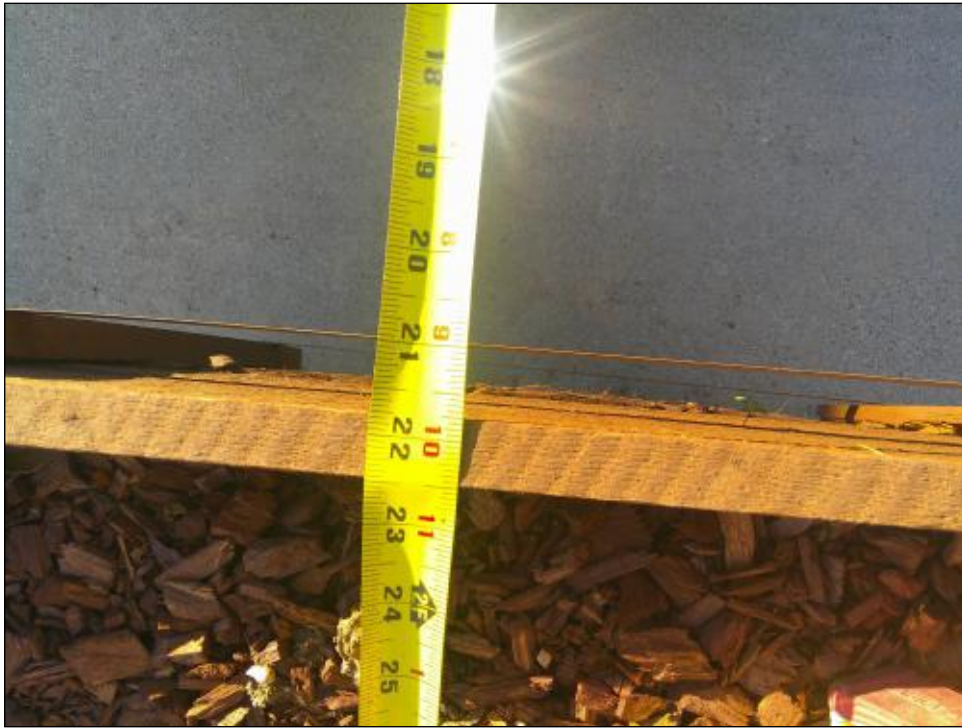
Finding: 11

The route of travel does not provide the required minimum width.

2022 CBC 11B Section: 11B-403.5.1 Exceptions: 3

Planter boxes have been installed on the entire sidewalk without a path of travel between them to cross the street or to be dropped off. Suggest new vegetation with 6" max. height with city permit.

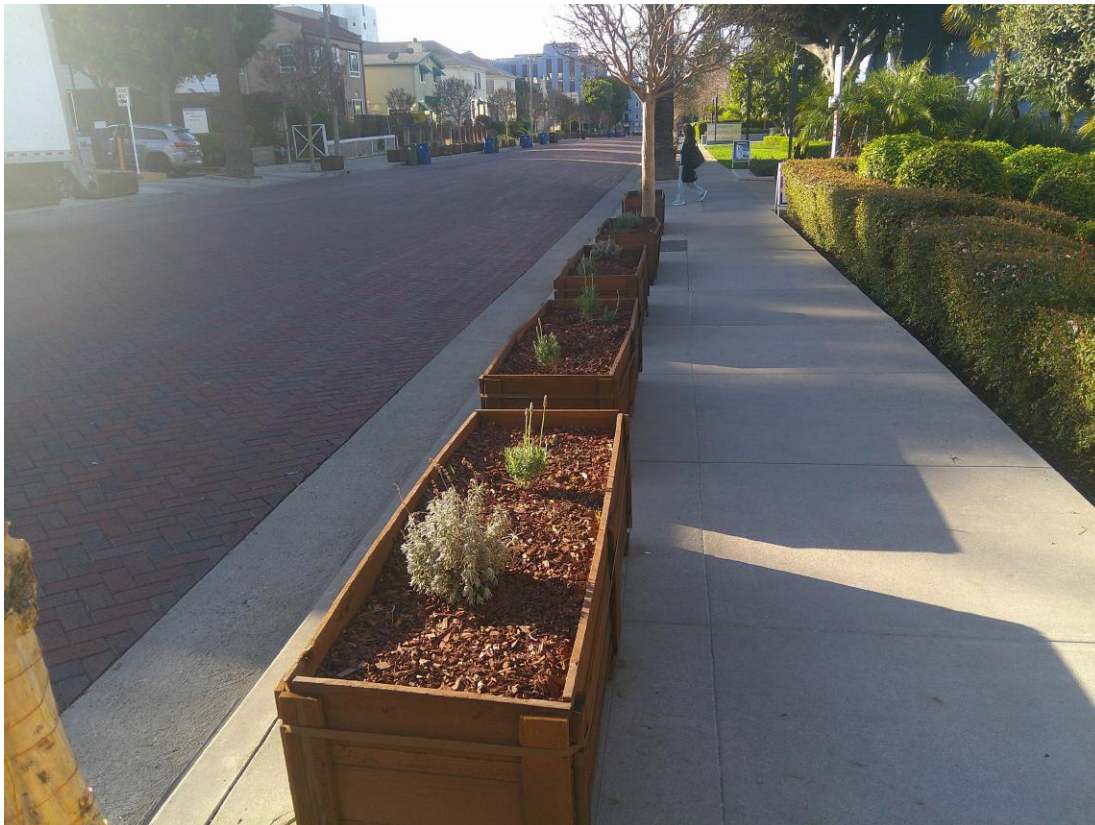
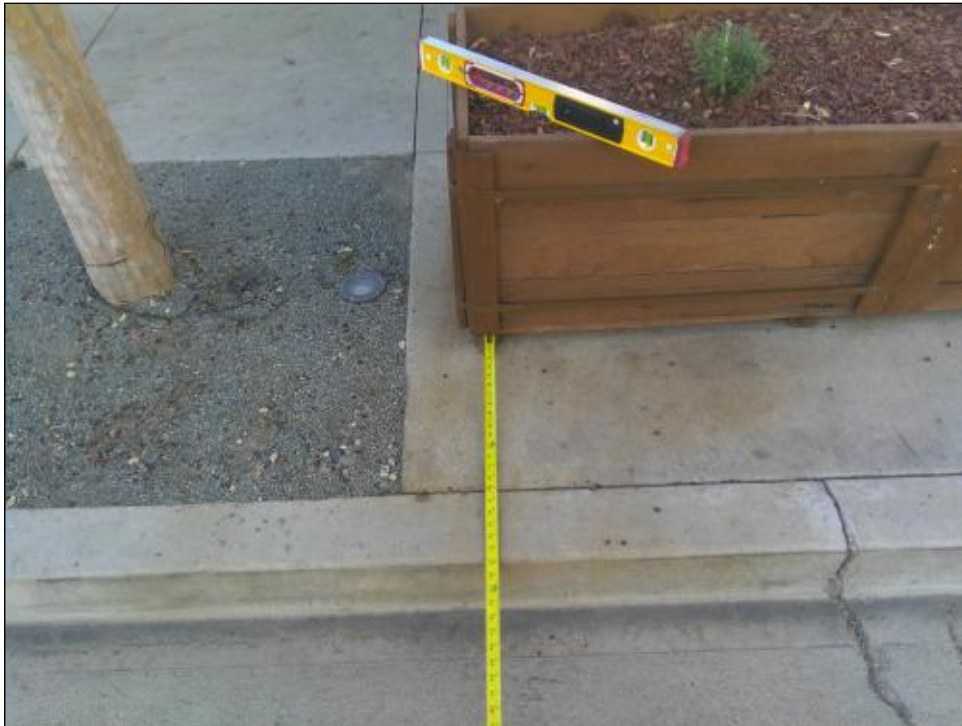
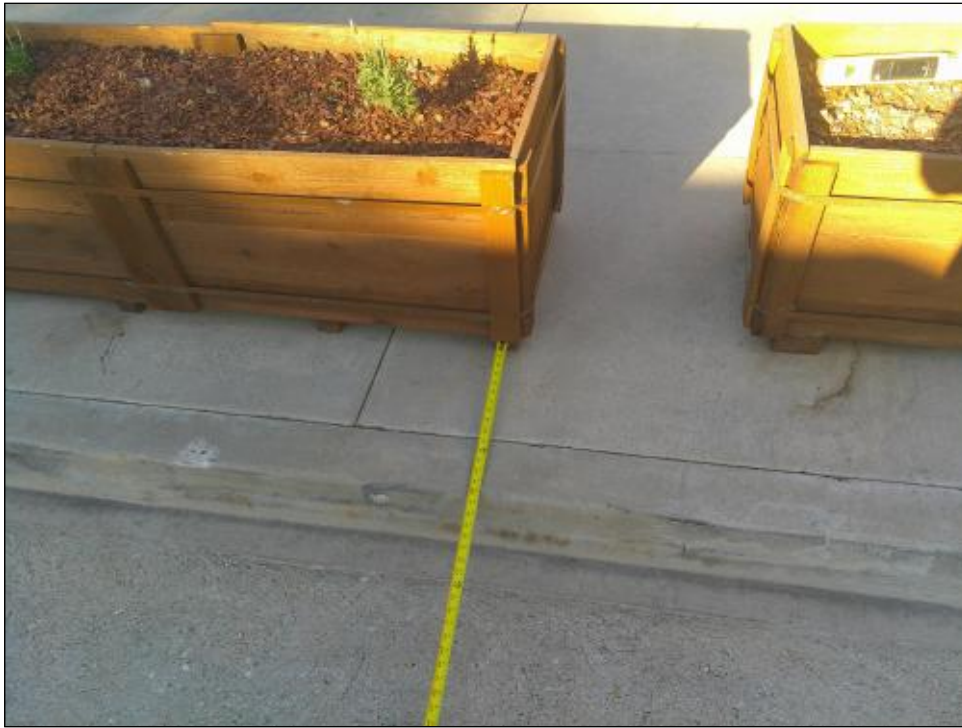
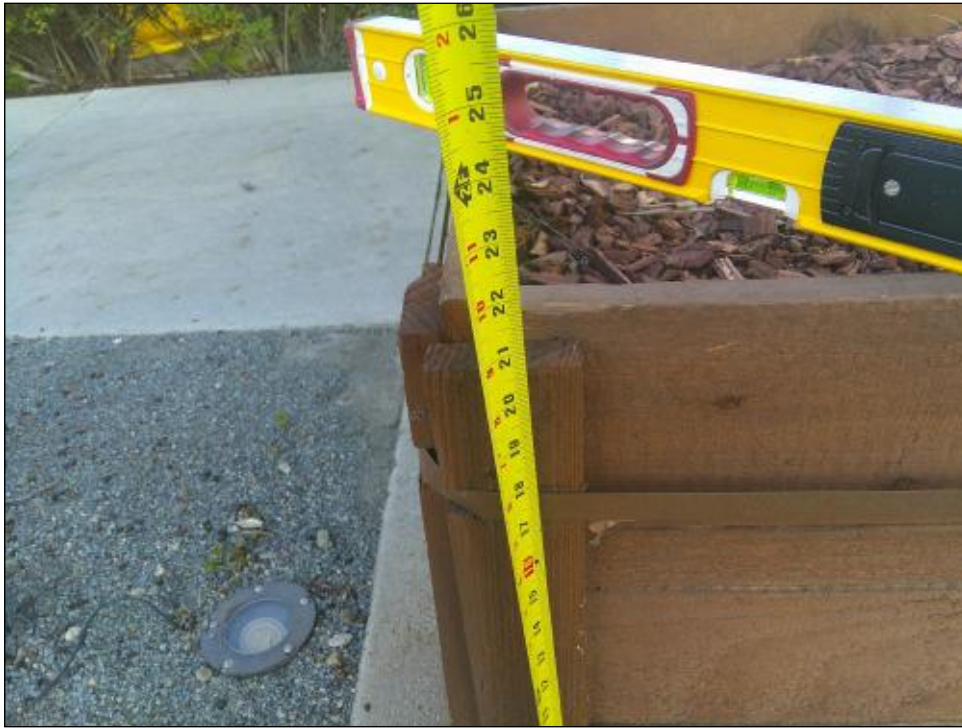
Finding: 12

The planter boxes are too high and close to the curb if a disabled person wanted to be dropped off.

Suggest removing oversized planter boxes and install vegetation with a 6" max height with a city permit.

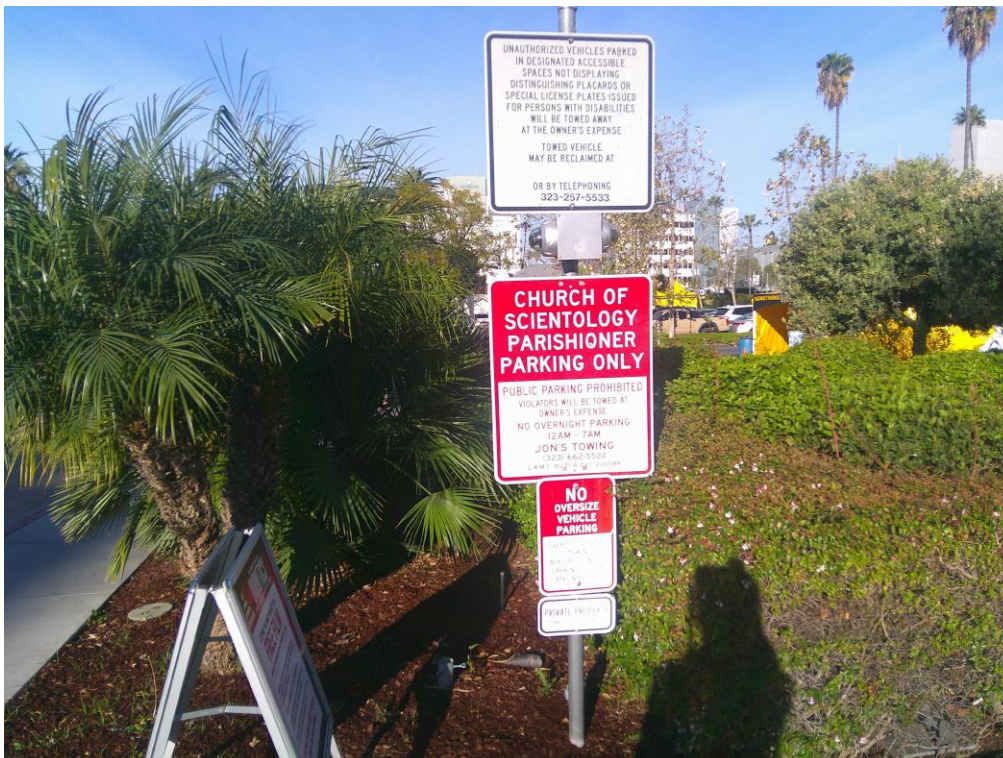
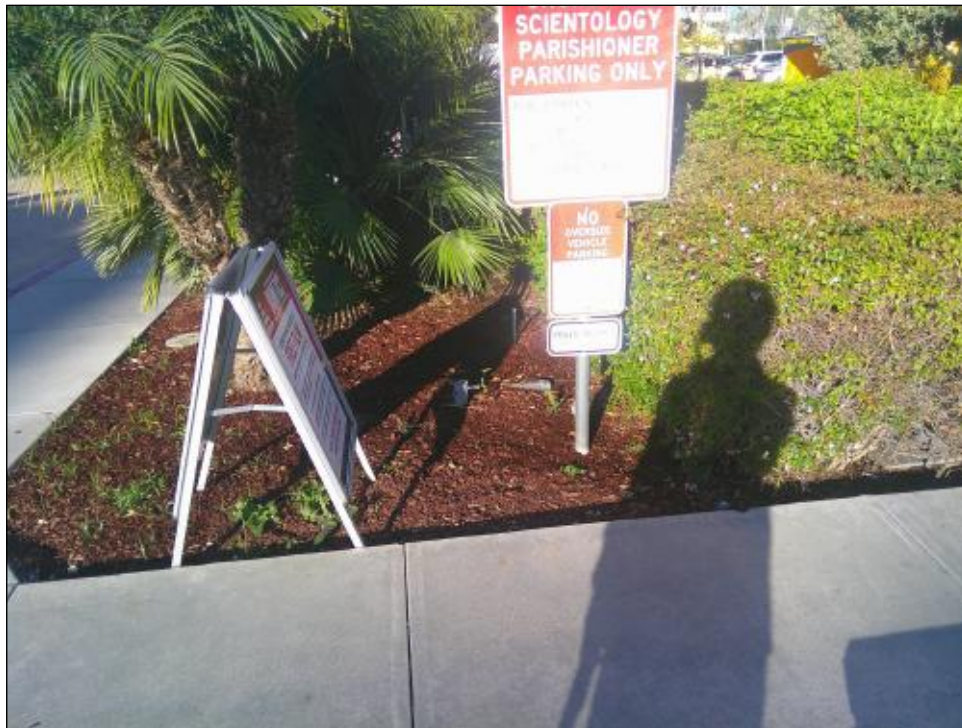
Finding: 13

Signs state this is private parking.

After speaking with Church of Scientology staff they are open for new members however, there is no parking for disabled persons nor is there a path of travel from the city sidewalk to the entrance. Suggest a accessible ramp and city parking.

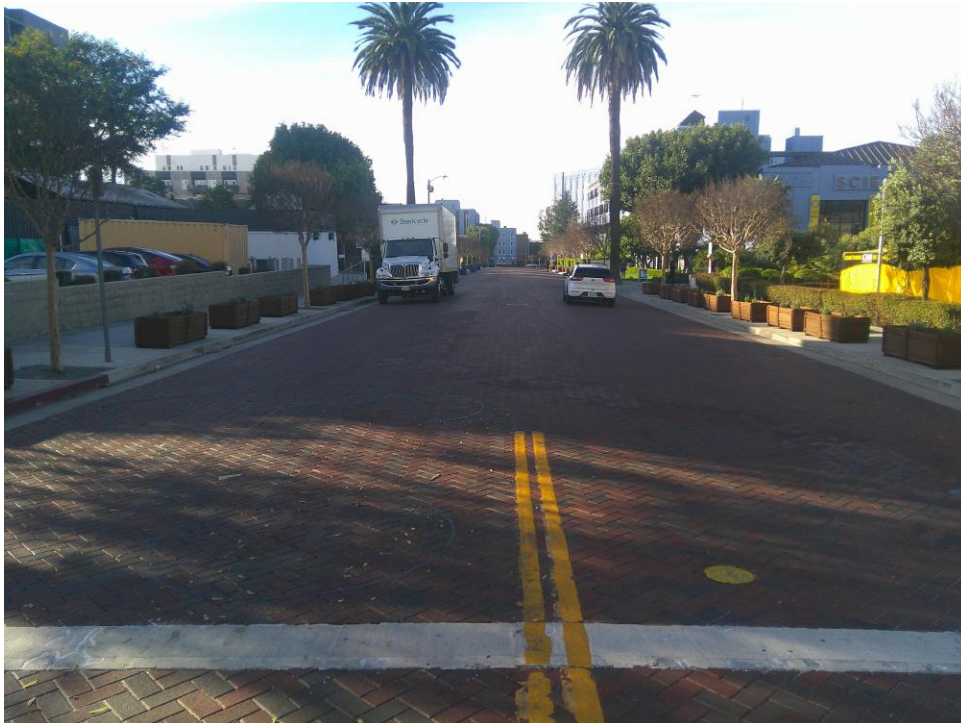
Finding: 14

L. Ron Hubbard Way is 40 lf. wide and appears to have room for public parking. The curbs are not painted red however, there are signs posted no parking but do not appear to be city signs.

Suggest the authority having jurisdiction consider public parking so disabled people have access to the public sidewalk by way of city transportation or by car. A second consideration would be to mirror N. Catalina with a one way traffic with parking on both sides.

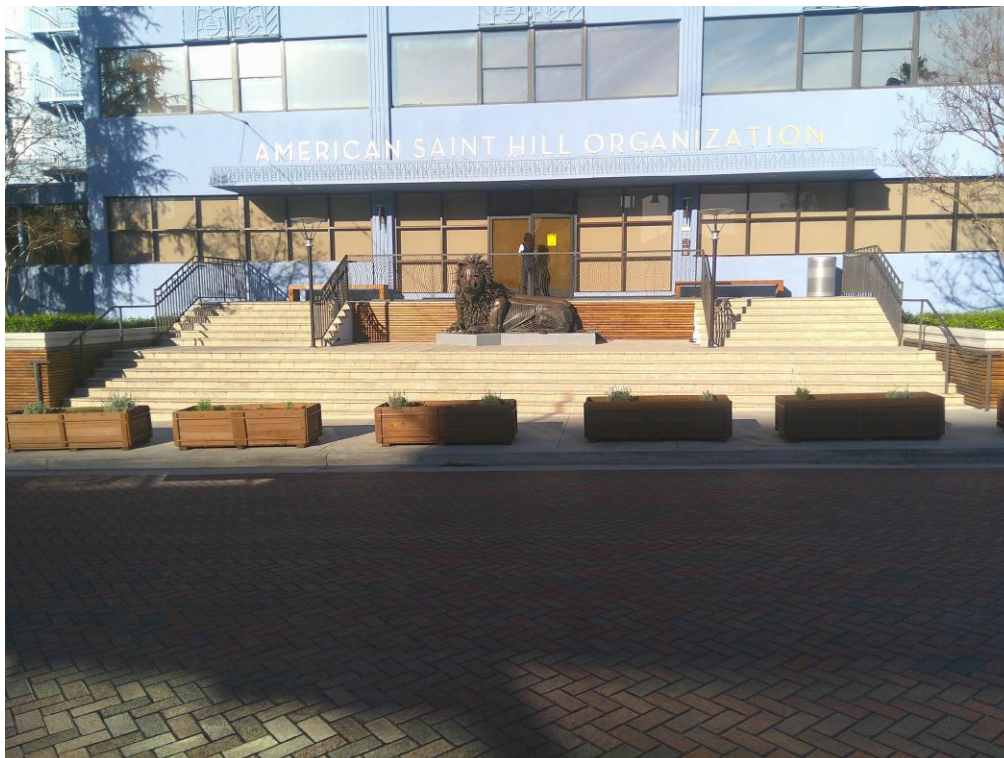
Finding: 15

There is no access from the city street or city sidewalk for access.

If a non-member seeks new membership to fill out an application or meet the director of new membership there is no access. The parking lot signs state this is private parking and you cannot park on the street.

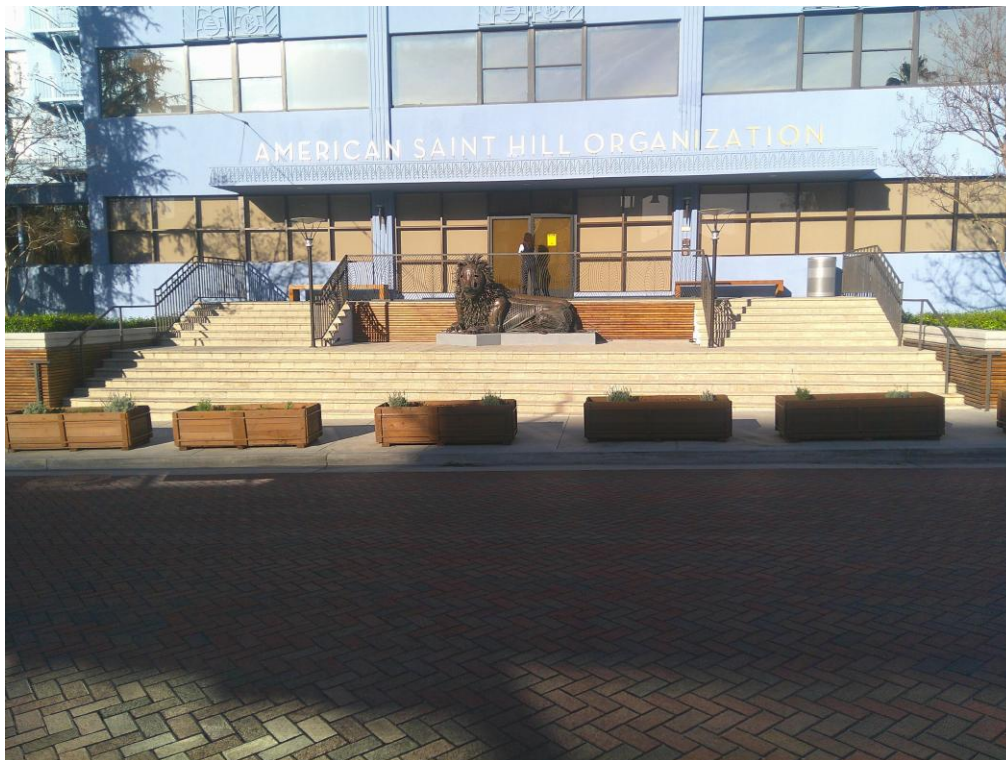
Finding: 16

No access from the city parking or drop off.

I believe the Church of Scientology is a private church however, when the church holds events open to the public they must be accessible. Suggest bringing the property, street parking and city sidewalk into compliance.

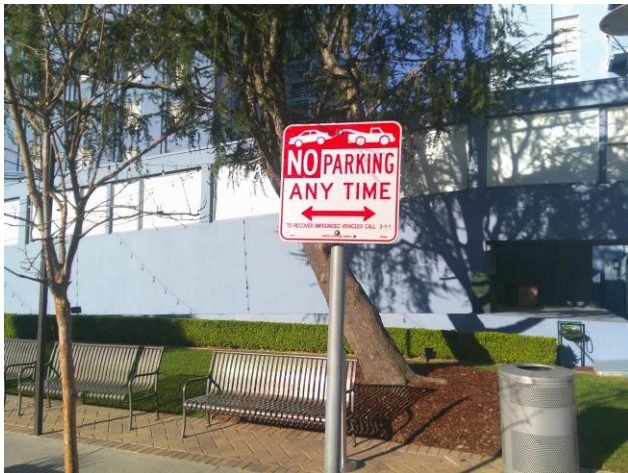
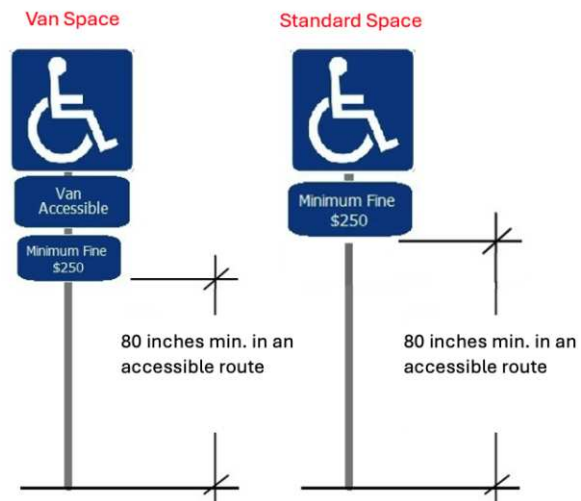
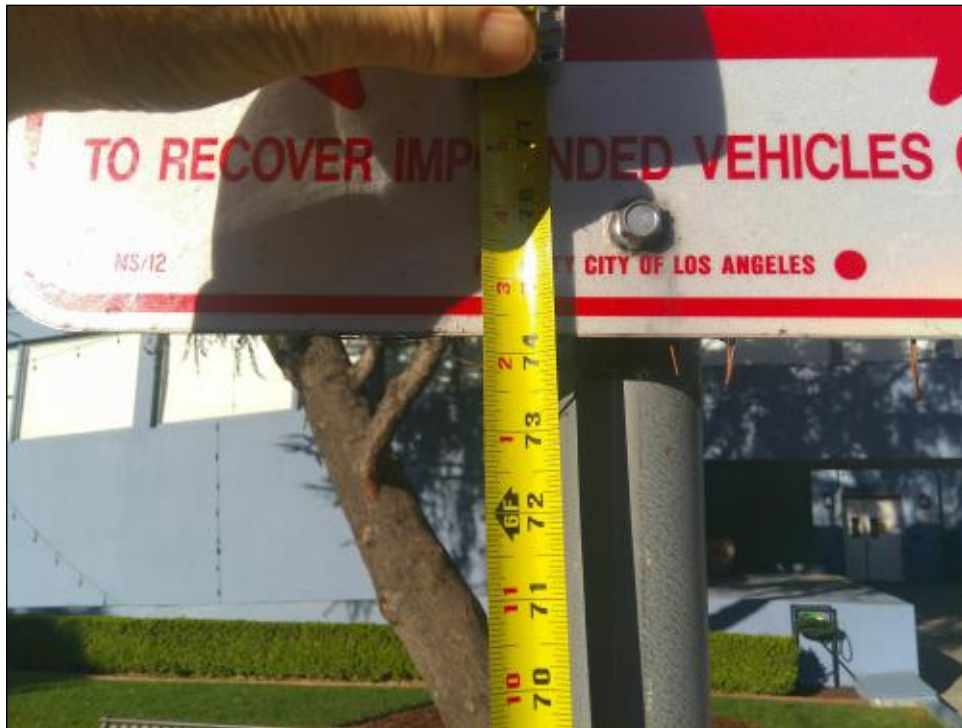
Finding: 17

The sign is mounted too low.

2022 CBC 11B Section: 11B-502.6
