Site Accessibility Evaluation

**L. Ron Hubbard Way to N.
Catalina Street
East Hollywood, CA 90027**

CASp Evaluation

Inspection Date: 02/27/2025

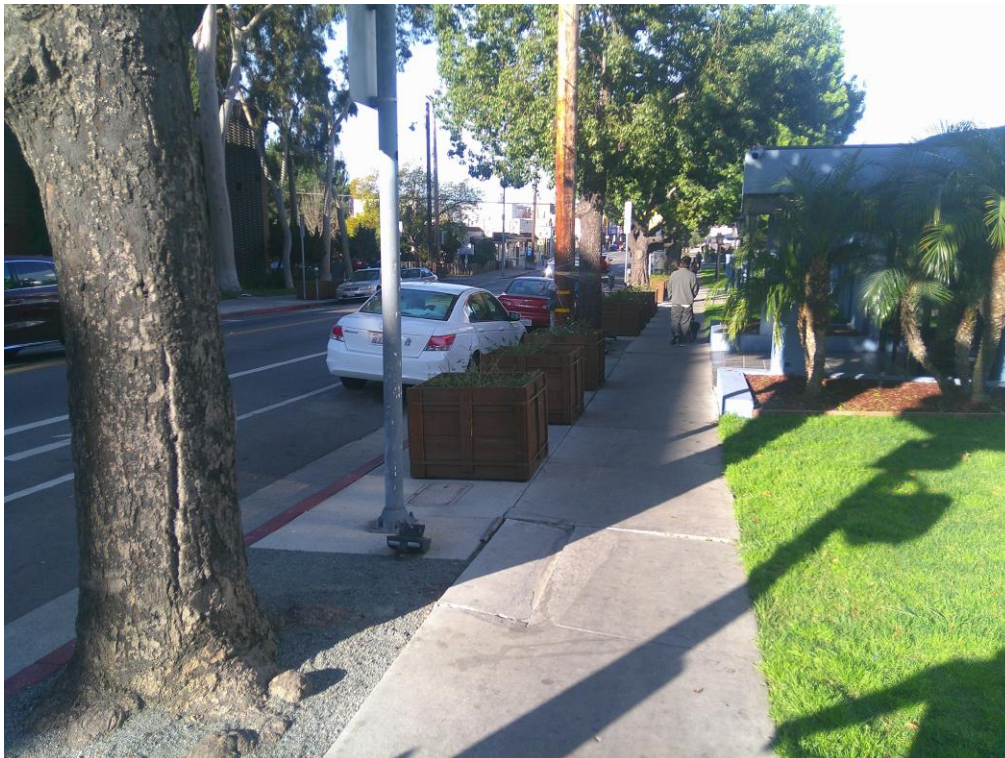
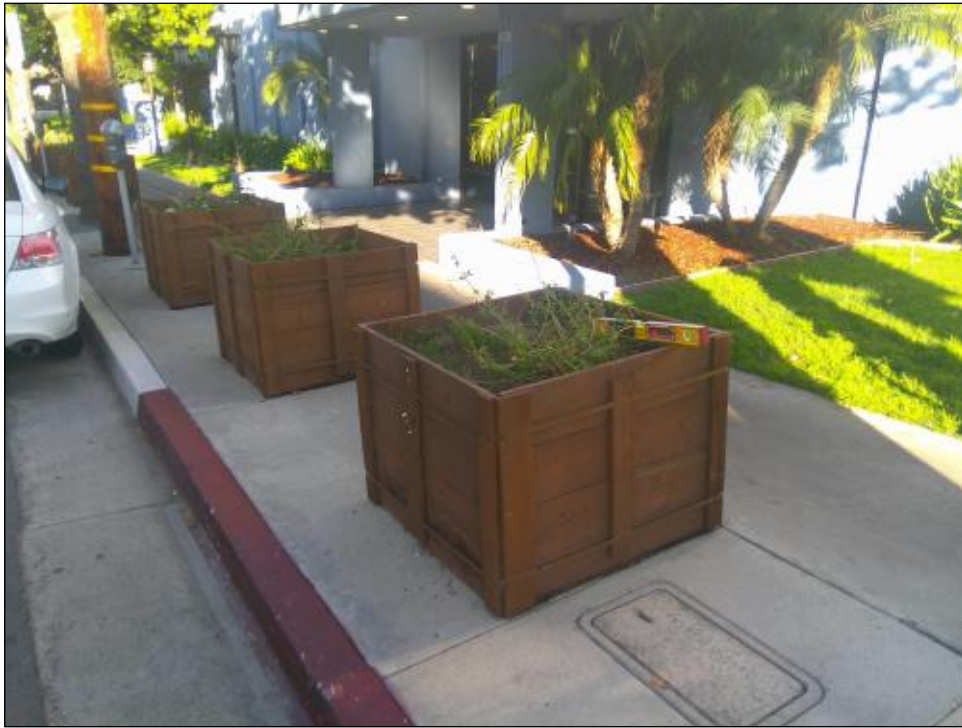
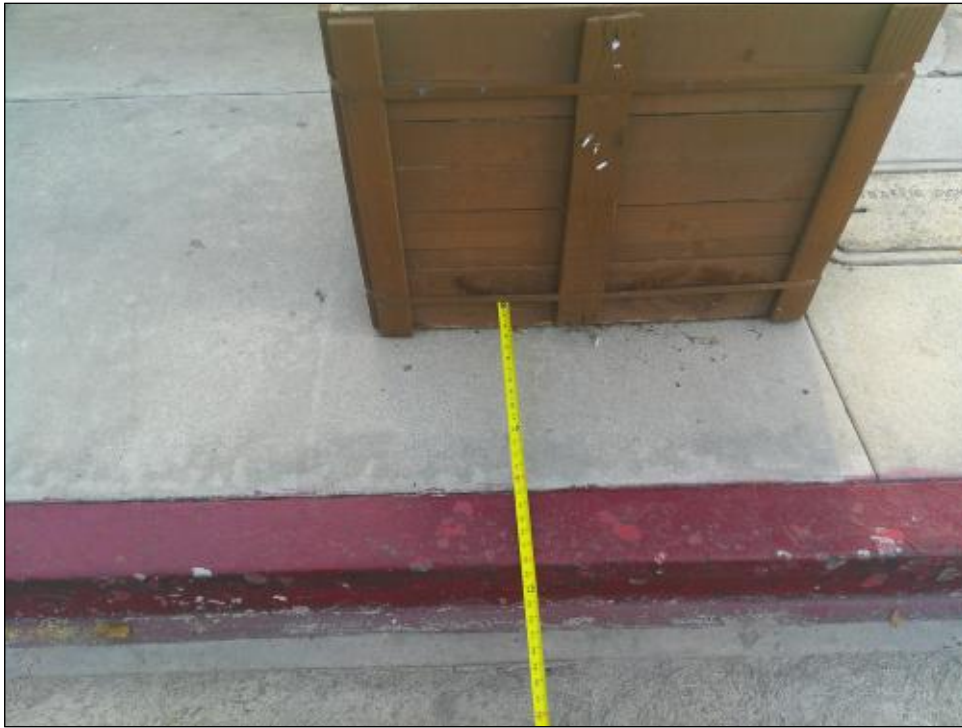
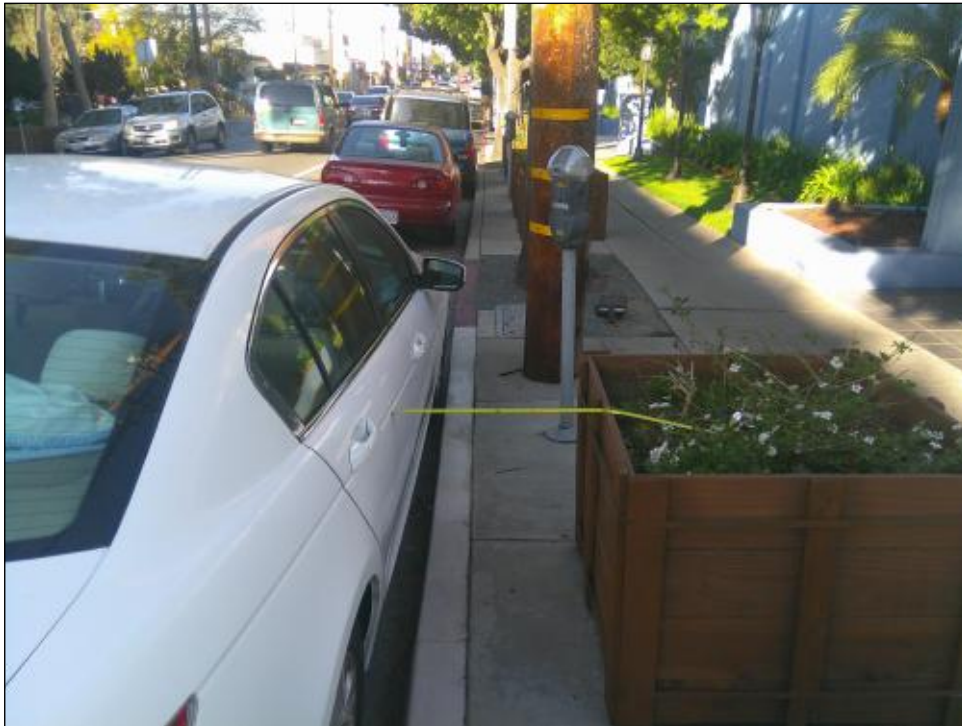
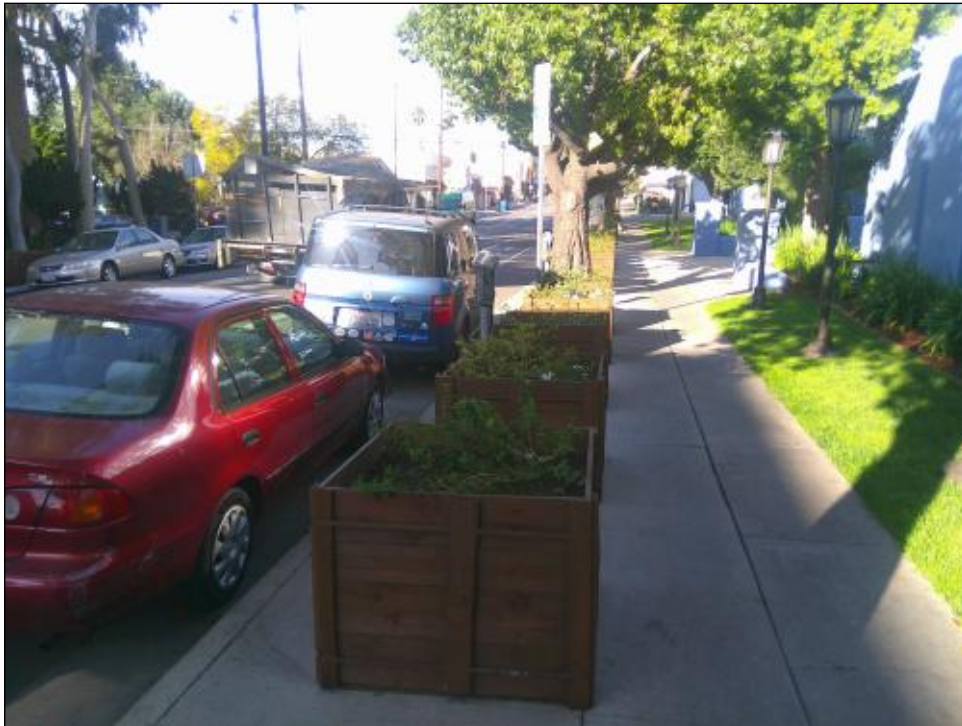
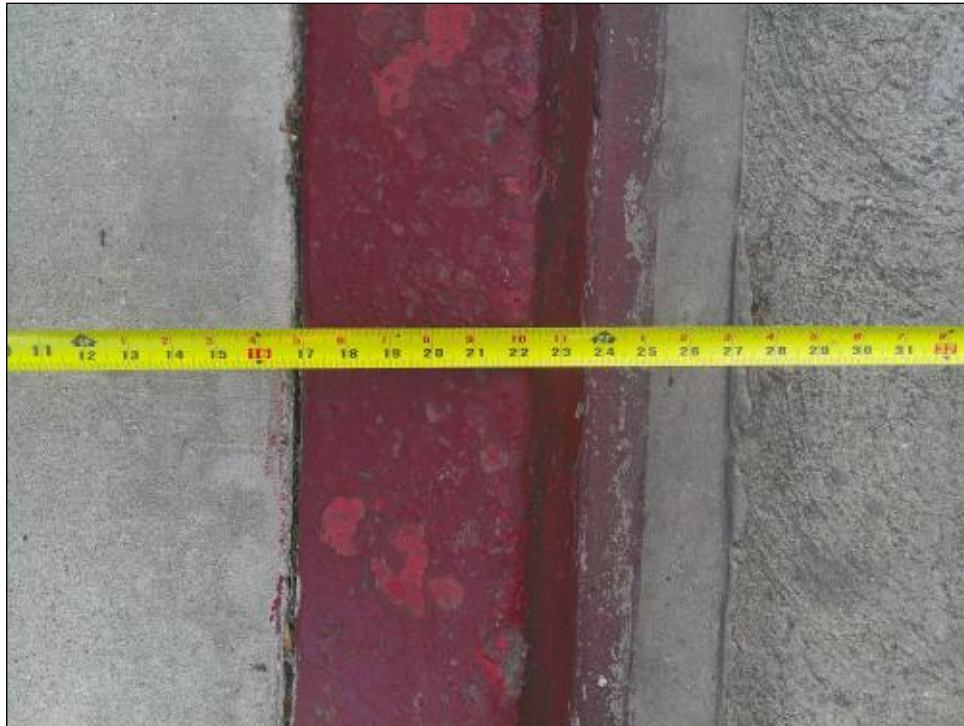
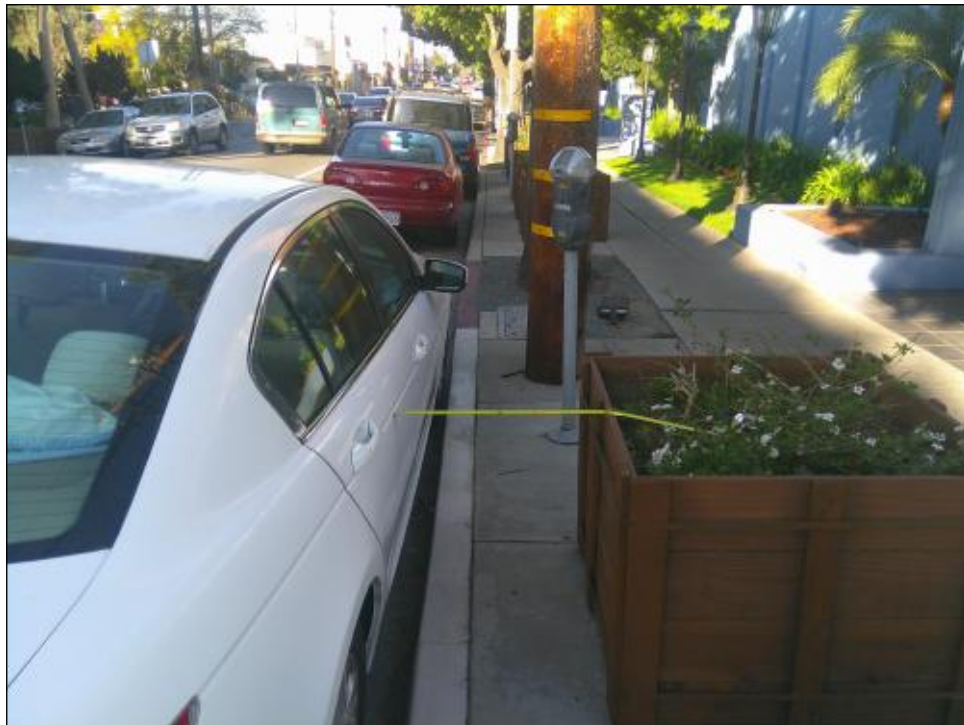
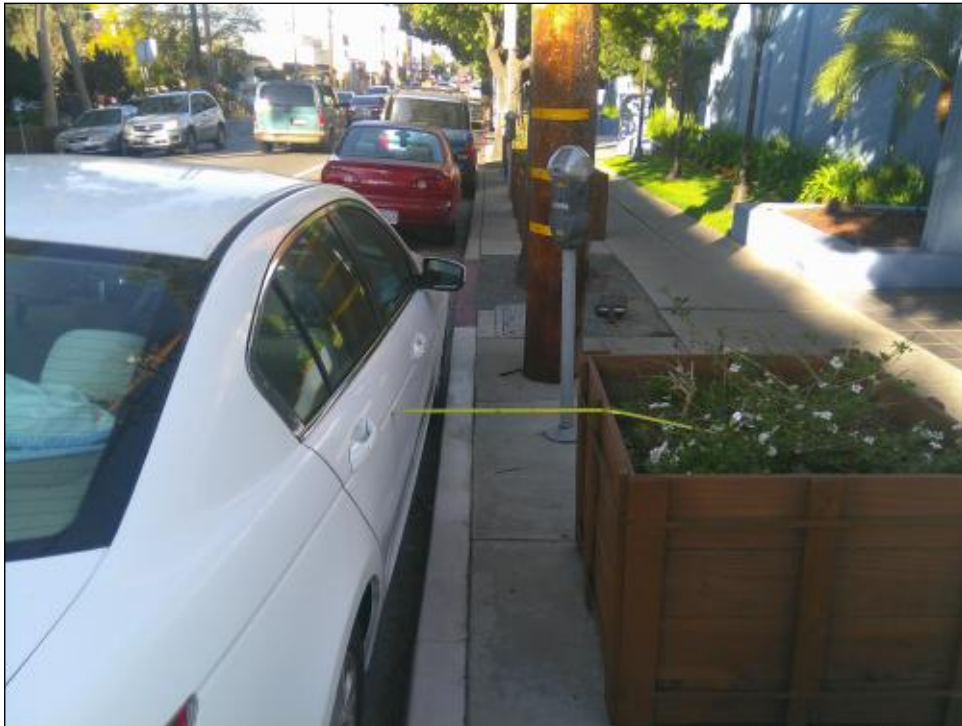
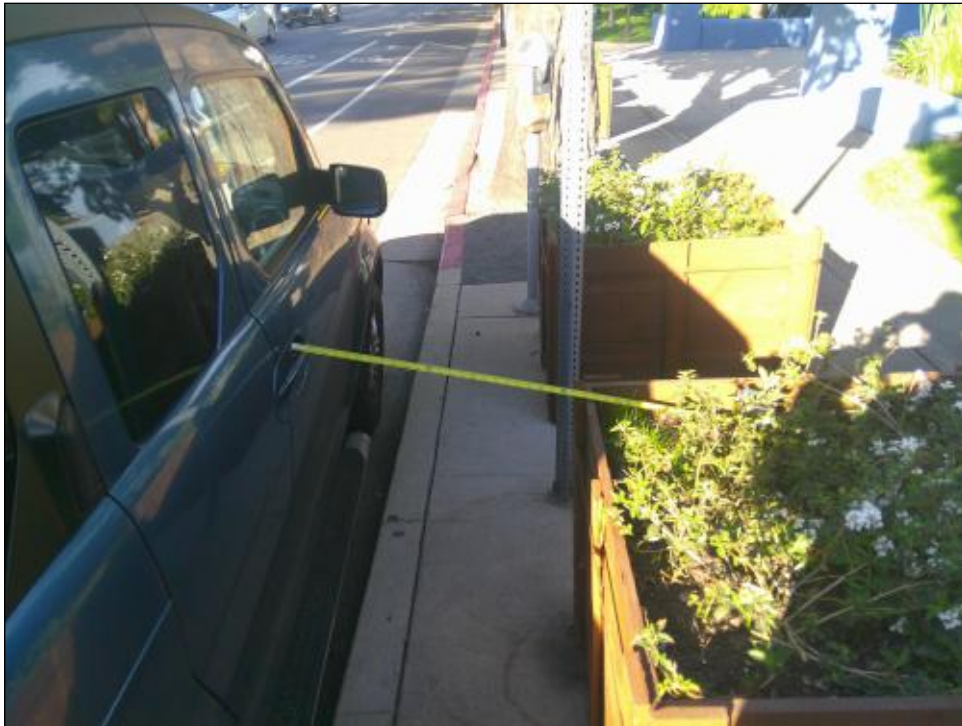
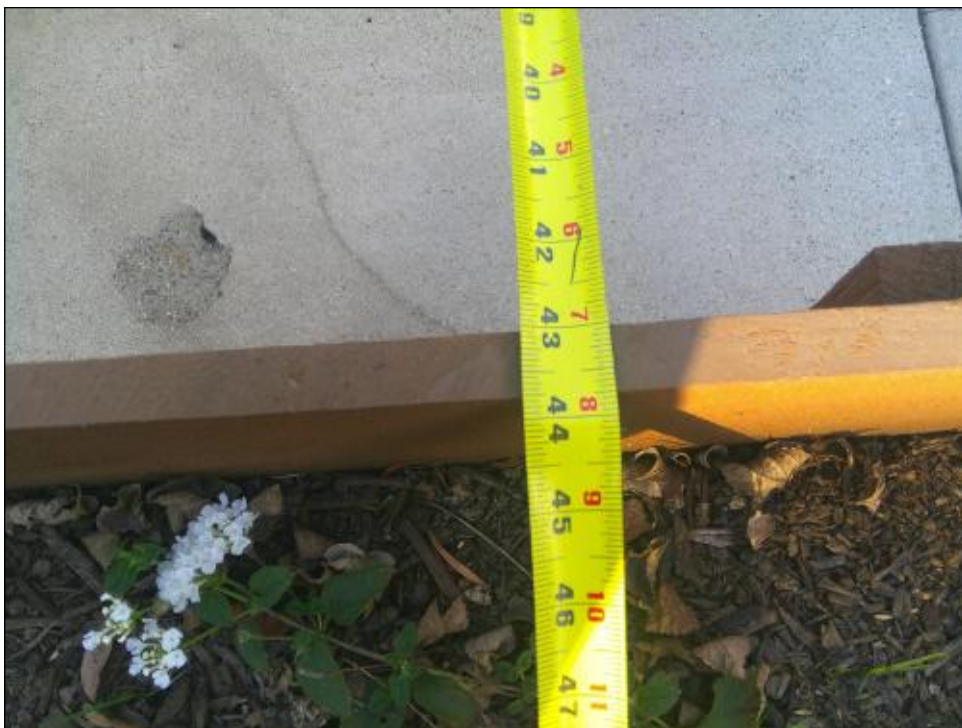
Finding: 18

The planter boxes are too high, and too close to the city curb. People with and without disabilities struggle to open their doors and exit their cars. Additionally, there is not a 48" min. path of travel between the boxes.

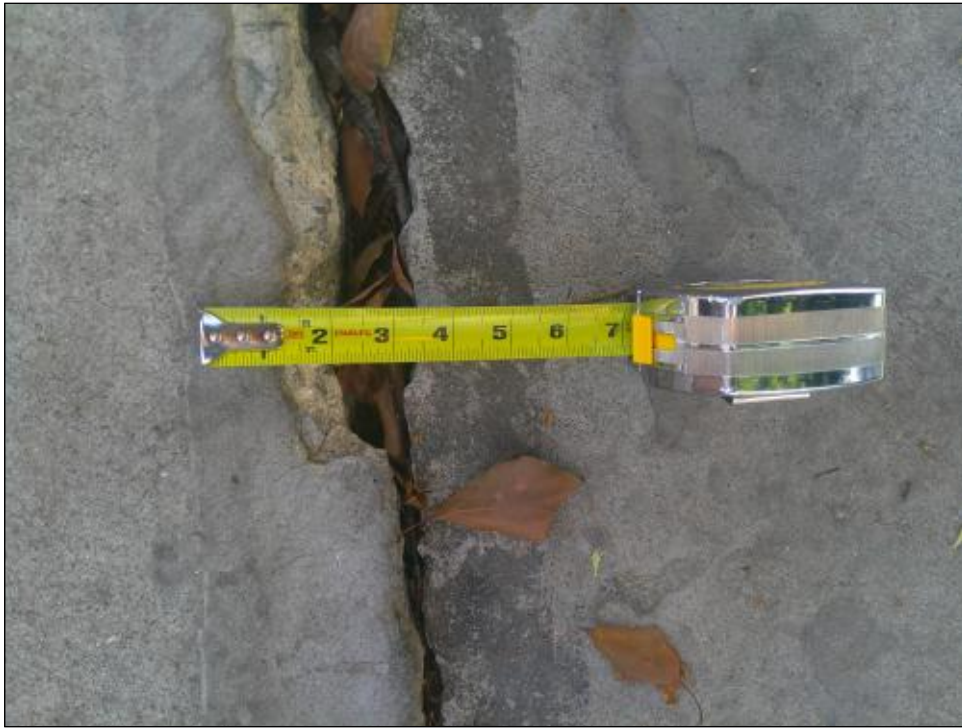
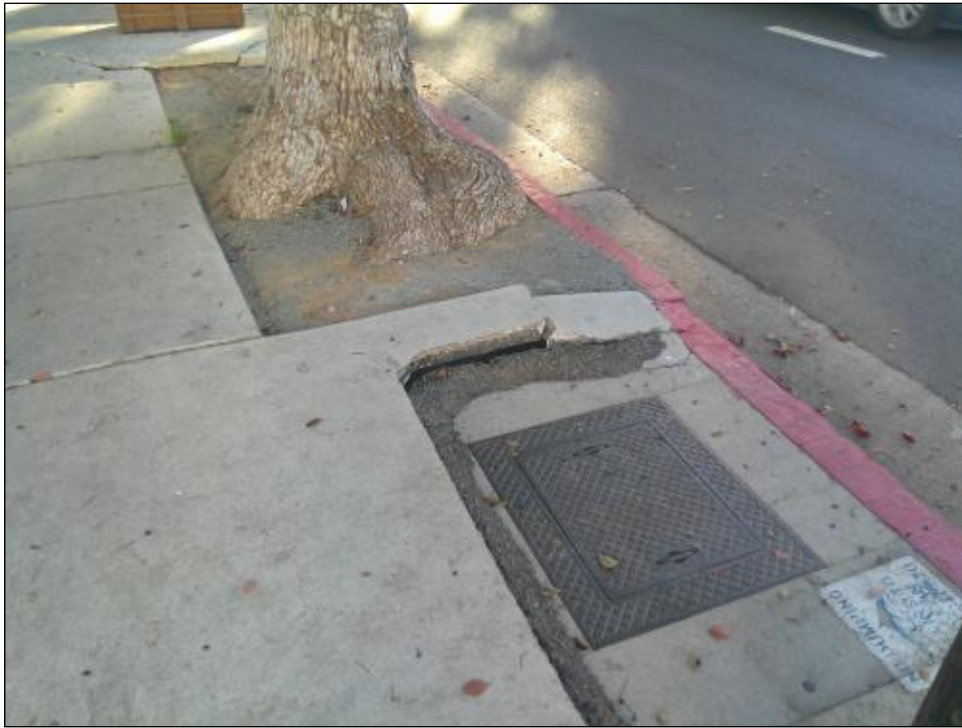
Finding: 19

The walkway contains abrupt vertical edges and/or variations over 1/4 inch.

2010 ADAS Section: 303.3, 303.2

2022 CBC 11B Section: 11B-303.2, 11B-303.3

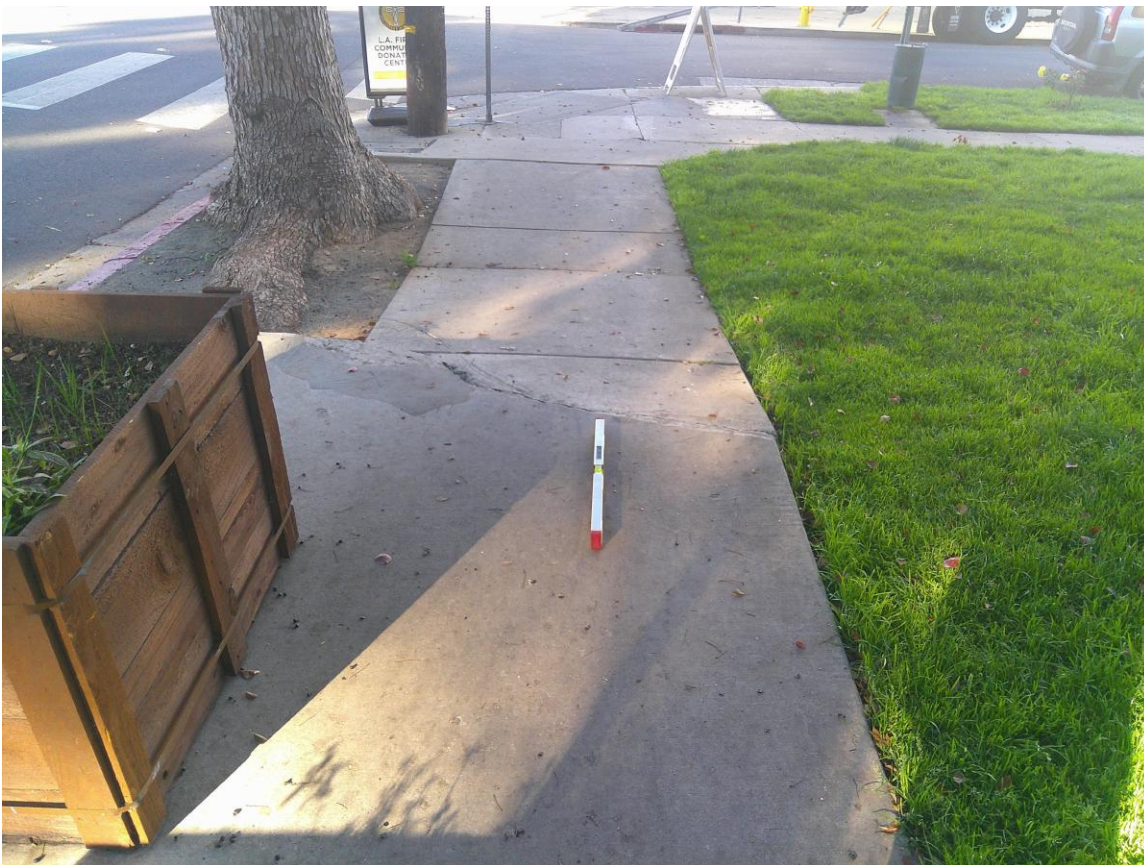
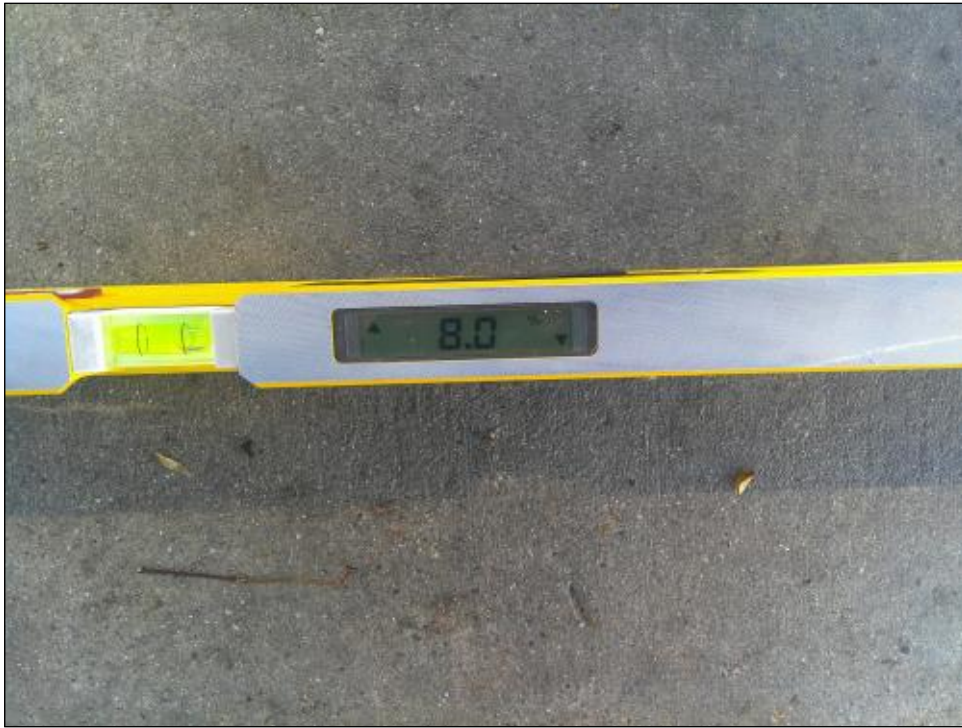
Finding: 20

The sidewalk does not follow the general grade of the adjacent street.

2022 CBC 11B Section: 11B-403.3 Exception:

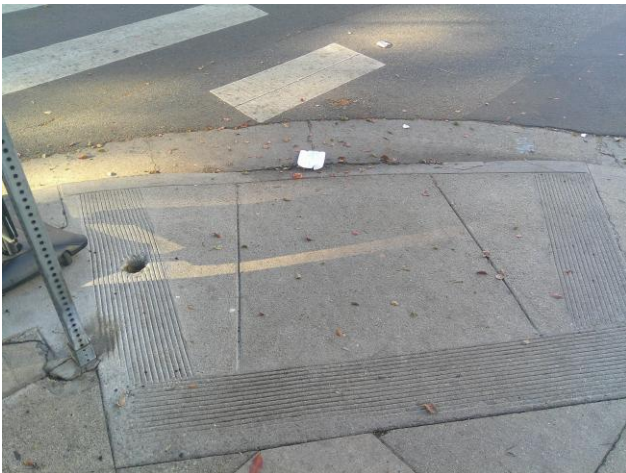
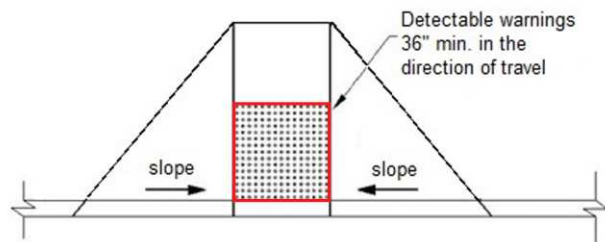
Finding: 21

Detectable warnings at curb ramps shall extend the full width of the curb ramp excluding any flared side and 36 inches in the direction of travel.

Detectable warnings shall extend the full width of the turning space at the flush transition between the street and the sidewalk less 2 inches maximum on each side.

2022 CBC 11B Section: 11B-705.1.2.2

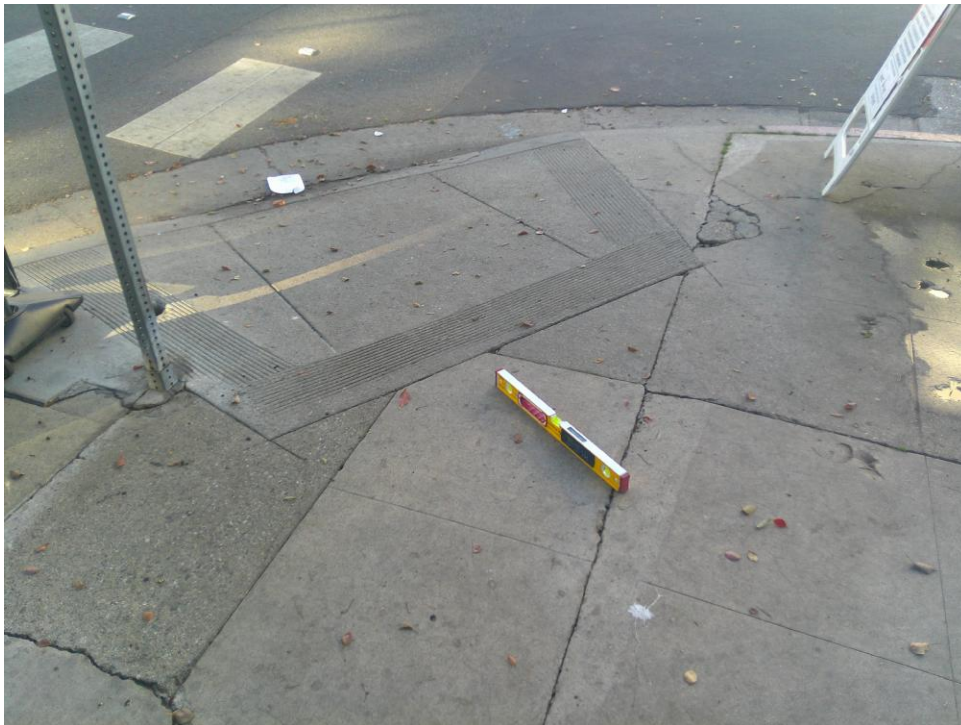
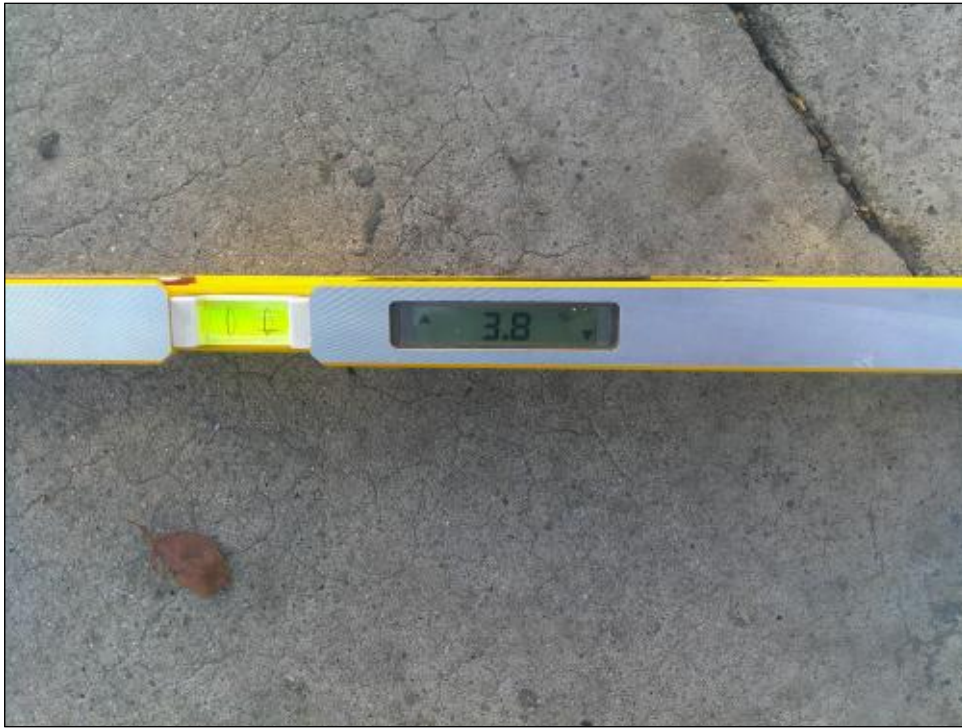
Finding: 22

The landing of the ramp has a slope greater than 2 percent.

2010 ADAS Section: 406.4, 406.4 Exception

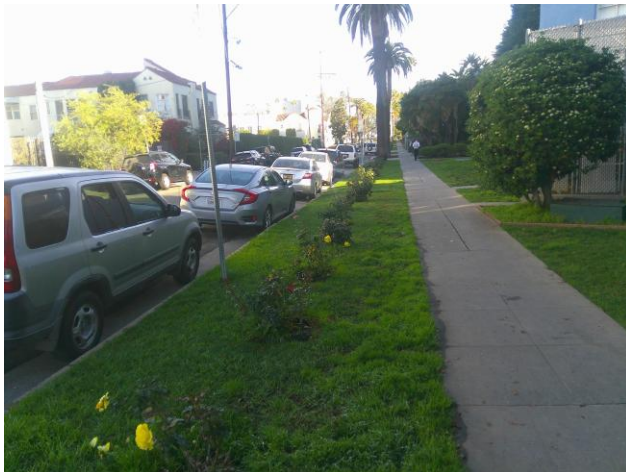
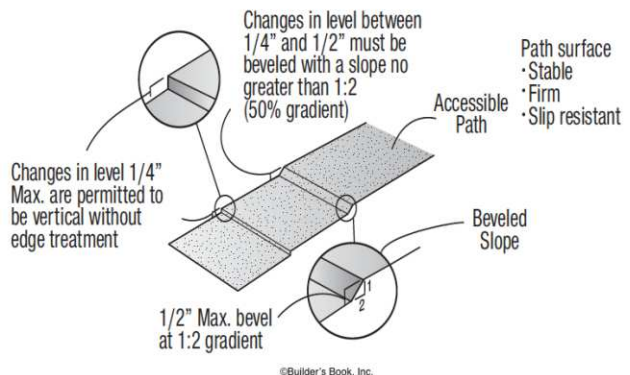
Finding: 23

The accessible route contains loose vegetation and/or surface materials that do not provide for a stable, firm slip resistant surface.

Suggest installing a firm path of travel for persons with disabilities that operate vehicles since the adjacent site is private parking. Additionally, suggest a different type of plant other than a thorny rose bush that makes it difficult for persons with or without disabilities.

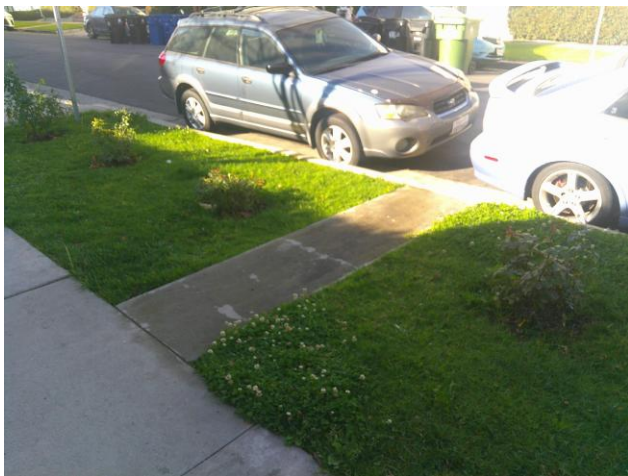
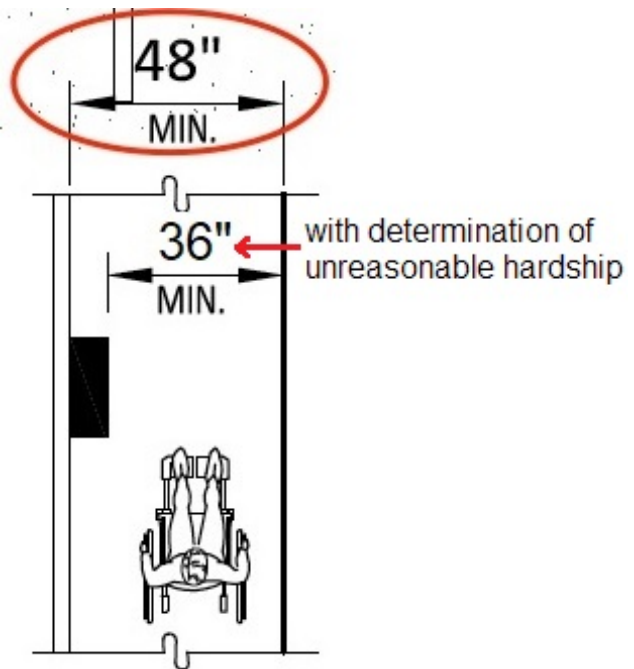
Finding: 27

When, because of right-of-way restrictions, natural barriers or other existing conditions, the enforcing agency determines that compliance with the 48-inch clear sidewalk width would create an unreasonable hardship, the clear width may be reduced to 36 inches.
