RAP Response to CF 25-0006-S23 Status of RAP owned facilities that were impacted by the City Wildfires in January 2025.

Site Assessment Report

Facility Name: Palisades Recreation Center
Facility Address: 851 Alma Real Drive, Palisades, CA 90272
Inspection Date: January 30, 2025
Inspection Time: 11:30 AM (Pacific Time)
Inspection Description: Fire Damage Visual Assessment
Prepared by: Bureau of Engineering

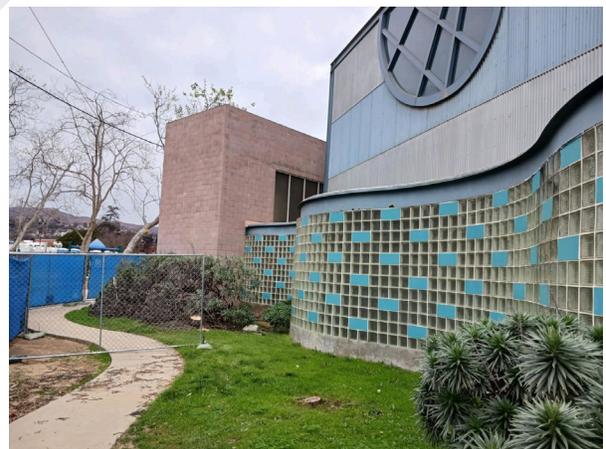
Figure-7

Photo from the main northwest entry, looking along the hallway west of the building.

This entry lobby to the gymnasium seems unaffected by the fire. Further destructive investigation is necessary to identify the extent of fire and water damage in the ceiling and wall cavities.

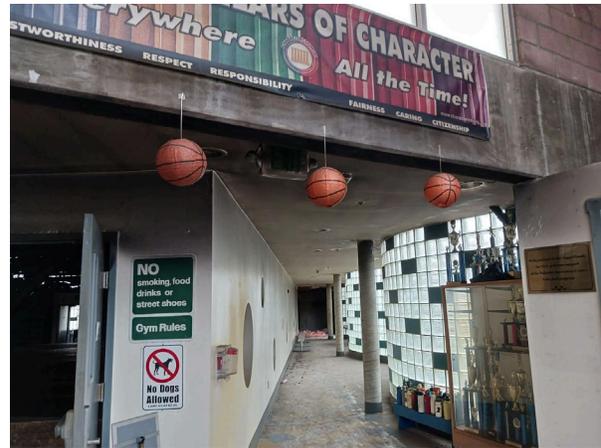
Figure-8

Photo from the southwest entry, looking along the hallway west of the building.

This entry shows a portion of the ceiling is damaged by the fire, otherwise the rest of the hallway seems intact. Further destructive investigation is necessary to identify the extent of fire and water damage in the ceiling and wall cavities.

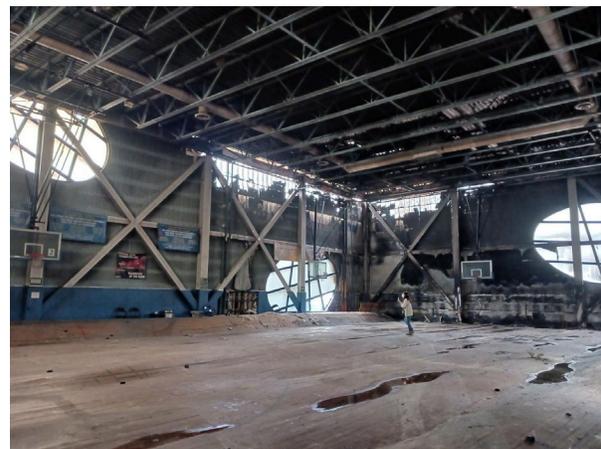
Figure-10

Photo of gym southwest interior corner.

Similar damage was sustained in this area of the gymnasium.

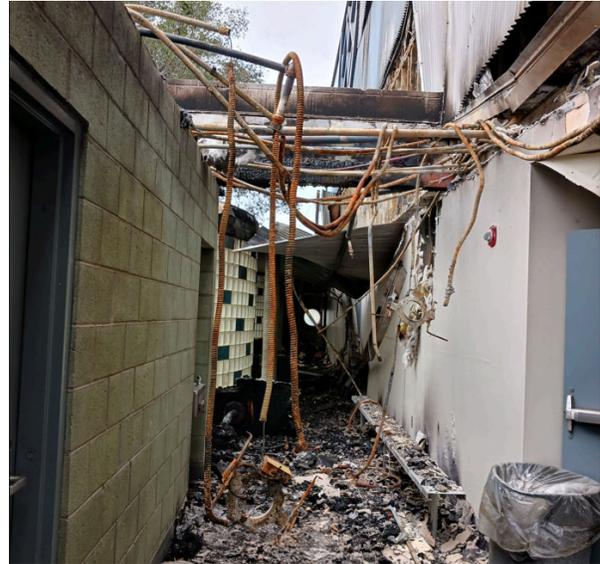
Figure-13

This portion of the building is completely burned down. Most of the glass blocks along the corridor are broken and need replacement. Further destructive investigation is necessary to identify the extent of fire and water damage in the framed wall cavities. Debris removal is required to further assess the slab beneath.

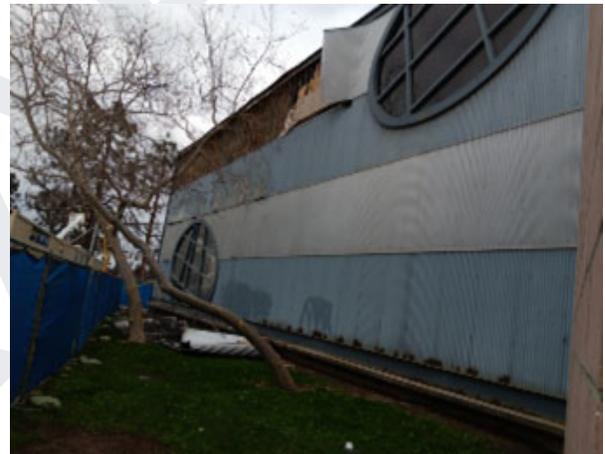
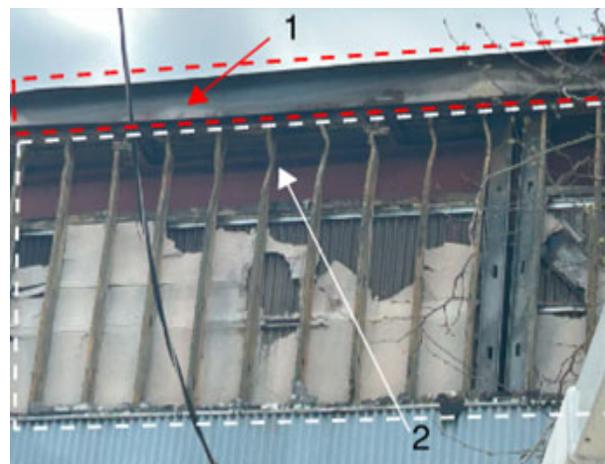
Figure-16a and Figure-16b

The top steel wide-flanged beam (*Label 1*) along the roof perimeter and the cold-formed metal studs (*Label 2*) have been warped due to fire damage and will require in-kind replacement. Additional investigation is needed to evaluate the extent of damage to other structural elements.

Any structural steel components that are not distorted or bent do not need to be replaced.

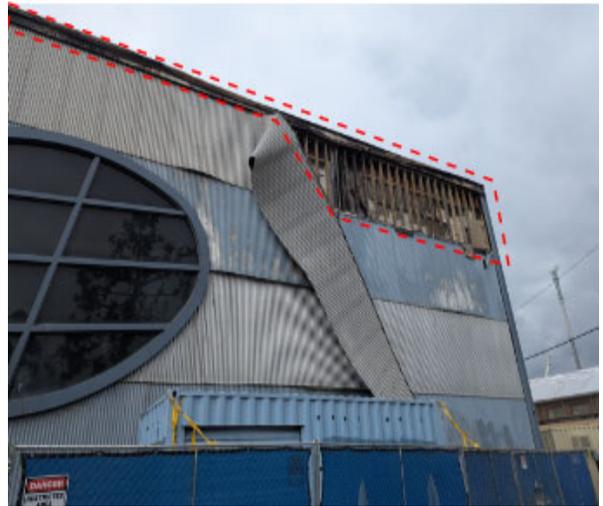
Figure-17

Similar to the north side, the top wide-flanged beam at the roof perimeter and the cold-formed metal studs have warped due to the fire. The top wide-flanged beam along the entire east perimeter of the roof and the warped exterior metal studs must be replaced in kind. Additional investigation is required to determine the full extent of the damage.

Any structural steel components that are not distorted or bent do not need to be replaced.

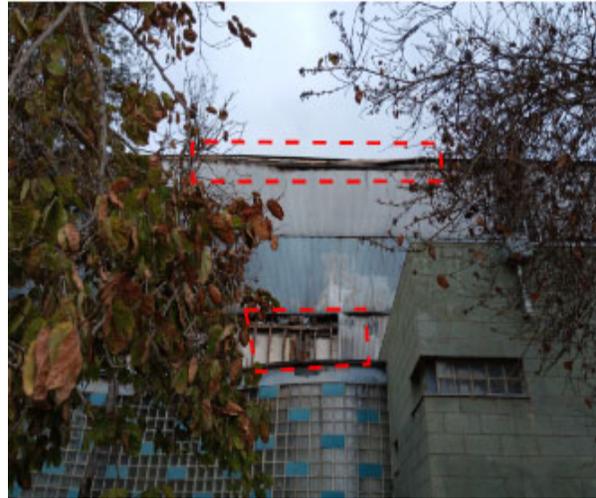
Figure-18

Similar to the northern and eastern sides, the top wide-flanged beam at the roof perimeter and the cold-formed metal studs have warped due to the fire. The top wide-flanged beam along the entire east perimeter of the roof and the warped exterior metal studs must be replaced in kind. Additional investigation is required to determine the full extent of the damage.

Any structural steel components that are not distorted or bent do not need to be replaced.

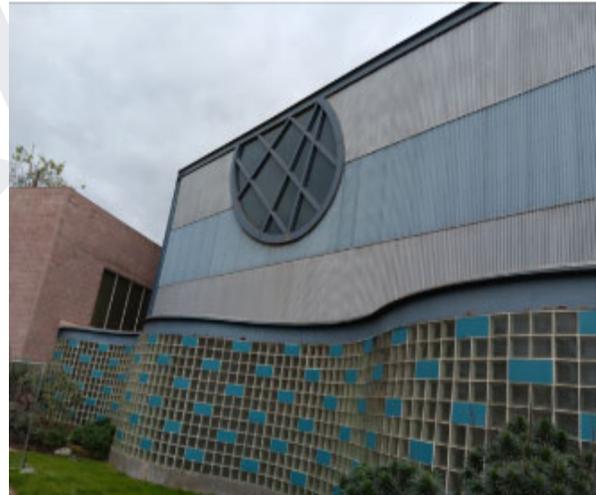
Figure-19

There seems to be no visible damage on the western side of the building.

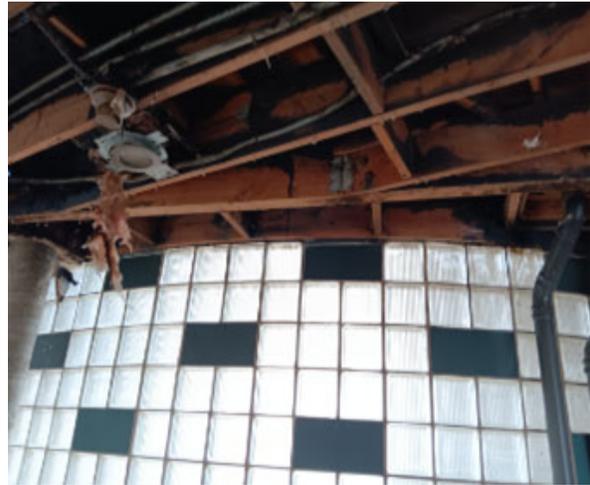
Figure-20

The hallway contains combustible roof structural components, including wood ledgers, wood blocking, ceiling joists, and plywood, which have been charred by the fire. Replace all charred or blackened wood roof members in kind. Additionally, replace the connections supporting the charred wood structural members.

For any water-damaged wood members, replace them in kind as well.

Alternatively, for better fire resistance, replace all wood framing with cold-formed framing to be consistent with the construction type of the gym.

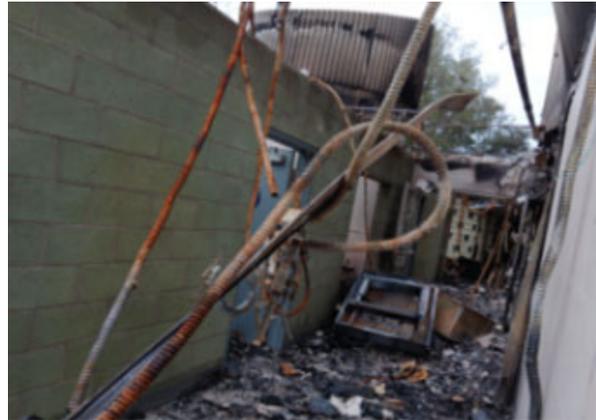
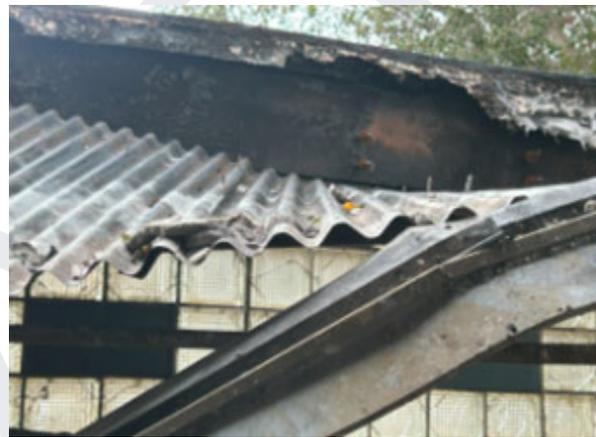
Figure-21a and 21b

A portion of the hallway metal roof deck and steel ledger have collapsed from the fire. To be replaced in kind.

The masonry wall requires further investigation to identify large cracks, excessive deformations, or significant spalling. If the wall exhibits signs of compromised structural integrity due to fire damage, replacement may be necessary.

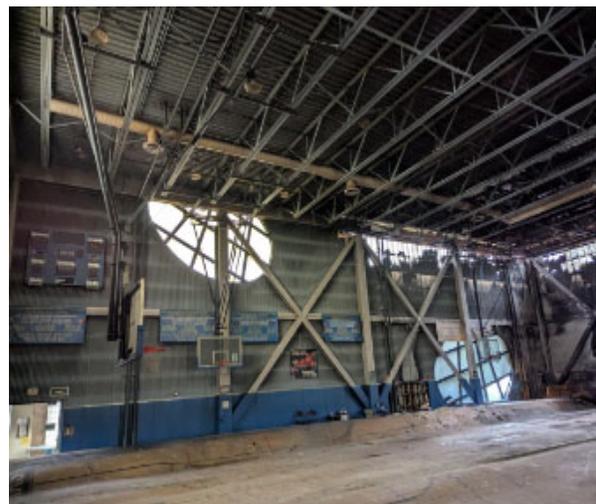
Figure-22

The fire damage is more pronounced at the eastern side of the northern wall in comparison to the western side.

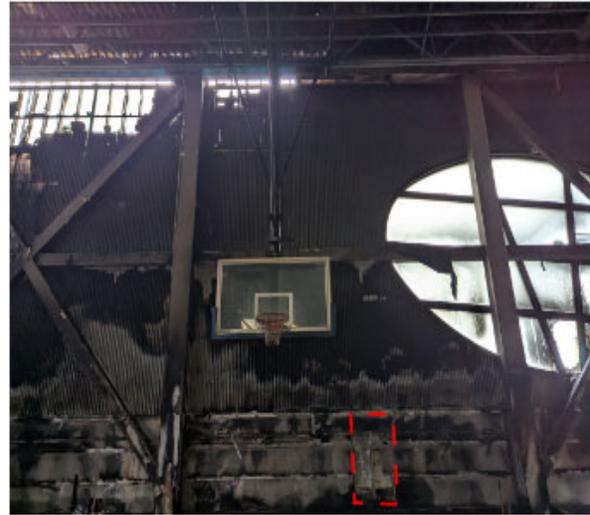
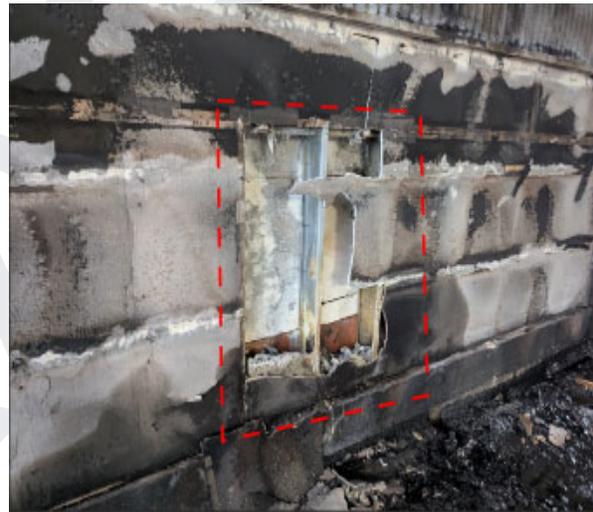
Figure-25

The cold-formed metal studs are exposed due to the damaged fire-resistance rating protection. The studs show yellow discoloration and slight buckling deformation. Replace all deformed cold-formed metal studs in kind.

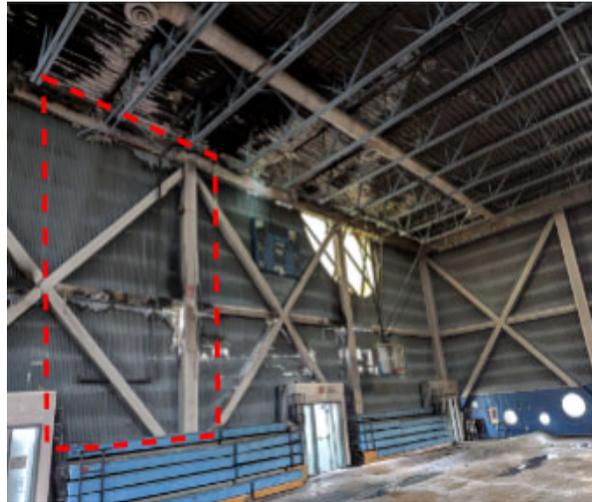
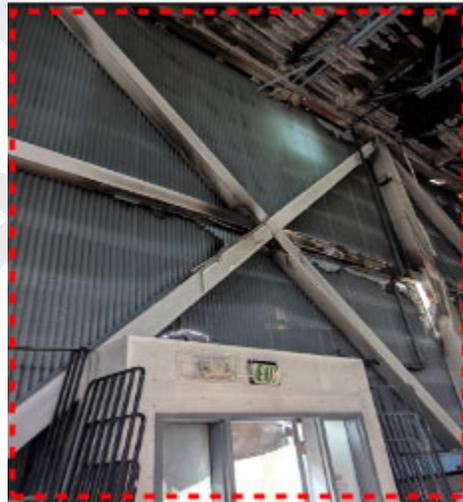
Figure-26

The fire-protection drywall shows sign of fire damage and needs to be removed and replaced.

Inspect the structural steel for signs of deformation after the removal of the damaged drywall.

Any structural steel components that are not distorted or bent do not need to be replaced.

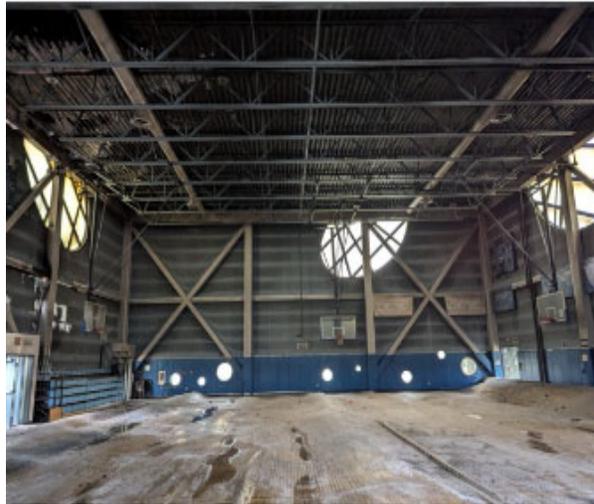
Figure-27

The gym's interior western elevation shows no visible fire damage to the structural brace-frame system.

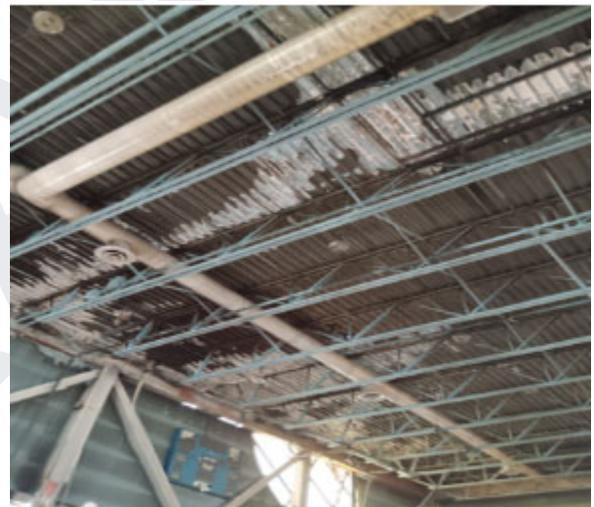
Figure-28

Any deformed steel top chords and braces of the roof trusses must also be replaced in kind. The bottom chords of the roof trusses show no signs of fire damage or deformation.

All fire-damaged metal decking must be replaced in kind.

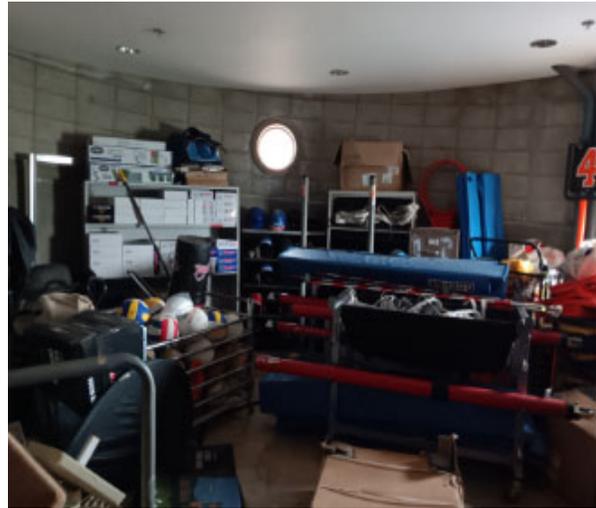
Figure-29

The storage space, enclosed with masonry walls, shows no apparent signs of fire damage.

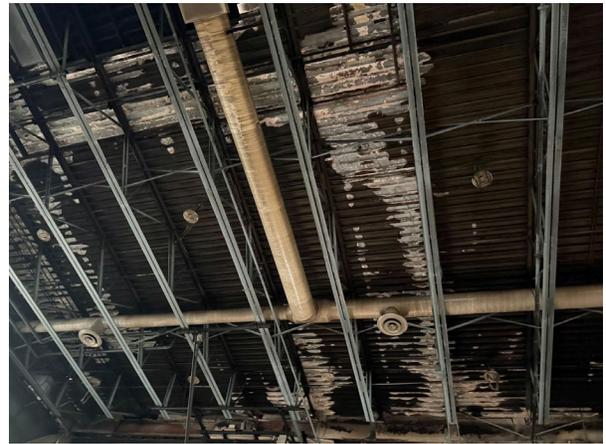
The entire duct system in the gym shows heat warping, soot contamination, and insulation deterioration. Diffusers, vents, and air distribution components are damaged and likely inefficient.

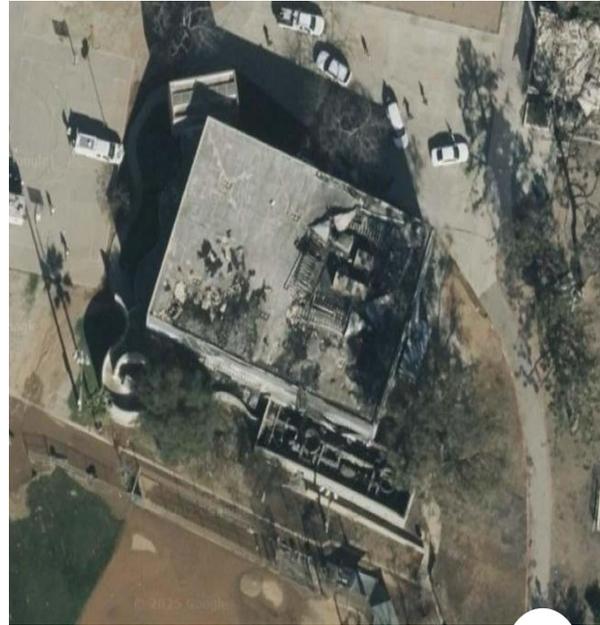
Figure-32

Aerial photo of the gym roof, showing rooftop HVAC units located on the burned section of the building.

Due to safety concerns, we were unable to access the roof to assess mechanical equipment directly. However, given the severity of fire exposure and damage to interior mechanical systems, it is highly likely that all rooftop HVAC equipment has been compromised and should be fully replaced. The structural framework supporting mechanical systems should undergo a full engineering review and possible reinforcement.

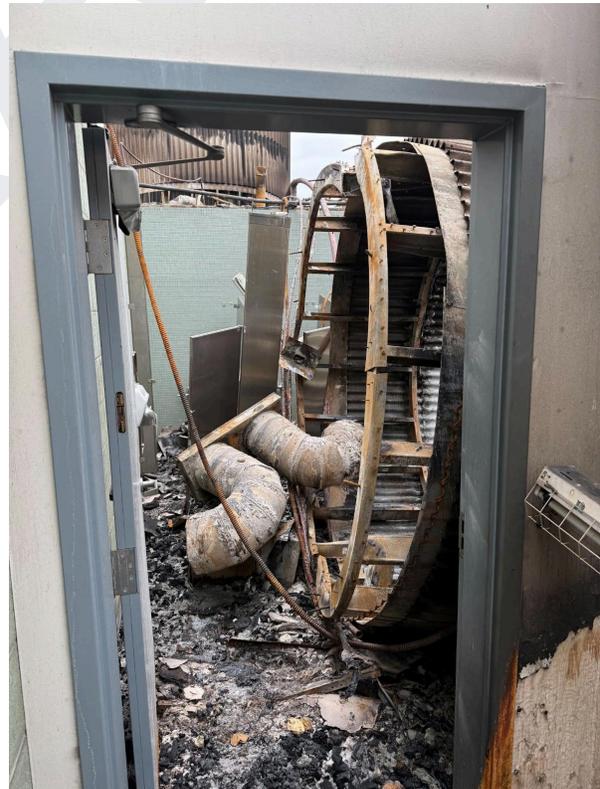
Figure-33

Photo of the women's restroom. The exhaust fans and ventilation systems have sustained severe fire damage.

The ductwork is extensively burned, and the plumbing fixtures including toilets and lavatory are either melted or heavily scorched, requiring full replacement.

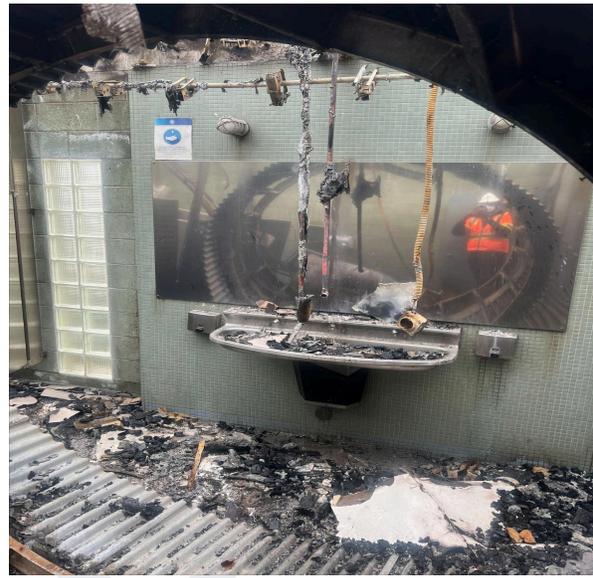
Figure-34

The water supply lines are ruptured, and the drainage systems may be clogged or damaged due to fire debris. The sprinkler system has also sustained severe damage. The full replacement of the water line and fire sprinkler is recommended. A comprehensive inspection shall be done to identify blockages or damage in the waste and vent pipes.

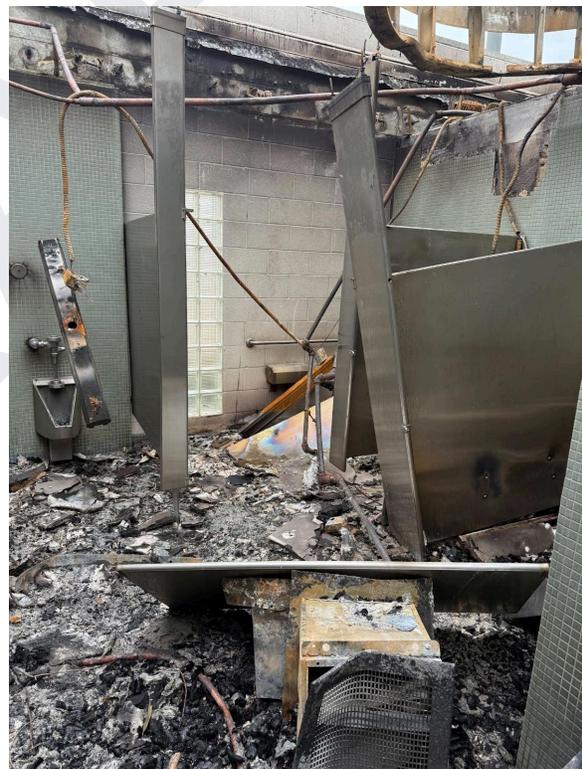
Figure-35

Photo of the men's restrooms showing urinals and damaged toilet stalls

The exhaust fans and ventilation systems have sustained severe fire damage. The plumbing fixtures, including urinals, toilets and lavatory are heavily scorched or partially melted. Full replacement of the fixture units and ventilation system is recommended.

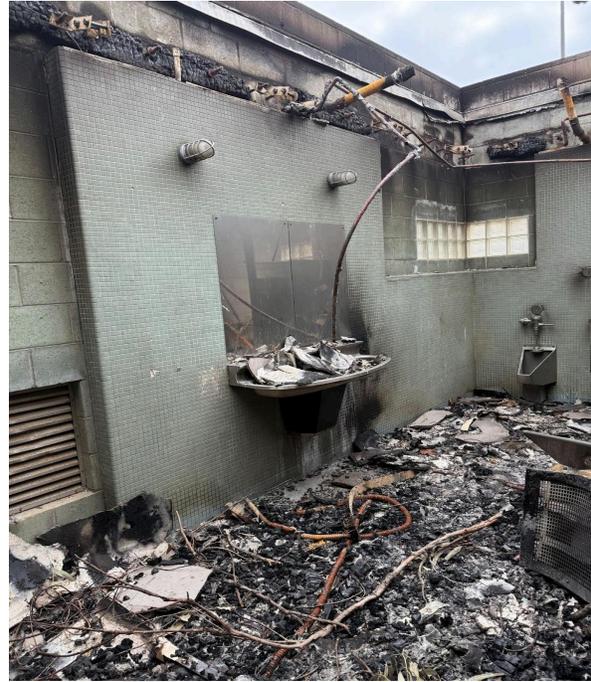
Figure-36

The water supply lines are damaged, and the drainage systems may be clogged or damaged due to fire debris. The sprinkler system is ruptured. The full replacement of the water line and fire sprinkler is recommended. The full inspection is needed to identify any blockages or damage in the waste and vent pipes. The water heaters can't be found but they are likely damaged due to the fire and need replacment.

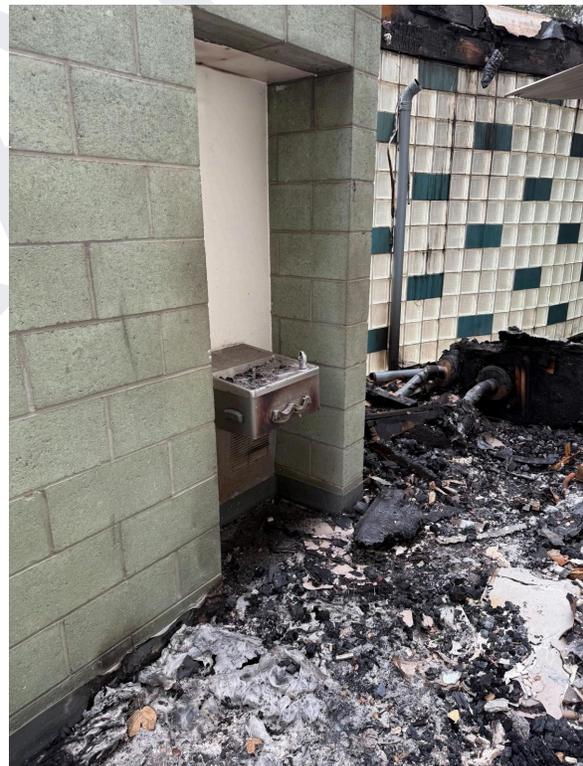
Figure-37

Both fountains are deformed from heat and covered in soot. There is potential contamination and damage to the water supply lines. It is recommended to replace the damaged drinking fountains and supply water lines.

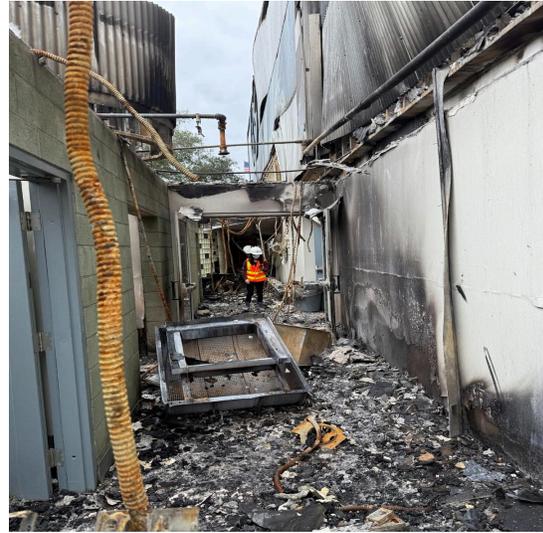
Figure-38

The area has sustained significant fire damage. The fire sprinkler system in this section is severely damaged. Given the extent of the destruction, the entire sprinkler system in this area will require a full replacement.

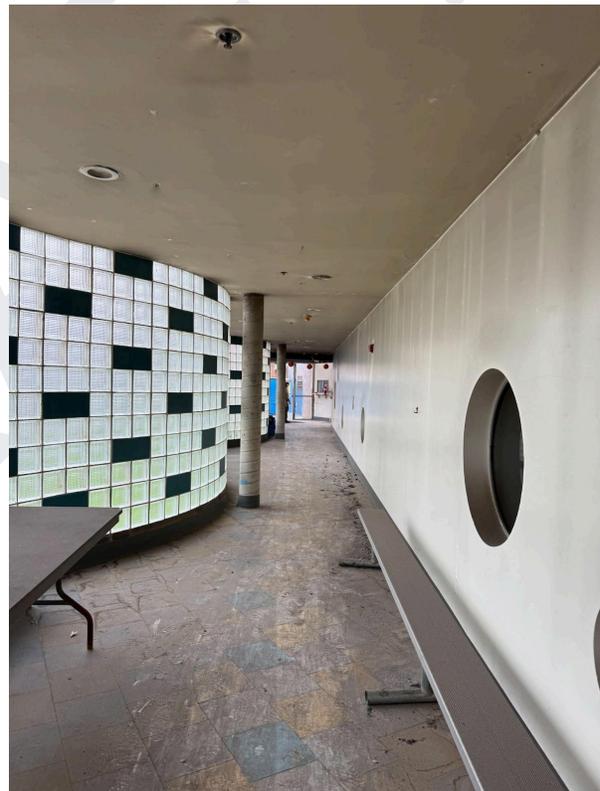
Figure-39

The sprinkler appears to be in place without any visible physical damage. However, the fire sprinkler head shows some discoloration, which could indicate exposure to heat or smoke. Conduct a full inspection to verify any damage.

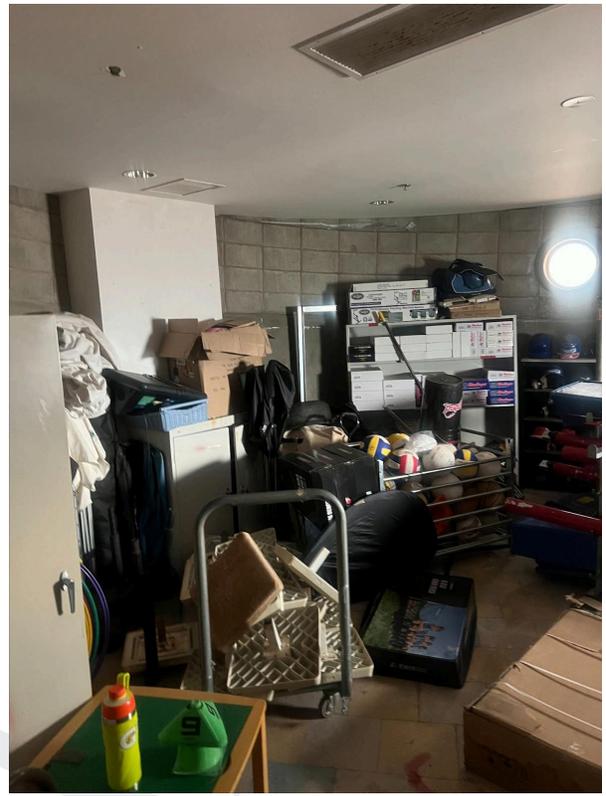
Figure-40

The ceiling diffusers and fire sprinkler heads appear intact. However, further investigation is necessary to confirm the functionality of the fire sprinkler system, ductwork, and associated equipment.

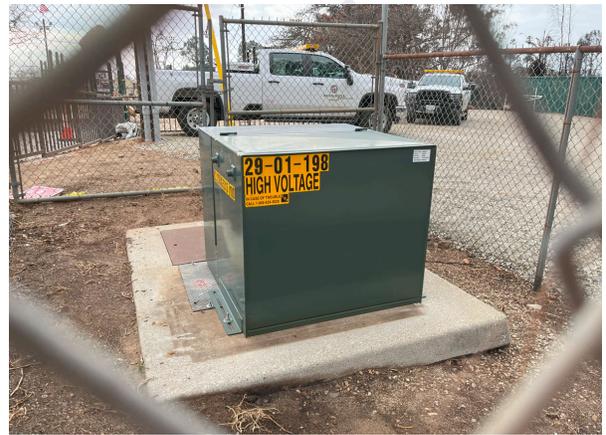
There are no signs of damage caused by the fire to the electrical equipment. The pad mounted electrical equipment can be reused to service the building if it is acceptable to LADWP based on the new demand load of the gymnasium.

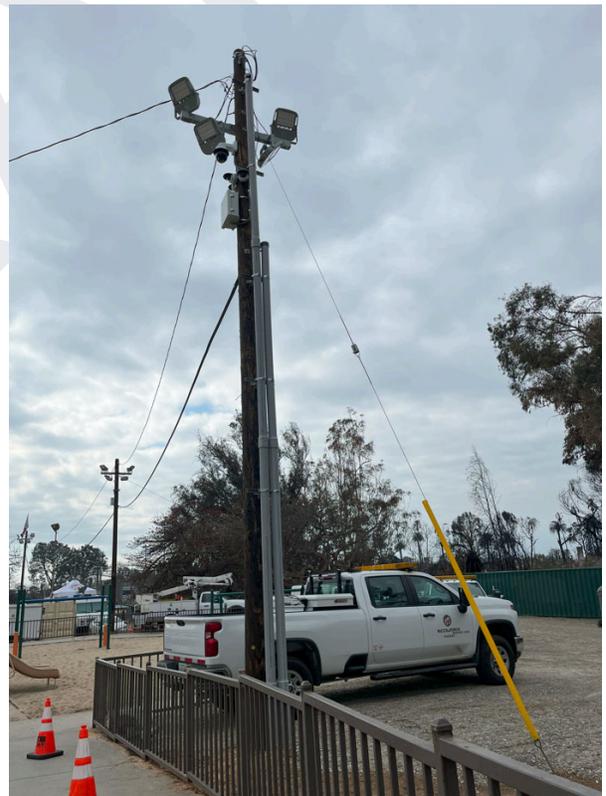
Figure-42

There are no signs of damage to the pole.

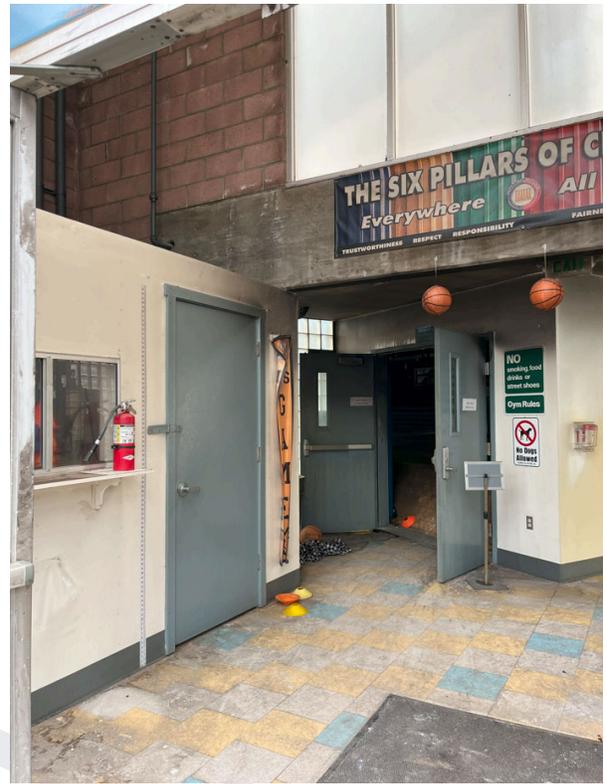
Figure-43

This entry lobby to the gymnasium seems unaffected by the fire. Further investigation is required to determine if any electrical equipment is damaged.

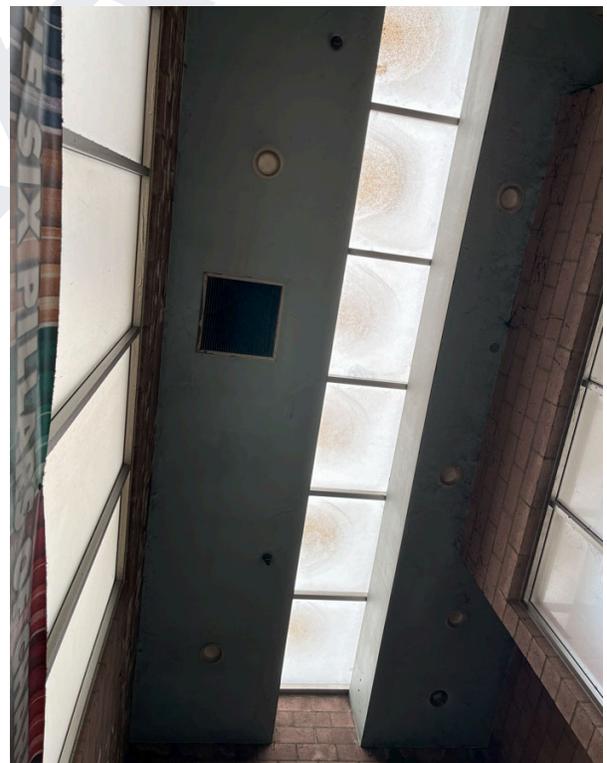
Figure-44

This entry lobby to the gymnasium seems unaffected by the fire. Light fixtures show no signs of significant damage. Further investigation is needed to see if there is any damage to the conductors or conduits.

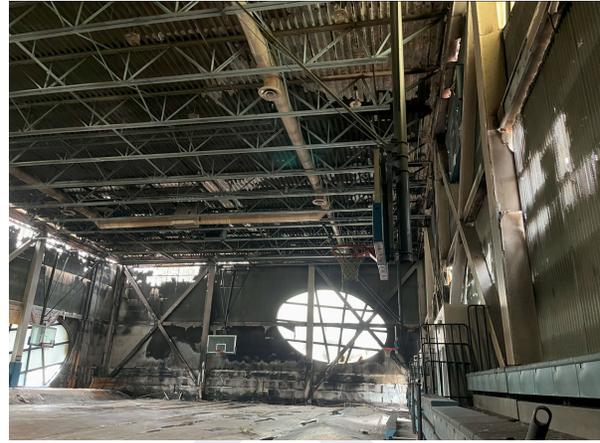
Figure-45

The inside of the gymnasium sustained significant damage from the fire and water. Recommend to replace receptacles, light fixtures, exit signs, and fire alarm equipment inside the gym. Conduits may be utilized with new wires.

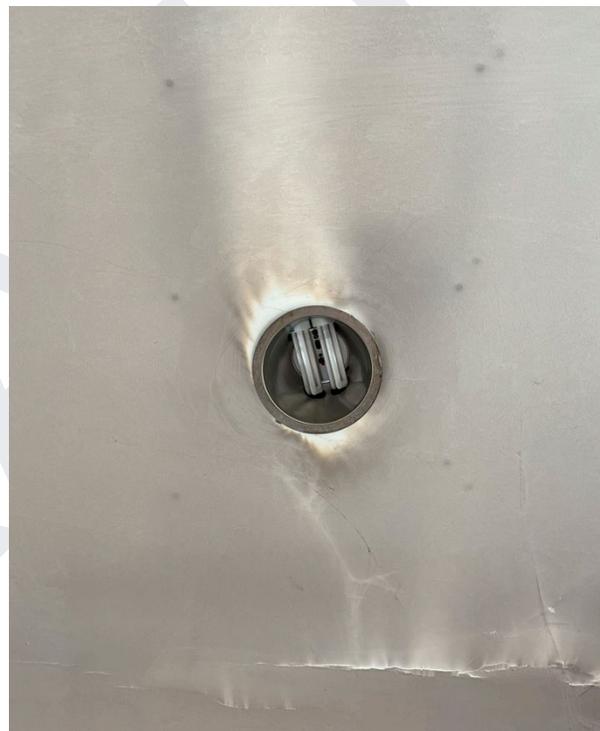
Figure-46

Most light fixtures and their respective electrical connections have sustained damage from the fire. It is recommended to replace the fixtures and conductors.

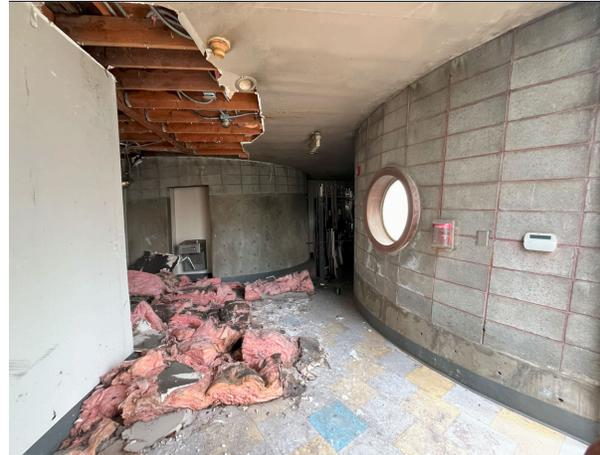
Figure-47

Light fixtures have sustained significant fire damage. The fire alarm pull station, exit sign, and security equipment do not seem damaged. Recommend to replace all electrical systems, including light fixtures.

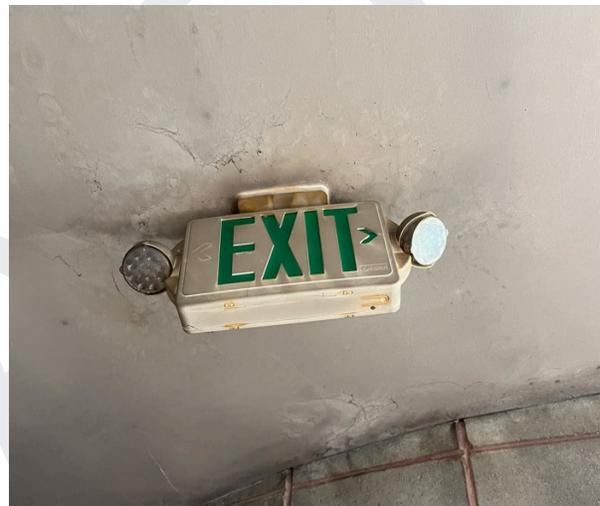
Figure-48

There are no signs of significant damage caused by the fire. Recommend to replace the exit sign as needed.

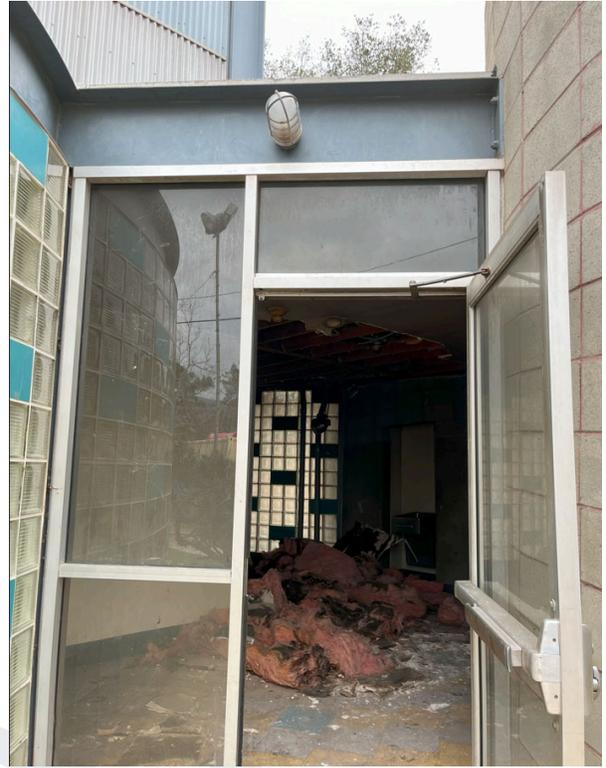
Figure-49

There are no signs of significant damage caused by the fire. Recommend to replace the light fixture with an LED fixture.

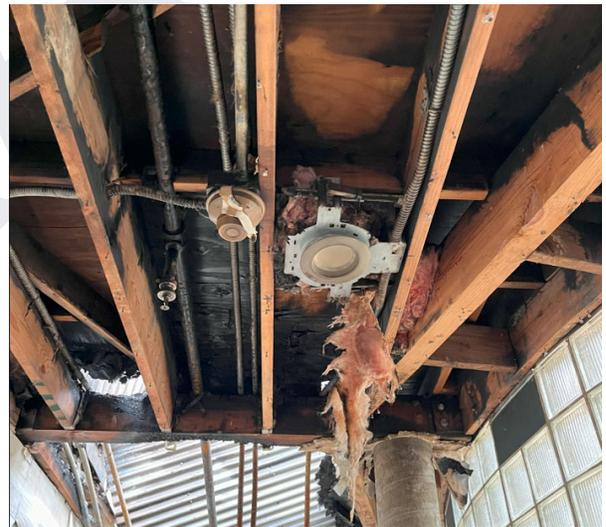
Figure-50

Light fixtures and fire alarm devices have sustained significant fire damage. Recommend to replace all light fixtures and fire alarm devices.

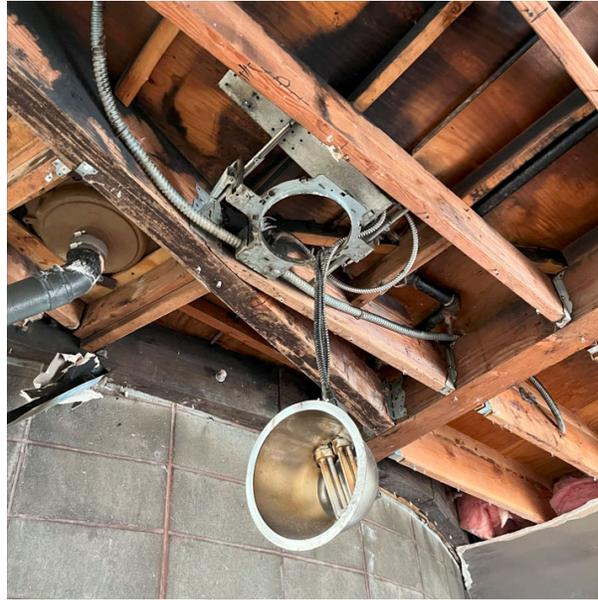
Figure-51

Light fixtures have sustained significant fire damage. Recommend to replace all light fixtures.

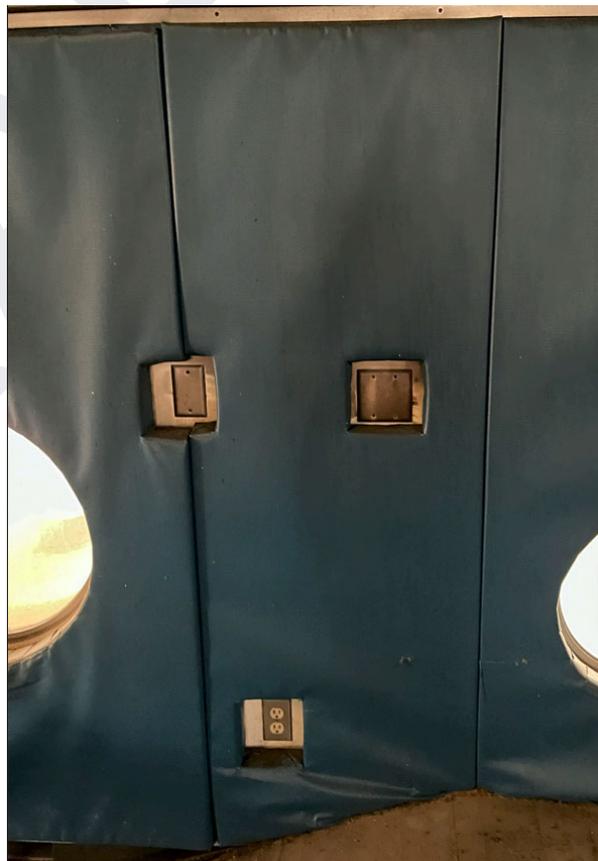
Figure-52

The inside of the gymnasium sustained significant damage from the fire and water. Replacing the receptacles, light fixtures, exit signs, security alarm system, and fire alarm equipment inside the gym is recommended. Further investigation is required by ITA to determine if communication equipment, including telephone and data outlets, are damaged.

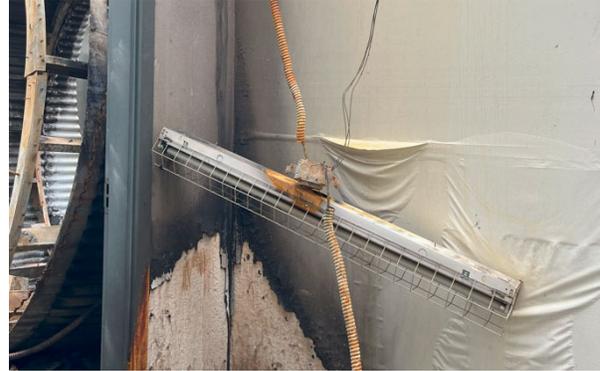
Figure-53

Light fixtures have sustained significant fire damage. Recommend to replace all light fixtures.

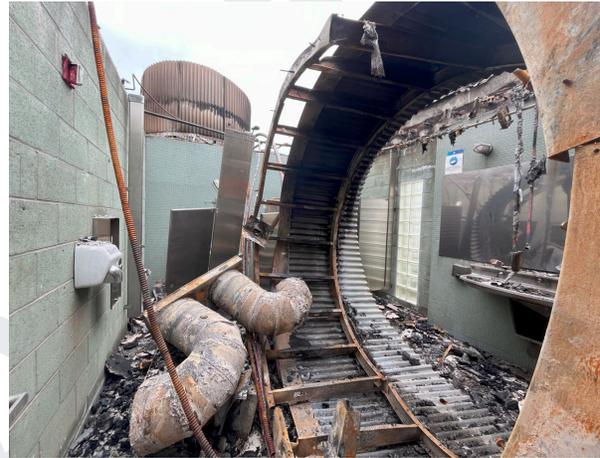
Figure-54

The fire alarm strobe was scorched. Recommend to replace all electrical equipment in this area.

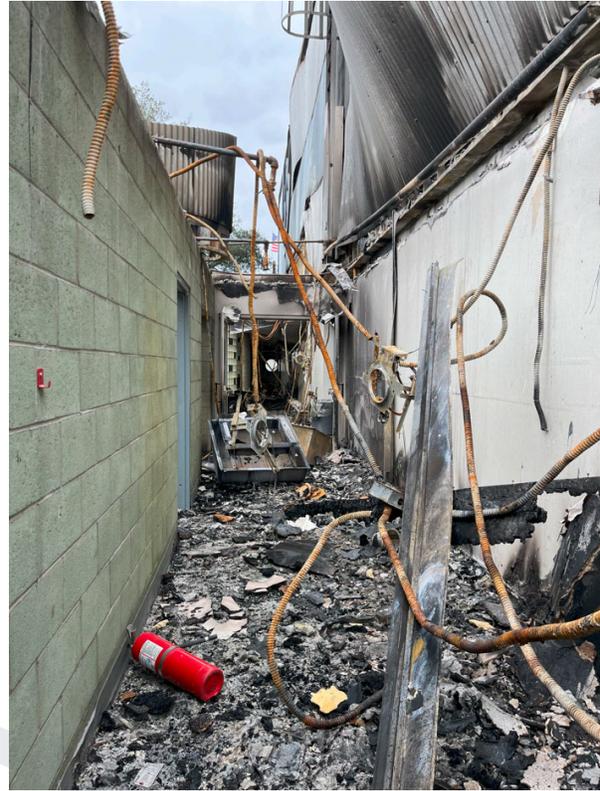
This portion of the building is completely burned down. The light fixtures, receptacles, fire alarm system, and exit signs have sustained severe damage. Recommend to provide this area with new electrical equipment and fire alarm system.

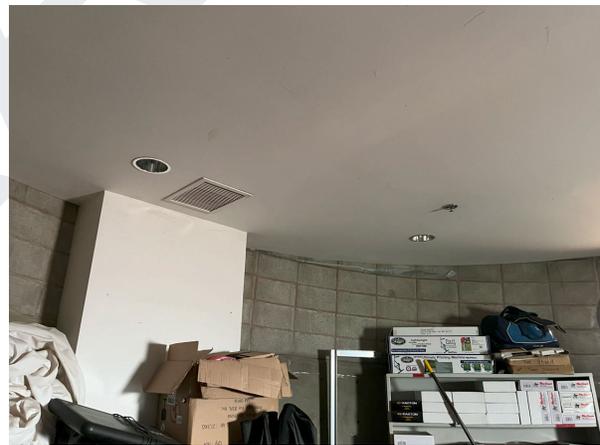
Figure-56

This room has no evidence of damage from the fire. Light fixtures and switches show no signs of damage. Further investigation is required to confirm if any fire or water damage occurred to the conduits, conductors, light fixtures, or any other electrical equipment.

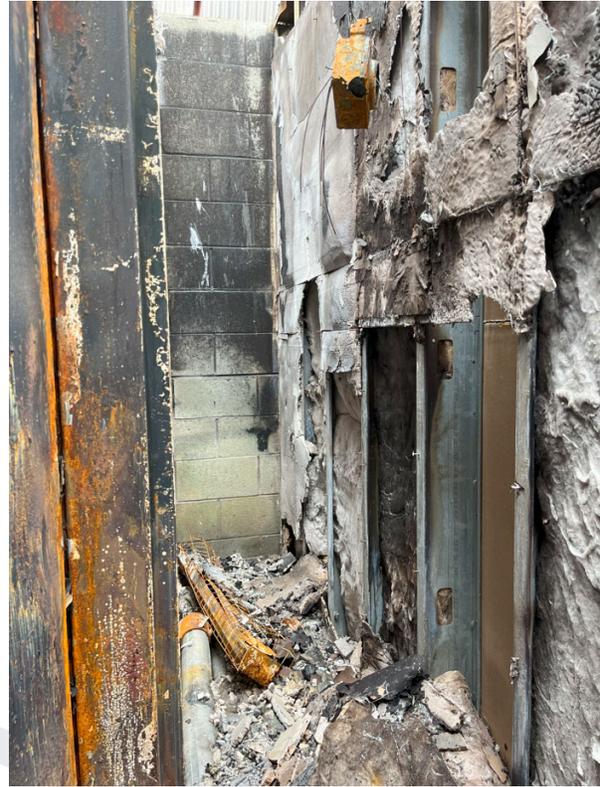
Figure-57

The area has sustained severe damage. It is recommended to replace the receptacles, fire alarm systems, irrigation controls, lights, communications equipment (per ITA), and all other electrical equipment due to direct or indirect damage caused by the fire or water.

Further investigation is required to find the status of the electrical panels, switchboards, inverters, fire alarm equipment, communication equipment, and security alarm equipment.

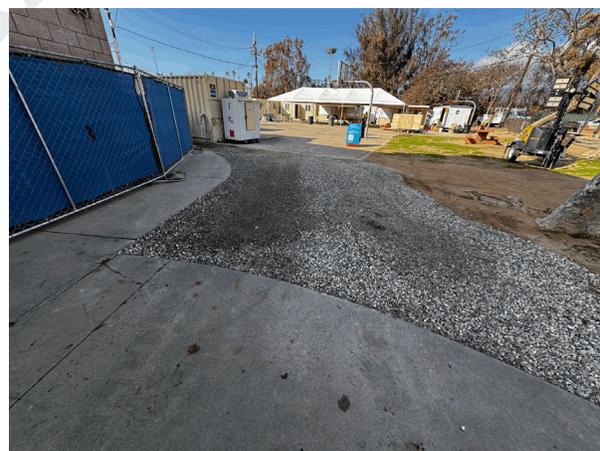
Due to temporary measures for large vehicle access, this area will require soil replacement and amendment, turf and irrigation repair, and specific measures to remediate root compaction around the existing tree.

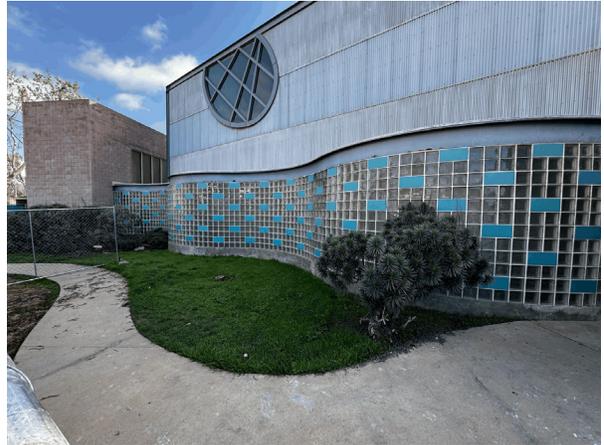
Figure-59

I was unable to initiate the irrigation systems to look for damage here. I expect this area will require soil amendment, turf and irrigation repair, and possibly hardscape repair after re-construction is completed.

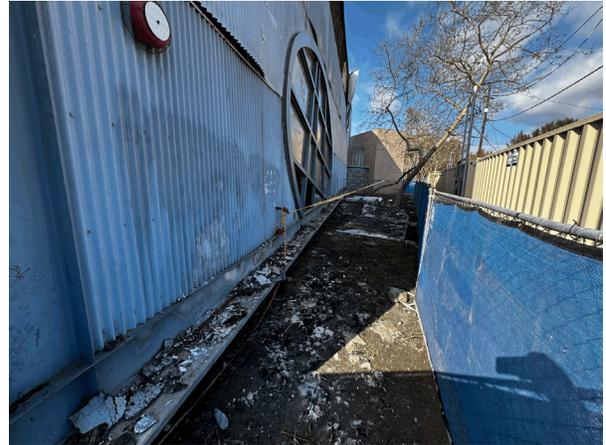
I was unable to initiate the irrigation systems to look for damage here. This area will require soil amendment, turf and irrigation repair after re-construction of the building is completed. Protection of existing trees and supplemental will be required during re-construction.

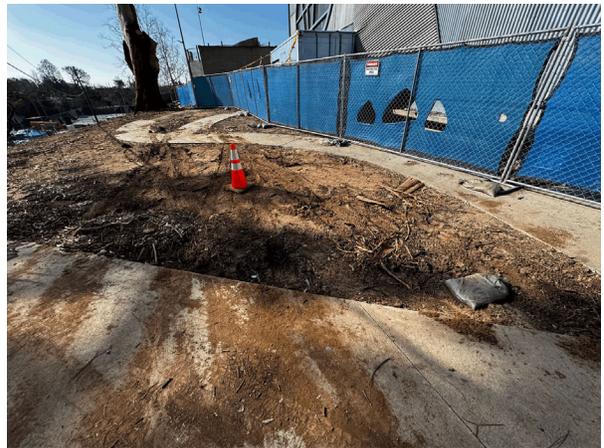
This area will need soil amendment & de-compaction measures, turf replacement, specimen tree replacement, and irrigation repair. Hardscape repair/replacement will likely be required after re-construction of the building.

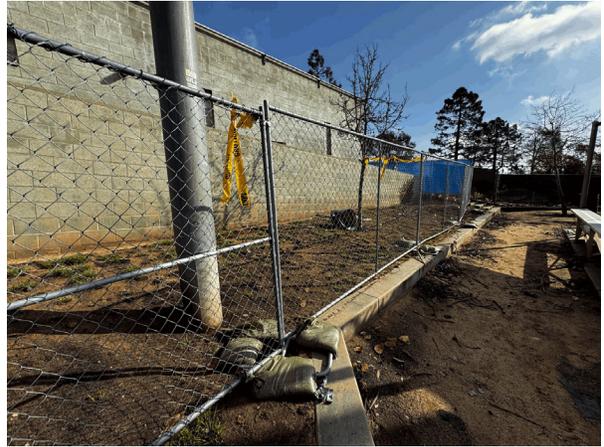
This area will require soil amendment, turf and irrigation repair after re-construction of the building is completed. Protection of existing trees and supplemental watering will be required during re-construction.
