TRANSMITTAL

**AUTHORIZE THE DEPARTMENT OF GENERAL SERVICES
TO REPLACE THE EXISTING 7th STREET BODY SHOP**

7th STREET BODY SHOP – STRUCTURAL EVALUATION

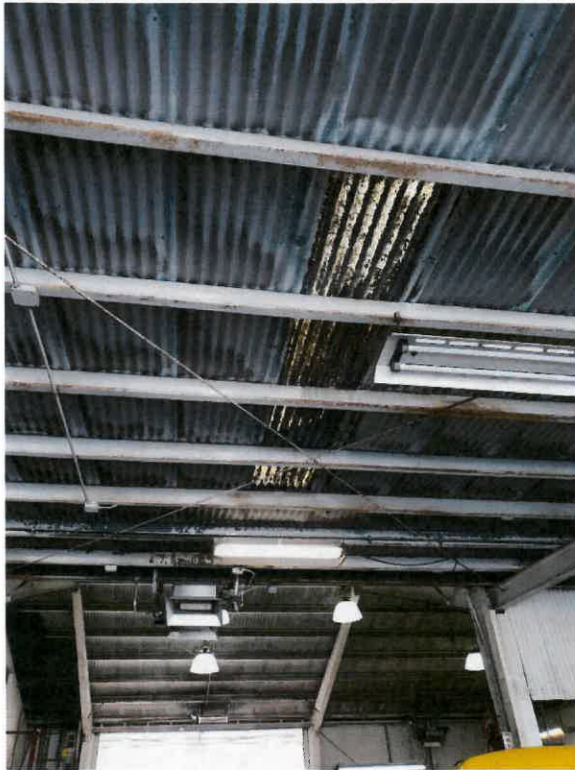
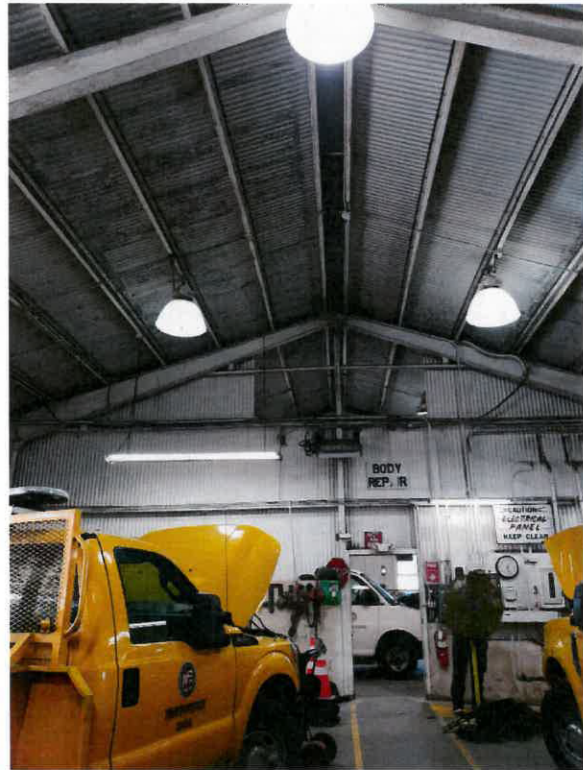
Above: Existing Body Shop interior. Below: Existing Body Shop exterior.

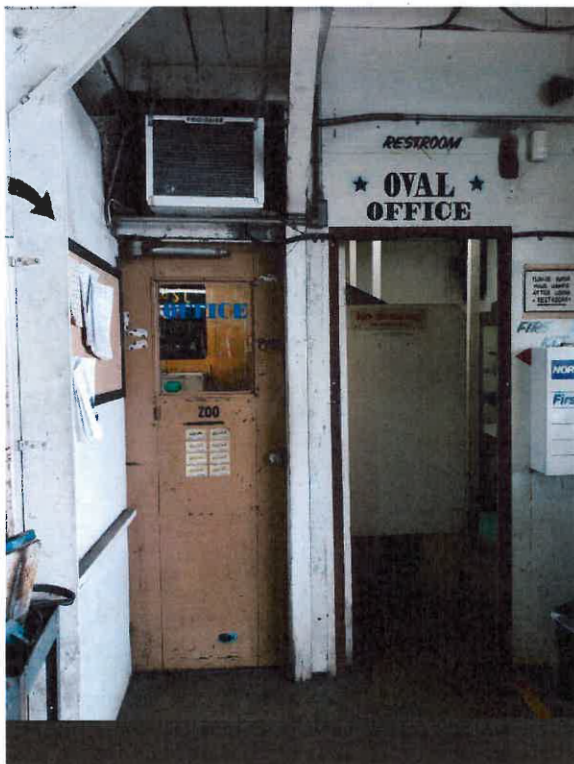
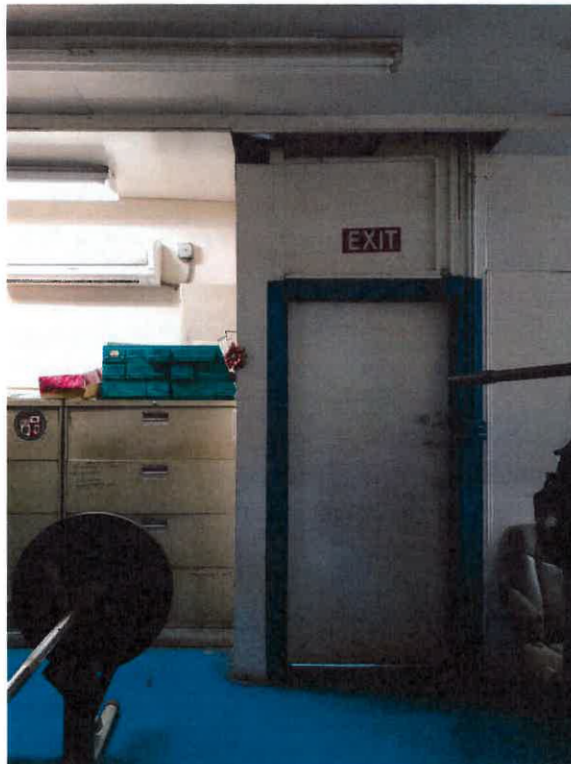
Above: Non-compliant office, restroom, and lunch room doors. Below: Inadequate and inaccessible restroom facility.

- The locker room and restroom facilities are inadequate for employee use and do not comply with ADA requirements. They will need to be replaced with code compliant men's and women's locker rooms and restrooms, which will require more area.

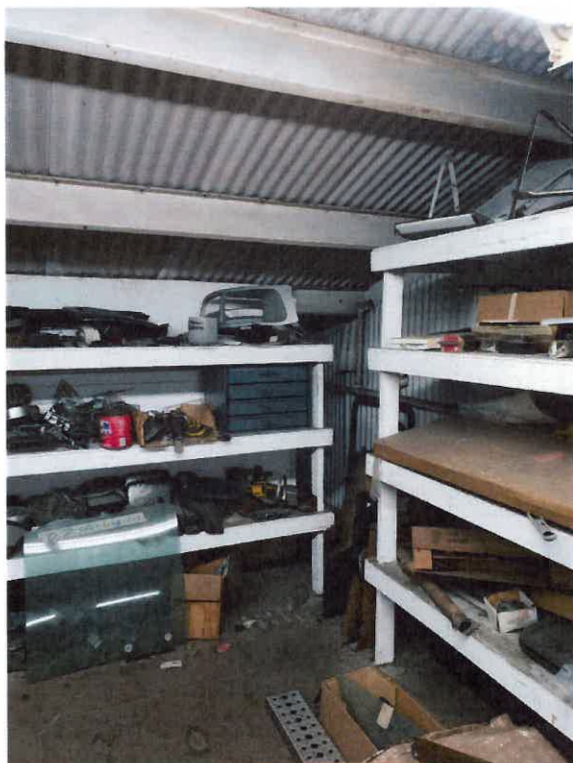
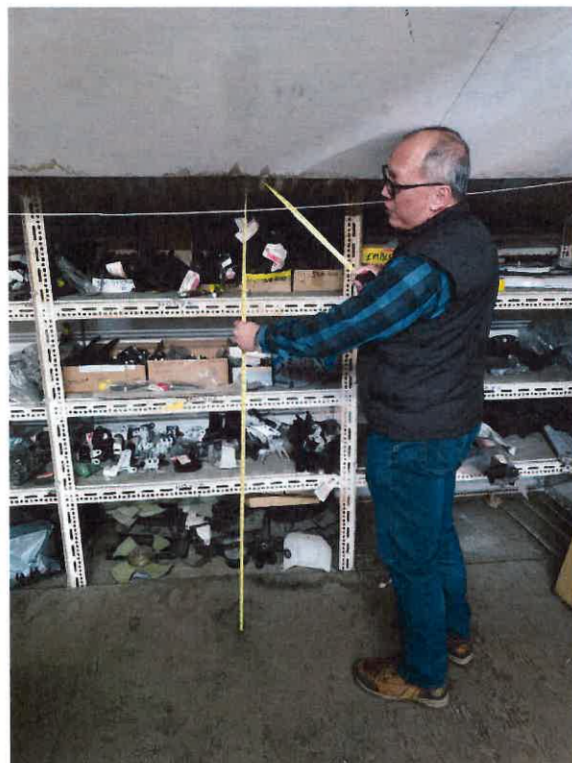
Above: Non-compliant mezzanine stairs. Below: Non-compliant stair handrail.

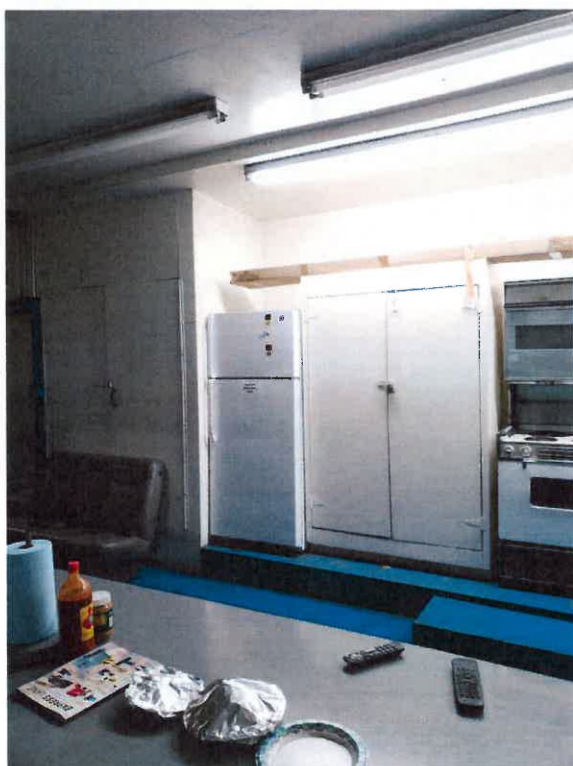
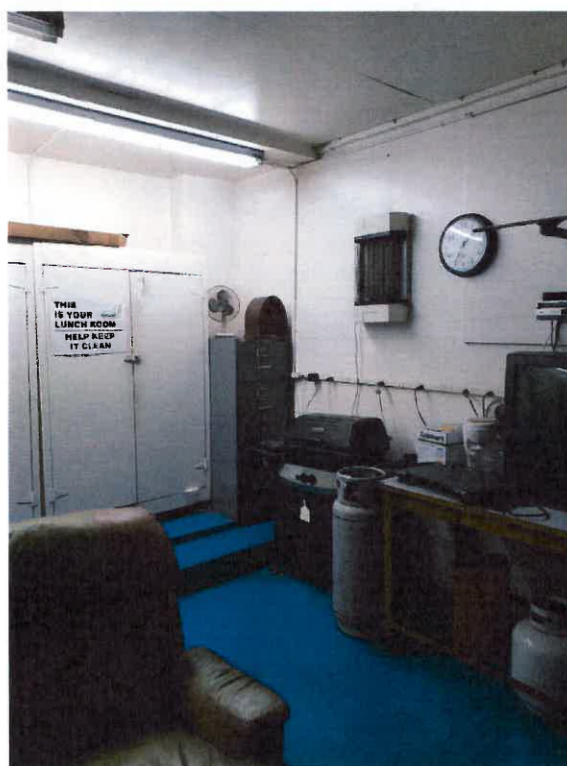
Above: Non-compliant vertical clearance in mezzanine storage area. Below: Inaccessible lunch room storage and appliances, and non-compliant change in level.

- The lunch room area does not comply with ADA requirements. The change in level in front of the counters must be removed, and the counters must be replaced to comply with the Code.

- The ceiling height of the mezzanine is insufficient for use as a room and will need to be raised.
- **Hazardous Material Assessment:** A HazMat Survey is strongly recommended for the building.

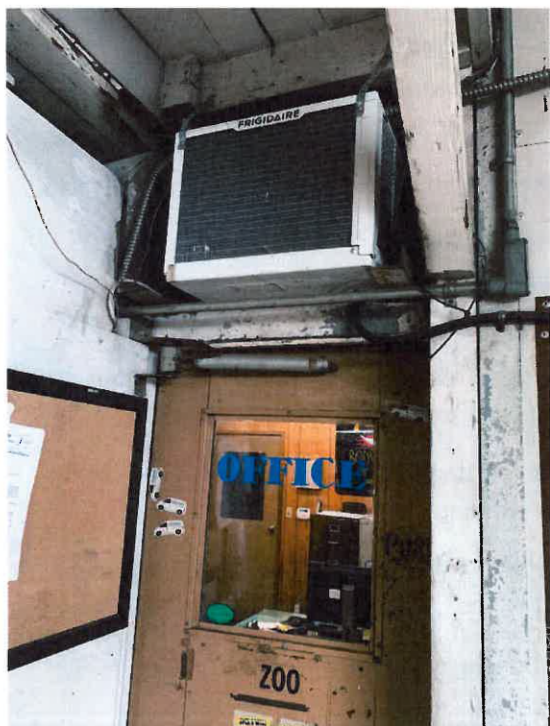
- Office has a half to three-quarter ton wall mounted window type A/C unit.¹ Lunchroom has a 2 ton split system A/C unit.² Replace these units with more energy efficient units.

¹ Photo of office A/C unit

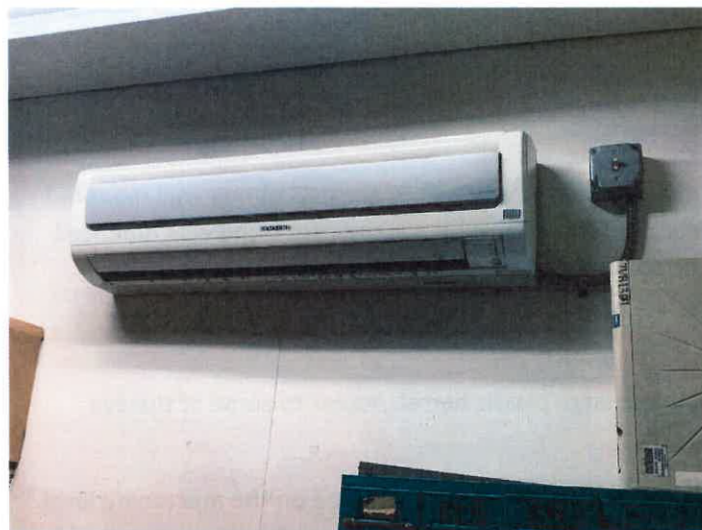
² Photo of lunchroom A/C unit

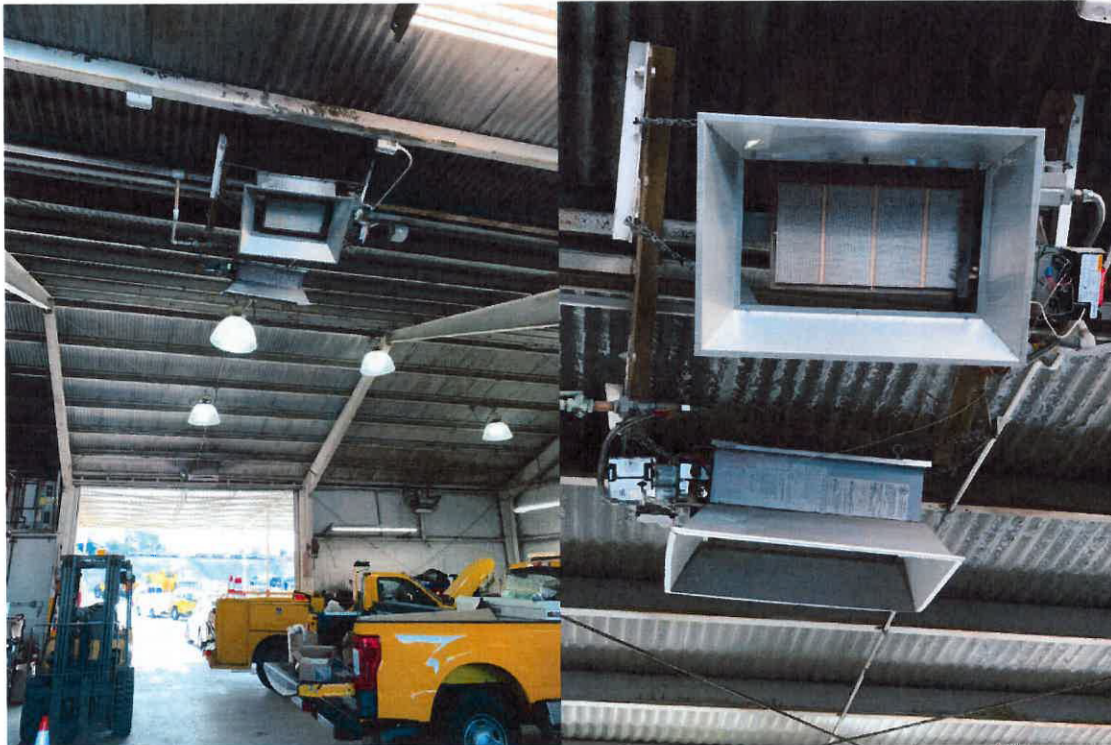
- Body shop repair areas have ceiling hung gas operated infra-red heaters and are not allowed in certain locations depending on the work performed.⁵
- Room where auto body parts are prepped for painting has a ceiling hung fan coil unit to provide ventilation and heating. Unit is not in working condition.⁶

⁵ Photo of gas operated infra-red heaters

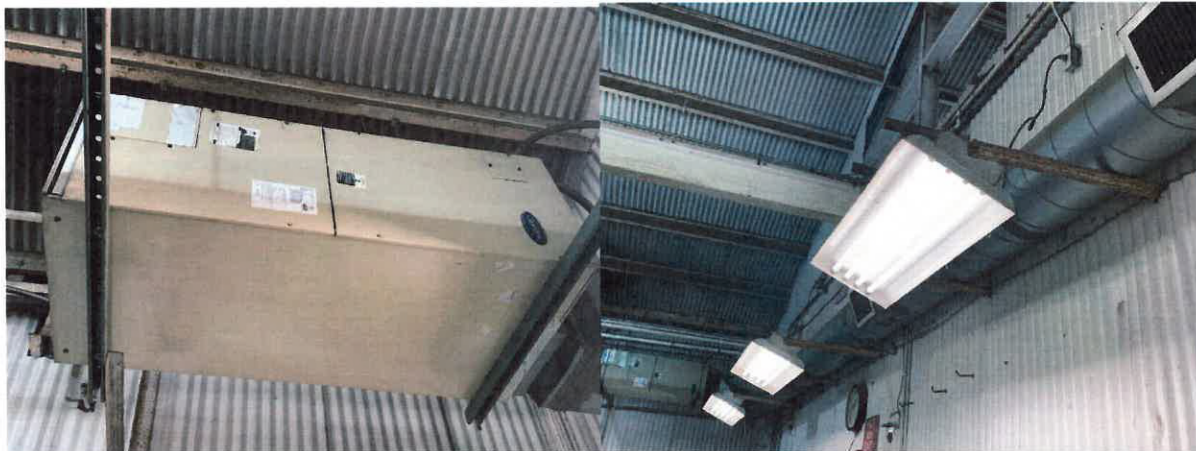
⁶ Photo of prep room ceiling hung fan coil

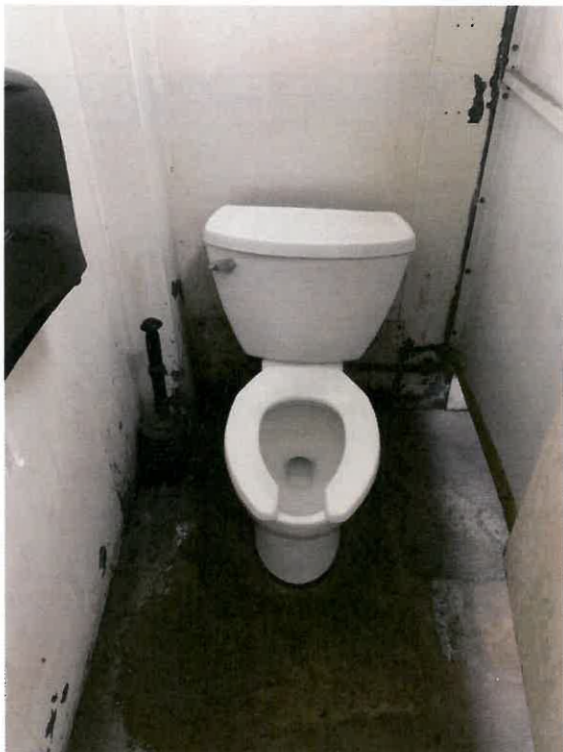
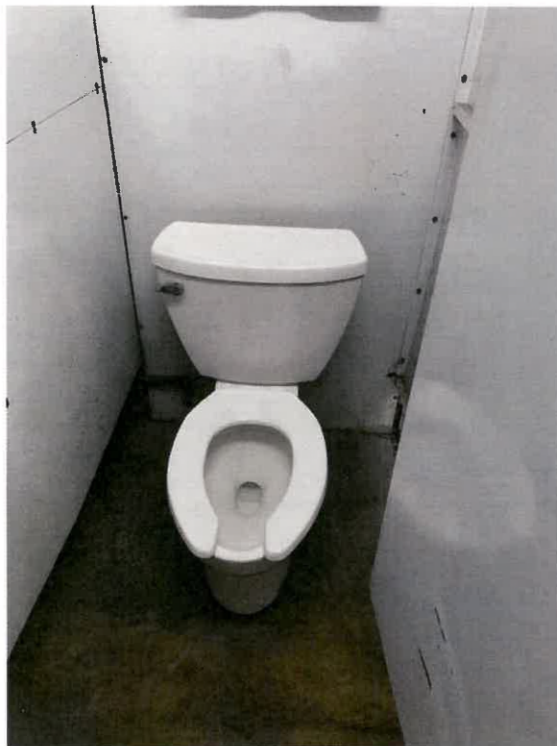
7 Photo of restroom plumbing fixtures

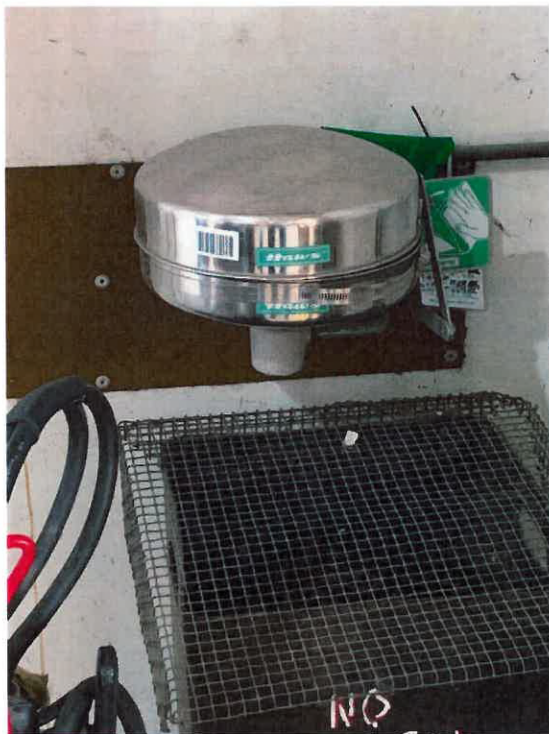
⁸ Photo of emergency eye wash station

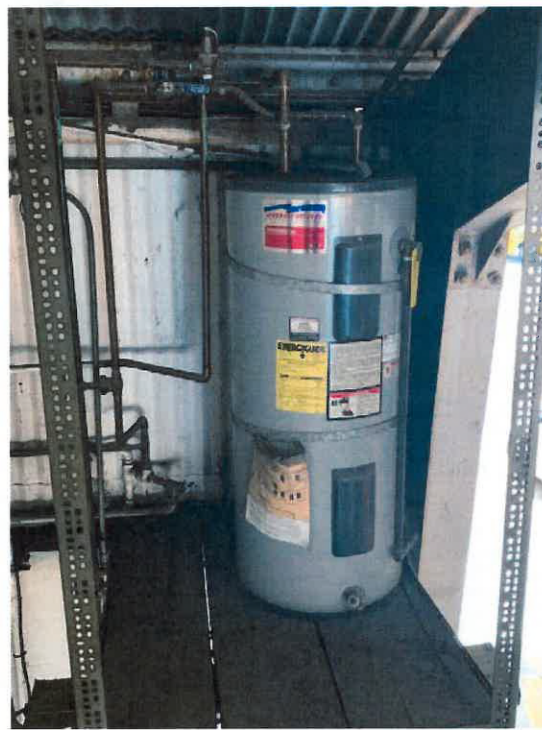
⁹ Photo of electric water heater

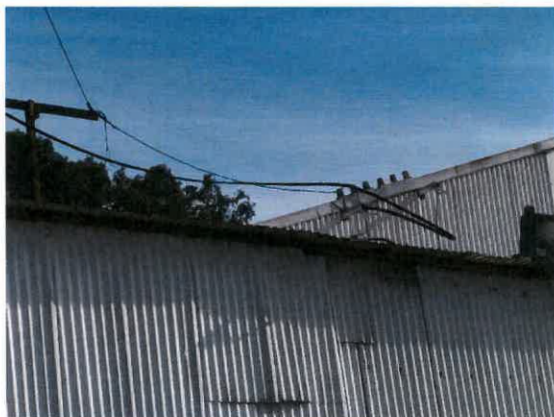
Building DWP Electrical Services are provided by overhead lines from a nearby power pole connection that enters the building through the roof. An underground conduit was noted to enter an unidentified pull box on the outside wall of the building before it entered the building. At about 25 feet away, there were 2 service meters; a 200A, 240V, 3Phase, 3Wire service & a 200A, 120/240V, 1Phase, 3Wire service located inside of the building. There were no main service disconnects installed outside of the building or inside the nearest point of service entrance conductors which is a major violation of NEC section 230.70. The 3-phase service was used mostly for 3-phase motor loads. The 1-phase service was used for lighting & smaller loads. The electrical services equipment are outdated with old fused disconnects. Labeling on some of the panels and disconnect switches were not present, or deteriorated, which do not meet the NEC code section 110.21.

Figure 1: Utility entry point through the roof of the building.

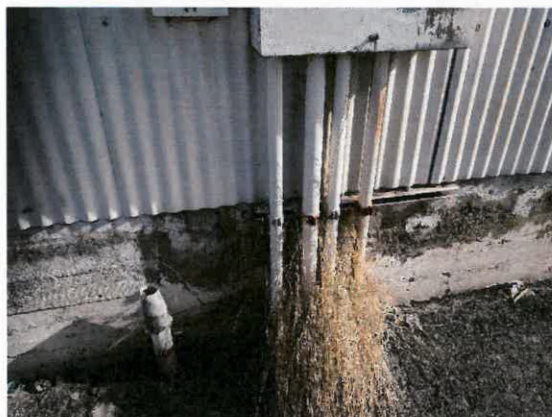
Figure 2: Underground utility entry point.

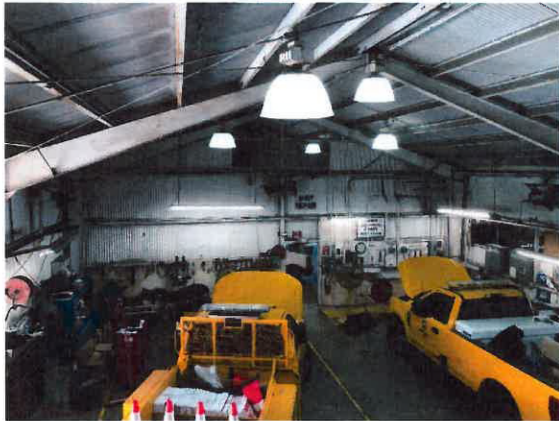
There is no clear path or accessible path to the electrical service equipment. There are many portable shop equipment found in front of the electrical panels.

Figure 3: Inside location of electrical panels & meters.

Recommend a service upgrade because the existing one is very old and is in poor condition. All Electrical Panels need to be properly labeled and secured. Additional labels are required for panels near hazardous locations. All panels need to have enough working clearance in front per code.

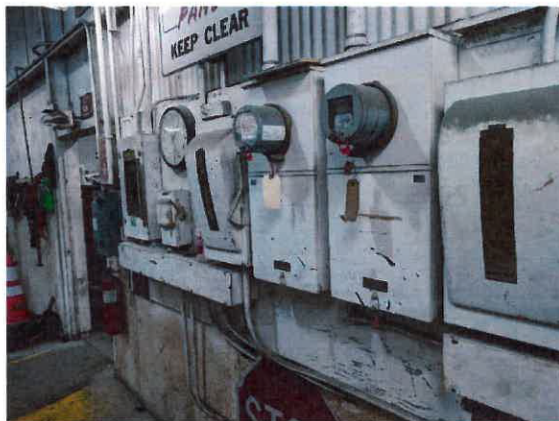
Figure 4: Utility service meters, main fuse disconnects, panels, and wire ways.

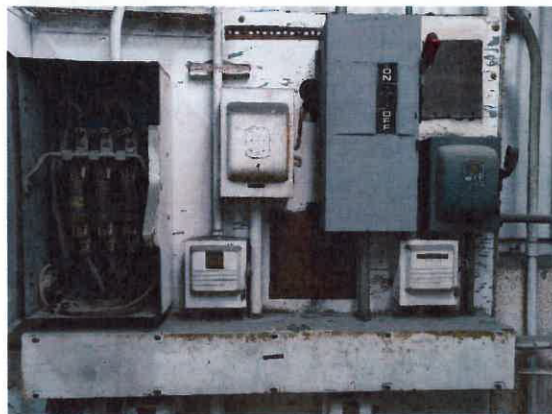
Figure 5: Dusty condition of fuse disconnects and wire way.

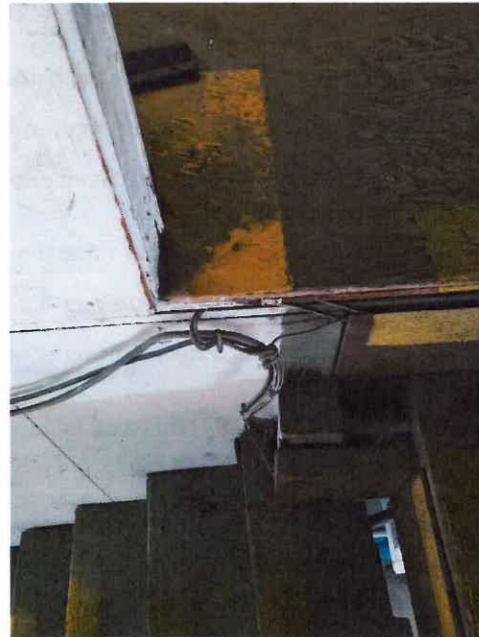
Figure 6: Exposed unsecured wires on the side of a stair case.

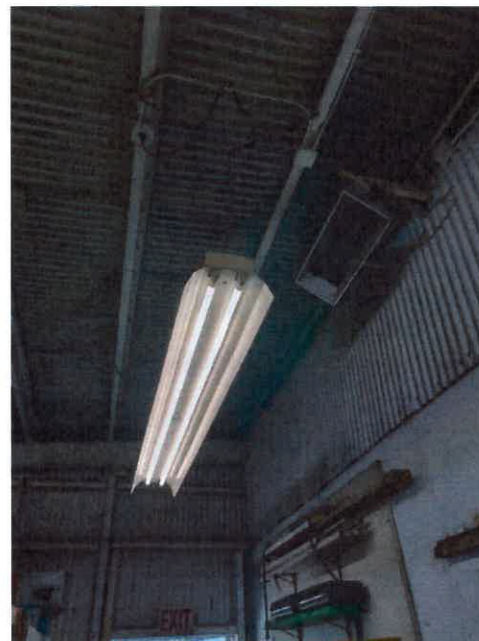
There were no illuminated exit signs, there were only few exit sign labels throughout the building. Required exit signs may be internally or externally illuminated as required per Section 1011.3 of LABC. Also noted is an old speaker Public Address (PA) system outside and throughout the inside of the building.

Figure 7: Exit to back of building is not illuminated properly nor is there a bug eyes light fixture.

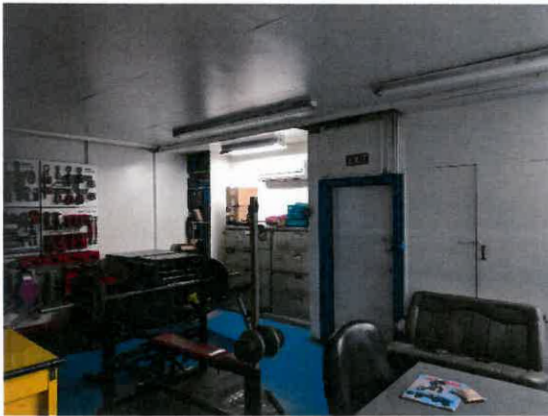
Figure 8: Exit inside lunch/ lounge/ gym room is not illuminated properly nor is there a bug eyes light fixture.

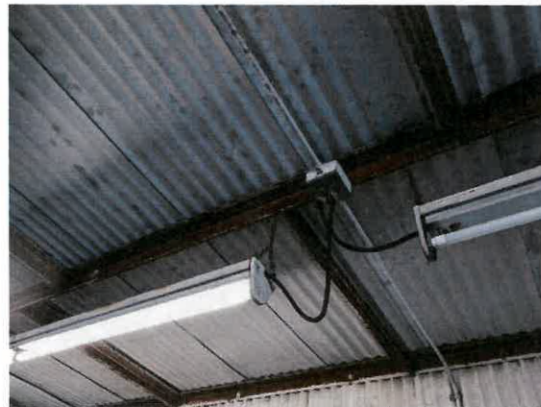
The fluorescent light fixtures were original with inefficient T-12 lamps. Some were missing lenses, not working at all, and all were plug in type connected to the ceiling surface mounted receptacles. Area lighting controls were not complying with T24 requirements because they were not present nor accessible. There were some outdoor security lights on the top of the building. An outdoor panel labeled "Canopy" found near the vehicle lift bay, fed from the single-phase service which provided power to the outdoor lights, equipment loads, and a parking lot light pole. There were emergency bug eye type light fixtures inside the body shop as well.

Figure 10: All fluorescent light fixtures are Plug in type.

The lighting would need to be updated since the existing is original and there were notable areas that did not have proper illumination. Recommend a new LED lighting system for the entire facility to save energy over time. In addition, a new lighting controls complying with title 24 shall be installed.

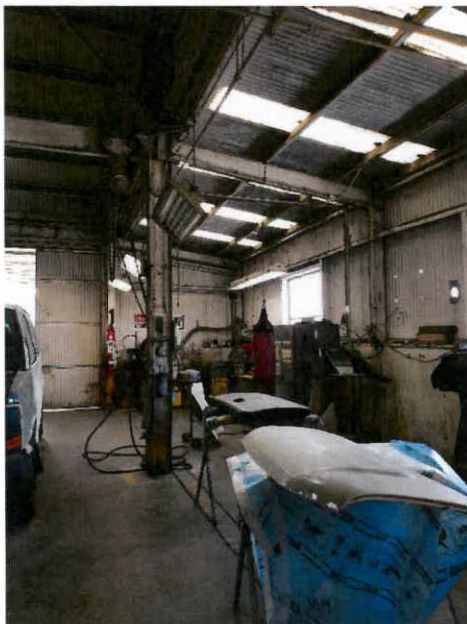
Figure 9: Not all fluorescent light fixtures are working.

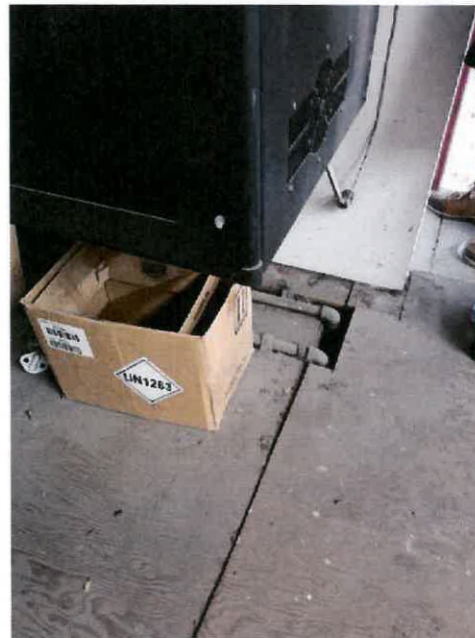
Figure 12: Communication server rack has unsecured exposed conduit going down into the floor below.

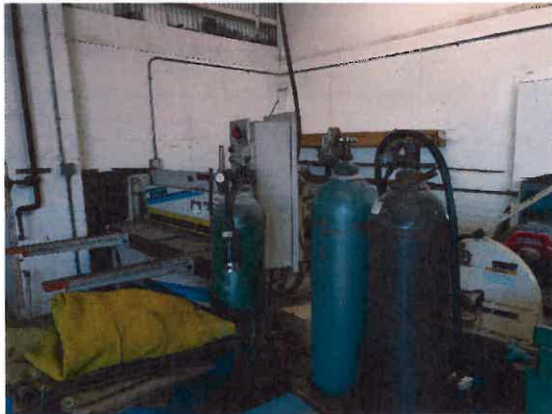
Due to many equipment being stored throughout the facility, there was not enough working clearance required per code in front of and around the electrical equipment. Large electrical shop equipment were not secured permanently to the floor and were missing labels.

Figure 11: Unsecured large equipment.

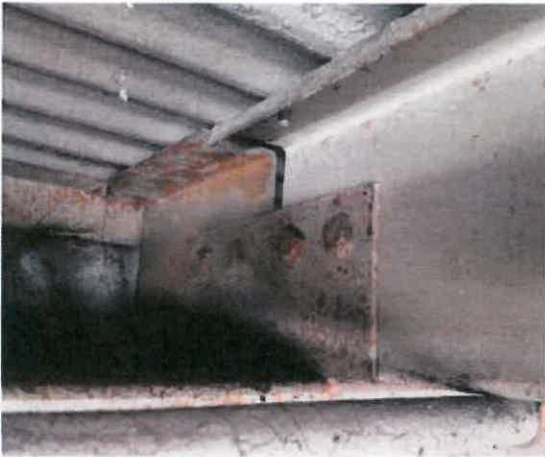
1. Rusting at Z purlin connections. (Photo F)
2. Rusting at moment frame connections. (Photo G)
3. Rusting at other gravity system connection points. (Photo H)
4. Cut and missing (E-W) direction tension braces. (Photos I, J, K and L)
5. Bent moment frame flanges. (Photo L)
6. Interior wood framed office/storage structure. (Photo M)
 - a. Excessive floor vibrations and deflections.
 - b. Substandard stair case structure.
7. Damaged corrugated metal sheathing at roof. (Photo N)
8. Missing bolt(s) at moment frame ridge connection. (Photo O)
9. Possible roof system discontinuity for lateral resistance as bracing rods are removed. (Photo P)
10. Cracked slab-on-grade. (Photo Q)

(Photo F - Rust at Z purlins)

- Repair bent flanges.
- Replace missing bolts in kind.
- Fill foundation cracks with epoxy grout.
- Bracing where removed, to be reinstalled immediately.
- Remove rust, coat with rust proof premier and paint.
- For maintenance - Install adequate waterproofing at roof or replace localized roof panels.

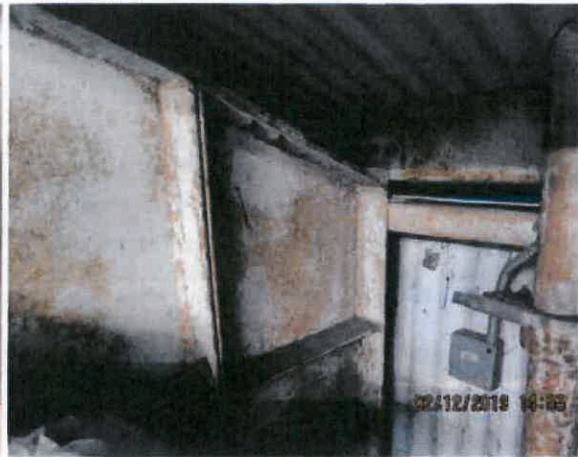
(Photo G - Moment Frame Rusting)

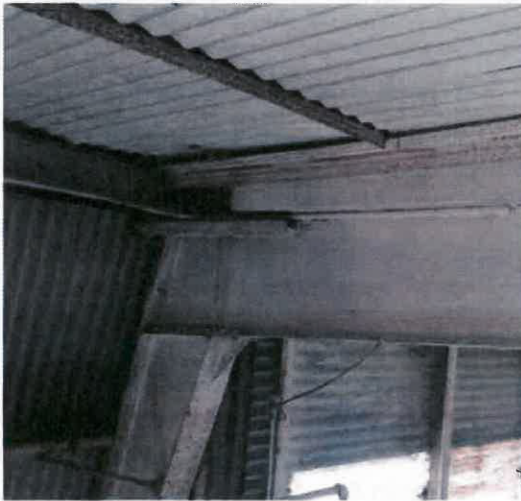
(Photo H - Gravity System Rusting)

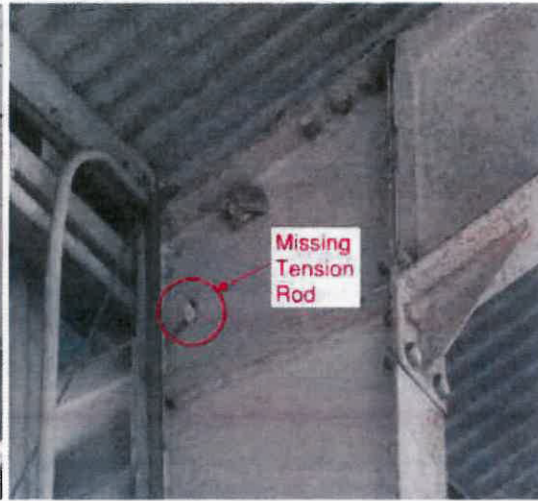
The structural investigation showed that tie rods were missing and cut, which compromises the design seismic capacity of the building to resist lateral forces. In addition, there were missing bolts on connections. These items need to be reinstalled in kind immediately.

(Photo I - Missing Tension Rod)

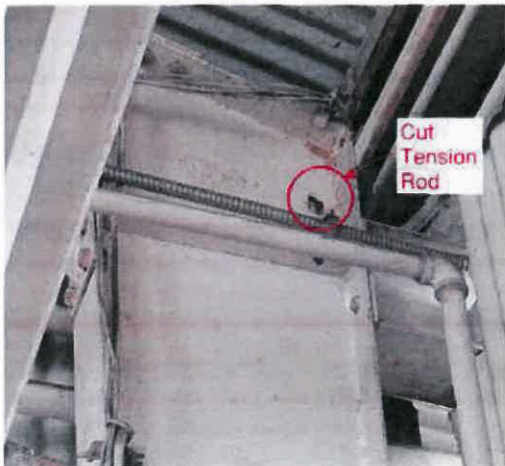
(Photo J - Missing Tension Rod)

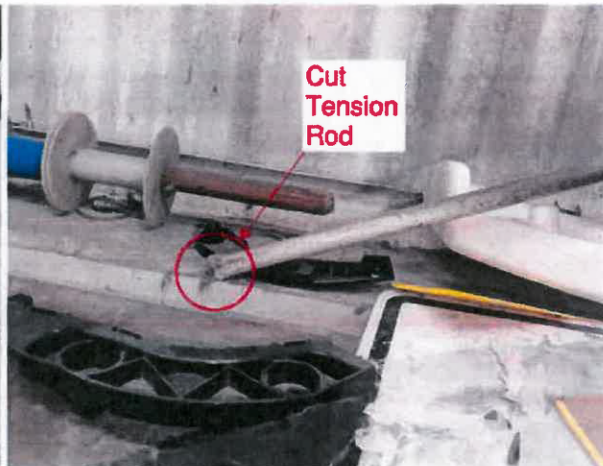
(Photo K -Tension Rod Cut)

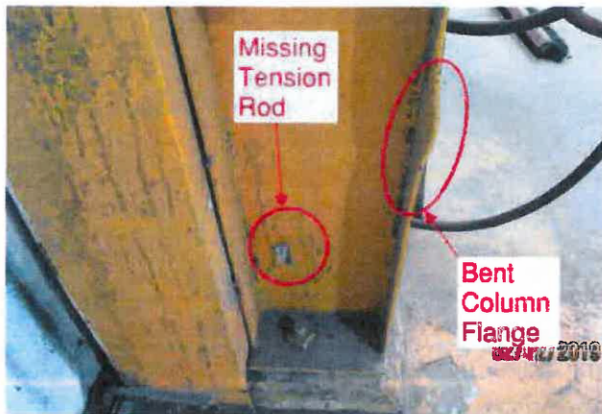
(Photo L – Damaged Column Flanges)

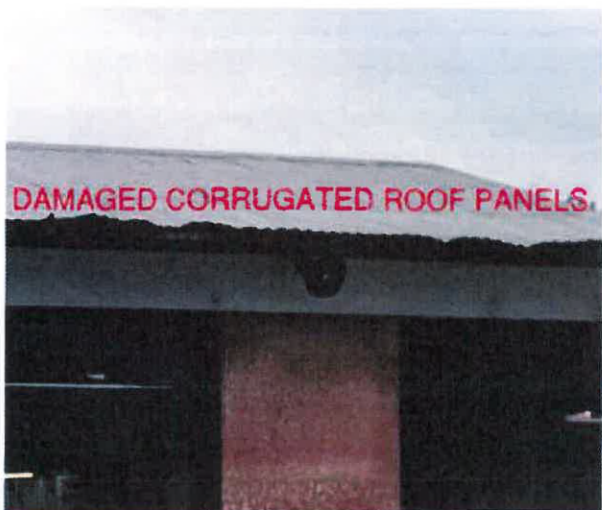
(Photo N – Damaged Roof Sheathing)

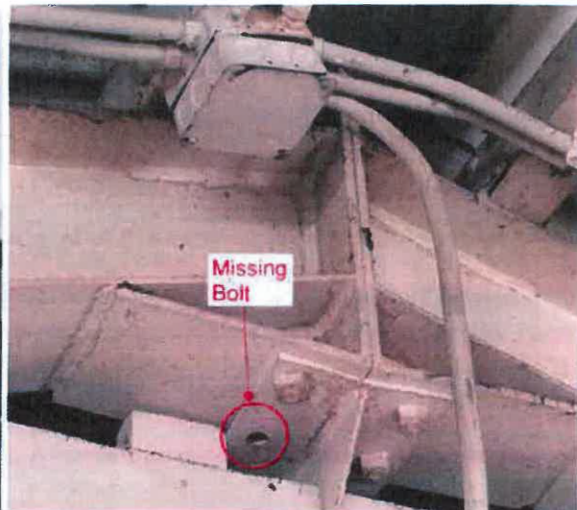
(Photo O – Missing Bolt)

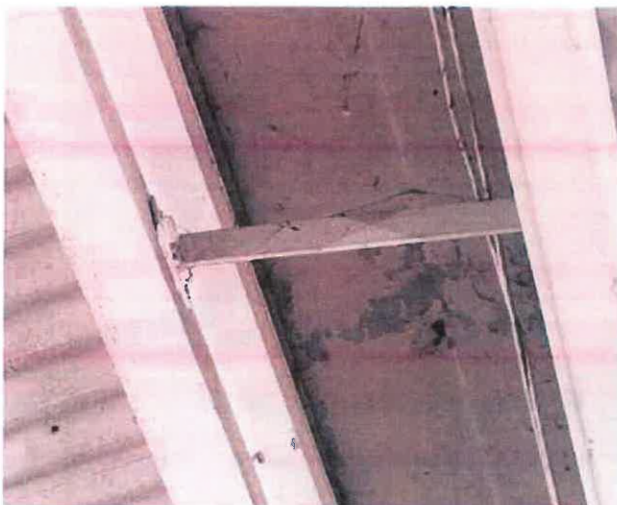
(Photo P – Possible Diaphragm Discontinuity)

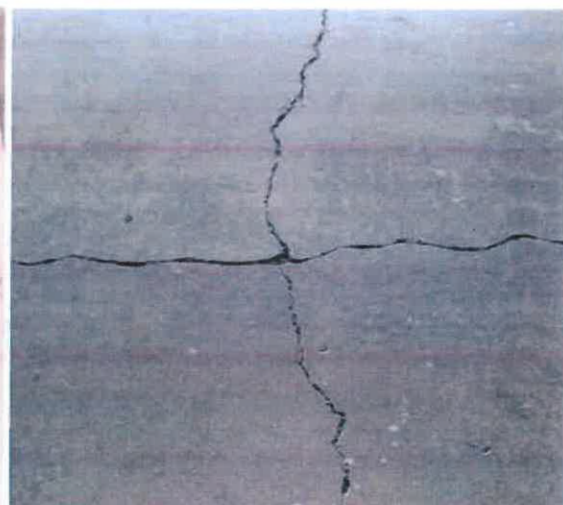
Based on a visual observation only, the foundation appears to either be a grade beam system with thickened slab or a mat foundation. Foundation slab cracks were visible; however, no settlement of the foundation was noticed.

(Photo Q – Cracked Slab)
