Attachment A: Tree Report

### TREE REPORT

7322-7340 N. Topanga Blvd. Canoga Park, CA 91303

August 3, 2020

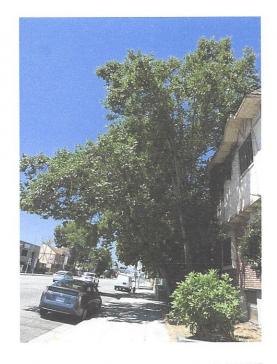
Tree 1 is *Platanus occidentalis*, American Sycamore in fair condition with evidence of dieback, anthracnose and canker. It is 36' high by 22' wide with calipers of 13" and 19". Replacement value is 1 24"-box tree.

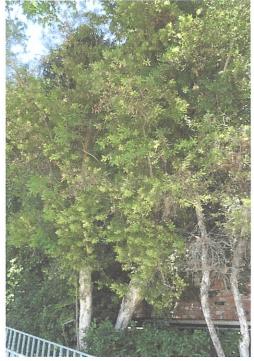
Tree 2 is *Melaleuca quinquenervia*, Cajeput Tree, in good condition. It stands 19' high by 9' wide, with calipers of 7" and 9". Replacement value is 1 24"-box tree.

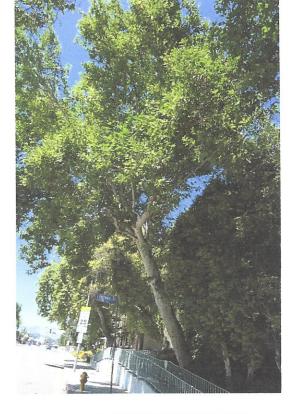
Tree 3 is *Platanus occidentalis*, American Sycamore in good condition with evidence of canker. It is 36' high by 21' wide with a caliper of 20". Replacement value is 1 24"-box tree.

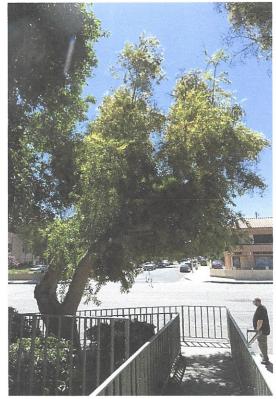
Tree 4 is *Melaleuca quinquenervia*, Cajeput Tree, in fair condition with poor pruning and yellowed foliage. It stands 17' high by 11' wide, with calipers of 9" and 11". Replacement value is 1 24"-box tree

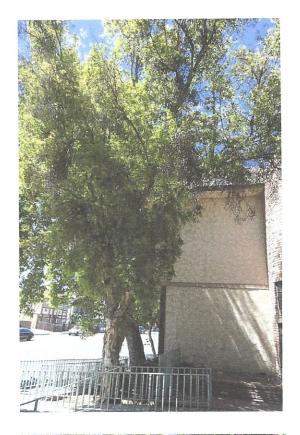
Tree 5 is *Melaleuca* quinquenervia, Cajeput Tree, in good condition. It stands 27' high by 15' wide, with a calipers of 19". Replacement value is 1 24"-box tree

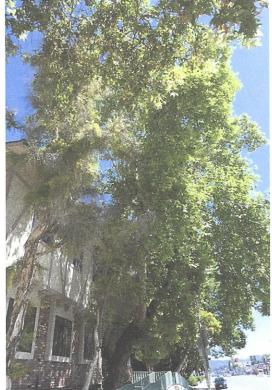
Tree 6 is *Platanus occidentalis*, American Sycamore in good condition. It is 38' high by 15' wide with a caliper of 28". Replacement value is 1 24"-box tree

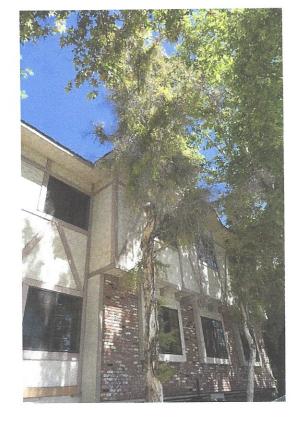
Tree 7 is *Melaleuca* quinquenervia, Cajeput Tree, in fair condition with declining health and signs of dieback. It stands 24' high by 8' wide, with a caliper of 11". Replacement value is 1 24"-box tree

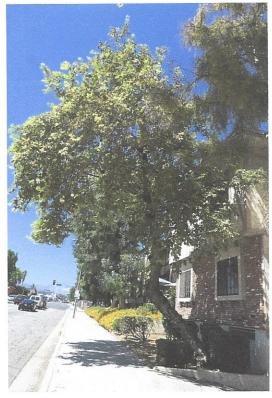
Tree 8 is *Platanus occidentalis*, American Sycamore in good condition. It is 23' high by 15' wide with a caliper of 16". Replacement value is 1 24"-box tree

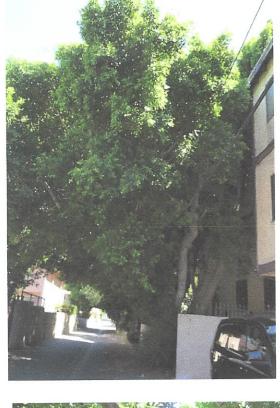
Tree 9 is *Ficus microcarpa v. nitida*, Indian Laurel in good condition. It stands 21' high by 21' wide, with a caliper of 32". Replacement value is 1 24"-box tree

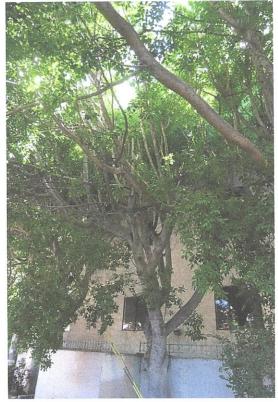
Tree 10 is *Ficus microcarpa v. nitida*, Indian Laurel in good condition. It stands 21' high by 21' wide, with a caliper of 21". Replacement value is 1 24"-box tree

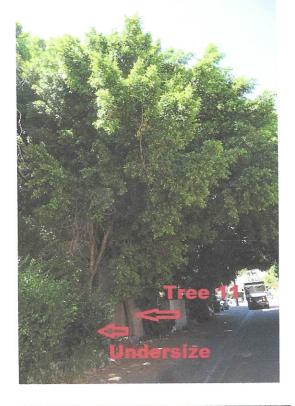
Tree 11 is *Ficus microcarpa v. nitida*, Indian Laurel in good condition. It stands 22' high by 22' wide, with a caliper of 22". Replacement value is 1 24"-box tree

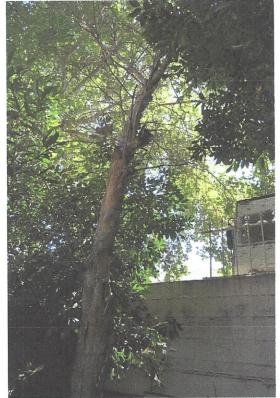
Tree 12 is *Platanus occidentalis*, American Sycamore in fair condition with declining health and poorly pruned. It is 18' high by 7' wide with a caliper of 18". Replacement value is 1 24"-box tree

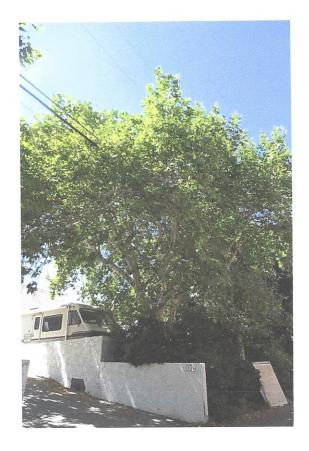
Tree 13 is *Platanus occidentalis*, American Sycamore in fair condition with evidence of dieback, anthracnose and canker. It is 22' high by 24' wide with a caliper of 32". Replacement value is 1 24"-box tree.

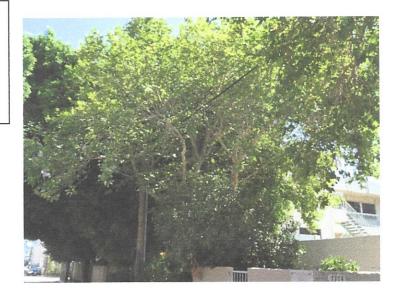
Tree 14 is *Platanus occidentalis*, American Sycamore in fair condition. It is 22' high by 22' wide with a caliper of 16". Replacement value is 1 24"-box tree

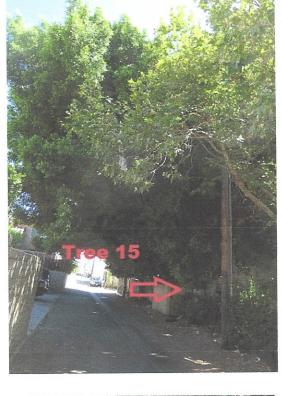
Tree 15 is *Ficus microcarpa v. nitida*, Indian Laurel in good condition. It stands 24' high by 21' wide, with a caliper of 46". Replacement value is 1 24"-box tree

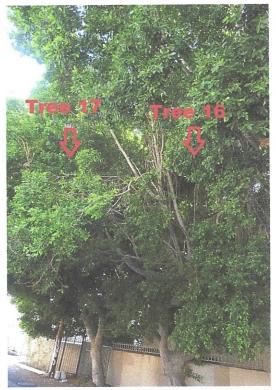
Tree 17 is *Ficus microcarpa v. nitida*, Indian Laurel in good condition. It stands 28' high by 29' wide, with a caliper of 28". Replacement value is 1 24"-box tree
