**PHASE I ENVIRONMENTAL
SITE ASSESSMENT REPORT**

1155 and 1165 South Main Street
Los Angeles, California 90015
Assessor's Parcel Numbers: 5139-017-015 and 5139-017-016

Jade Enterprises
888 South Figueroa Street
Los Angeles, California 90017

March 14, 2014

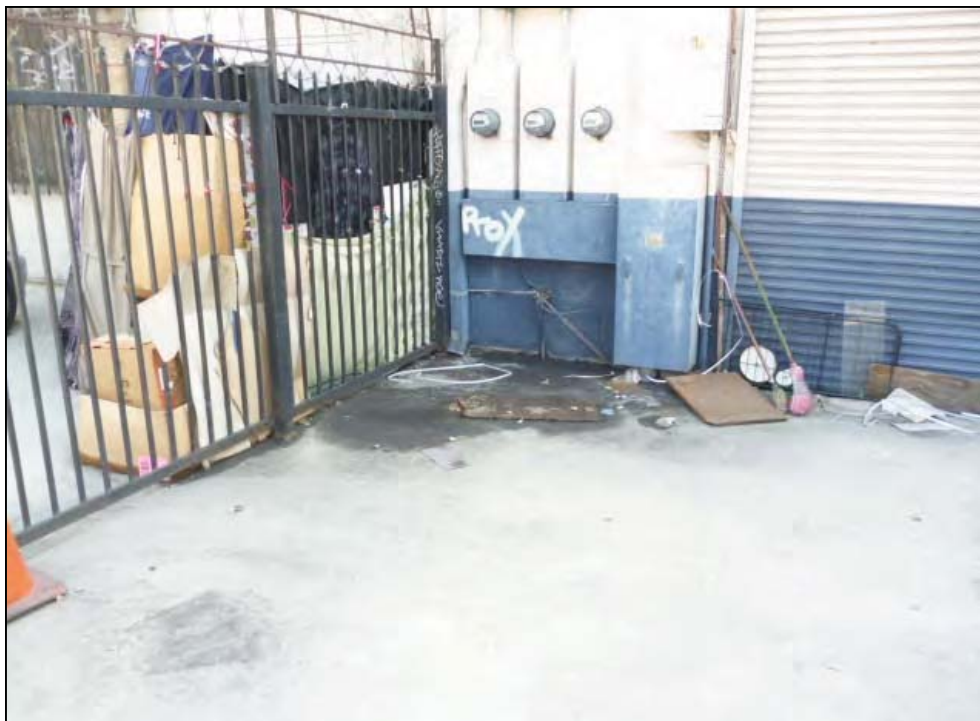
The subject property is developed with two single-story adjoining structures which occupy the majority of the subject property. The exterior portions of the property consist of an enclosed asphalt paved area to the north which is utilized for parking. The asphalt appeared to be in good condition with no indication of significant staining or cracking. No recognized environmental conditions were observed in this portion of the site.

Photo 6: Exterior portion of subject property

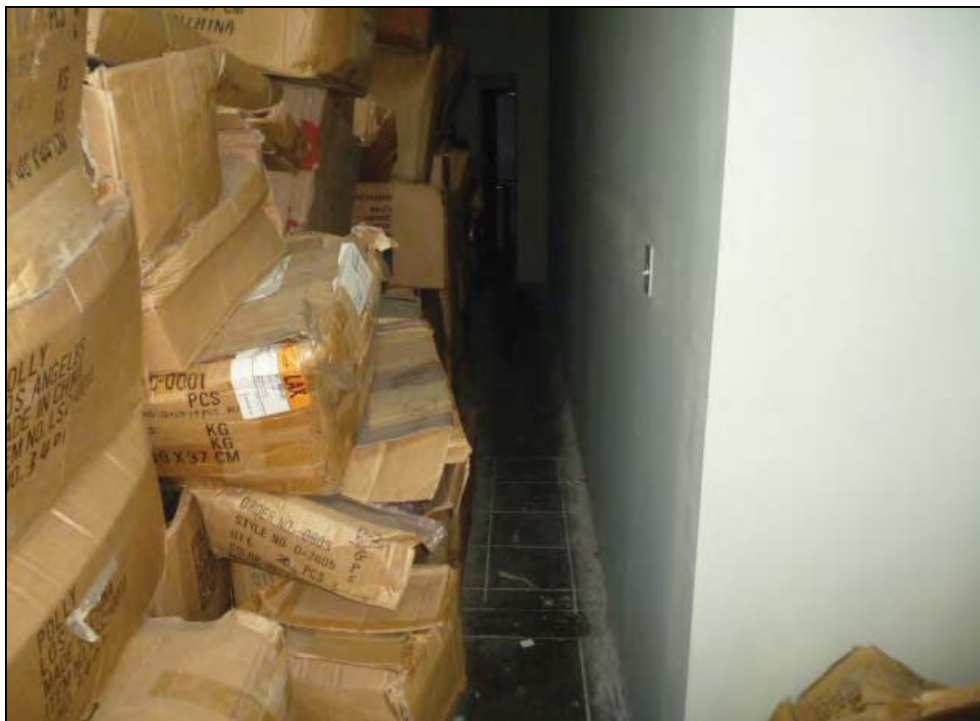
Due to the large number of boxes stored within the two units associated with 111 West 12th Street, Andersen Environmental was unable to observe the condition of all concrete floor surfaces in these units. Concrete surfaces observed appeared to be in good condition. However, the subject property was formerly utilized for auto repair operations. For more information please refer to Section 5.1.

Photo 10: Box clutter within Polly Trading Company

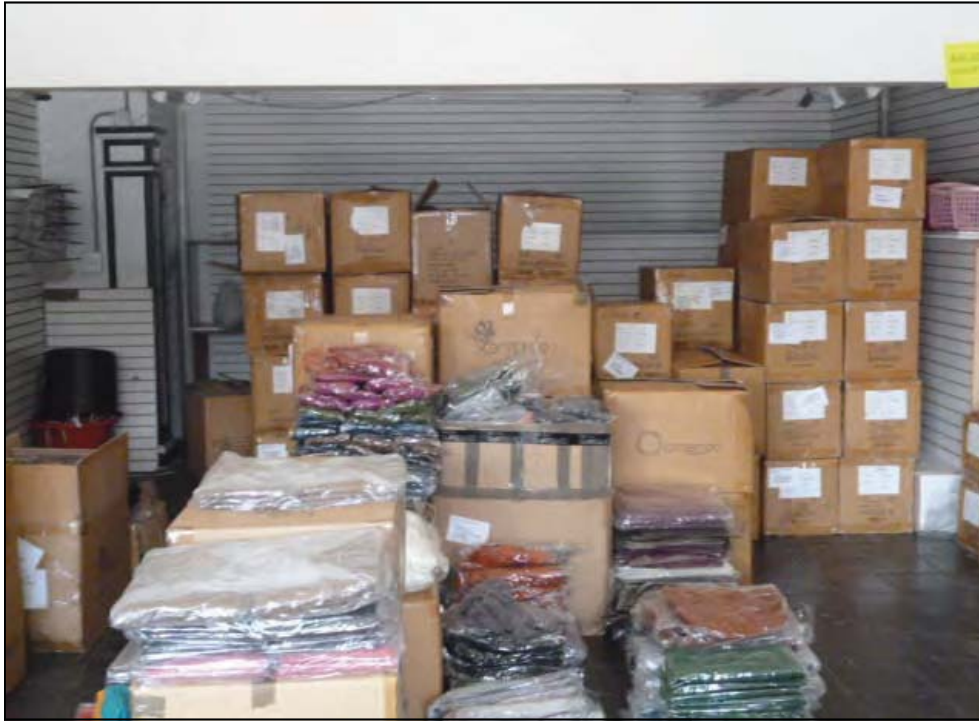
Photo 11: Box clutter within Polly Trading Company
