# Street Tree Report

**For: 1911-1931 Sunset Blvd, Echo Park, CA**

*Prepared by:* **Greg Applegate, RCA #365**  
**Arborgate Consulting, Inc.**  
**1131 Lucinda Way**  
**Tustin, CA 92780**  
**714/ 731-6240**

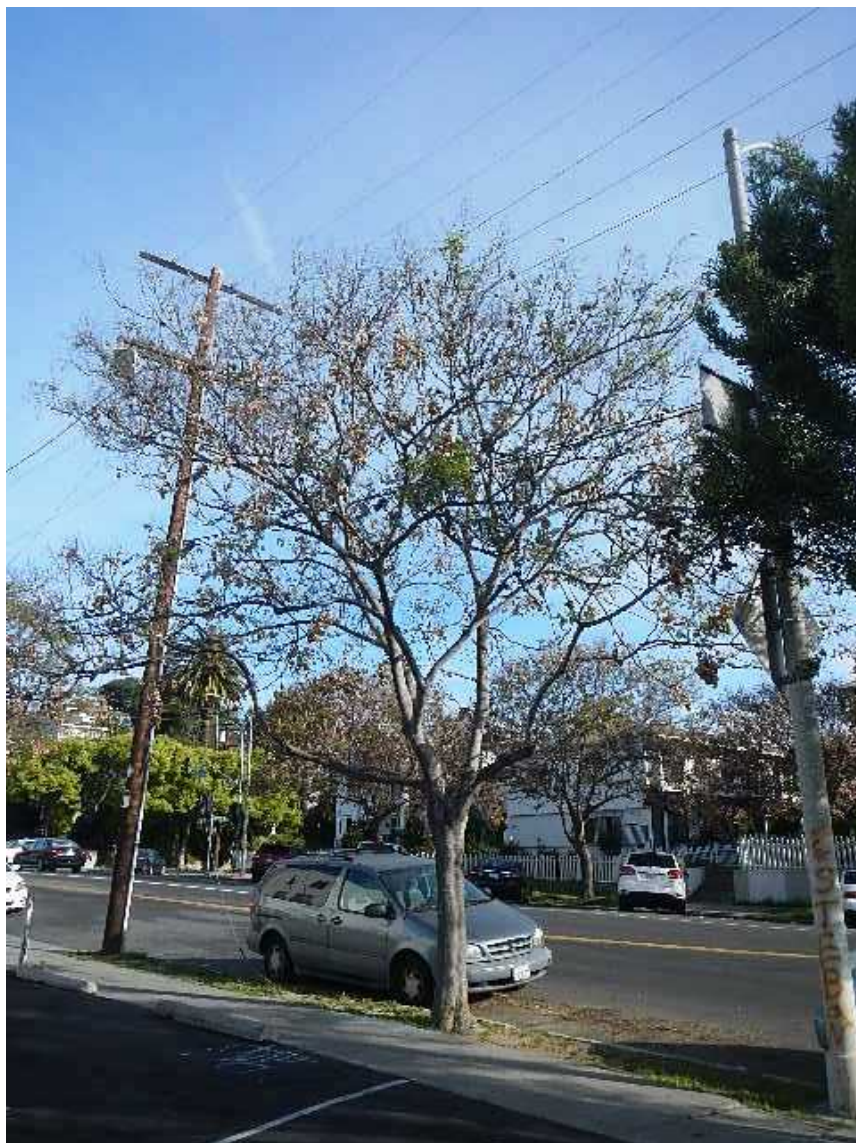
Tree #34, a golden rain tree

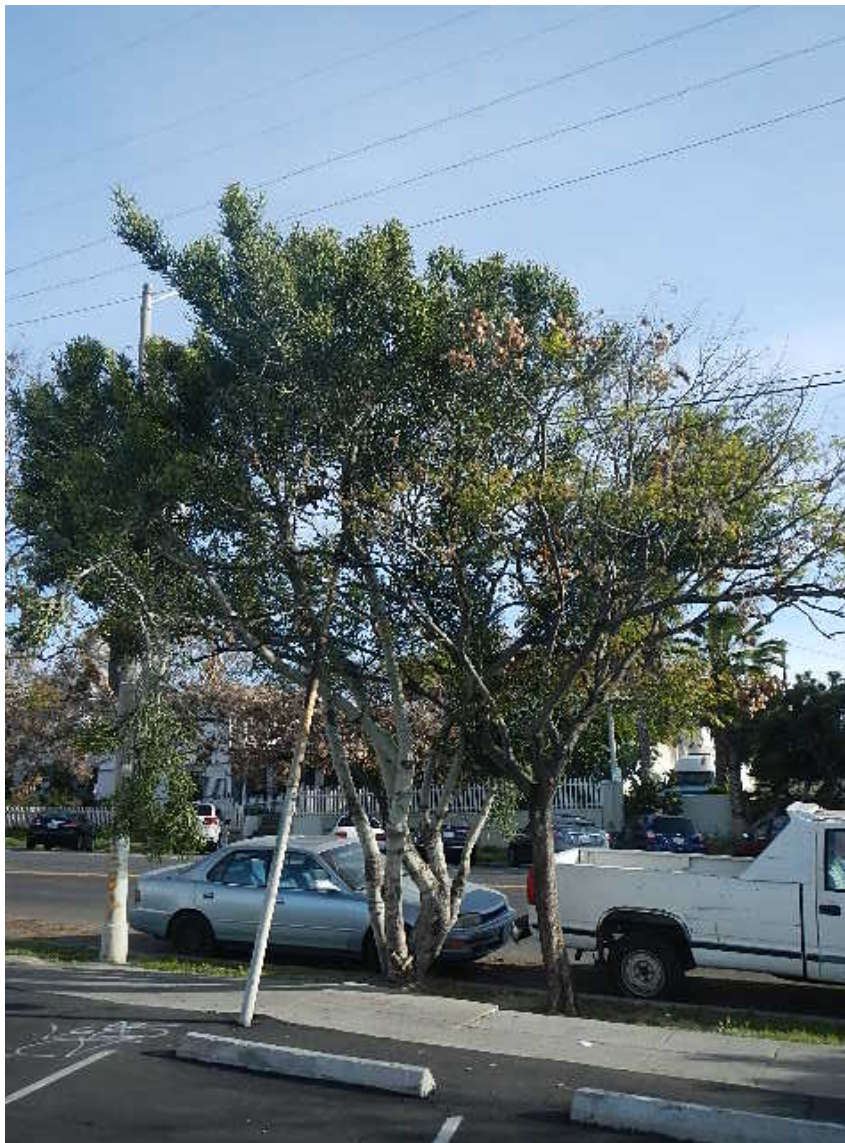
Trees #35 and 36, a pencil tree and a Chinese flame tree.

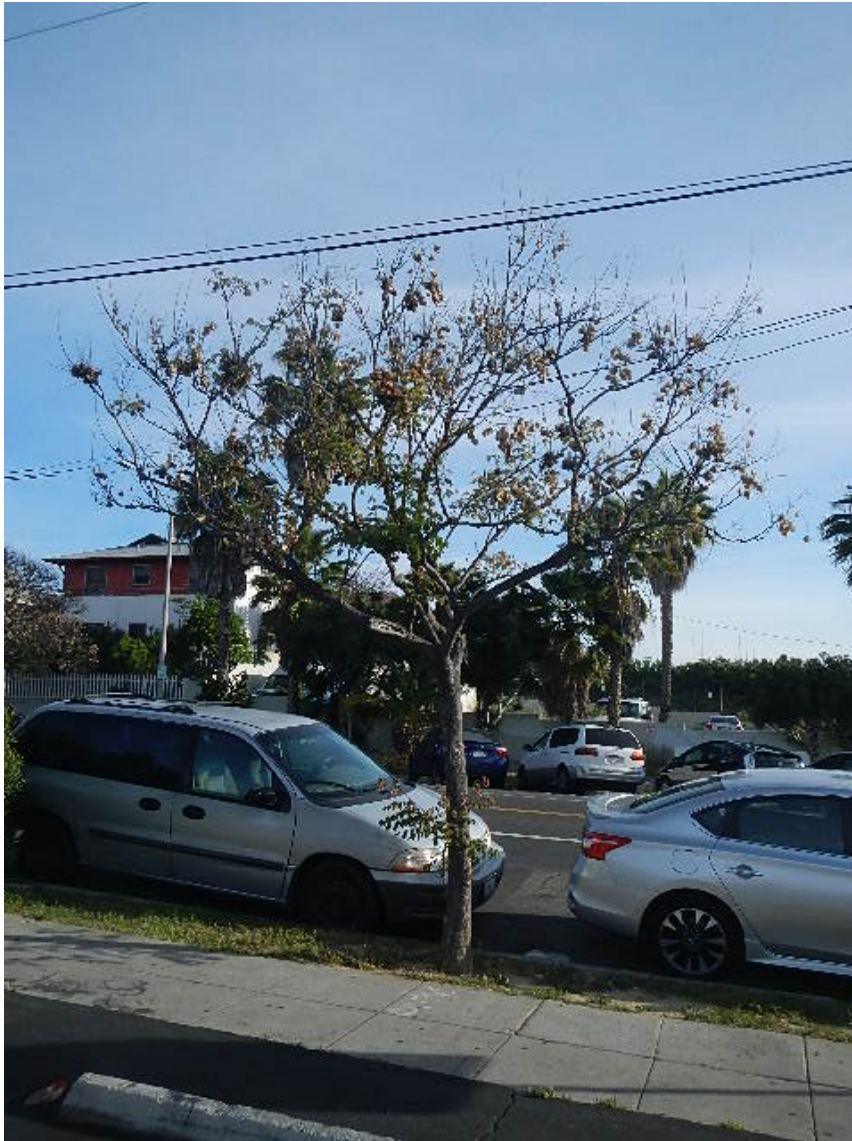
Tree #37, a Chinese flame tree

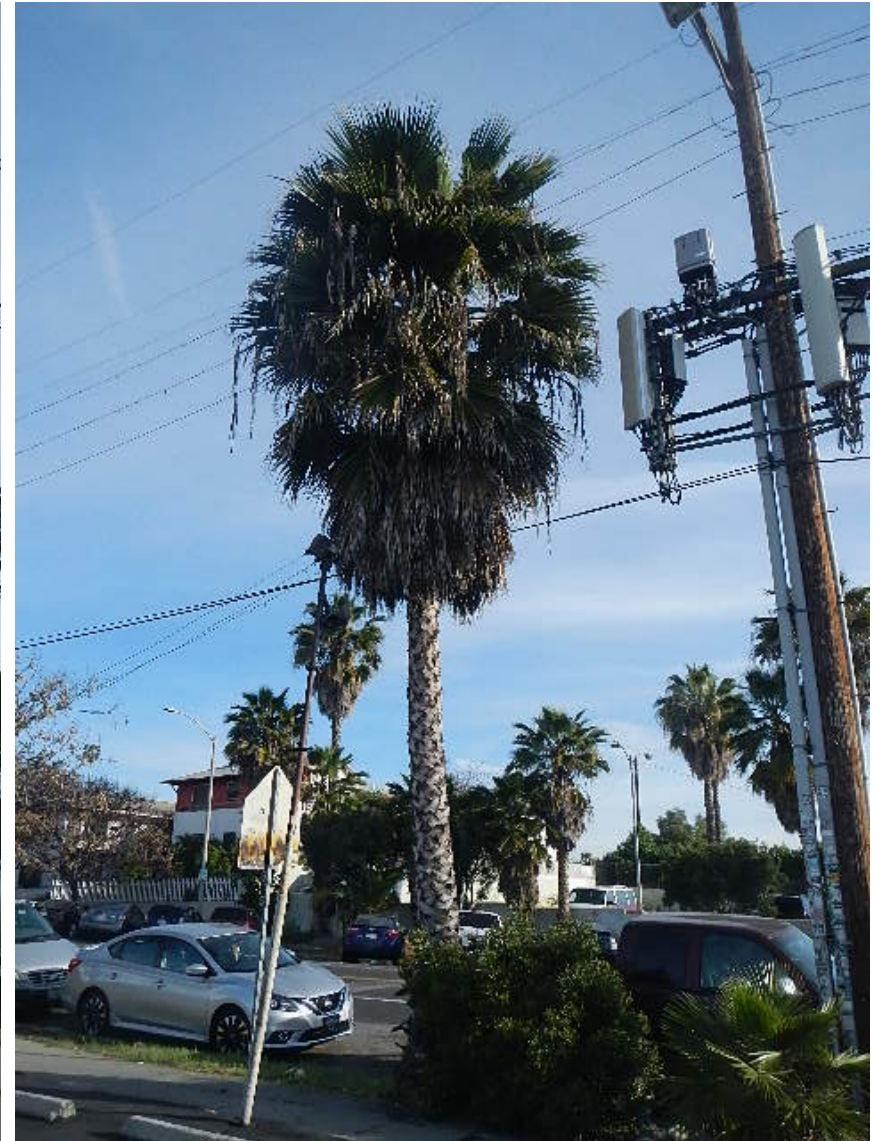
Palm tree #38, a Mexican fan palm.

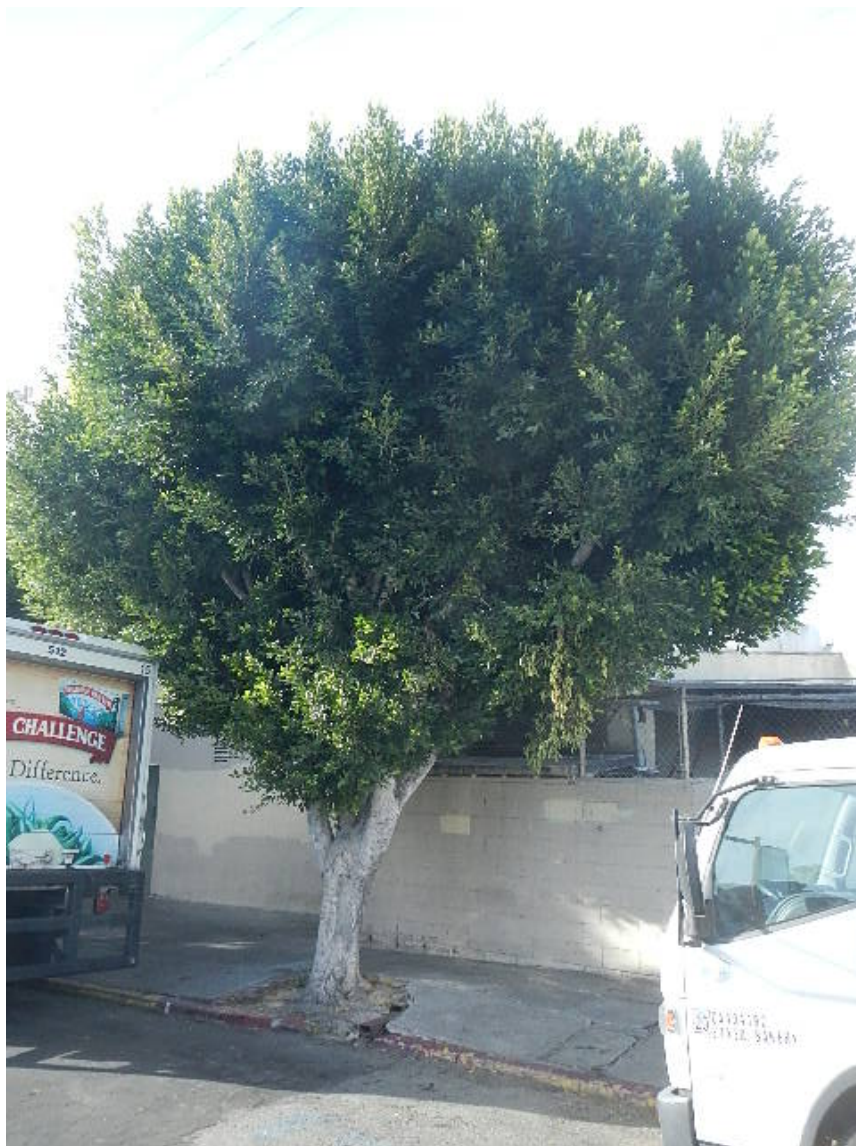
Tree #39, an Indian laurel

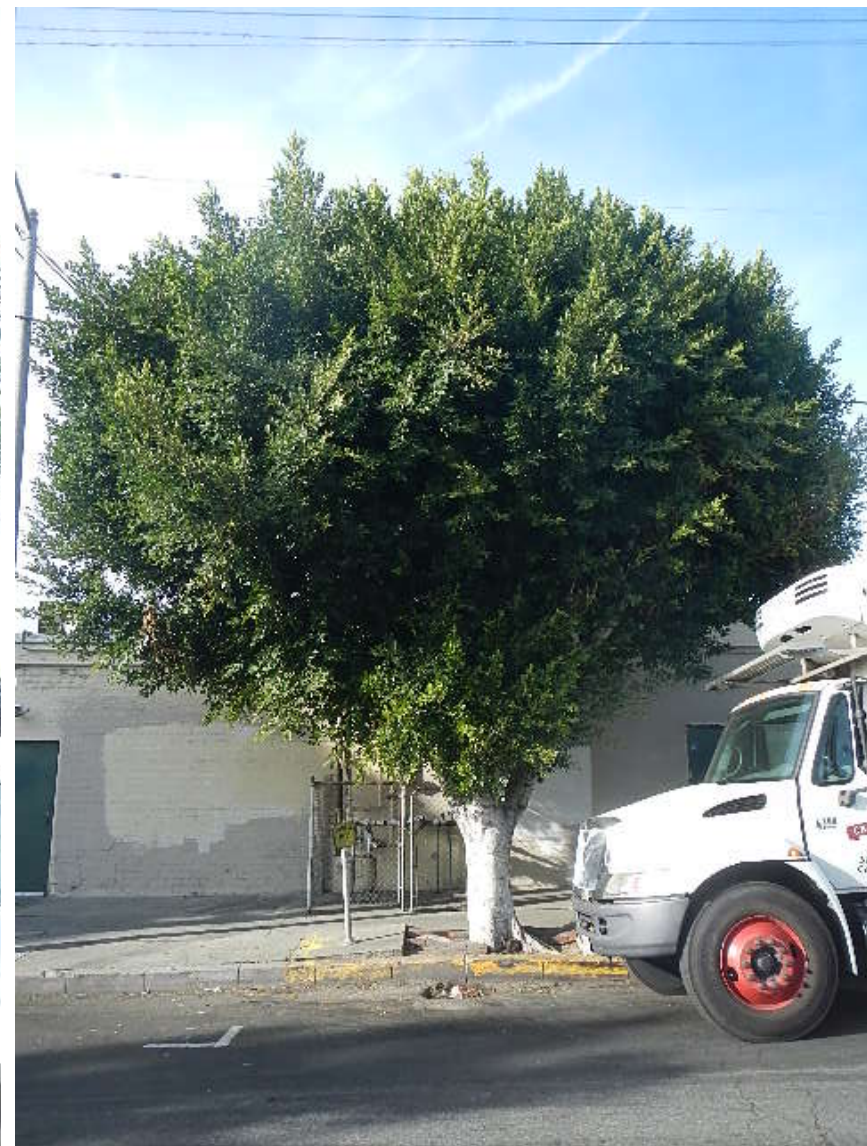
Tree #40, an Indian laurel

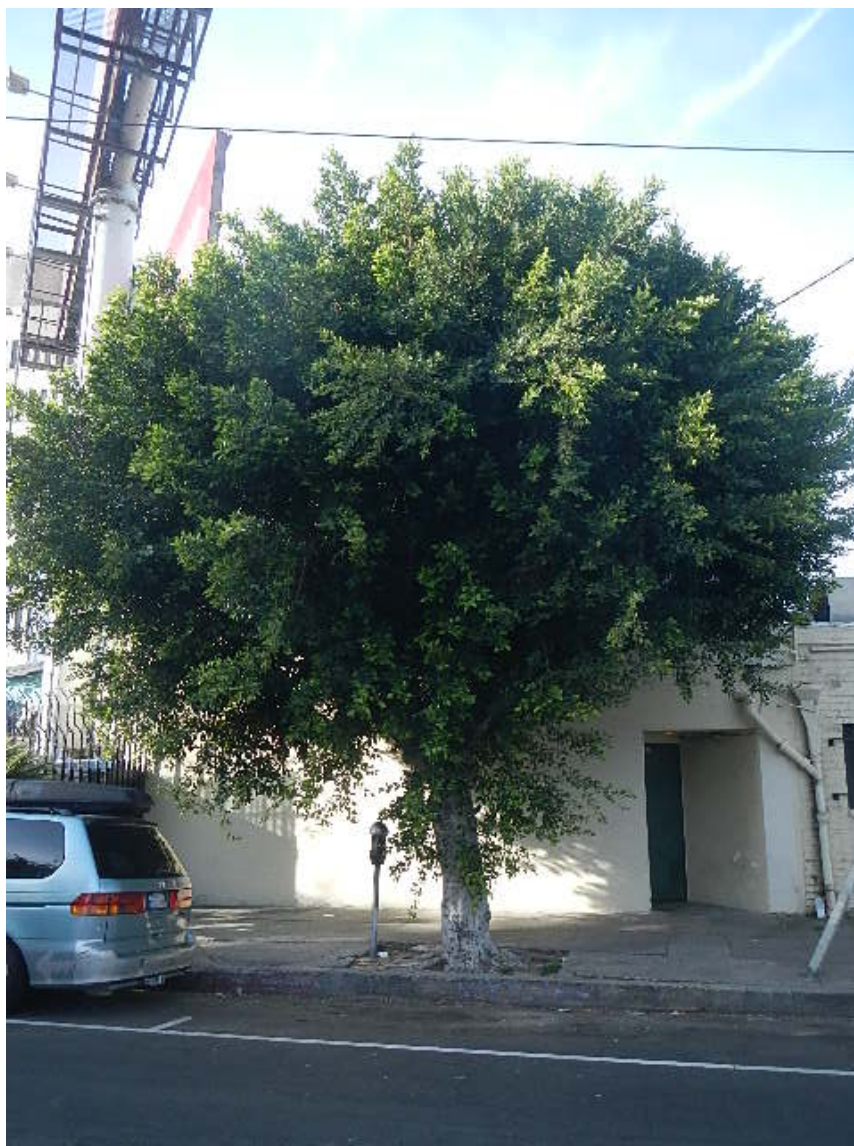
Tree #41, an Indian laurel

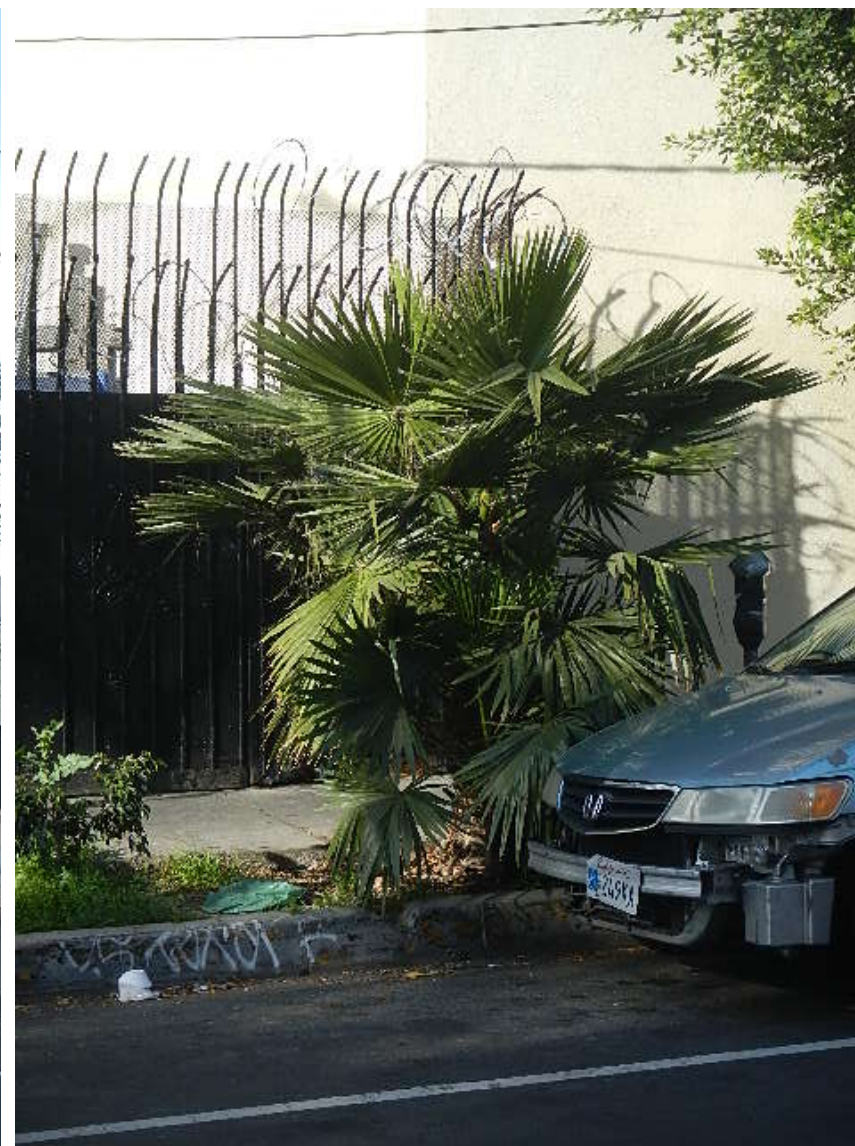
Palm tree #42, a Mexcan fan palm.

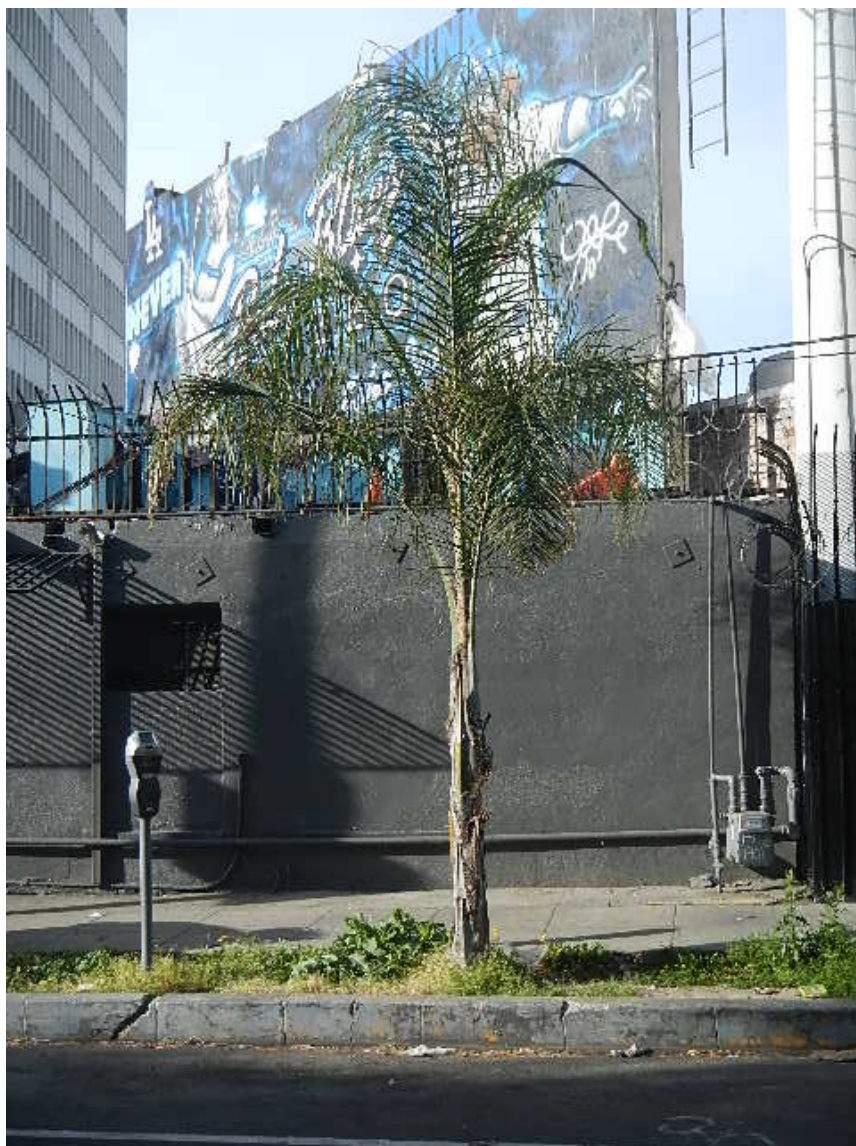
Palm tree #43, a queen palm

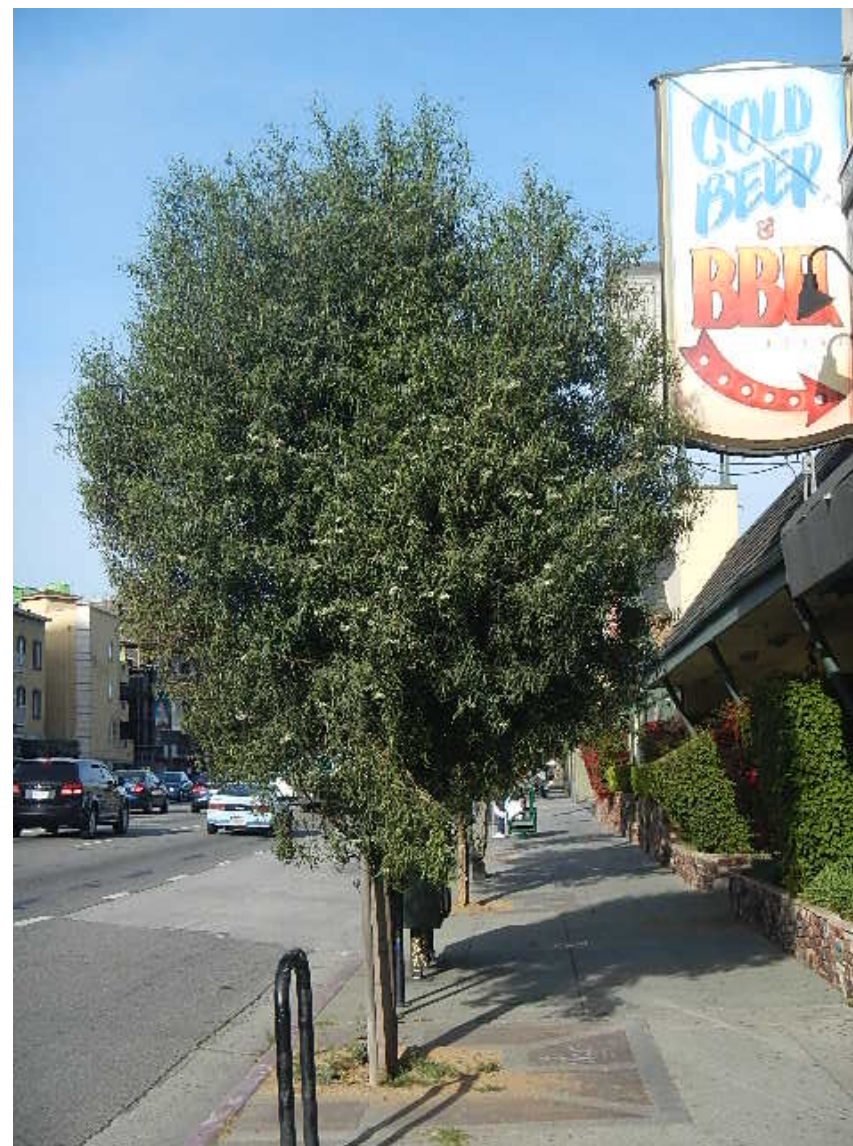
Tree #44, an Australian willow.

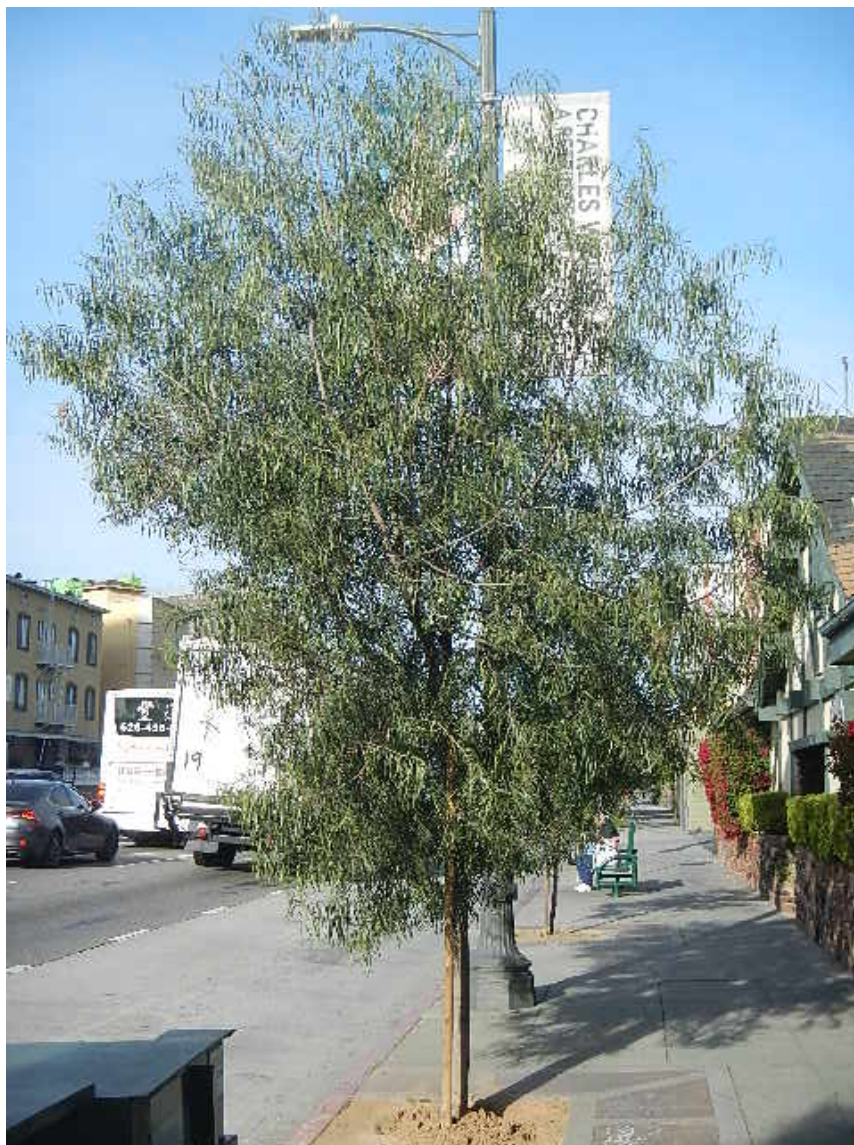
Tree #45, an Australian willow.

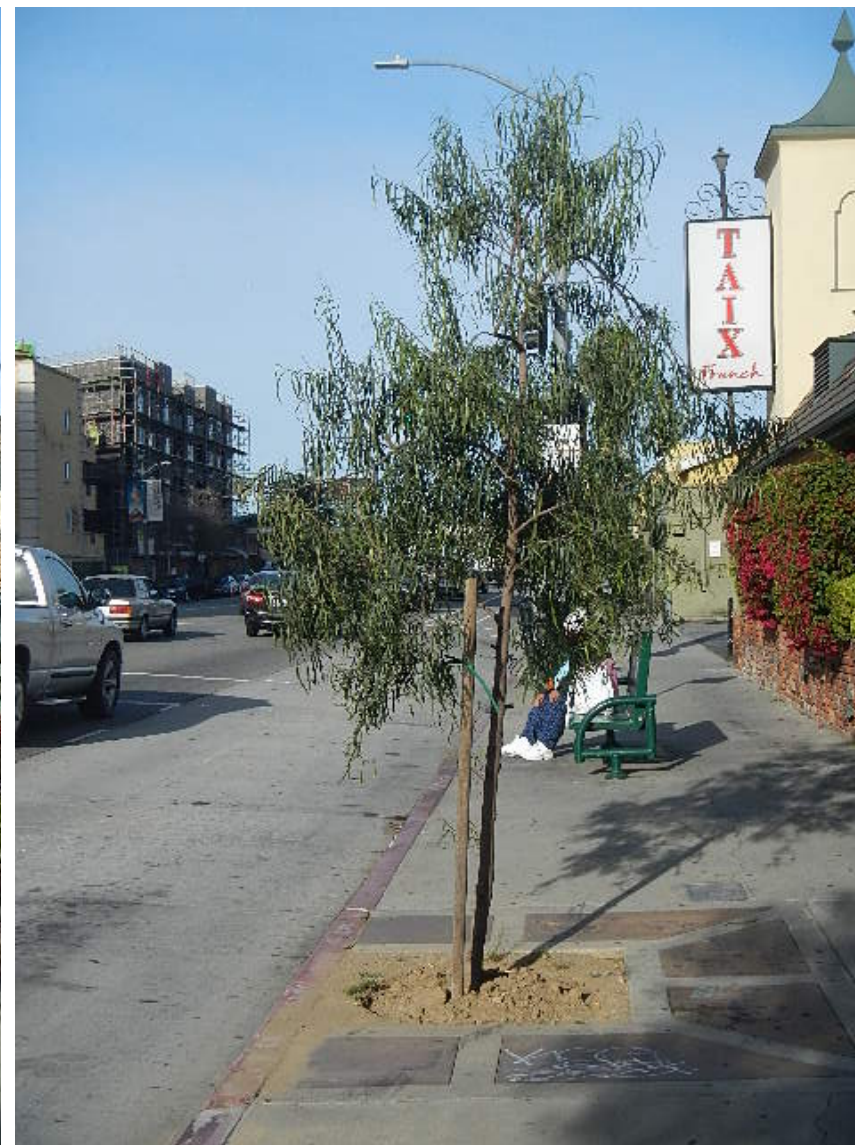
Tree #46, an Australian willow.

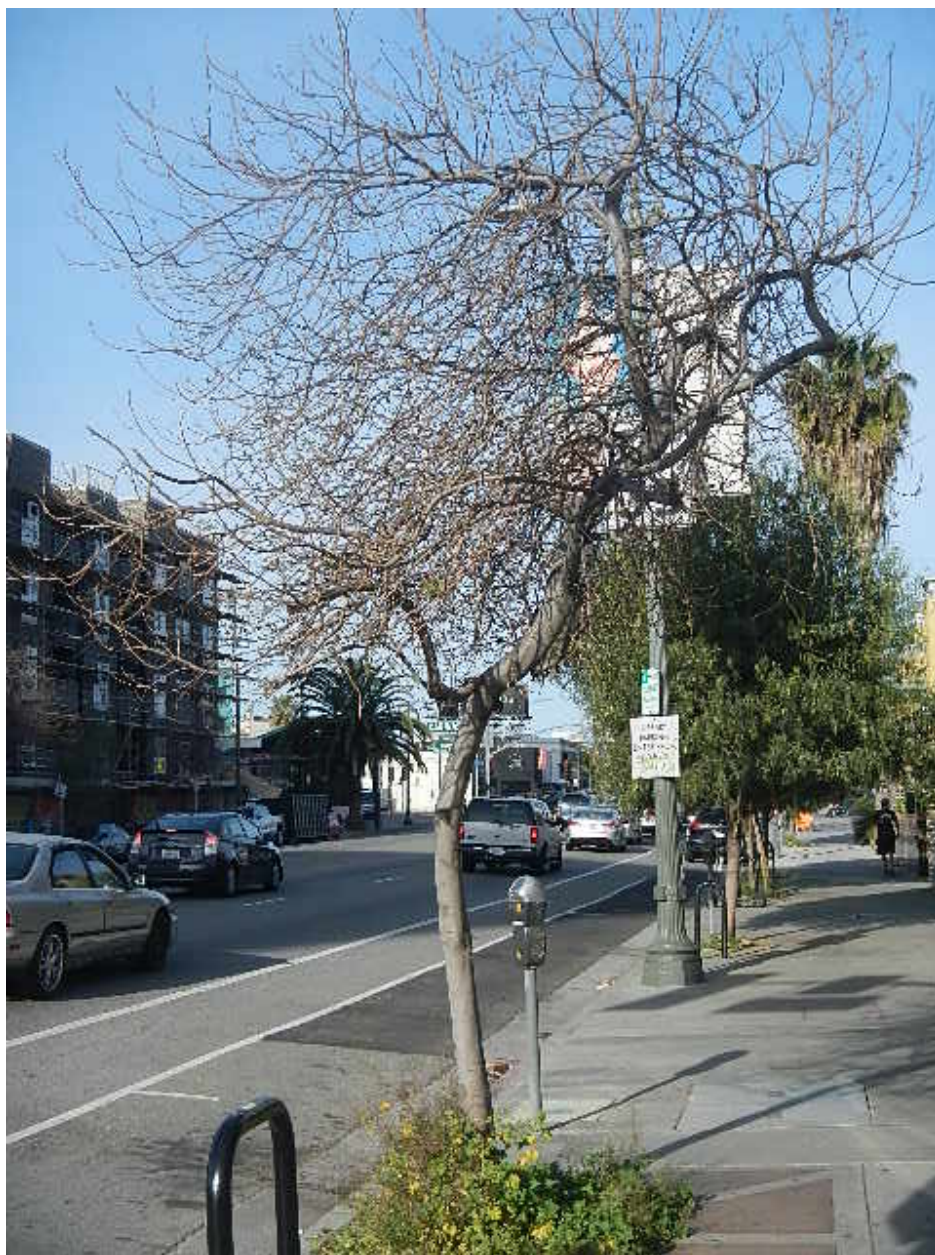
44	Geijera parviflora	4.5	17	11	A	4' CO	cod	CrS	okay	CO	On Sunset
45	Geijera parviflora	4.2	18	11	A	4' CO	cod	CrS	okay	CO	On Sunset
46	Geijera parviflora	1.7	13	8	B	4' CO	okay	okay	Sp	CO	On Sunset
47	Tabebuia avellaneda	4	18	12	D	4' CO	bow'd	okay	bare	CO	On Sunset

Tree #47, a pink trumpet tree
