MEMORANDUM

DATE: DECEMBER 13, 2021

SUBJECT: Surface Expression, Pacific Coast Energy Company LP, 9151 West Pico Boulevard, Los Angeles, CA 90035

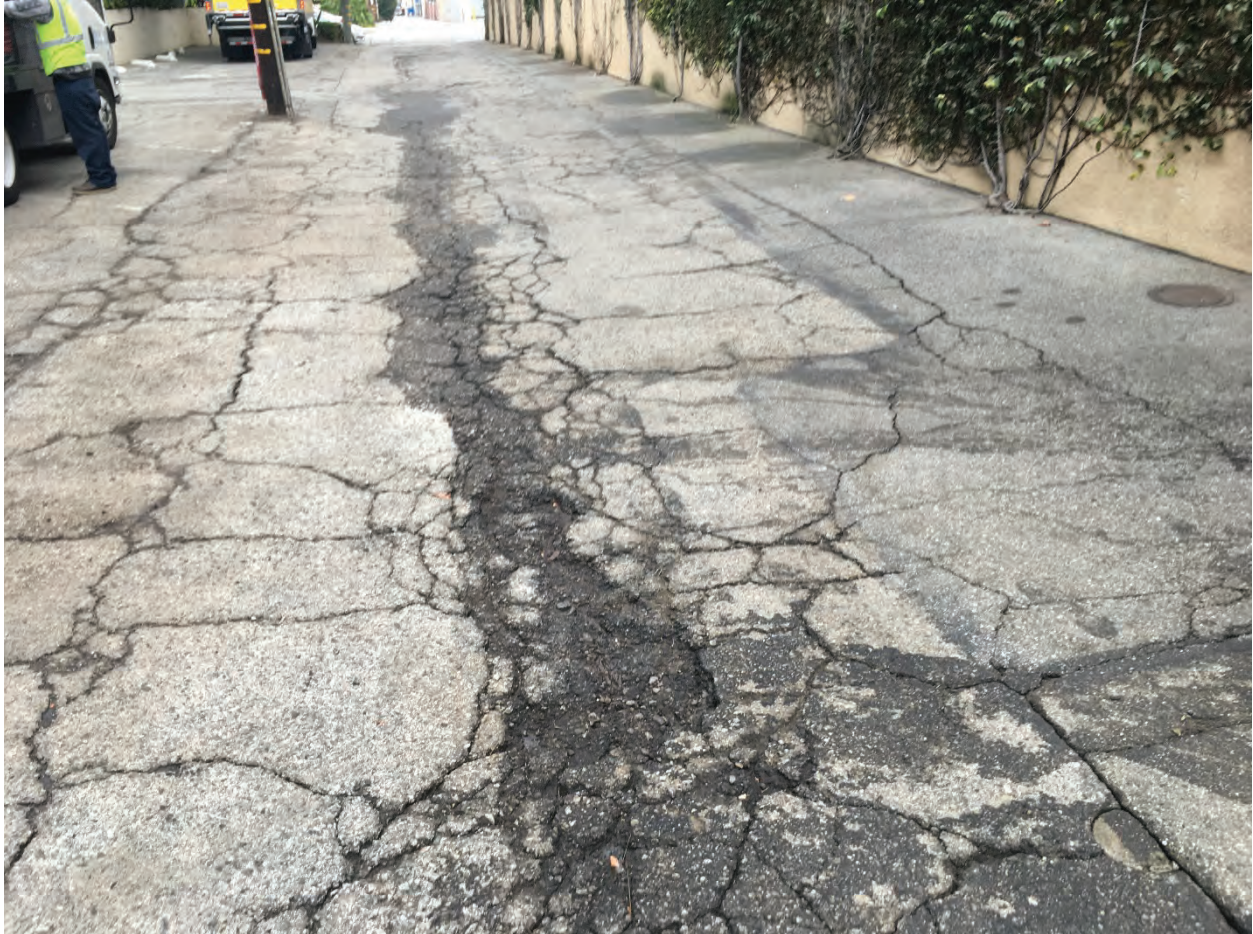
Figure 2. *This photo shows the area affected by the leaked fluid. The fluid pooled in the center of the alley and travelled west down the alley. It was reported that the fluid was removed with absorbent material and the ground was steam cleaned. At the time of the photo, there was no oil present. What is seen here is staining. There are no sewer or drainage systems affected. Visual staining was present on the alley surface.*

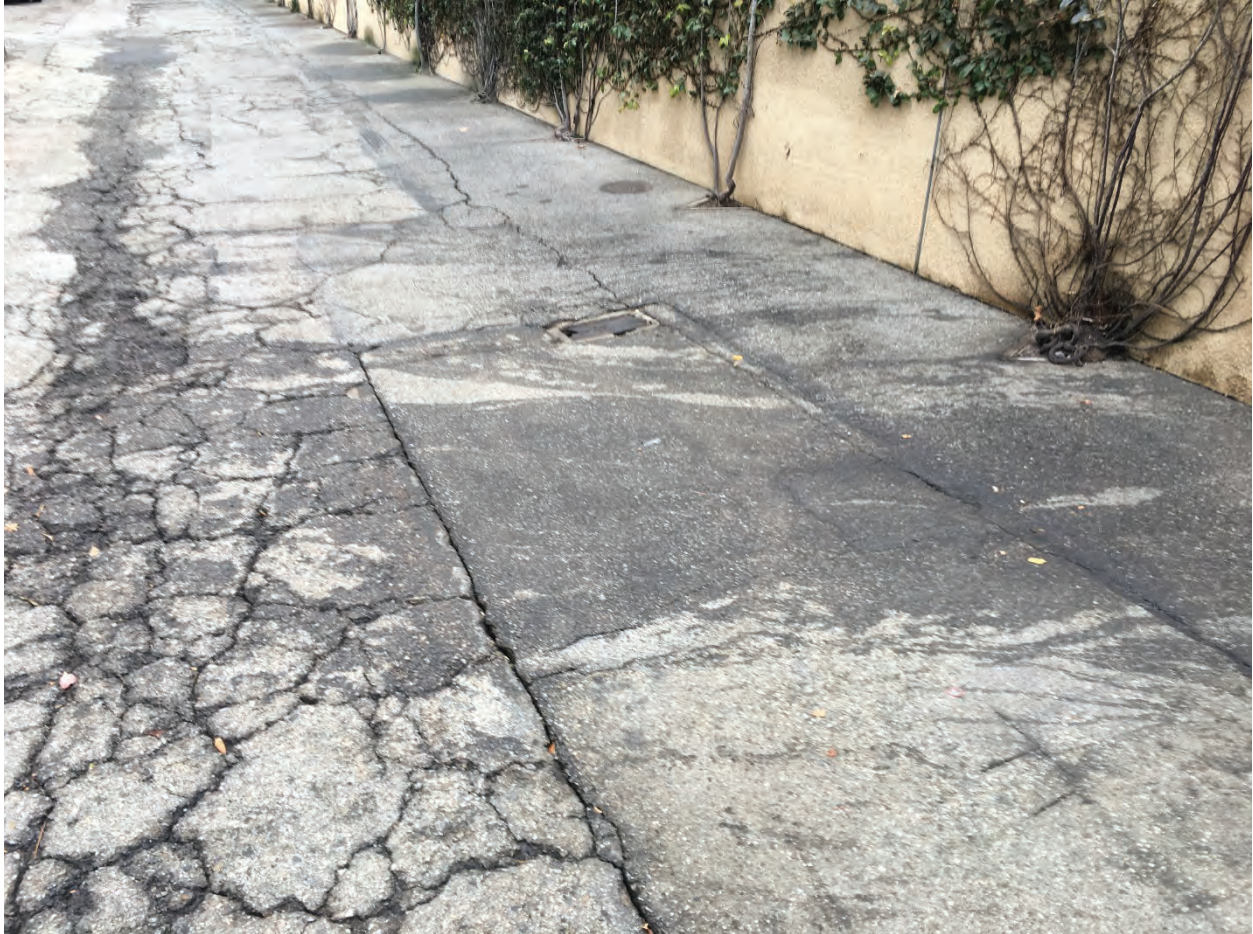
Figure 3. Staining shows point source with most discharge as well as lateral extent into the alley

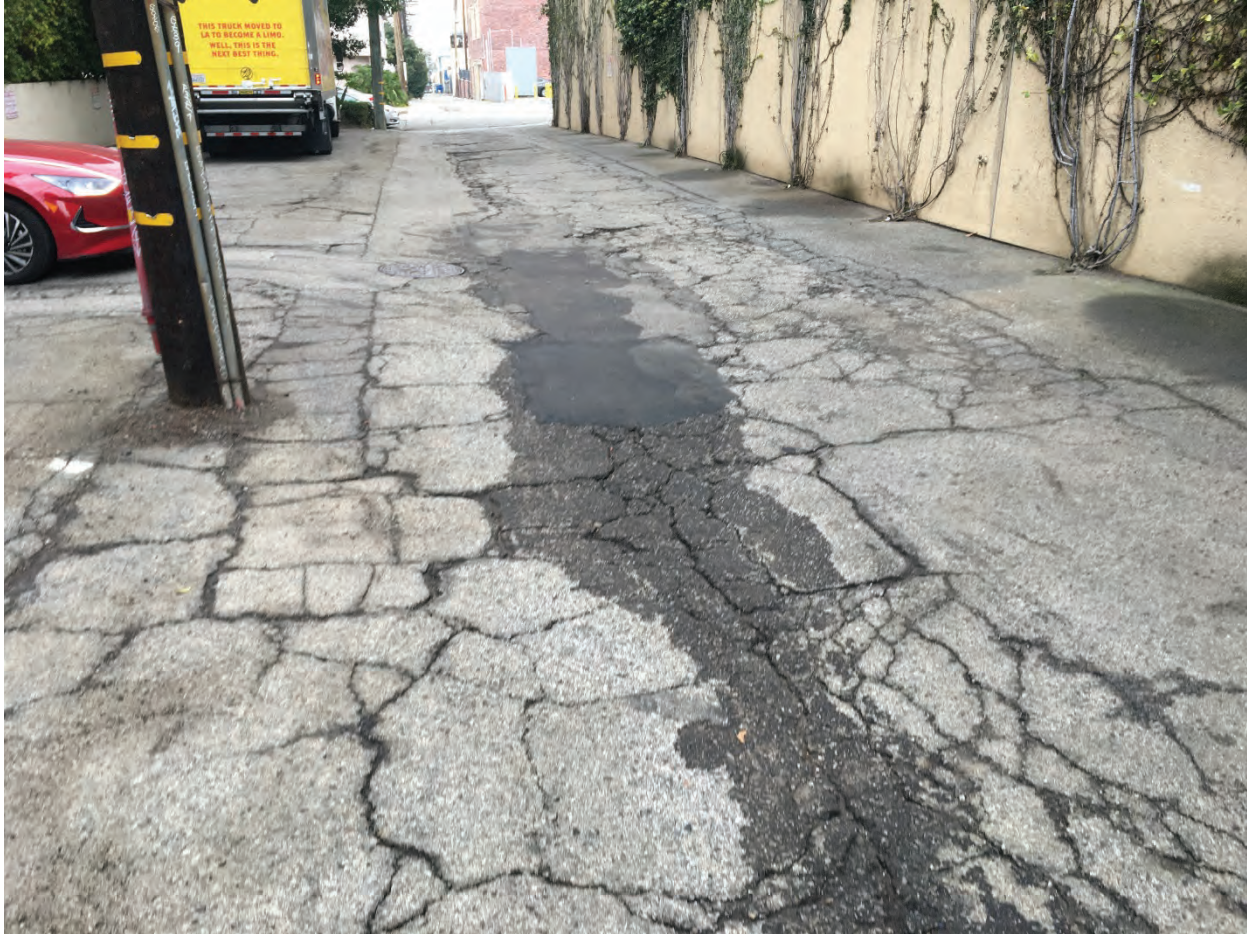
Figure 4. Shows areal extent of leaked fluid migration

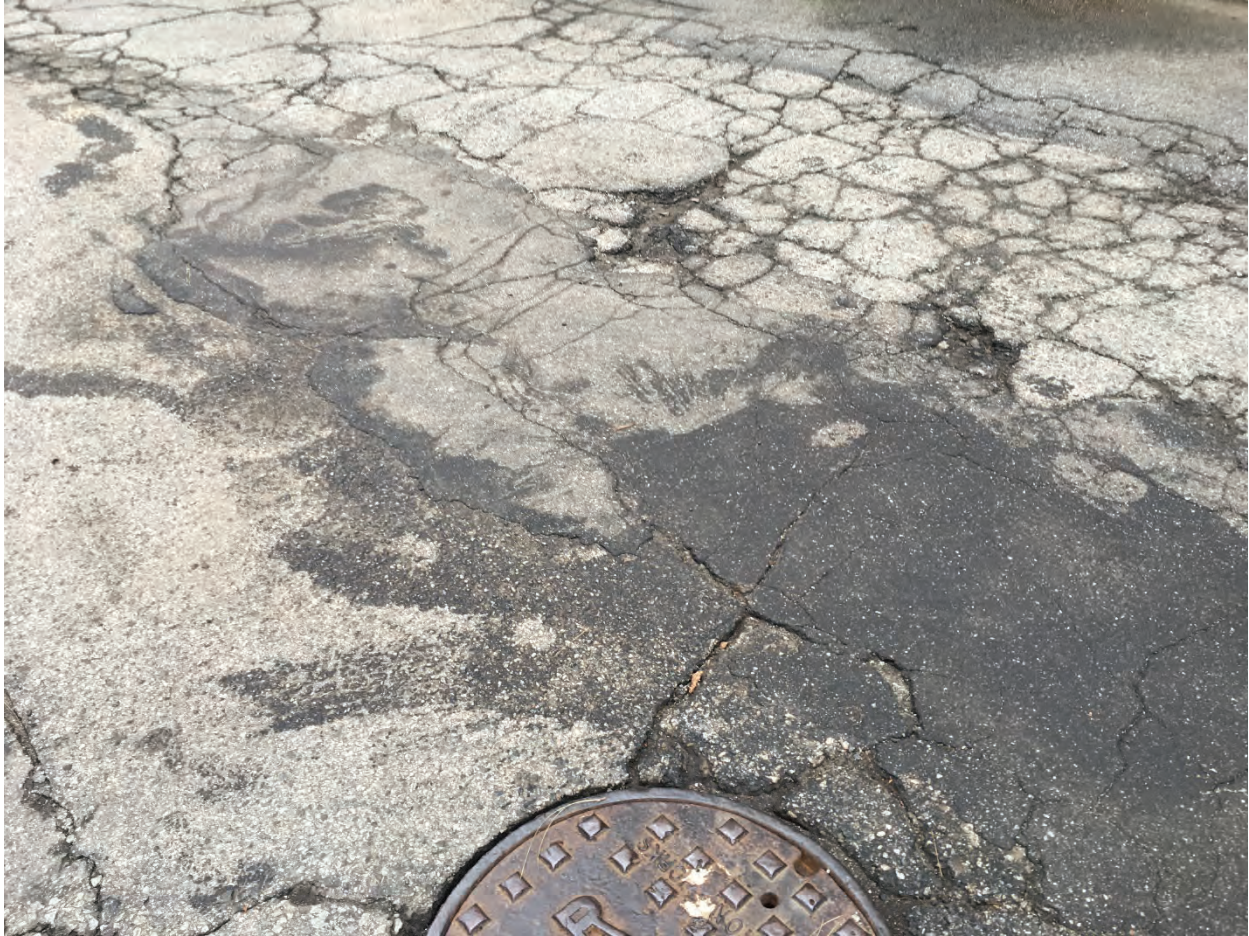
Figure 5. shows leaked fluid migration extent

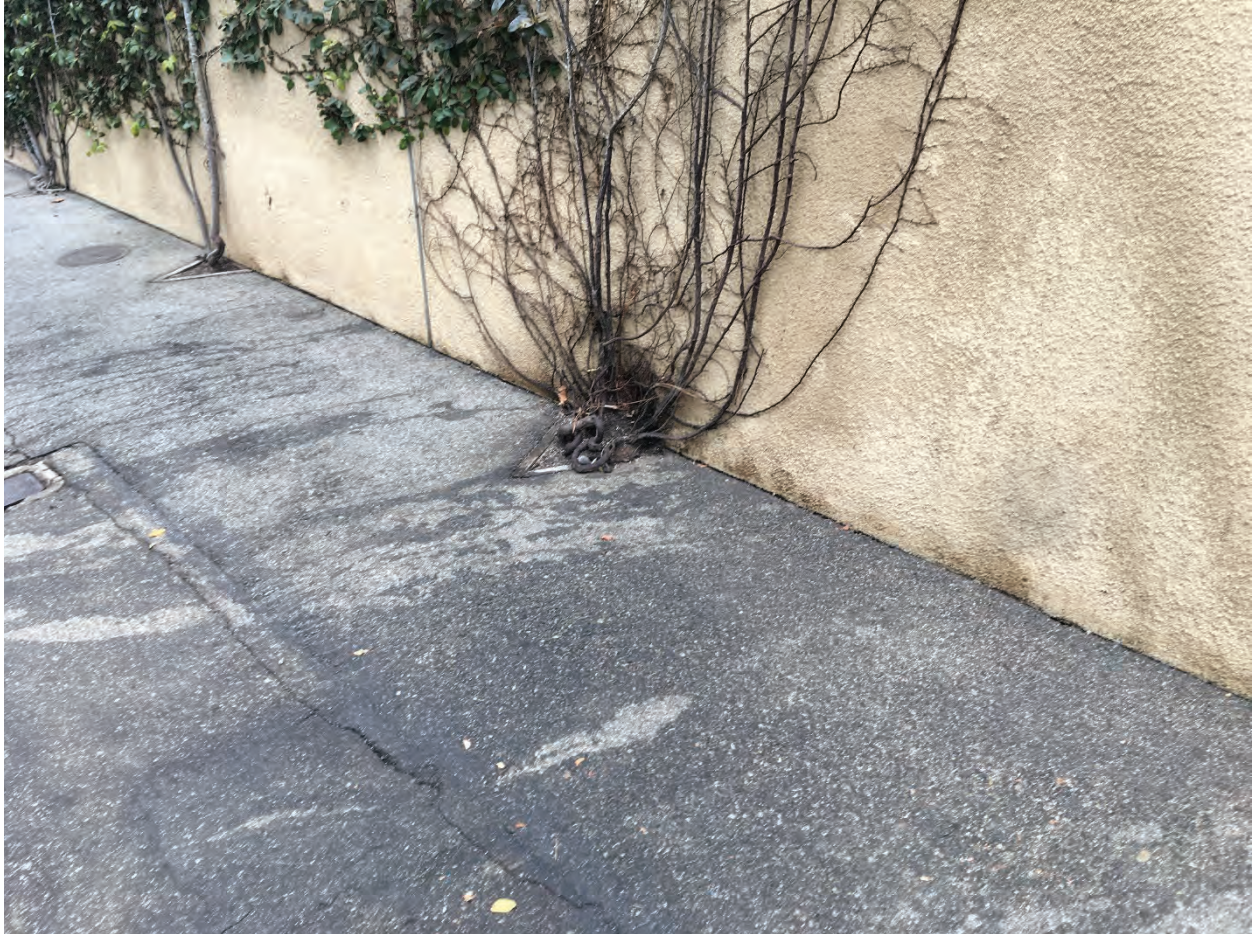
Figure 6. The fluid was extruded through the joint where the building wall met with the asphalt alley. The area shown here was the main location of leaking with minor leaks further east and west in the photo. The area which had leaks was approximately 10 feet in length.

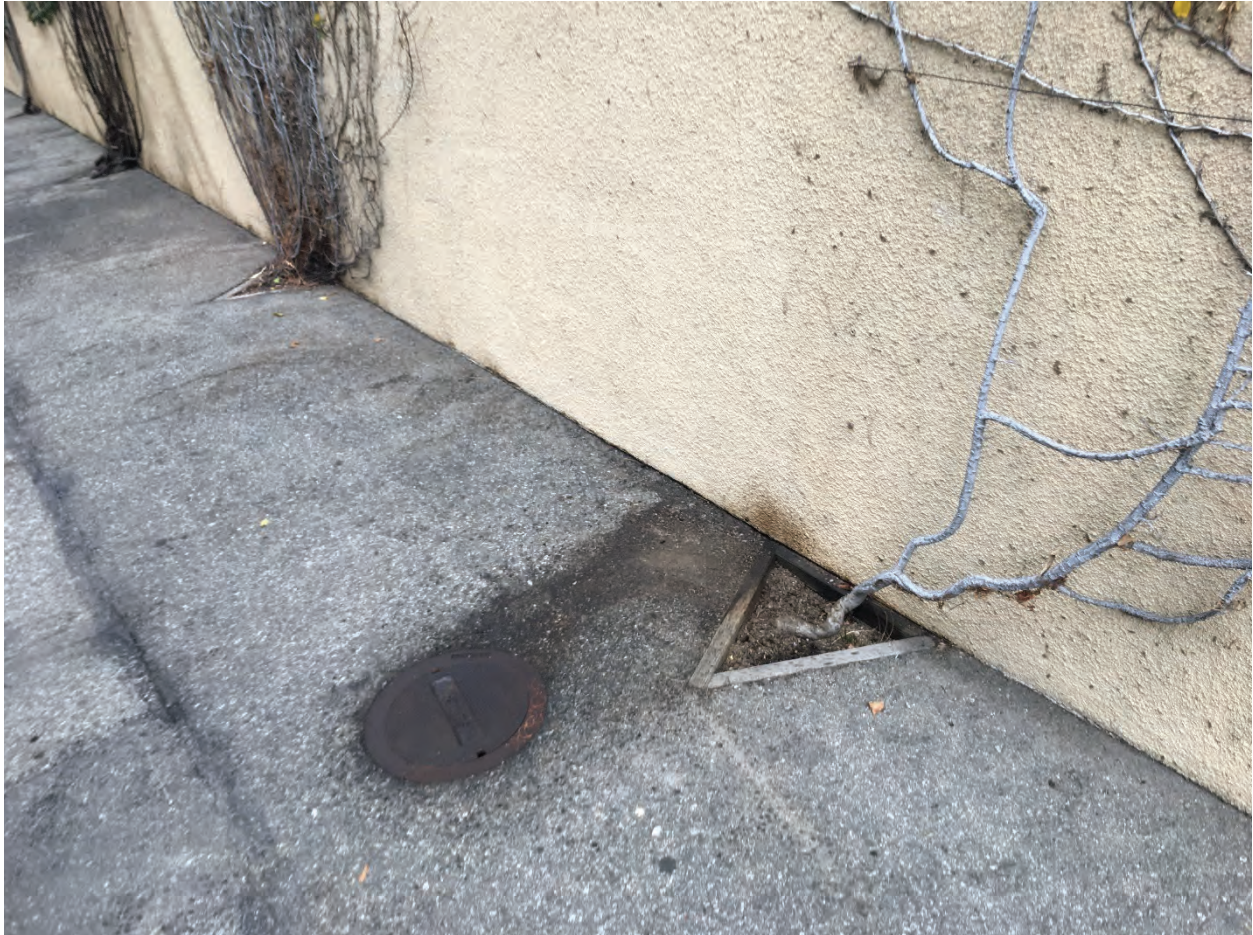
Figure 7. *The leaks were in between these four vines pictured.*

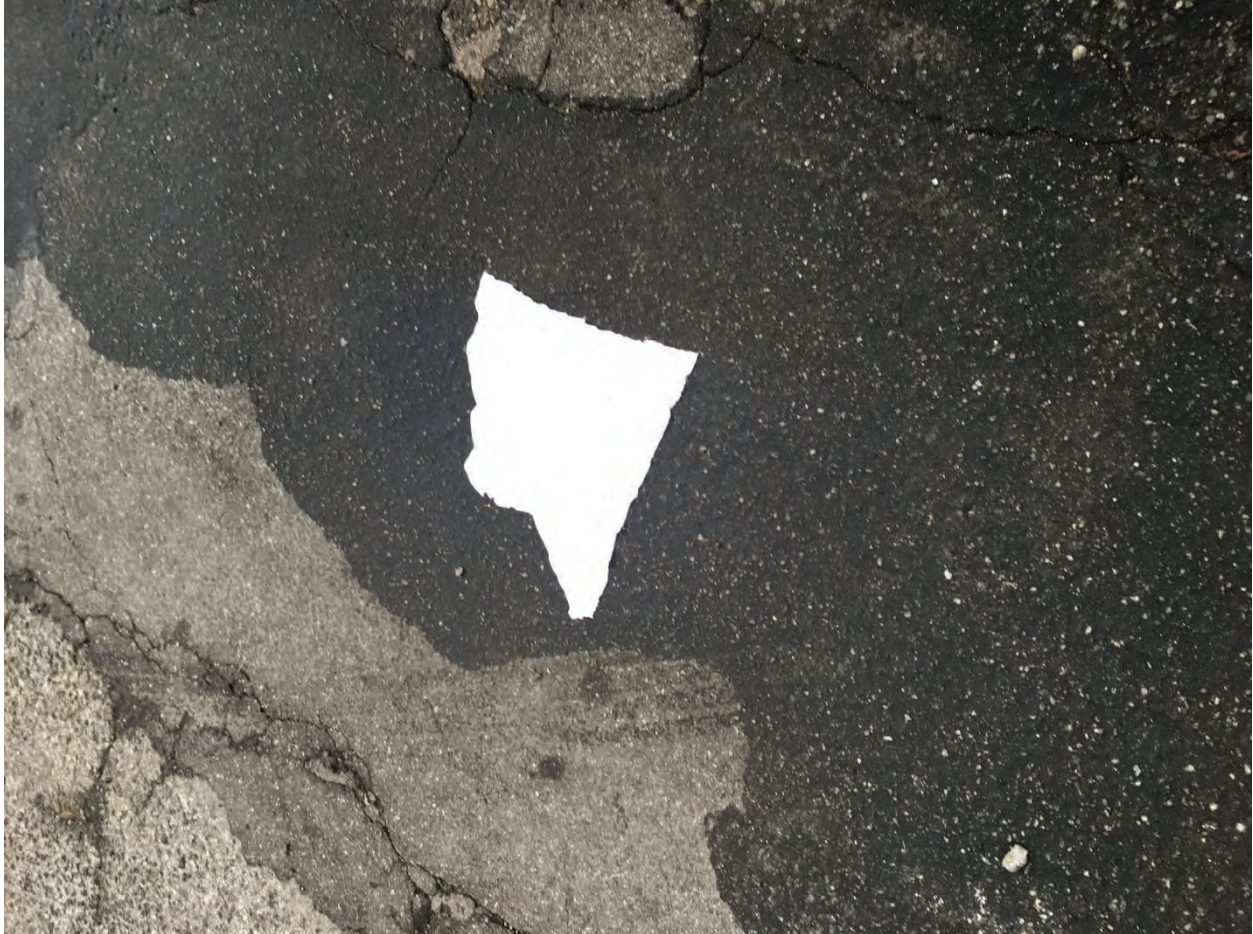
Figure 8. *This photo was taken before the rag was stepped on to show that there was no longer any leaked liquid present.*

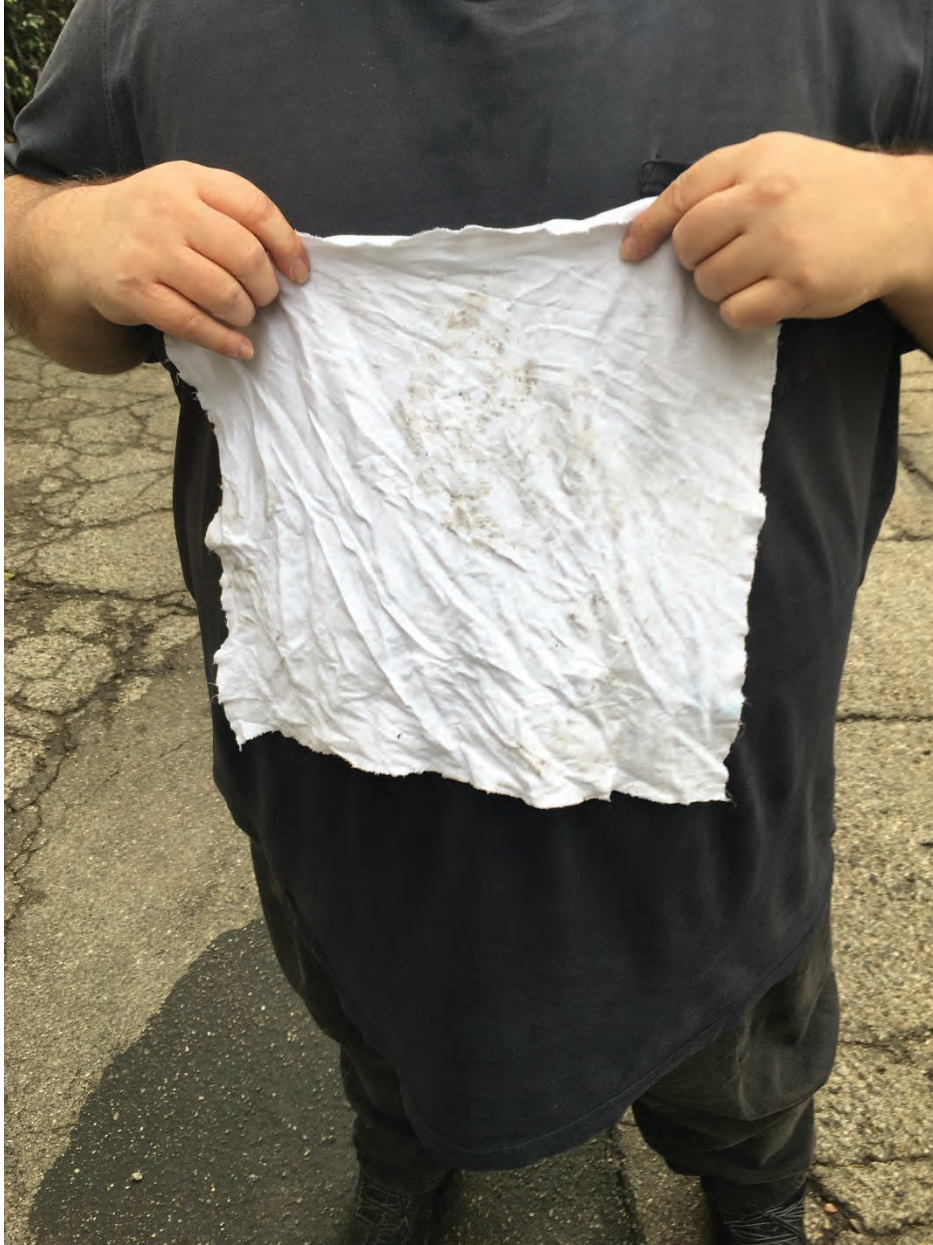
Figure 9. The rag was examined by J. Athanasious and did not show any evidence of liquid absorption.

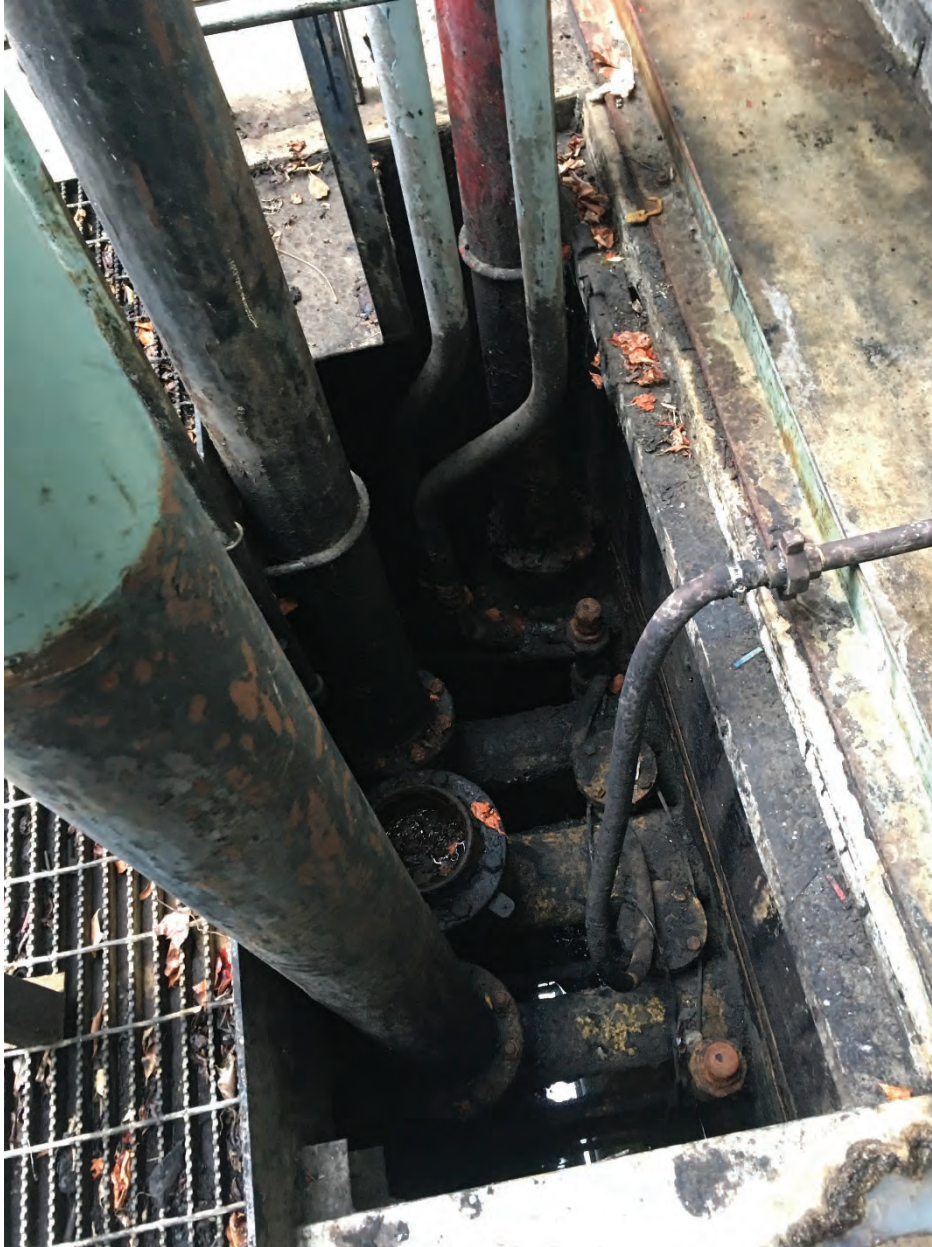
- The out of service pipeline was still physically connected to the in-service, pressurized pipeline system at the time of the incident.
- The out of service pipeline was isolated by use of "slip blinds".
- The slip blind was removed and had visible corrosion and full failure of structural integrity.
- The failure of the out of service buried line, buried below the surface expression of the leak was not determined at the time of my visit.

Figure 10. This photo shows the out of service lines entering the cement to run underground to the production facility. The two 6-inch lines were still connected to the pressurized pipeline system but isolated with a "slip blind" that failed.

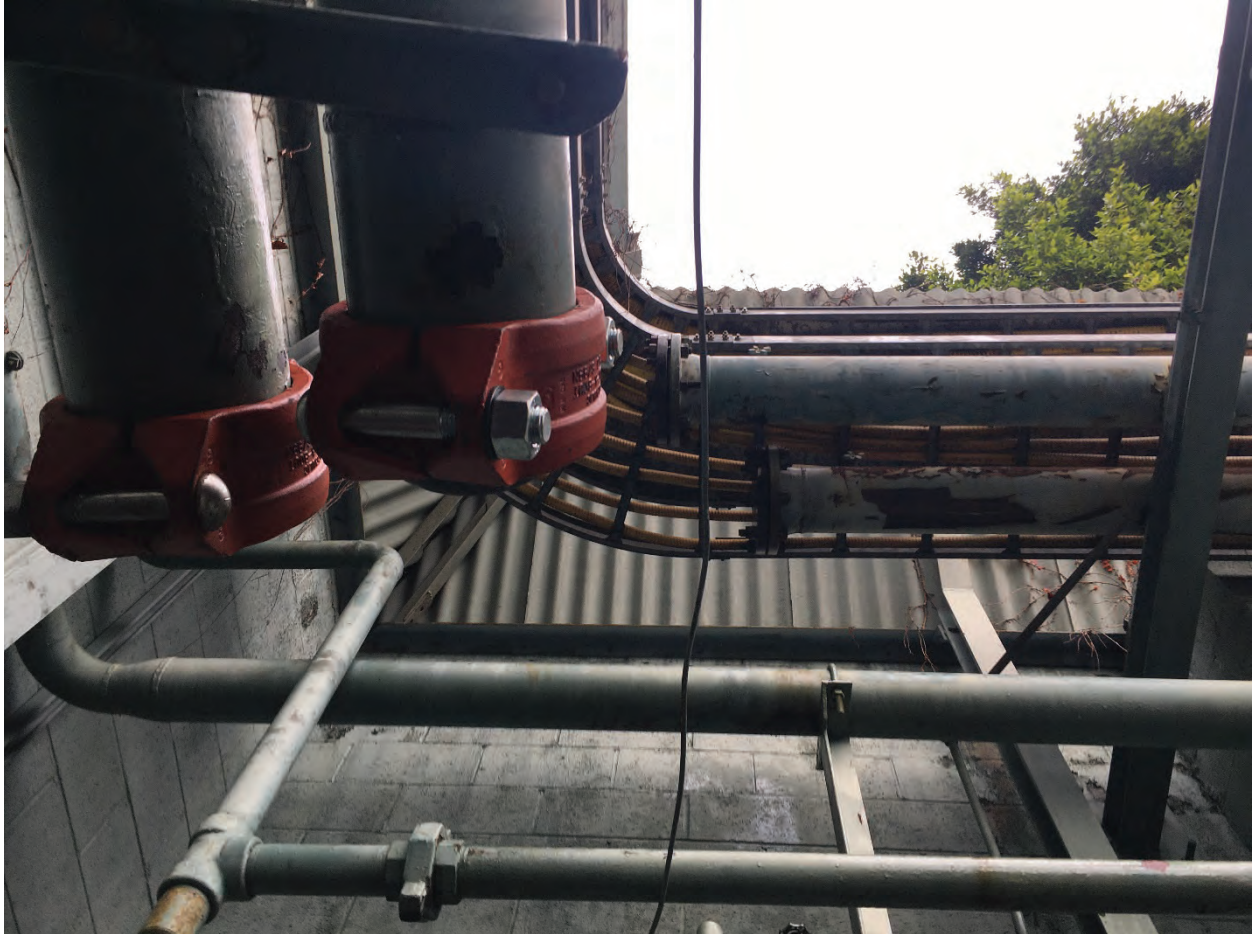
Figure 11. The photo shows the out of service pipelines with red caps having been disconnected from the horizontal pipelines that are still under pressure. At the time of the leak, these two ends were connected and the out of service segment was isolated from pressure with the use of a “blind slip” that was found to be corroded to the point of leaking.

- At 0700 crew began to isolate line.
- Removed sections of pipe to airgap pipeline.
- Added caps to the disconnected portions of the line.
- At 1300 resumed operations.

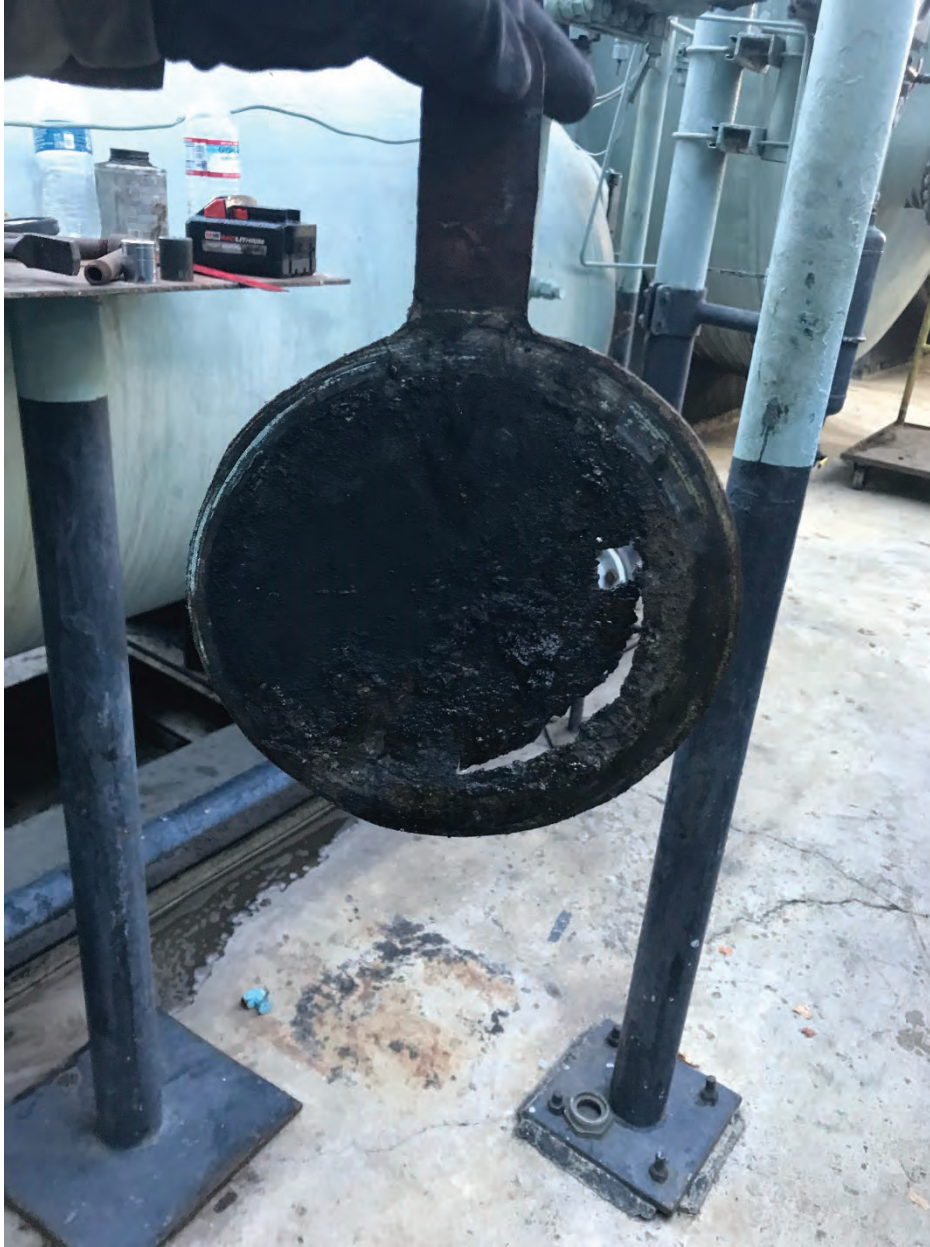
Figure 12. This picture shows the corroded blind slip that was the root cause of fluid entering the out of service pipeline that is buried near surface expression of the leak in the alley.
