Arborist Report

505-517 N. Hoover St., Los Angeles, CA 90004
 c/o 511 Hoover, LLC
 8271 Melrose Ave, Suite 207, Los Angeles, CA 90046
 July 7, 2020

The following arborist assessment was conducted by Brandon Linz of Brandon's Landscapes, Inc. under ISA# WE-8719A on July 2, 2020 at 505-517 N. Hoover St., Los Angeles, CA 90004.

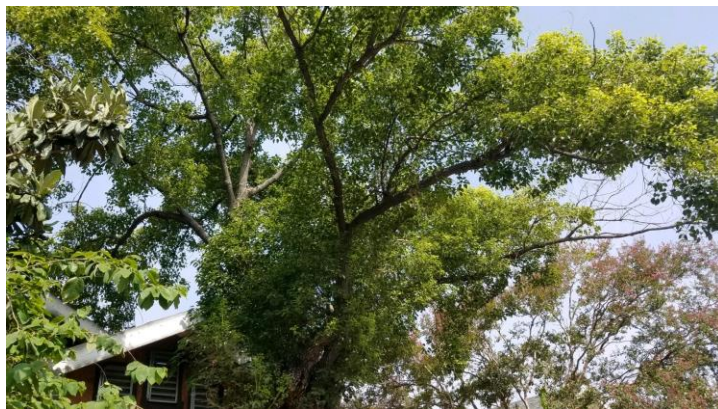
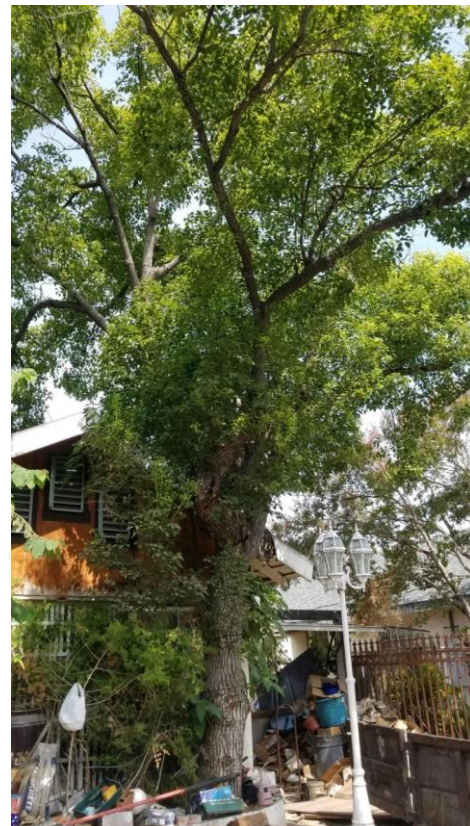
ID #	#1
Common Name	Camphor
Botanical	Cinnamomum camphora
DBH: 17 1/2"	Height: 25' Spread: 30'

Tree #1: *Cinnamomum camphora* has a DBH of 17 1/2". Tree #1 is in good health and there are no issues found by arborist. This tree to be removed for proposed construction. This is not a protected tree according to the City of Los Angeles Ordinance No. 177404.

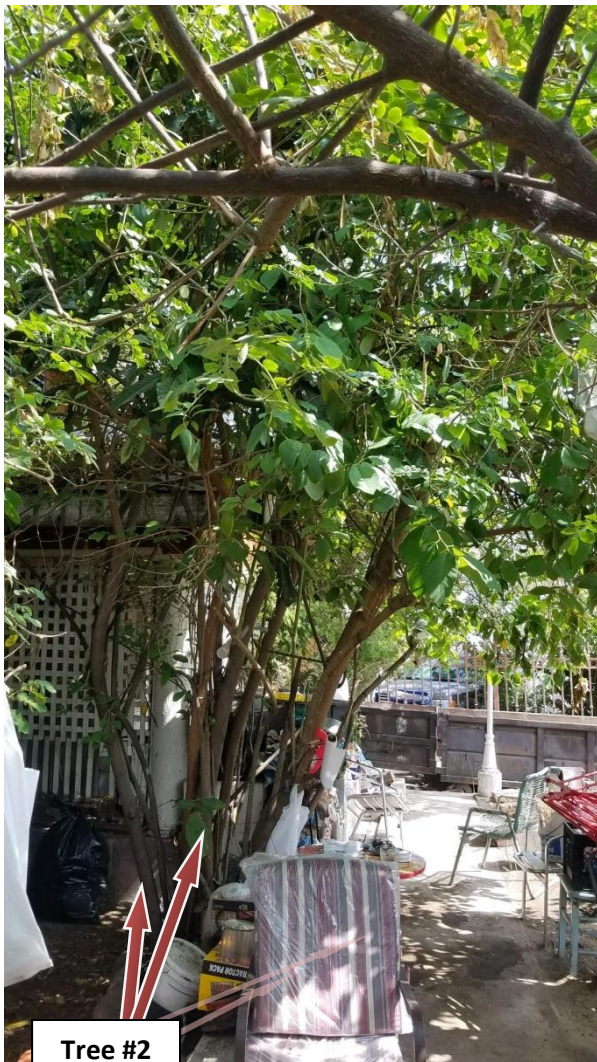
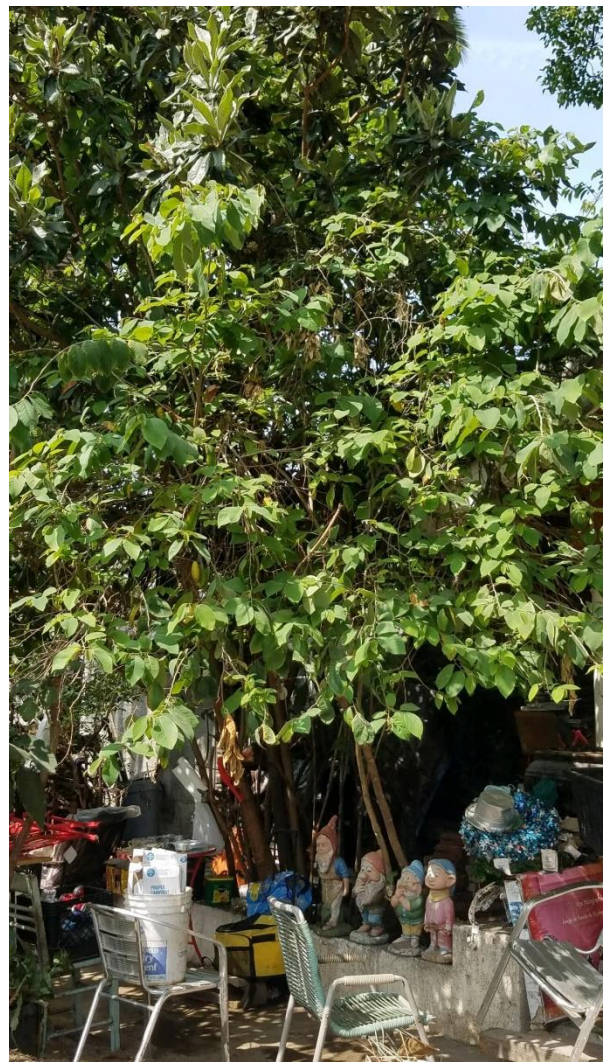
ID #	#2
Common Name	Orchid Tree
Botanical	Bauhinia variegata
DBH: 4"	Height: 10' Spread: 10'

Tree #2: *Bauhinia variegata* has a DBH of 4". Tree #2 is in moderate health. This tree is growing in close proximity to tree #3 and the two canopies are competing with one another for sun exposure, this has caused the tree to have multiple central leaders. This tree to be removed for proposed construction. This is not a protected tree according to the City of Los Angeles Ordinance No. 177404.

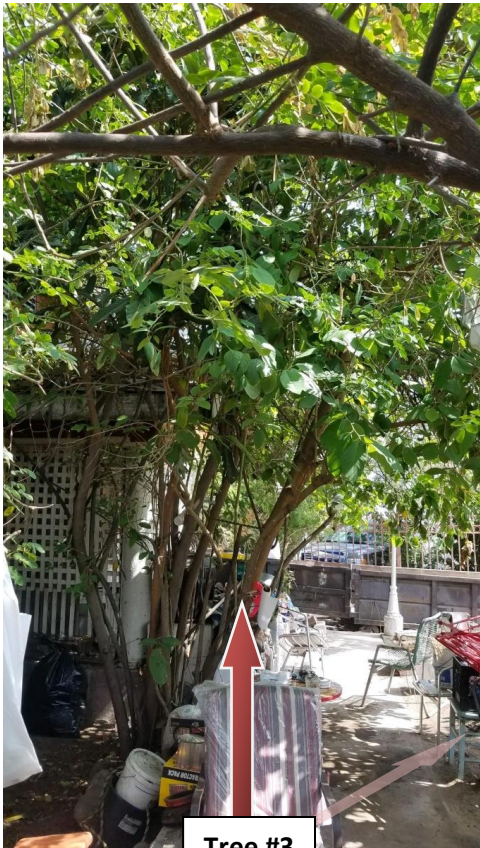
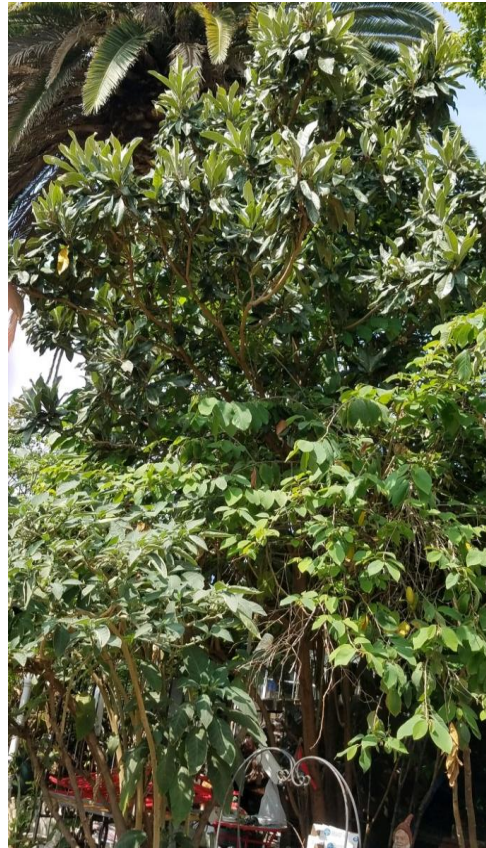
ID #	#3		
Common Name	Loquat		
Botanical	<i>Eriobotrya japonica</i>		
DBH: 8"	Height: 15'	Spread: 10'

Tree #3: *Eriobotrya japonica* has a DBH of 8". Tree #3 is in moderate health. This tree is growing in close proximity to tree #2 and the two canopies are competing with one another for sun exposure, this has caused the tree to have multiple central leaders. This tree to be removed for proposed construction. This is not a protected tree according to the City of Los Angeles Ordinance No. 177404.

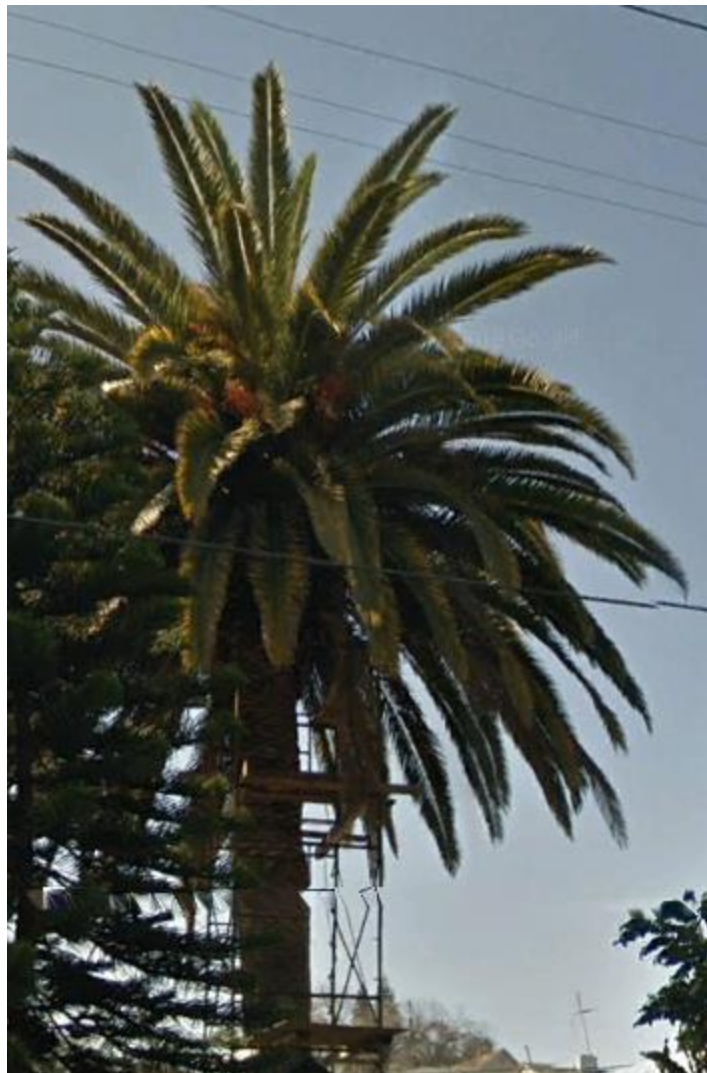
ID #	#4		
Common Name	Date Palm		
Botanical	Phoenix dactylifera		
DBH: 39 1/2"	Height: 45'	Spread: 35'

Tree #4: *Phoenix dactylifera* has a DBH of 39 1/2". Tree #4 is in good health and there are no issues found by arborist. This tree to be removed for proposed construction. This is not a protected tree according to the City of Los Angeles Ordinance No. 177404.

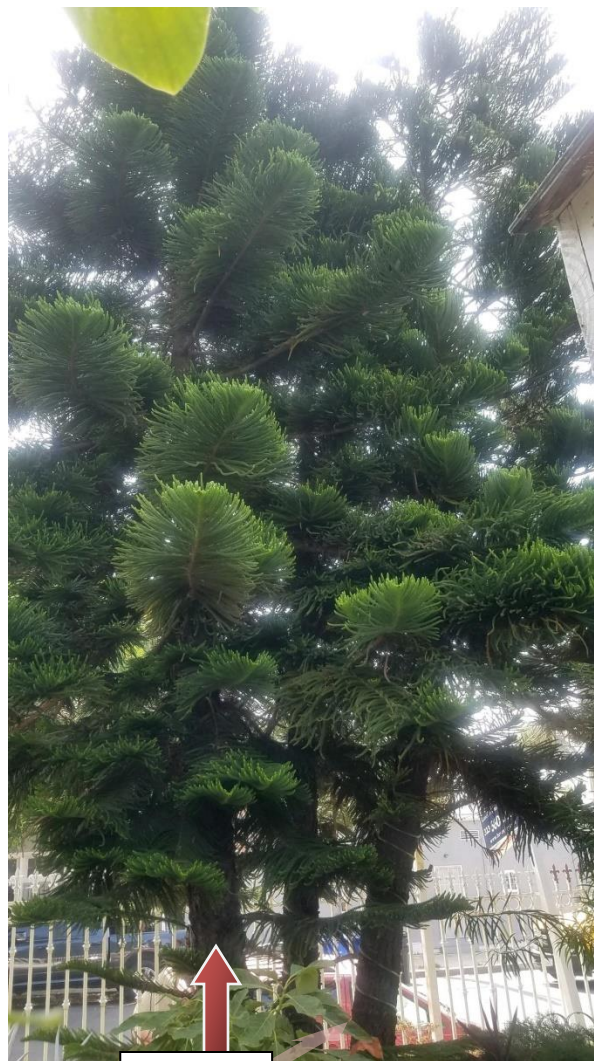
ID #	#5		
Common Name	Star Pine		
Botanical	Araucaria heterophylla		
DBH: 11"	Height: 30'	Spread: 8'

Tree #5: *Araucaria heterophylla* has DBH of 11". Tree #5 is in good health. This tree is growing in close proximity to tree 6, the two canopies are competing with one another for sun exposure. This tree to be removed for proposed construction. This is not a protected tree according to the City of Los Angeles Ordinance No. 177404.

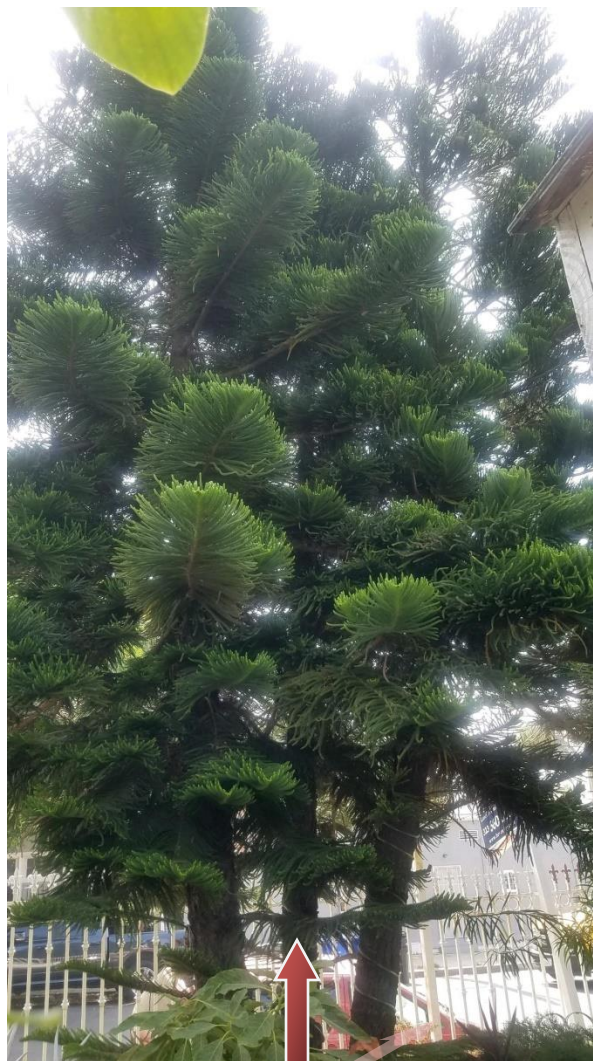
ID #	#6		
Common Name	Star Pine		
Botanical	Araucaria heterophylla		
DBH: 7 1/2"	Height: 30'	Spread: 8'

Tree #6: *Araucaria heterophylla* has a DBH of 7 1/2". Tree #6 is in good health. This tree is growing in close proximity to tree 5 and 7; the two canopies are competing with one another for sun exposure. This tree to be removed for proposed construction. This is not a protected tree according to the City of Los Angeles Ordinance No. 177404.

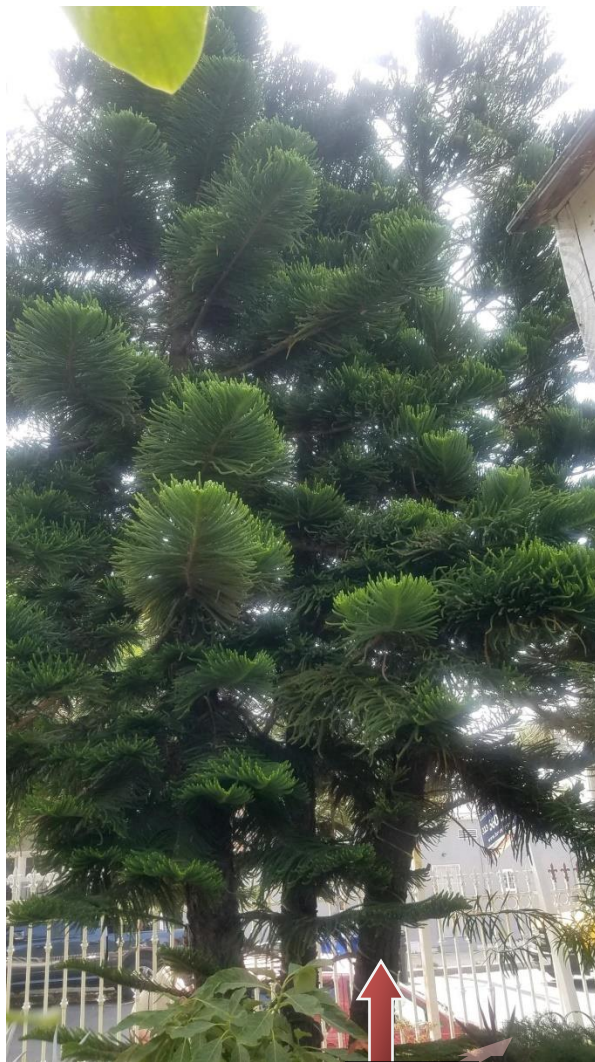
ID #	#7		
Common Name	Star Pine		
Botanical	Araucaria heterophylla		
DBH: 8 ½"	Height: 30'	Spread: 8'

Tree #7: *Araucaria heterophylla* has a DBH of 8 1/2". Tree #7 is in good health. This tree is growing in close proximity to tree 6; the two canopies are competing with one another for sun exposure. This tree to be removed for proposed construction. This is not a protected tree according to the City of Los Angeles Ordinance No. 177404.

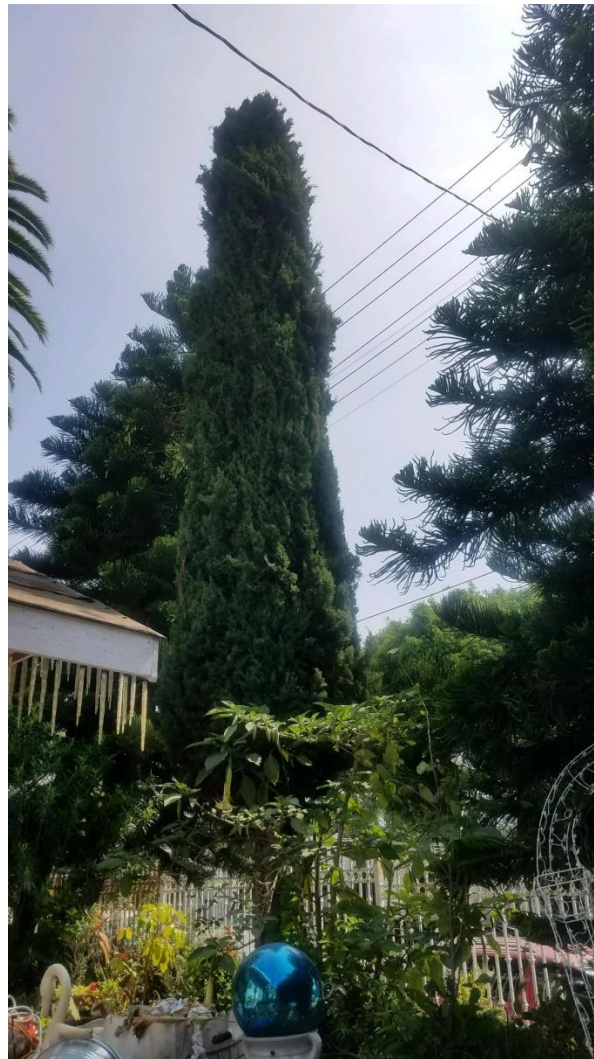
ID #	#8		
Common Name	Italian Cypress		
Botanical	<i>Cupressus sempervirens</i>		
DBH: 6"	Height: 30'	Spread: 4'

Tree #8: *Cupressus sempervirens* has a DBH of 6" Tree #8 is in good health and there are no issues found by arborist. This tree to be removed for proposed construction. This is not a protected tree according to the City of Los Angeles Ordinance No. 177404.

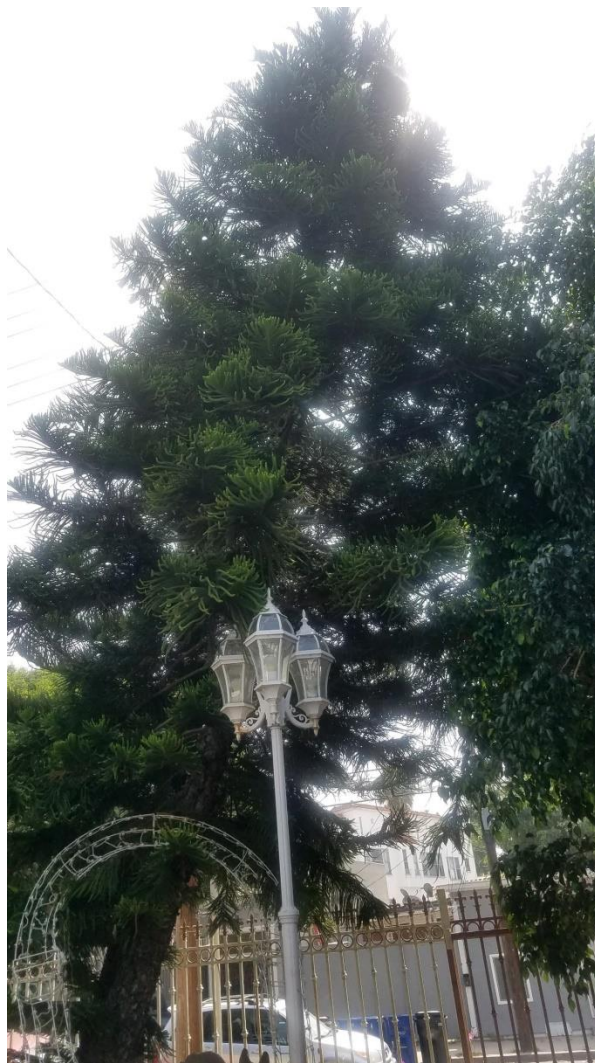
ID #	#9		
Common Name	Star Pine		
Botanical	Araucaria heterophylla		
DBH: 19 1/2"	Height: 25'	Spread: 20'

Tree #9: *Araucaria heterophylla* has a DBH of 19 1/2" Tree #9 is in good health and there are no issues found by arborist. This tree to be removed for proposed construction. This is not a protected tree according to the City of Los Angeles Ordinance No. 177404.

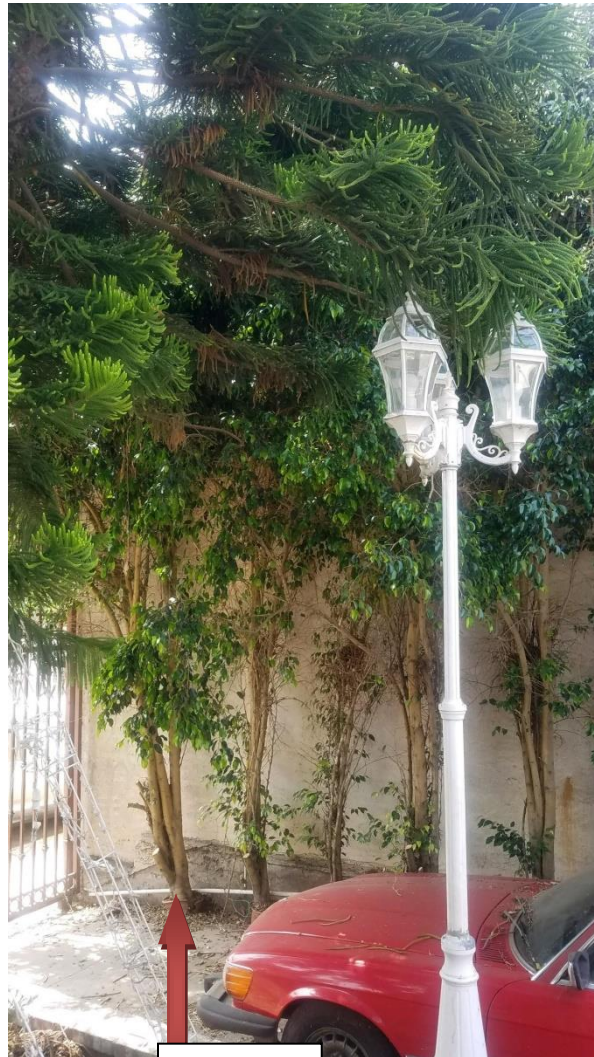
ID #	#10	
Common Name	Ficus benjamina	
Botanical	Ficus benjamina	
DBH: 4"	Height: 15'	Spread: 5

Tree #10: *Ficus Benjamina* has a DBH of 5 1/2". Tree #10 is in moderate health. This tree has multiple central leaders with included bark in the branch unions. This causes a weak branch union and can lead to structural failure if not corrected. These issues could potentially cause the tree to not be structurally sound which can pose a risk of branches falling causing damage to property and persons. This tree is growing in close proximity to the structure, as the tree matures, it will damage the structure. This tree is growing in close proximity to tree 11 and the two canopies are competing with one another for sun exposure. This tree to be removed for proposed construction. This is not a protected tree according to the City of Los Angeles Ordinance No. 177404.

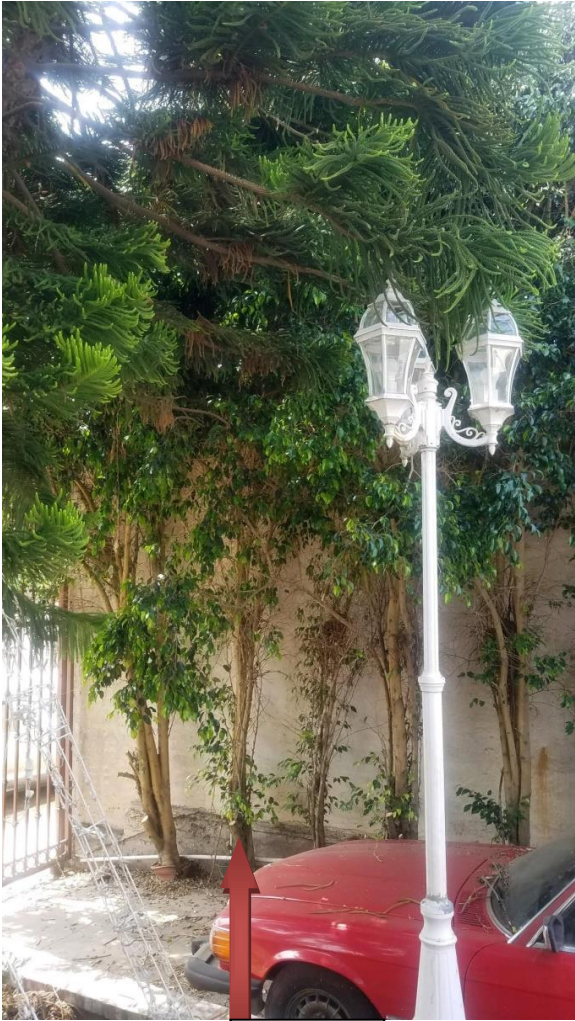
ID #	#11
Common Name	Ficus benjamina
Botanical	Ficus benjamina
DBH: 4"	Height: 15' Spread: 5'

Tree #11: Ficus Benjamina has a DBH of 5 1/2". Tree #11 is in moderate health. This tree has multiple central leaders with included bark in the branch unions. This causes a weak branch union and can lead to structural failure if not corrected. These issues could potentially cause the tree to not be structurally sound which can pose a risk of branches falling causing damage to property and persons. This tree is growing in close proximity to the structure, as the tree matures, it will damage the structure. This tree is growing in close proximity to trees 10 and 12, and the two canopies are competing with one another for sun exposure. This tree to be removed for proposed construction. This is not a protected tree according to the City of Los Angeles Ordinance No. 177404.

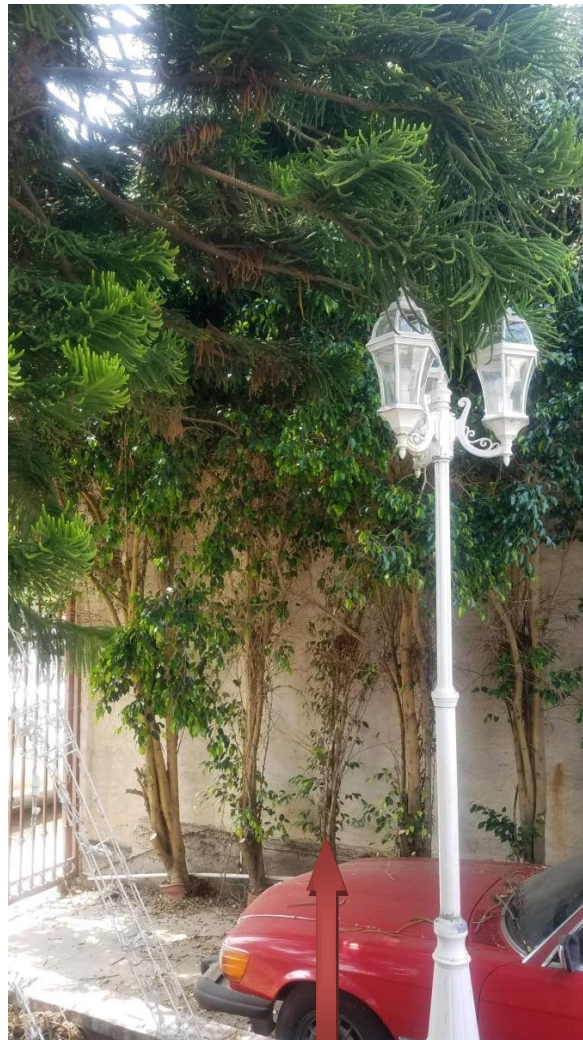
ID #	#12	
Common Name	Ficus benjamina	
Botanical	Ficus benjamina	
DBH: 4"	Height: 15'	Spread: 5'

Tree #12: Ficus Benjamina has a DBH of 4". Tree #12 is in moderate health. This tree has multiple central leaders with included bark in the branch unions. This causes a weak branch union and can lead to structural failure if not corrected. These issues could potentially cause the tree to not be structurally sound which can pose a risk of branches falling causing damage to property and persons. This tree is growing in close proximity to the structure, as the tree matures, it will damage the structure. This tree is growing in close proximity to trees 11 and 13, and the two canopies are competing with one another for sun exposure. This tree to be removed for proposed construction. This is not a protected tree according to the City of Los Angeles Ordinance No. 177404.

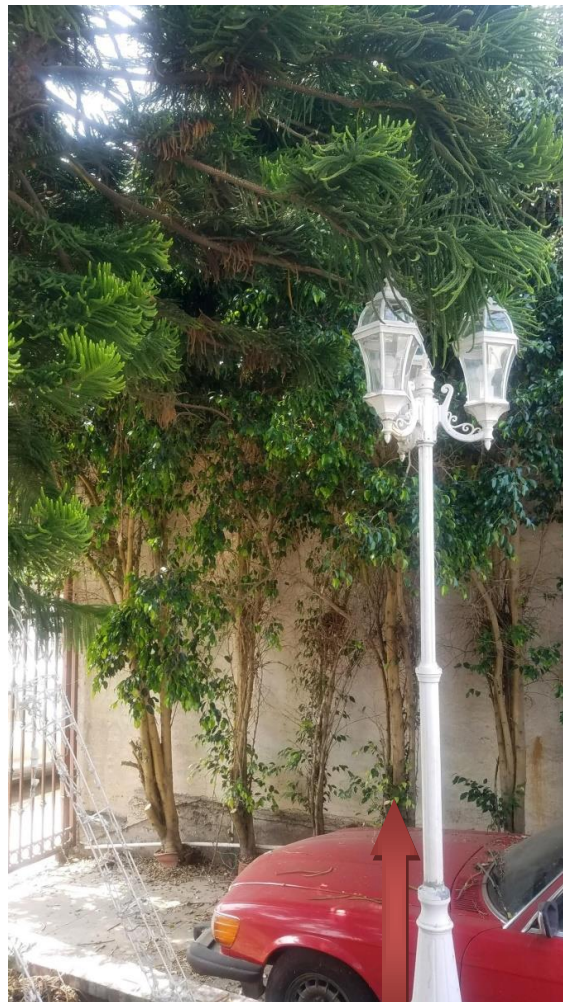
ID #	#13		
Common Name	Ficus benjamina		
Botanical	Ficus benjamina		
DBH: 4"	Height: 15'	Spread: 5'

Tree #13: Ficus Benjamina has a DBH of 6 1/2". Tree #13 is in moderate health. This tree has multiple central leaders with included bark in the branch unions. This causes a weak branch union and can lead to structural failure if not corrected. These issues could potentially cause the tree to not be structurally sound which can pose a risk of branches falling causing damage to property and persons. This tree is growing in close proximity to the structure, as the tree matures, it will damage the structure. This tree is growing in close proximity to trees 12 and 14, and the two canopies are competing with one another for sun exposure. This tree to be removed for proposed construction. This is not a protected tree according to the City of Los Angeles Ordinance No. 177404.

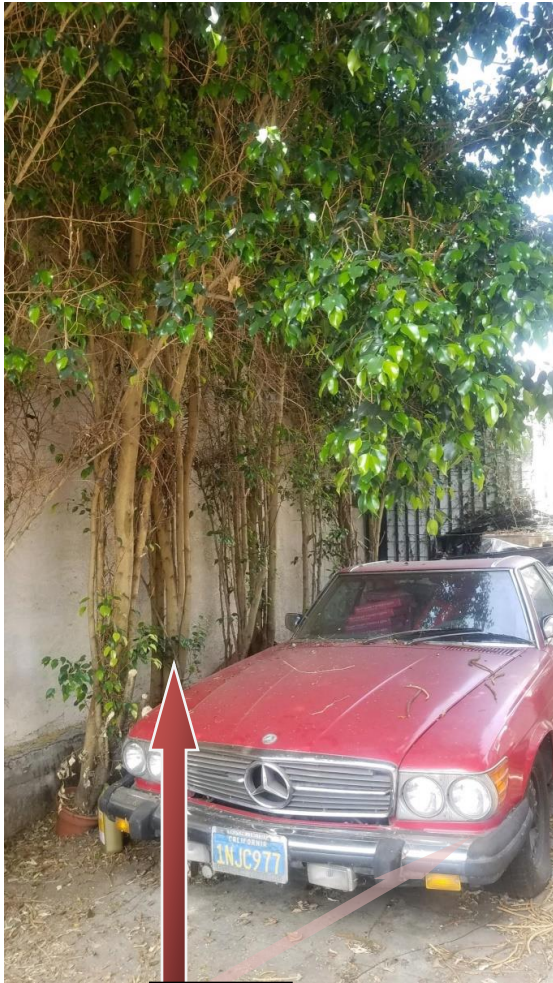
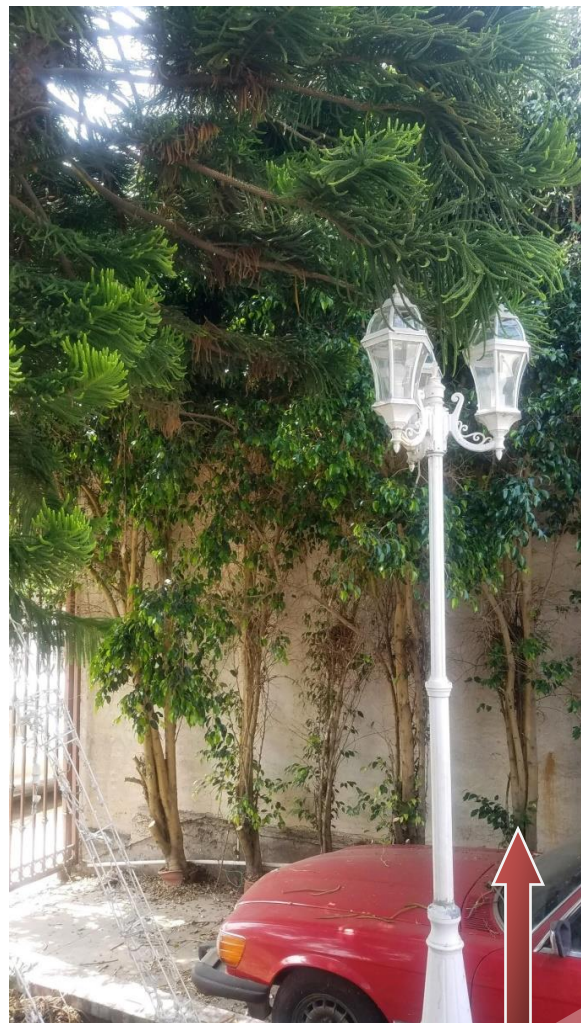
ID #	#14		
Common Name	Ficus benjamina		
Botanical	Ficus benjamina		
DBH: 4"	Height: 15'	Spread: 5'

Tree #14: Ficus Benjamina has a DBH of 6 1/2". Tree #14 is in moderate health. This tree has multiple central leaders with included bark in the branch unions. This causes a weak branch union and can lead to structural failure if not corrected. These issues could potentially cause the tree to not be structurally sound which can pose a risk of branches falling causing damage to property and persons. This tree is growing in close proximity to the structure, as the tree matures, it will damage the structure. This tree is growing in close proximity to trees 13 and 15, and the two canopies are competing with one another for sun exposure. This tree to be removed for proposed construction. This is not a protected tree according to the City of Los Angeles Ordinance No. 177404.

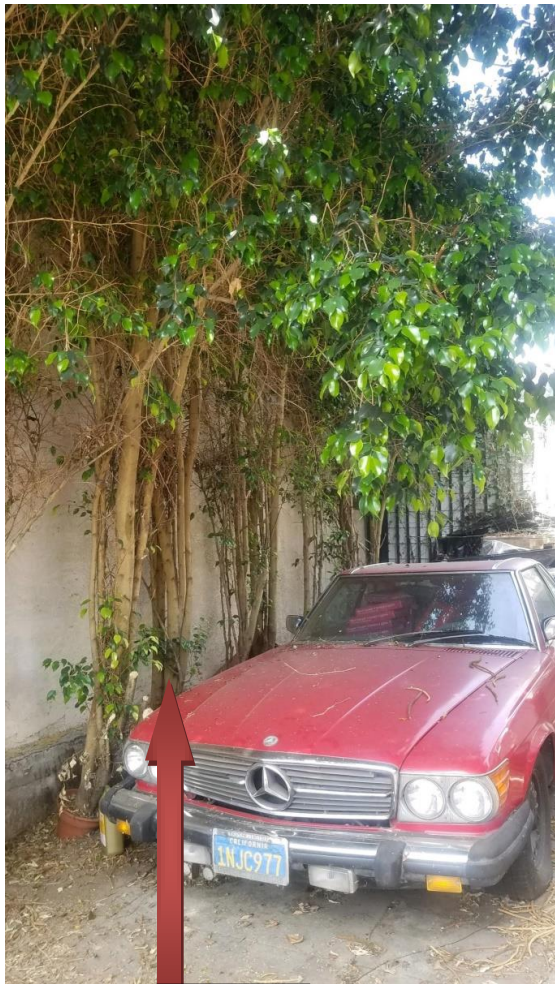
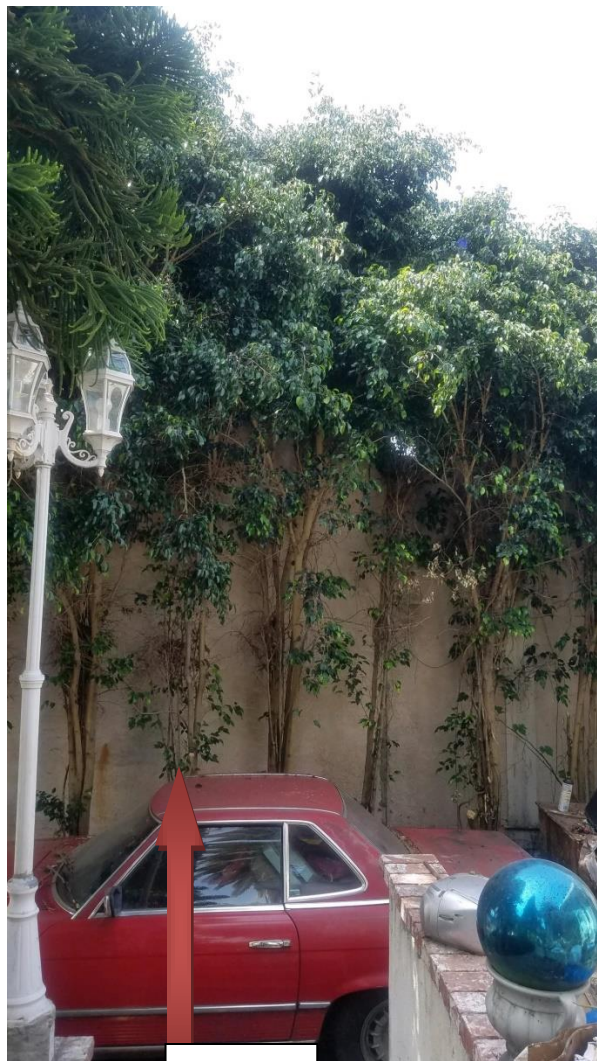
ID #	#15
Common Name	Ficus benjamina
Botanical	Ficus benjamina
DBH: 4"	Height: 15' Spread: 5'

Tree #15: Ficus Benjamina has a DBH of 6". Tree #15 is in moderate health. This tree has multiple central leaders with included bark in the branch unions. This causes a weak branch union and can lead to structural failure if not corrected. These issues could potentially cause the tree to not be structurally sound which can pose a risk of branches falling causing damage to property and persons. This tree is growing in close proximity to the structure, as the tree matures, it will damage the structure. This tree is growing in close proximity to trees 14 and 16, and the two canopies are competing with one another for sun exposure. This tree to be removed for proposed construction. This is not a protected tree according to the City of Los Angeles Ordinance No. 177404.

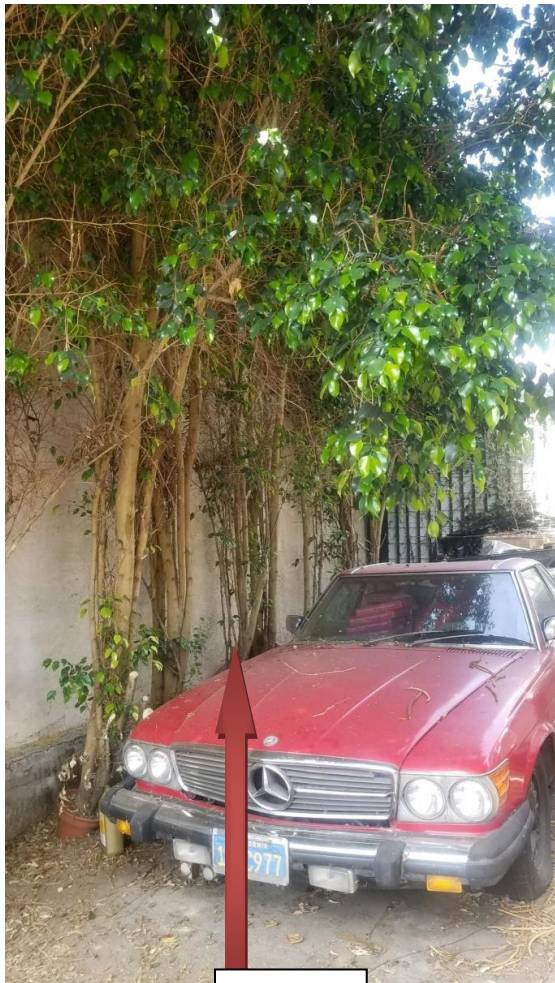
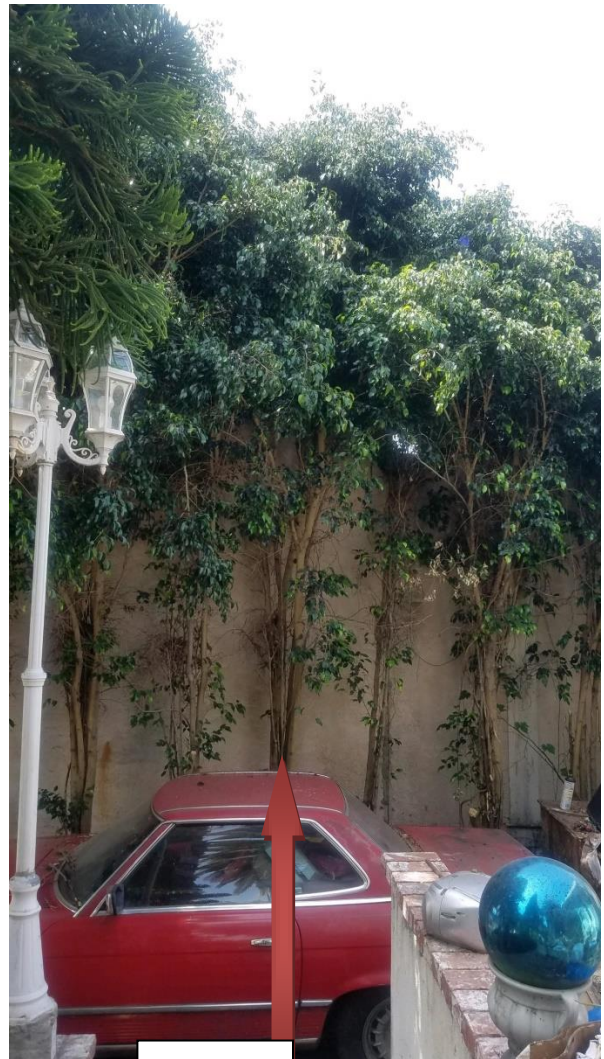
ID #	#16
Common Name	Ficus benjamina
Botanical	Ficus benjamina
DBH: 4"	Height: 15' Spread: 5'

Tree #16: Ficus Benjamina has a DBH of 6". Tree #16 is in moderate health. This tree has multiple central leaders with included bark in the branch unions. This causes a weak branch union and can lead to structural failure if not corrected. These issues could potentially cause the tree to not be structurally sound which can pose a risk of branches falling causing damage to property and persons. This tree is growing in close proximity to the structure, as the tree matures, it will damage the structure. This tree is growing in close proximity to trees 15 and 17, and the two canopies are competing with one another for

sun exposure. This tree to be removed for proposed construction. This is not a protected tree according to the City of Los Angeles Ordinance No. 177404.

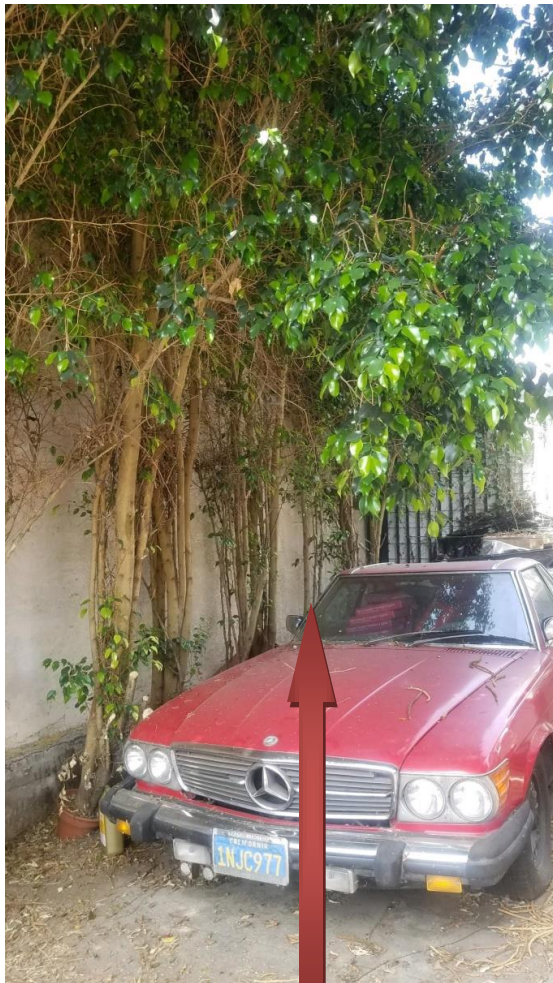
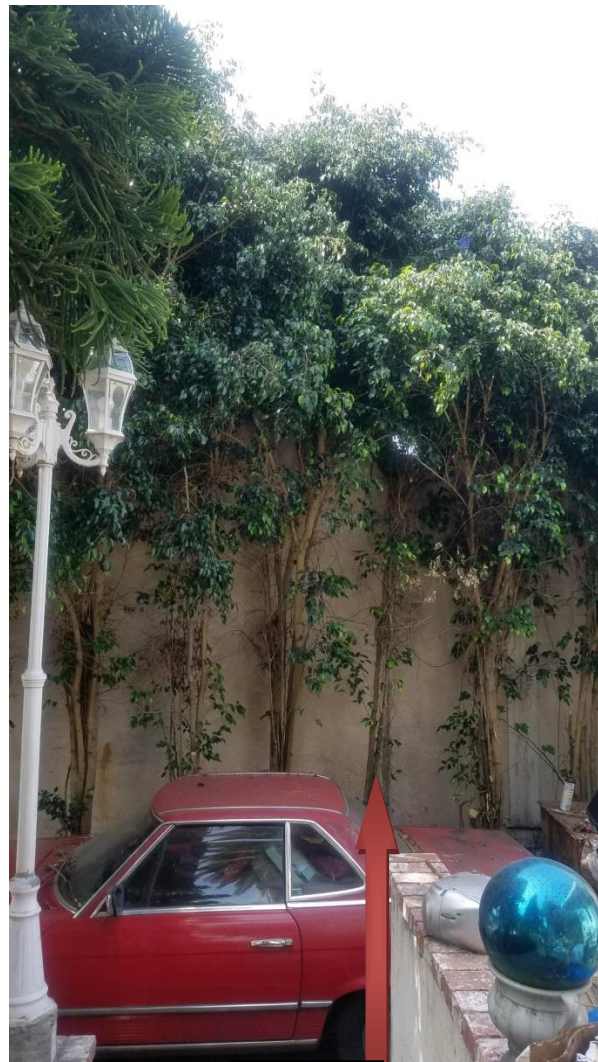
ID #	#17
Common Name	Ficus benjamina
Botanical	Ficus benjamina
DBH: 4"	Height: 15' Spread: 5'

Tree #17: Ficus Benjamina has a DBH of 5". Tree #17 is in moderate health. This tree has multiple central leaders with included bark in the branch unions. This causes a weak branch union and can lead to structural failure if not corrected. These issues could potentially cause the tree to not be structurally sound which can pose a risk of branches falling causing damage to property and persons. This tree is growing in close proximity to the structure, as the tree matures, it will damage the structure. This tree is growing in close proximity to trees 16 and 18, and the two canopies are competing with one another for sun exposure. This tree to be removed for proposed construction. This is not a protected tree according to the City of Los Angeles Ordinance No. 177404.

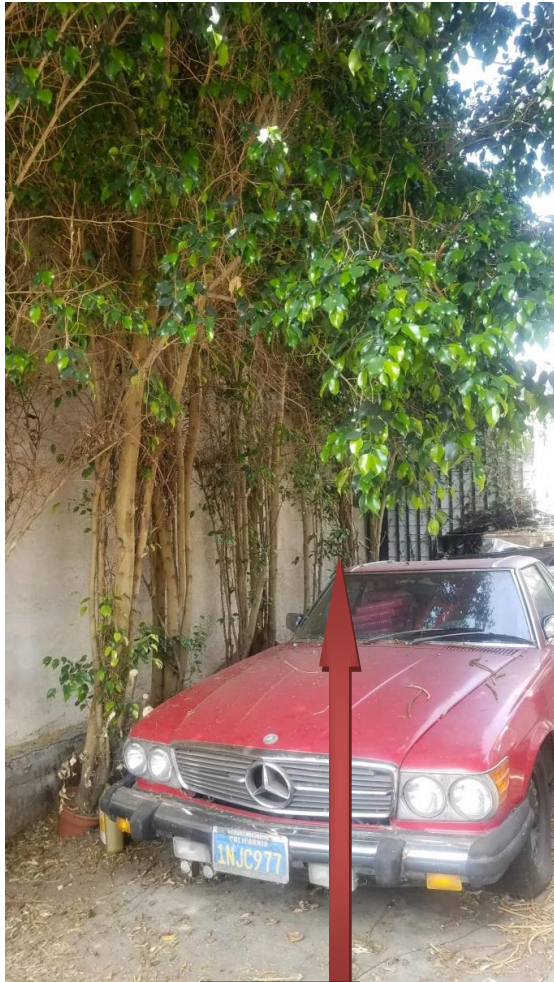
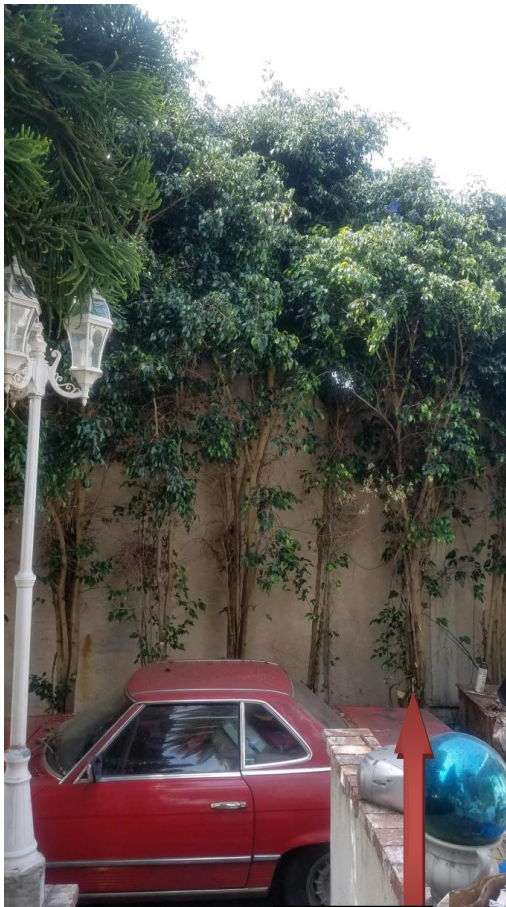
ID #	#18	
Common Name	Ficus benamina	
Botanical	Ficus benamina	
DBH: 4"	Height: 15'	Spread: 5'

Tree #18: Ficus Benjamina has a DBH of 6 1/2". Tree #18 is in moderate health. This tree has multiple central leaders with included bark in the branch unions. This causes a weak branch union and can lead to structural failure if not corrected. These issues could potentially cause the tree to not be structurally sound which can pose a risk of branches falling causing damage to property and persons. This tree is growing in close proximity to the structure, as the tree matures, it will damage the structure. This tree is growing in close proximity to trees 17 and 19, and the two canopies are competing with one another for sun exposure. This tree to be removed for proposed construction. This is not a protected tree according to the City of Los Angeles Ordinance No. 177404.

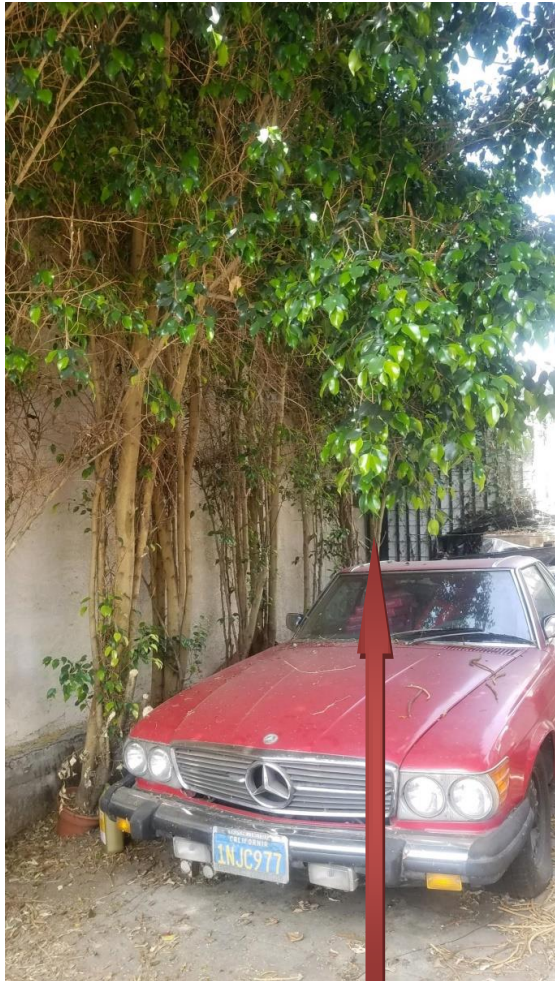
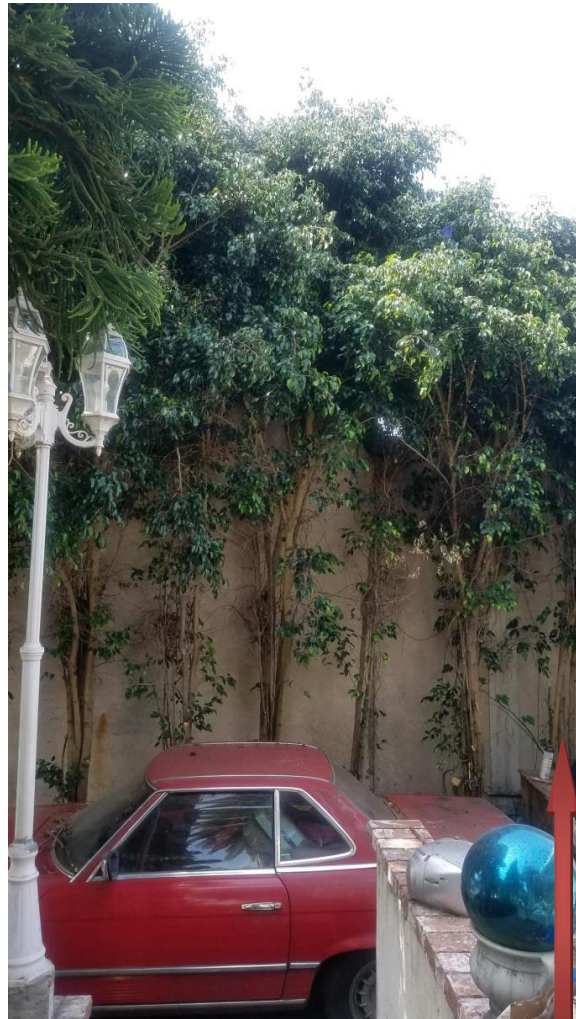
ID #	#19		
Common Name	Ficus benjamina		
Botanical	Ficus benjamina		
DBH: 4"	Height: 15'	Spread: 5'

Tree #19: Ficus Benjamina has a DBH of 5". Tree #19 is in moderate health. This tree has multiple central leaders with included bark in the branch unions. This causes a weak branch union and can lead to structural failure if not corrected. These issues could potentially cause the tree to not be structurally sound which can pose a risk of branches falling causing damage to property and persons. This tree is growing in close proximity to the structure, as the tree matures, it will damage the structure. This tree is growing in close proximity to tree 18 and the two canopies are competing with one another for sun exposure. This tree to be removed for proposed construction. This is not a protected tree according to the City of Los Angeles Ordinance No. 177404.

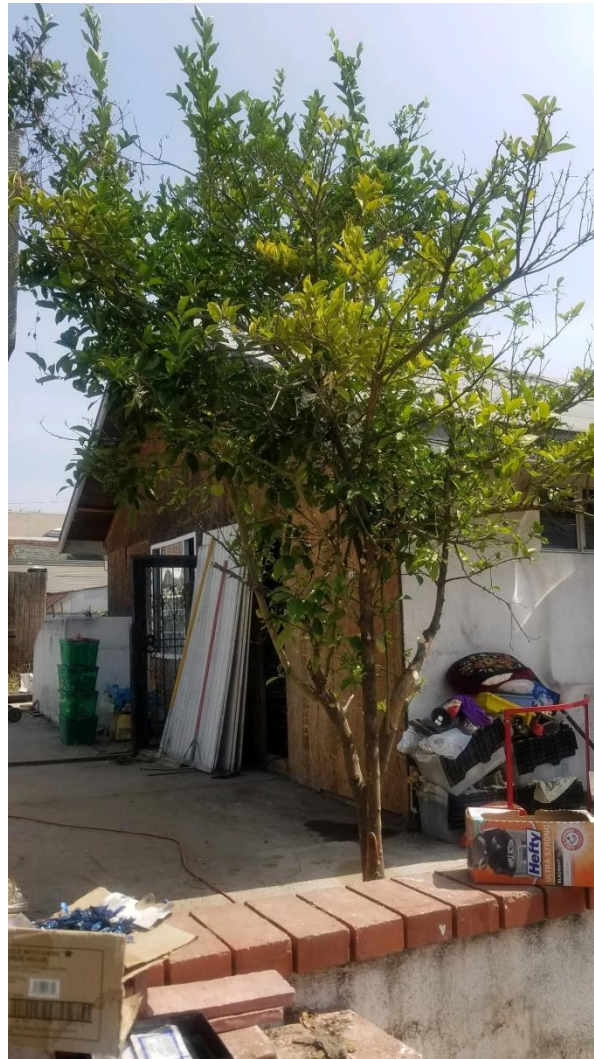
ID #	#20
Common Name	Key Lime
Botanical	Citrus × aurantiifolia
DBH: 5 ½"	Height: 12' Spread: 8'

Tree #20: Citrus × aurantiifolia has a DBH of 5 1/2" Tree #20 is in moderate health, as there are signs of drought stress. Due to the drought stress, I recommend installing drip irrigation to provide adequate water for the tree. I also recommend pruning the tree by a certified arborist in order to remove the dead branches as well as do necessary corrective pruning. This will help to obtain proper structure of the tree due to loss of branches because of lack of water. This tree to be removed for proposed construction. This is not a protected tree according to the City of Los Angeles Ordinance No. 177404.

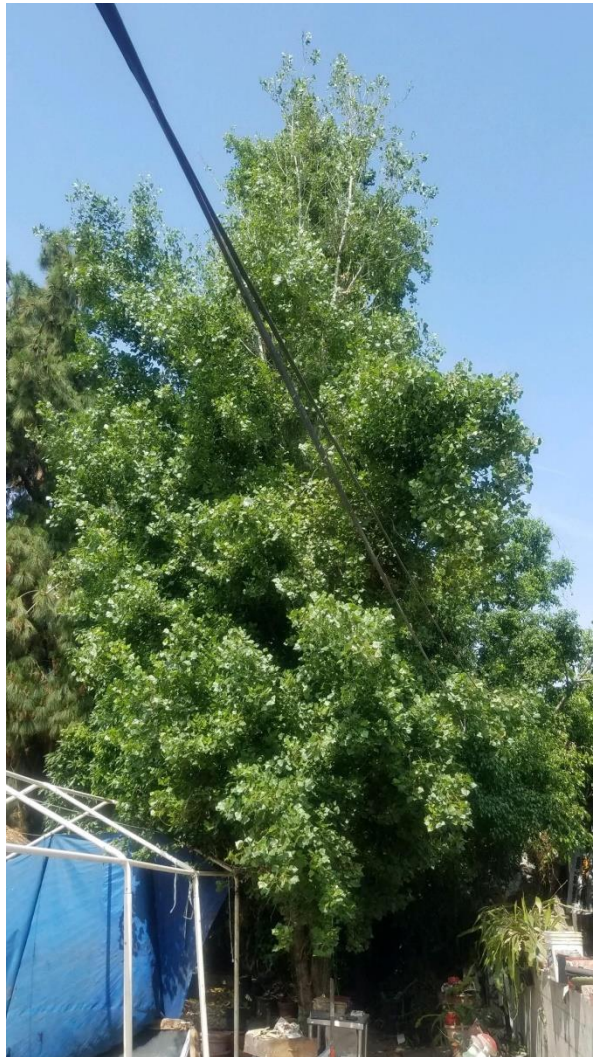
ID #	#21
Common Name	Cottonwood
Botanical	Populus sect. Aigeiros
DBH: 15 1/4"	Height: 40' Spread: 15'

Tree #21: Populus sect. Aigeiros has a DBH of 15 1/4". Tree #21 is in good health and there are no issues found by arborist. This tree to be removed for proposed construction. This is not a protected tree according to the City of Los Angeles Ordinance No. 177404.

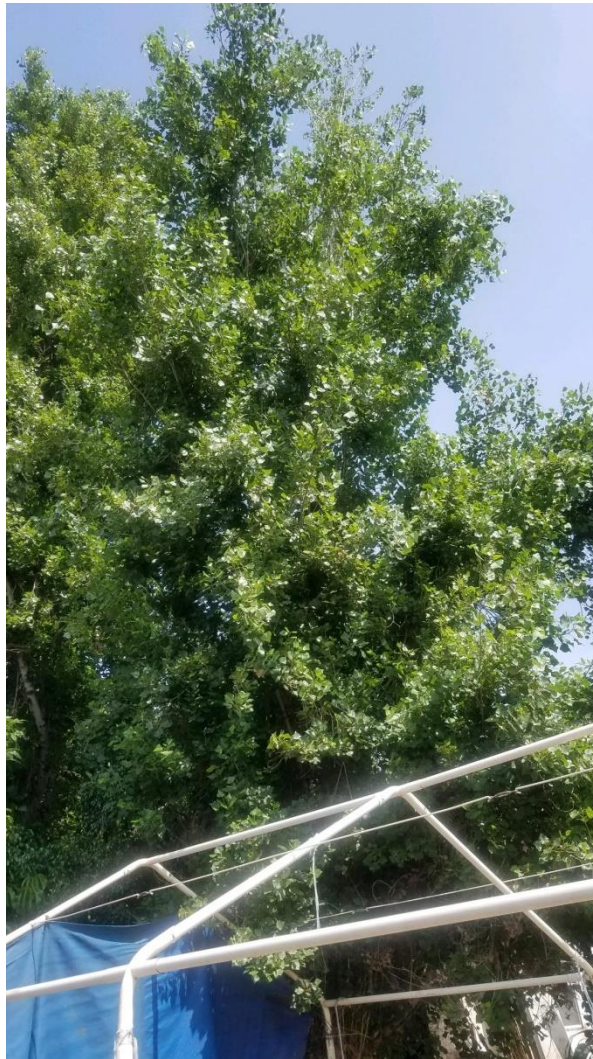
ID #	#22
Common Name	Cottonwood
Botanical	Populus sect. Aigeiros
DBH: 21 ½"	Height: 60' Spread: 20'

Tree #22: Populus sect. Aigeiros has a DBH of 21 1/2" Tree #22 is in good health and there are no issues found by arborist. This tree to be removed for proposed construction. This is not a protected tree according to the City of Los Angeles Ordinance No. 177404.
