Arborist Report

505-517 N. Hoover St., Los Angeles, CA 90004
 c/o 511 Hoover, LLC
 8271 Melrose Ave, Suite 207, Los Angeles, CA 90046
 July 7, 2020

The following arborist assessment was conducted by Brandon Linz of Brandon's Landscapes, Inc. under ISA# WE-8719A on July 2, 2020 at 505-517 N. Hoover St., Los Angeles, CA 90004.

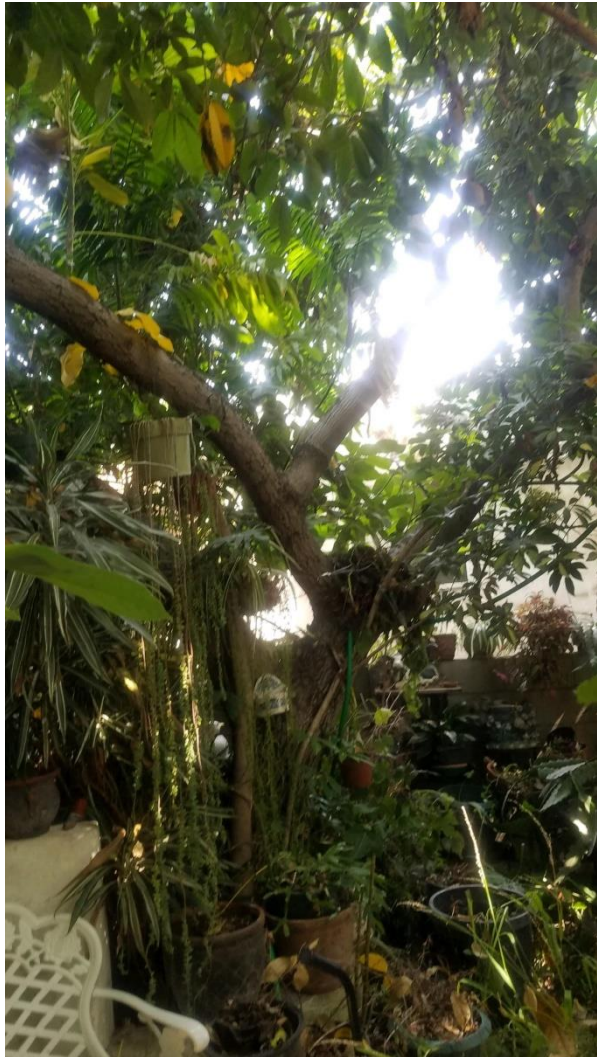
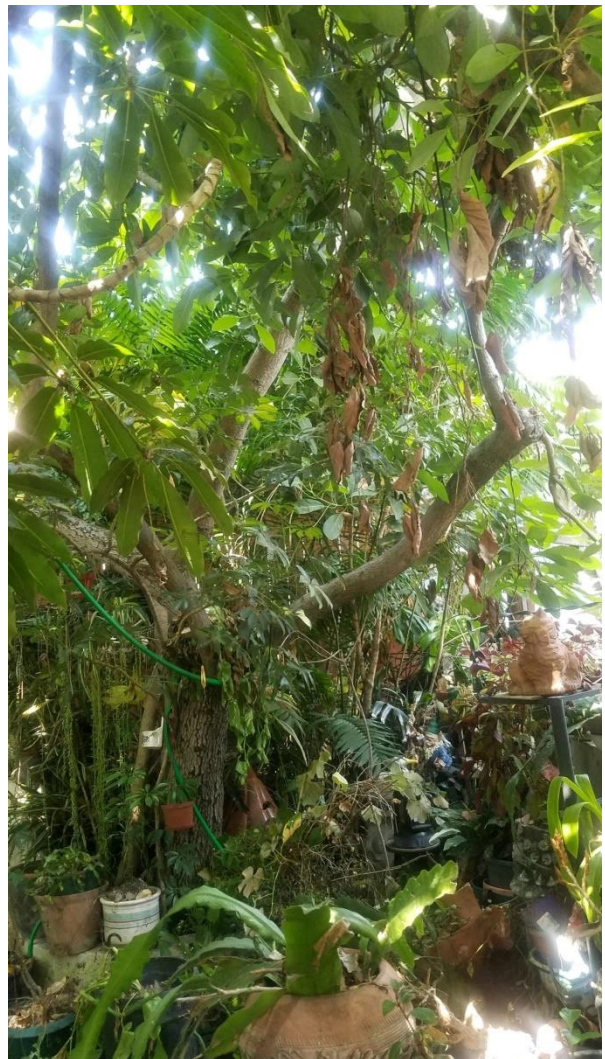
ID #	#23	
Common Name	Avocado	
Botanical	Persea americana	
DBH: 12 ¾"	Height: 20'	Spread: 20'

Tree #23: Persea americana has a DBH of 12 3/4". Tree #23 is in moderate health, as there are signs of decay. Decay in the trunk and root system causes the tree to not be structurally sound which can pose a safety risk, potentially causing damage to property and persons. This tree is growing in close proximity to tree 22 and the two canopies are competing with one another for sun exposure. This tree to be removed for proposed construction. This is not a protected tree according to the City of Los Angeles Ordinance No. 177404.

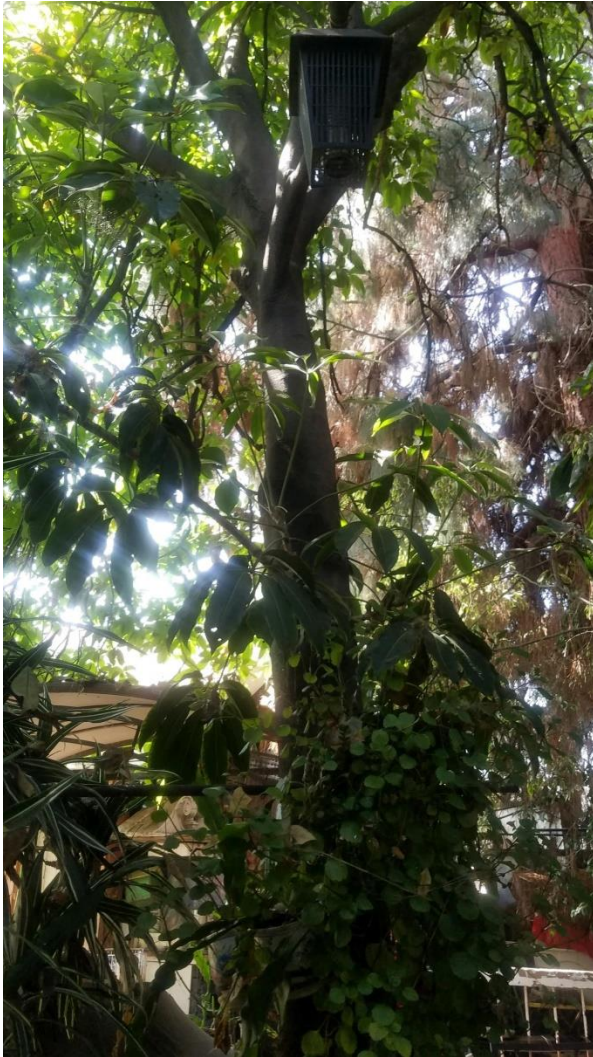
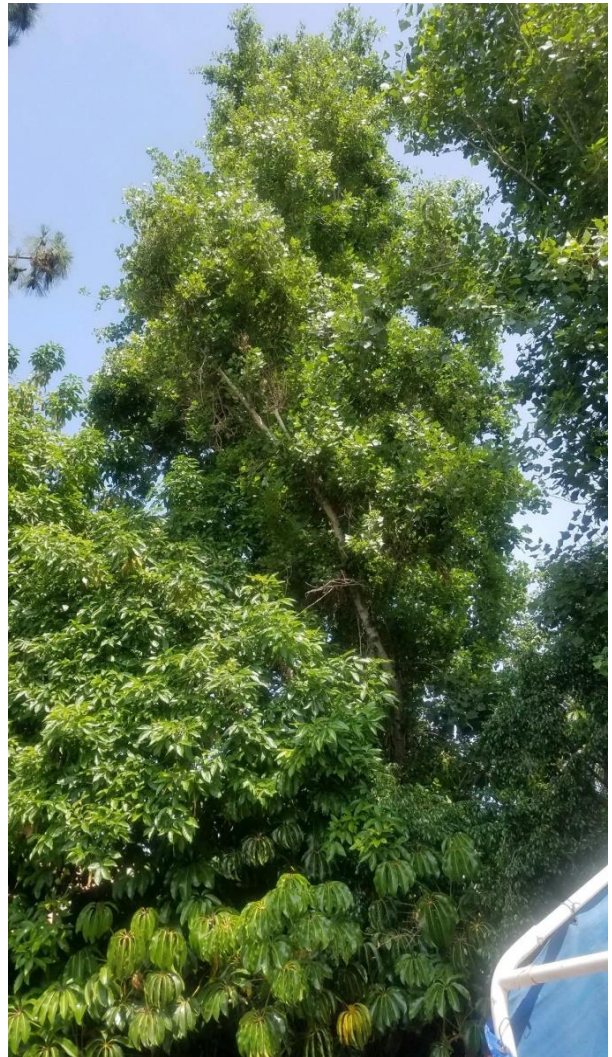
ID #	#24
Common Name	Zapote blanco
Botanical	Casimiroa edulis
DBH: 10 ¾"	Height: 30' Spread: 20'

Tree #24: Casimiroa edulis has a DBH of 10 3/4". Tree #24 is in moderate health. This tree is growing in close proximity to tree 22 and the two canopies are competing with one another for sun exposure. This

tree to be removed for proposed construction. This is not a protected tree according to the City of Los Angeles Ordinance No. 177404.

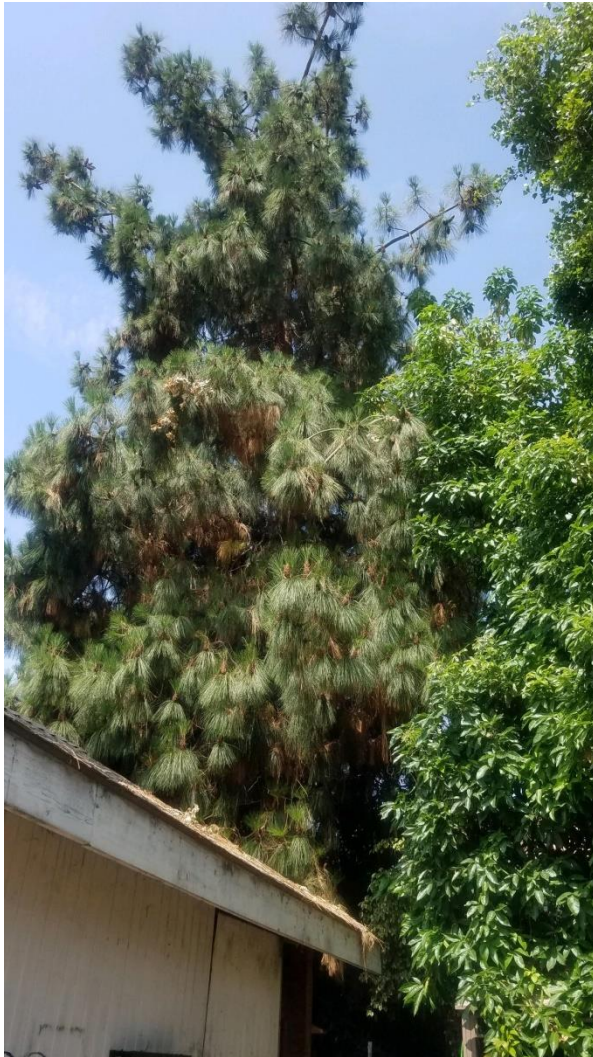
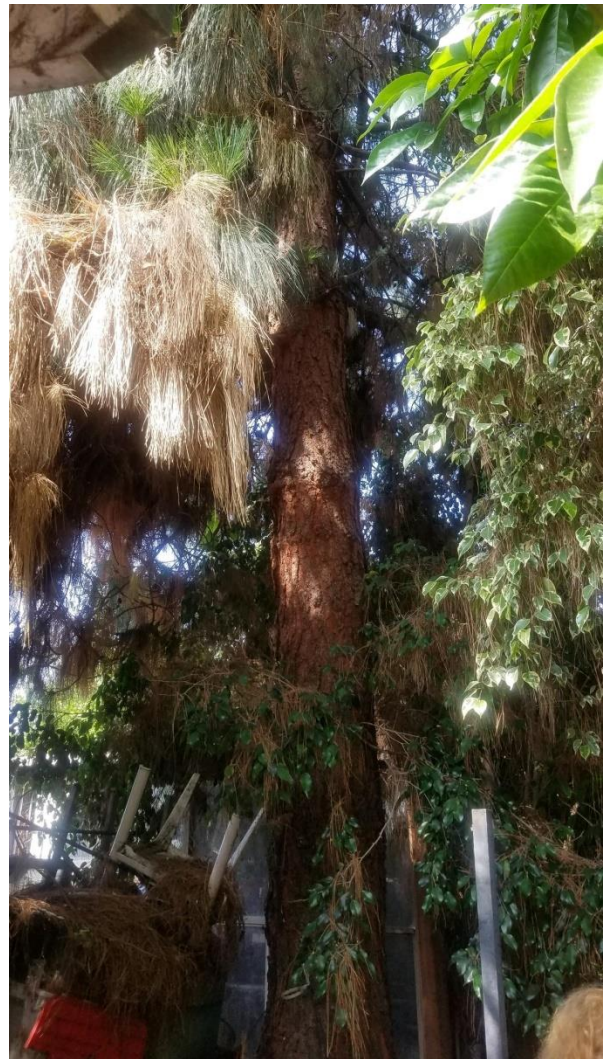
ID #	#25
Common Name	Canary Island Pine
Botanical	<i>Pinus canariensis</i>
DBH: 20 ½"	Height: 60' Spread: 30'

Tree #25: *Pinus canariensis* has a DBH of 20 1/2". Tree #25 is in moderate health, as a minor infestation of wood borers was observed. The wood borers feed on the dead and decaying wood inside the tree and will cause the tree to not be structurally sound which can pose a safety risk, potentially causing damage to property and persons. The insect infestation will eventually be detrimental to the tree. This tree is to be removed for the proposed construction. This is not a protected tree according to the City of Los Angeles Ordinance No. 177404.
