PROTECTED TREE REPORT

2669 N. Bronholly Dr.

October 13, 2021

LISA SMITH, THE TREE RESOURCE ®

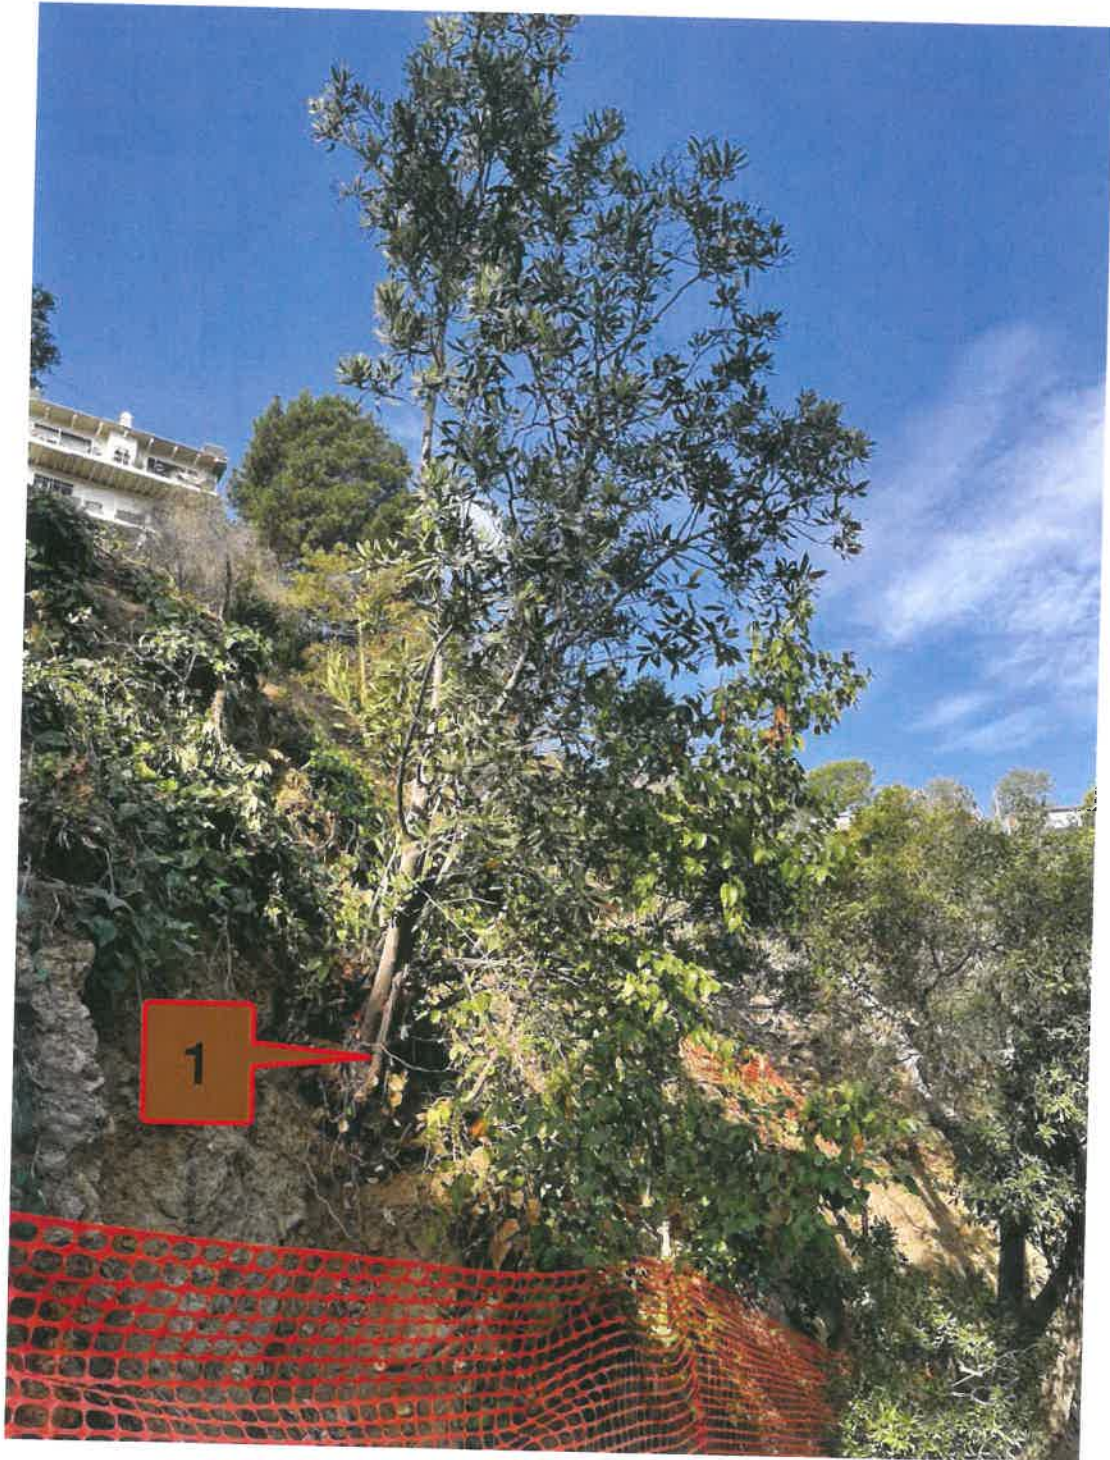
PHOTO 1 - Toyon (*Heteromeles arbutifolia*) shrub/tree #1 located at base of slope, will be impacted by the proposed new development and will be replaced at a 4:1 ratio further up the hillside, with new Toyon in 15 gallon or largest commonly available size (upon completion of construction project).

Toyon (*Heteromeles arbutifolia*) tree #3 located at base of slope, will be impacted by the proposed new development and will be replaced at a 4:1 ratio further up the hillside, with new Toyon in 15 gallon or largest commonly available size (upon completion of construction project).

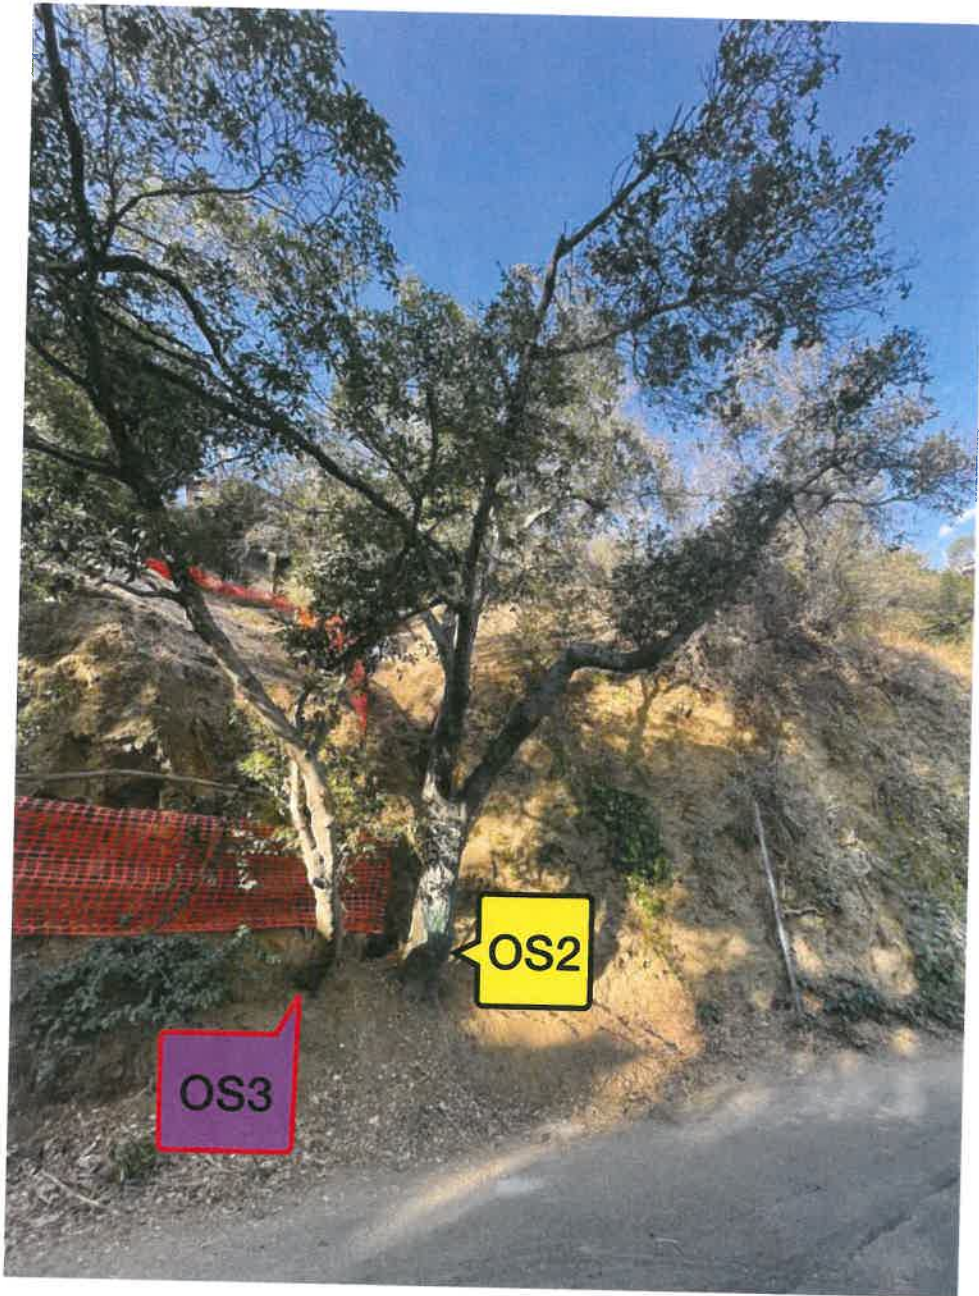
PHOTO 2 - Coast live oak (*Quercus agrifolia*) tree #OS2 is in the public right-of-way will receive minimal impact. Grading will occur approximately 5 feet above the Oak trunk. A 12" wall is proposed to keep out sediment. The road is proposed to be widened with a regular curb to be installed near the base of the tree. If roots are encountered a shallow curb will be installed instead and will be supported by a tube driven into the ground. This tree will be retained and protected in place.

Non-protected significant tree #OS3 located in the city easement will be impacted by the proposed construction and will be removed and replaced at a one-to-one (1:1) ratio, to the satisfaction of the City of Los Angeles if needed.

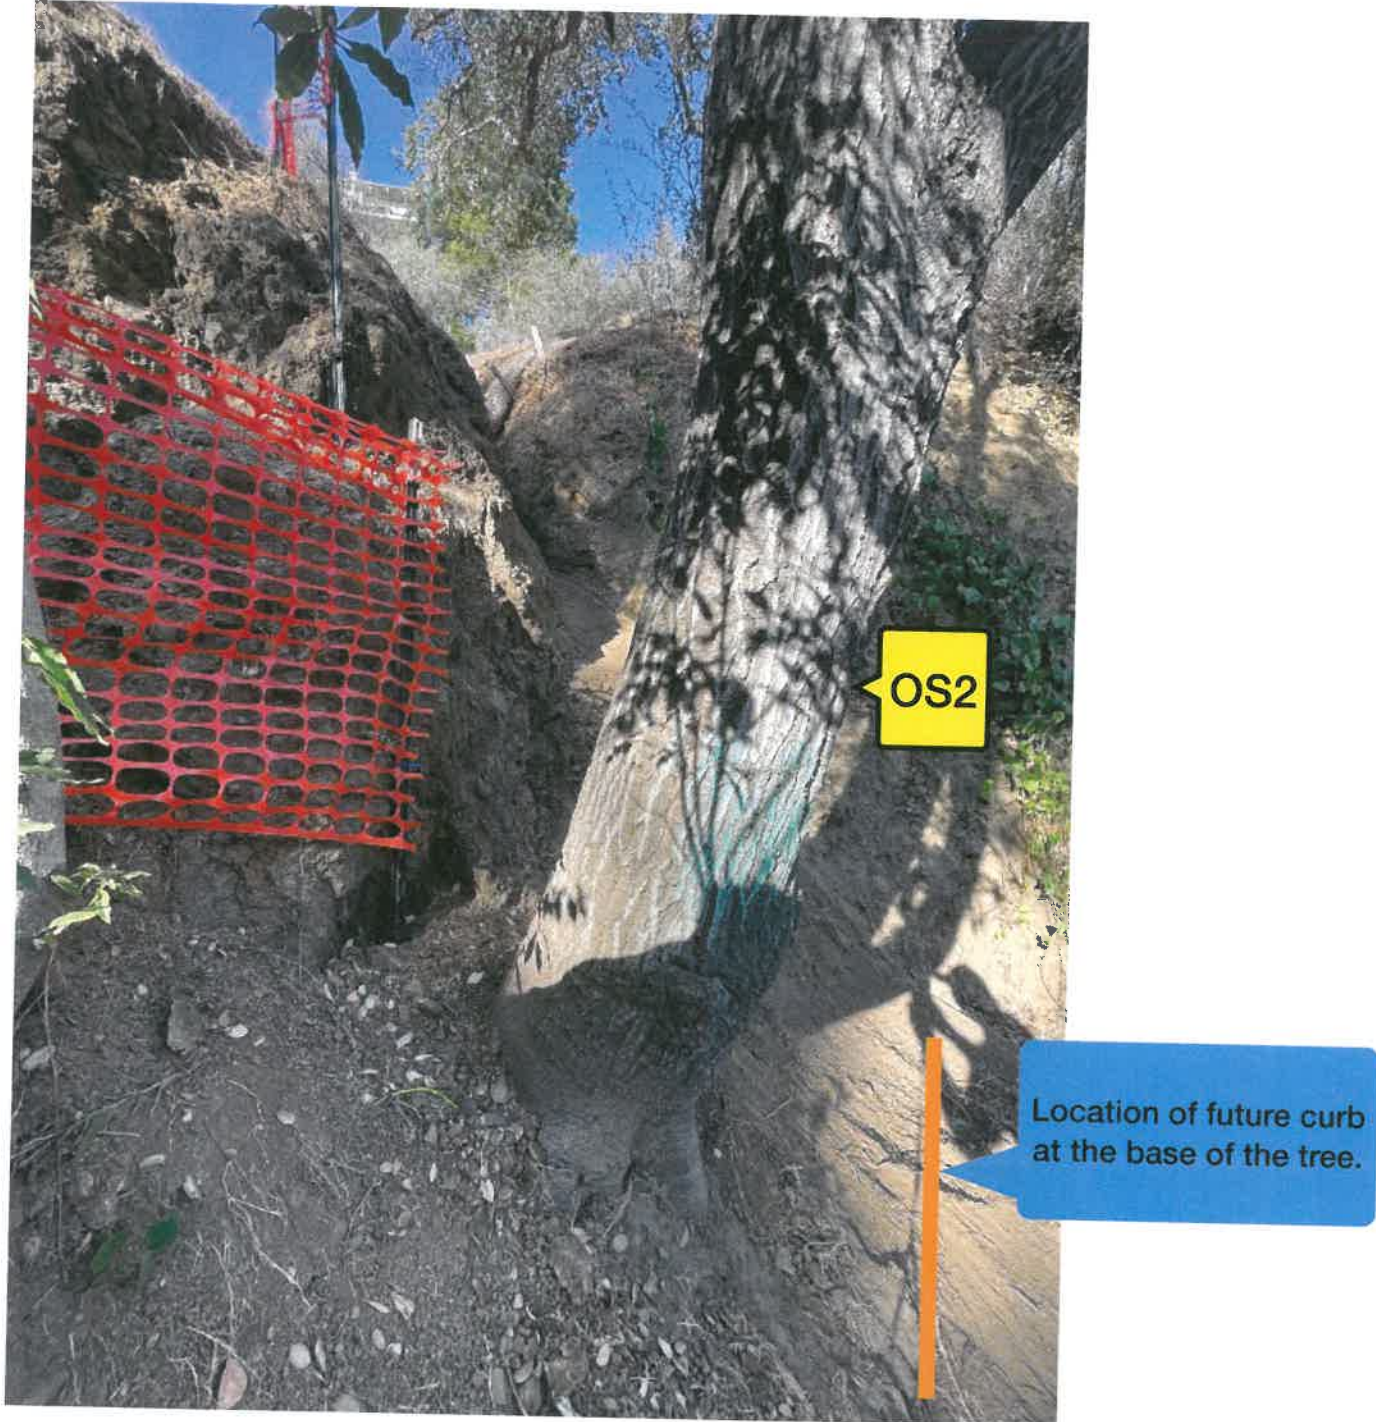
PHOTO 3 - Coast live oak (*Quercus agrifolia*) tree #OS2 is in the public right-of-way will receive minimal impact. Grading will occur approximately 5 feet above the Oak trunk. The road is proposed to be widened with a regular curb to be installed near the base of the tree. If roots are encountered a shallow curb will be installed instead and will be supported by a tube driven into the ground. This tree will be retained and protected in place.

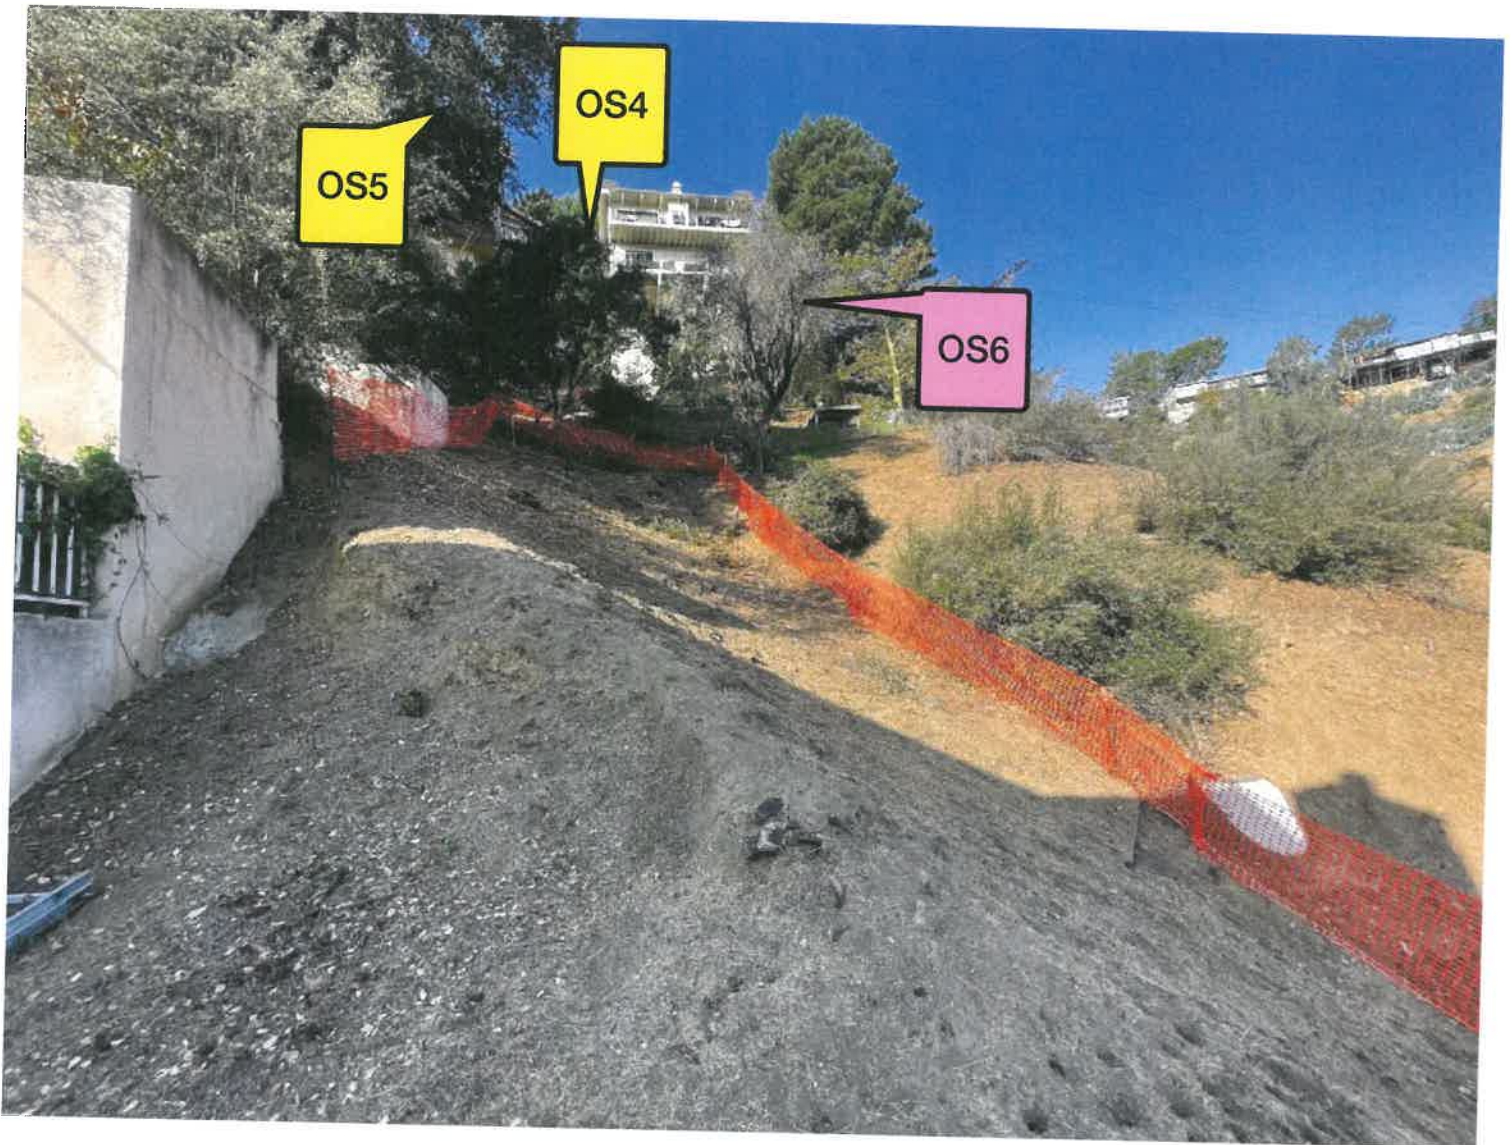
PHOTO 4 - Shows off site trees #OS4, #OS5 and #OS6. These trees will be retained and protected in place. These trees will receive no impact from the proposed new development.

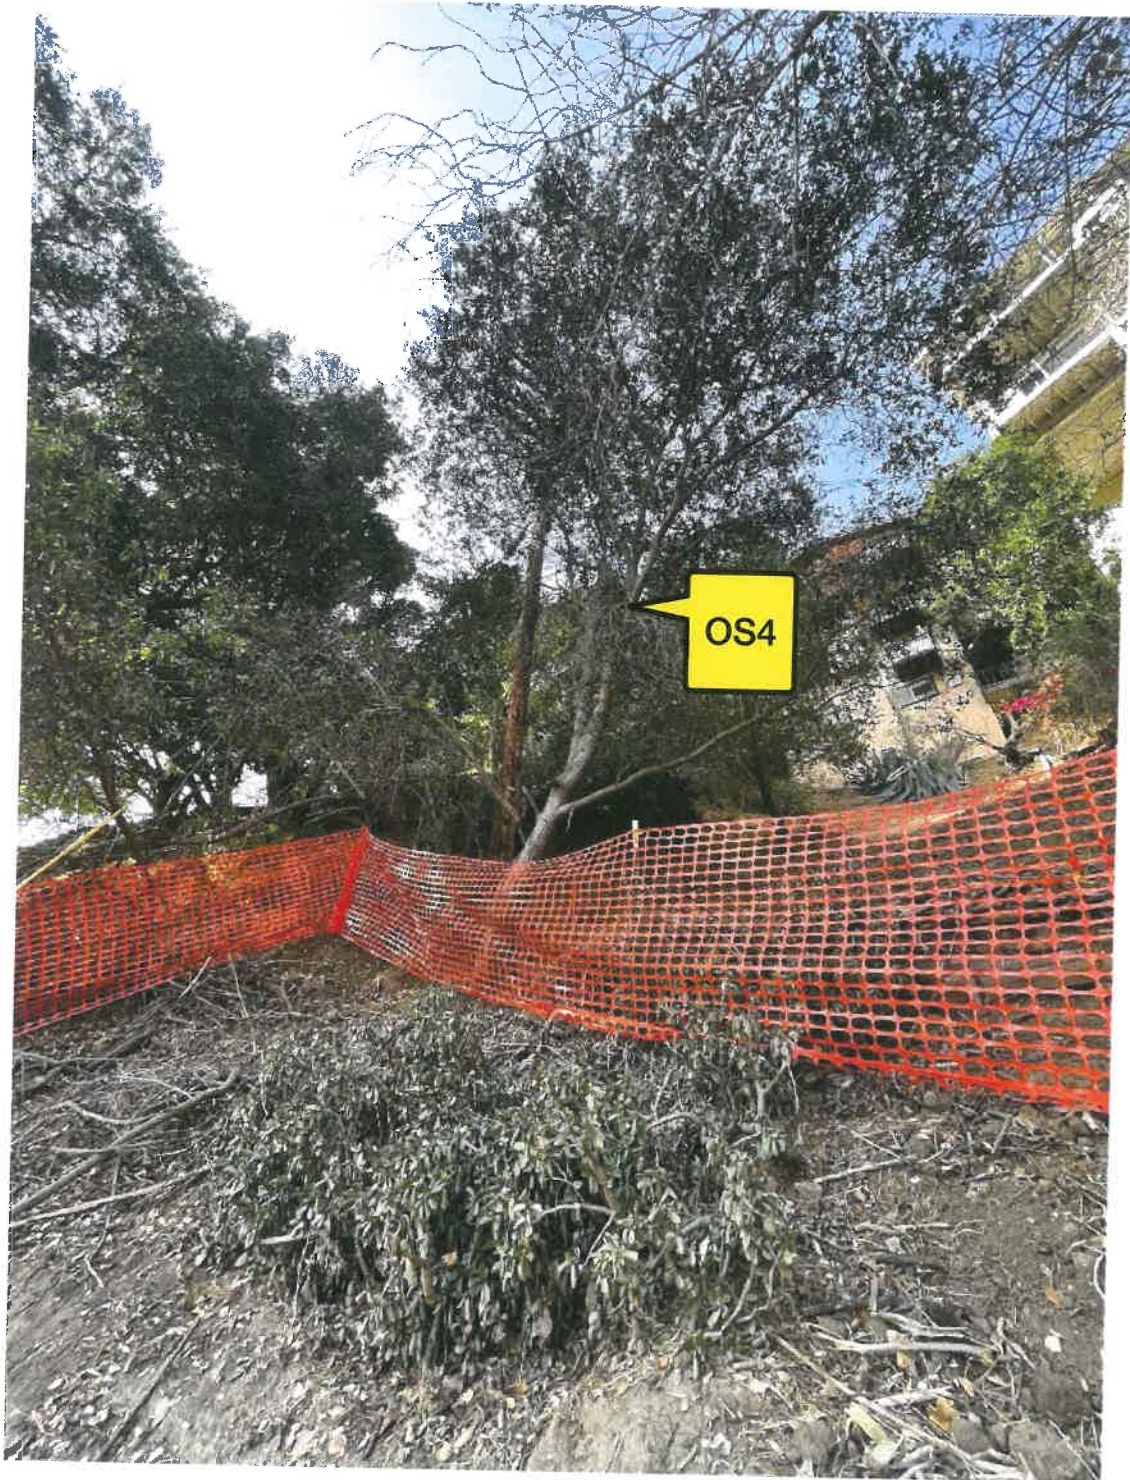
Coast live oak (*Quercus agrifolia*) tree #OS4 will not be impacted. The proposed ADU is sited approximately 6'-10" downhill from the oak trunk. This tree will receive minimal impact and will be retained and protected in place.

PHOTO 5 - Coast live oak (*Quercus agrifolia*) tree #OS4 will not be impacted. The proposed ADU is sited approximately 7' downhill from the oak trunk. This tree will receive no impact and will be retained and protected in place.

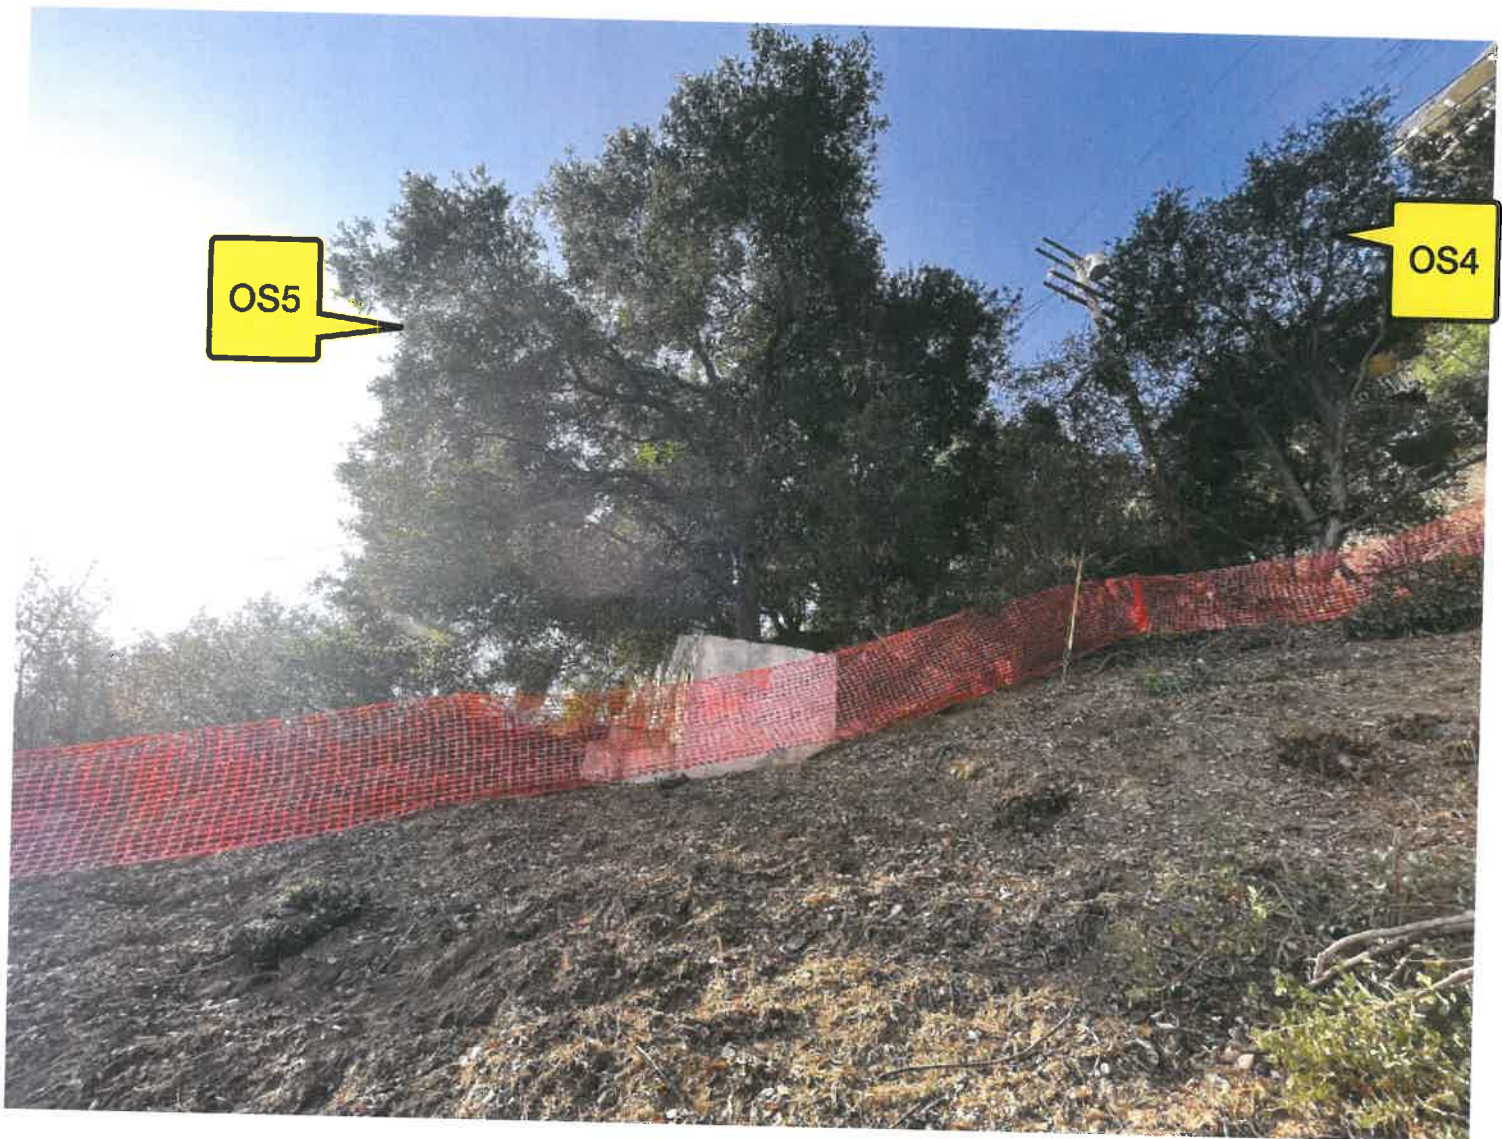
Coast live oak (*Quercus agrifolia*) tree #OS5 is located in an elevated concrete planter uphill from construction, and is outside of the construction zone and will not be impacted. This tree will receive no impact and will be retained and protected in place.

PHOTO 6 - Coast live oak (*Quercus agrifolia*) tree #OS5 is located in an elevated concrete planter uphill from construction, and is outside of the construction zone and will not be impacted. This tree will receive no impact and will be retained and protected in place.

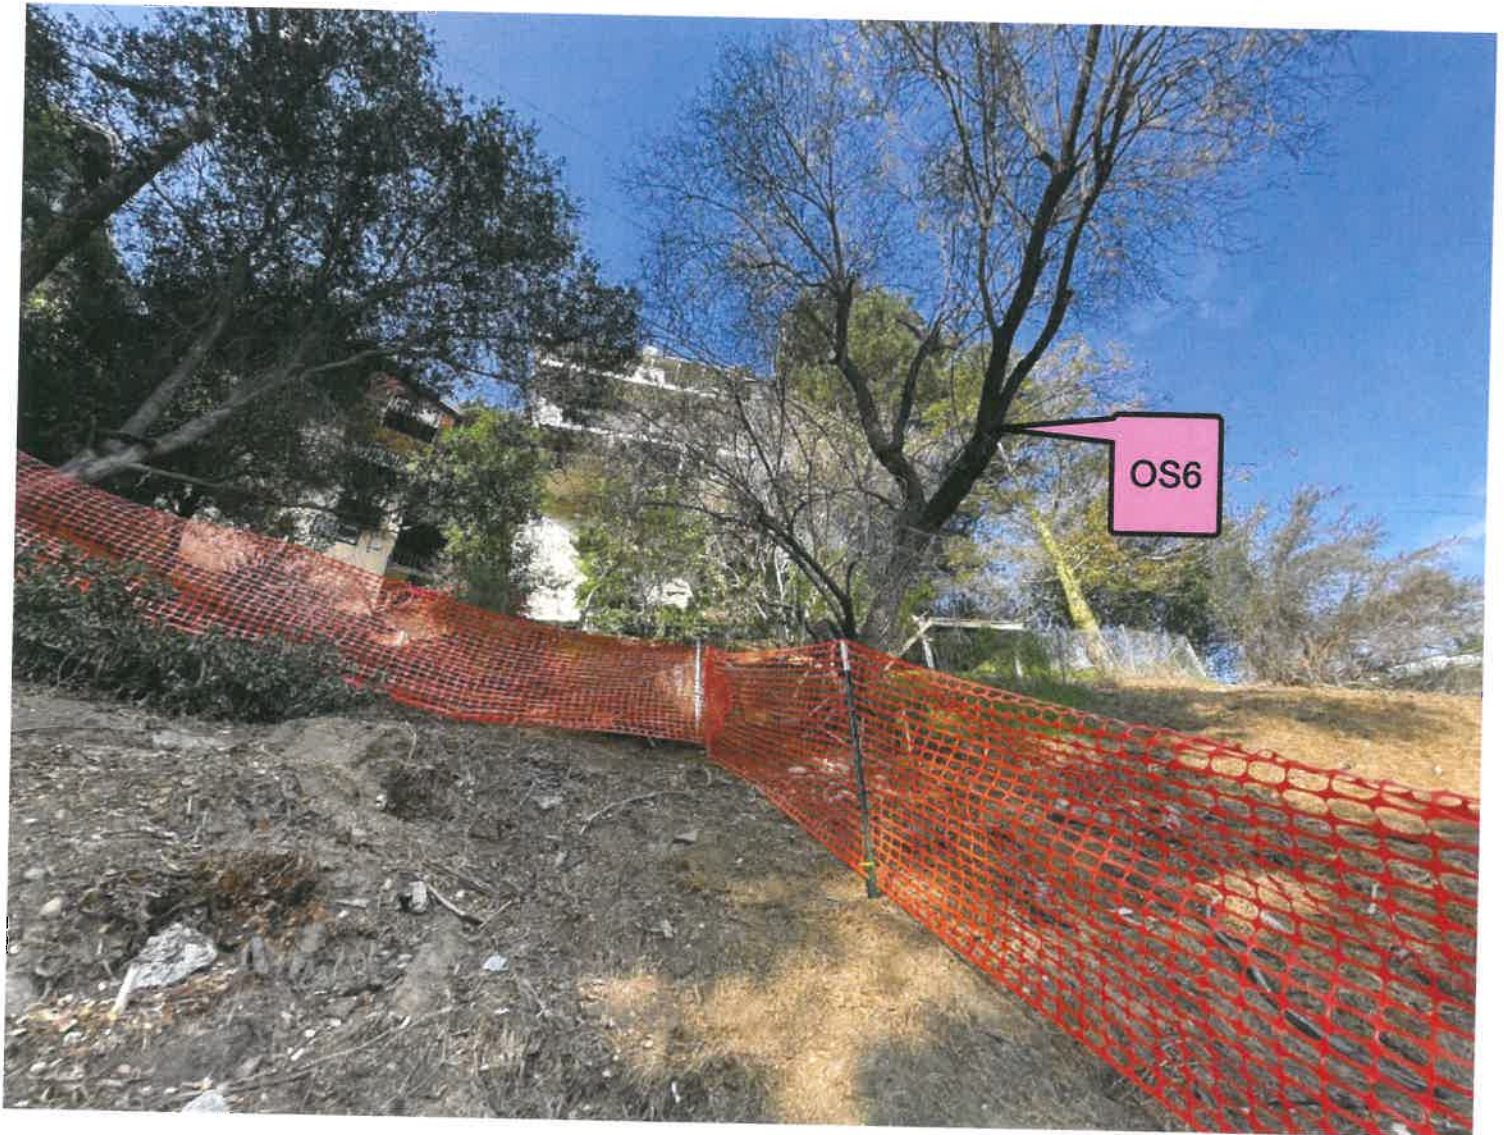
Mexican elderberry (*Sambucus mexicana*) tree #OS6 is off-site in the "sewer easement" area that extends about 6 feet across and is outside of the construction zone and will not be impacted. This tree is almost dead.

PHOTO 8 - Shows Off Site Mexican elderberry (*Sambucus mexicana*) tree #OS6. This tree will receive no impact and will be retained. This tree is off-site in the "sewer easement" area that extends about 6 feet across, this tree is poor condition and is almost dead, most likely due to drought conditions.

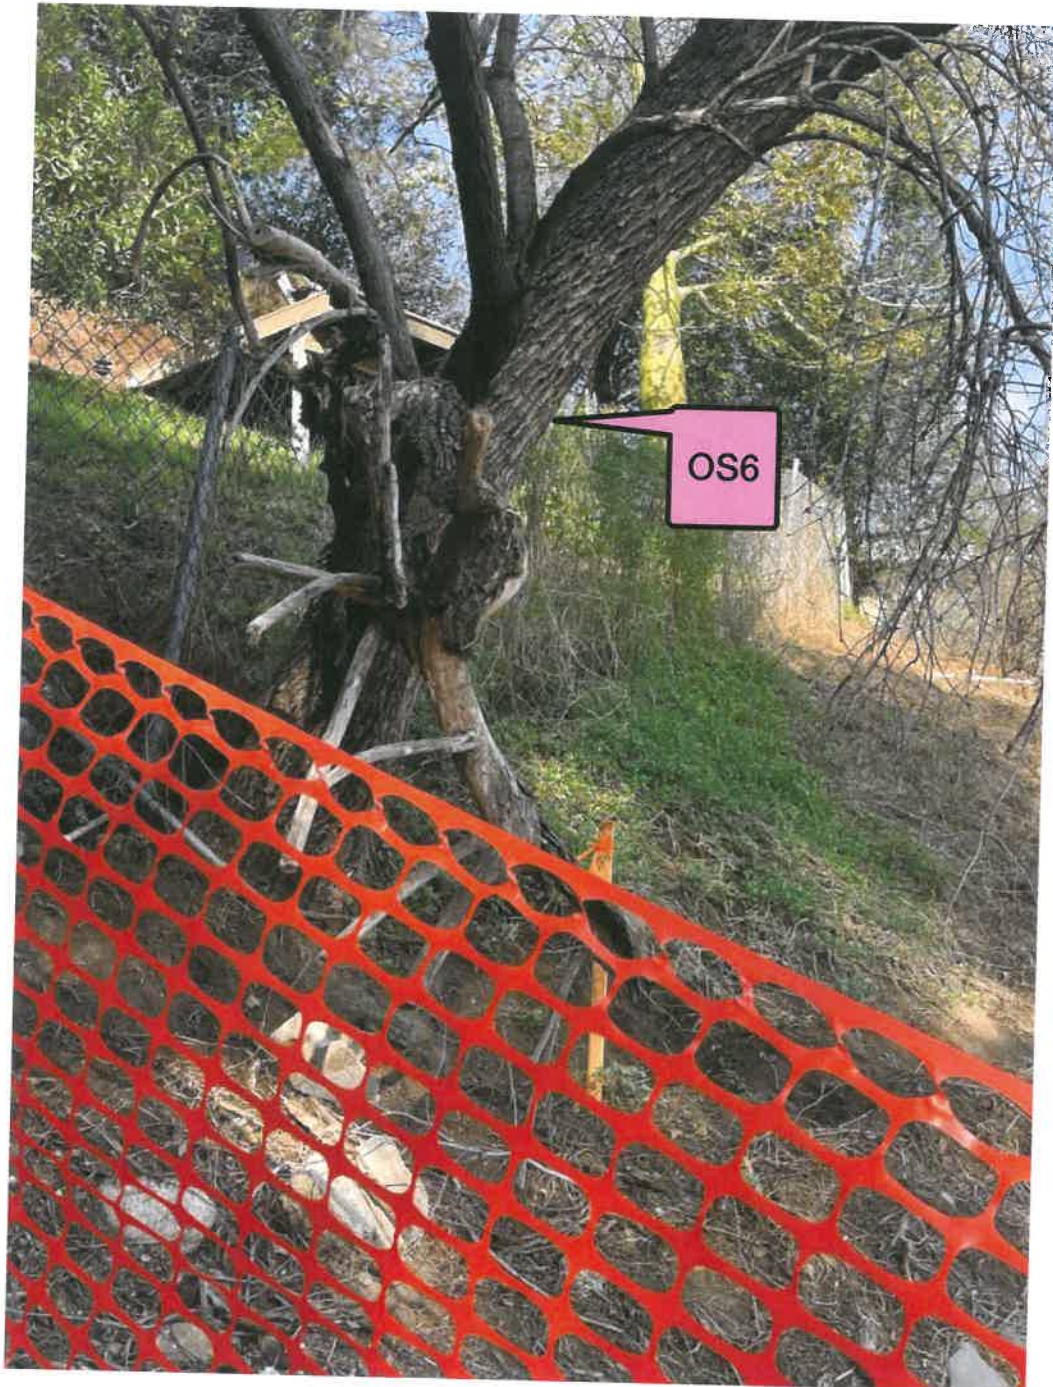
PHOTO 9 - Shows Off Site Mexican elderberry (*Sambucus mexicana*) tree #OS6. This tree will receive no impact and will be retained. This tree is off-site in the "sewer easement" area that extends about 6 feet across, this tree is almost dead.

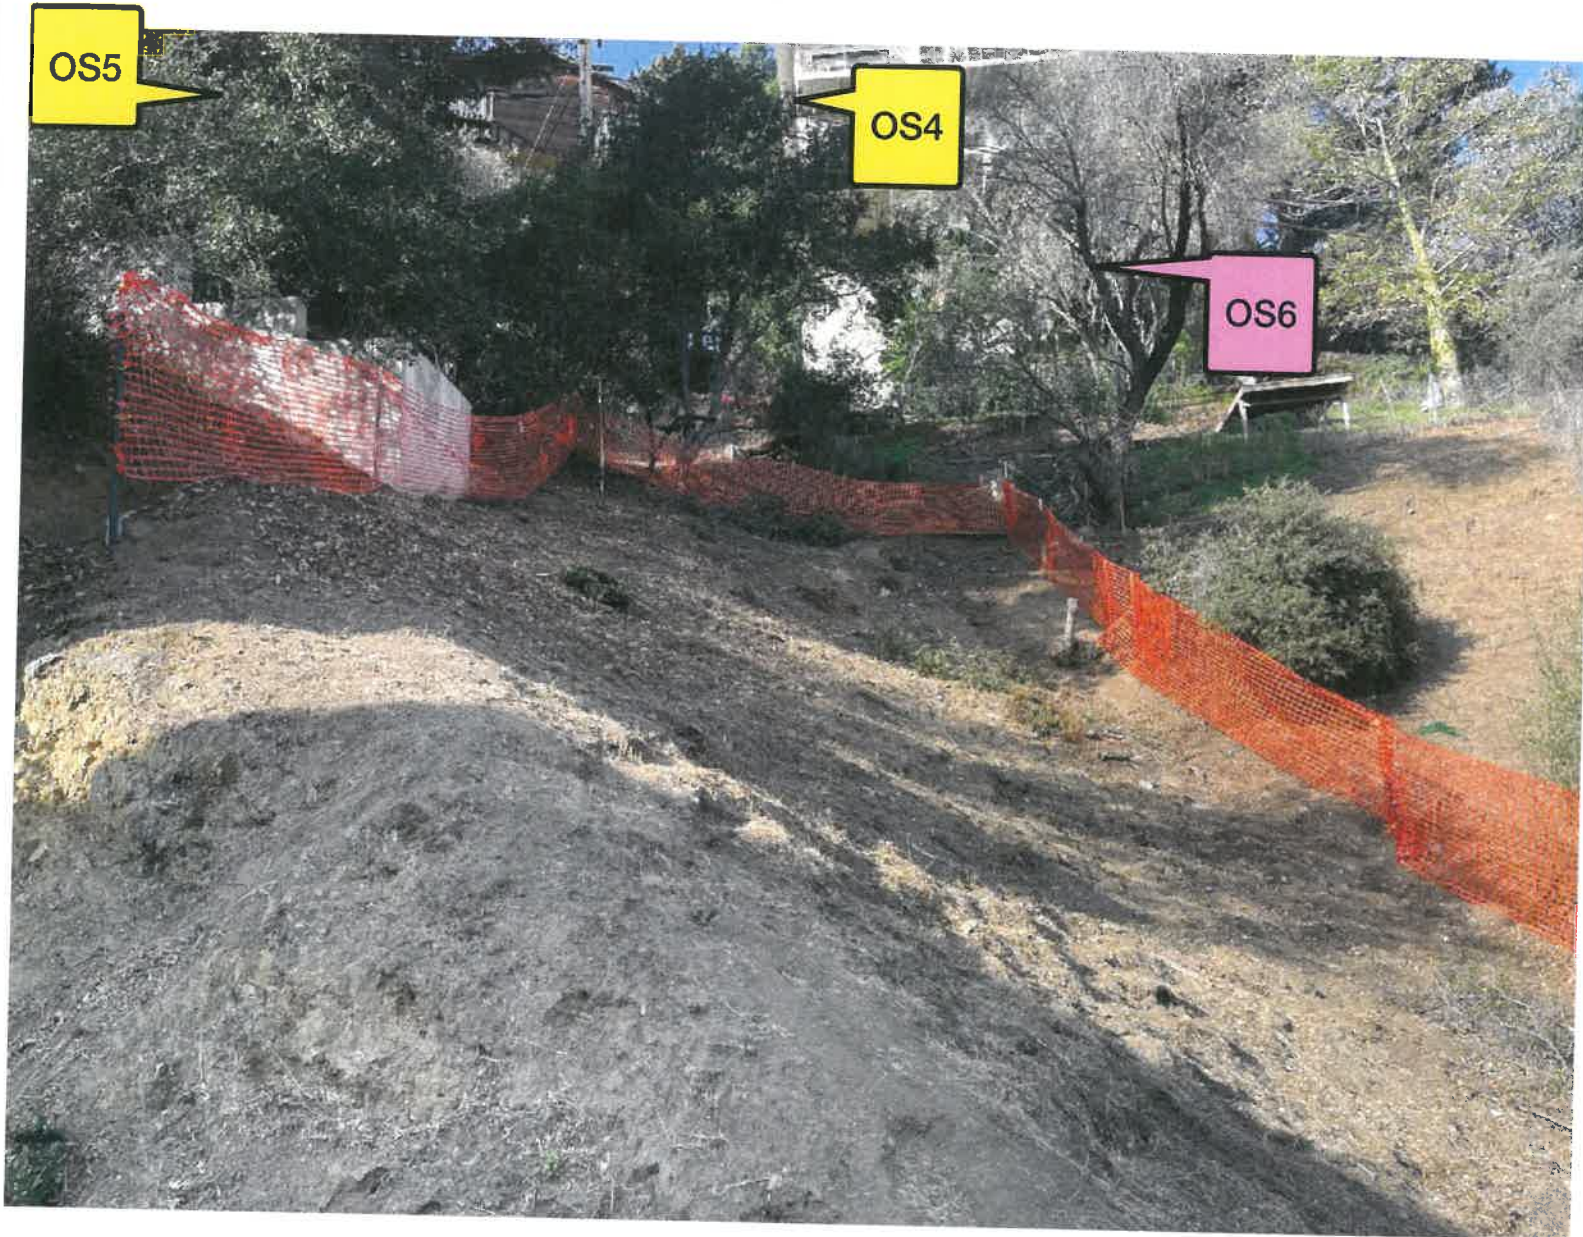
PHOTO 10 - Shows portion of slope where new project will be developed.

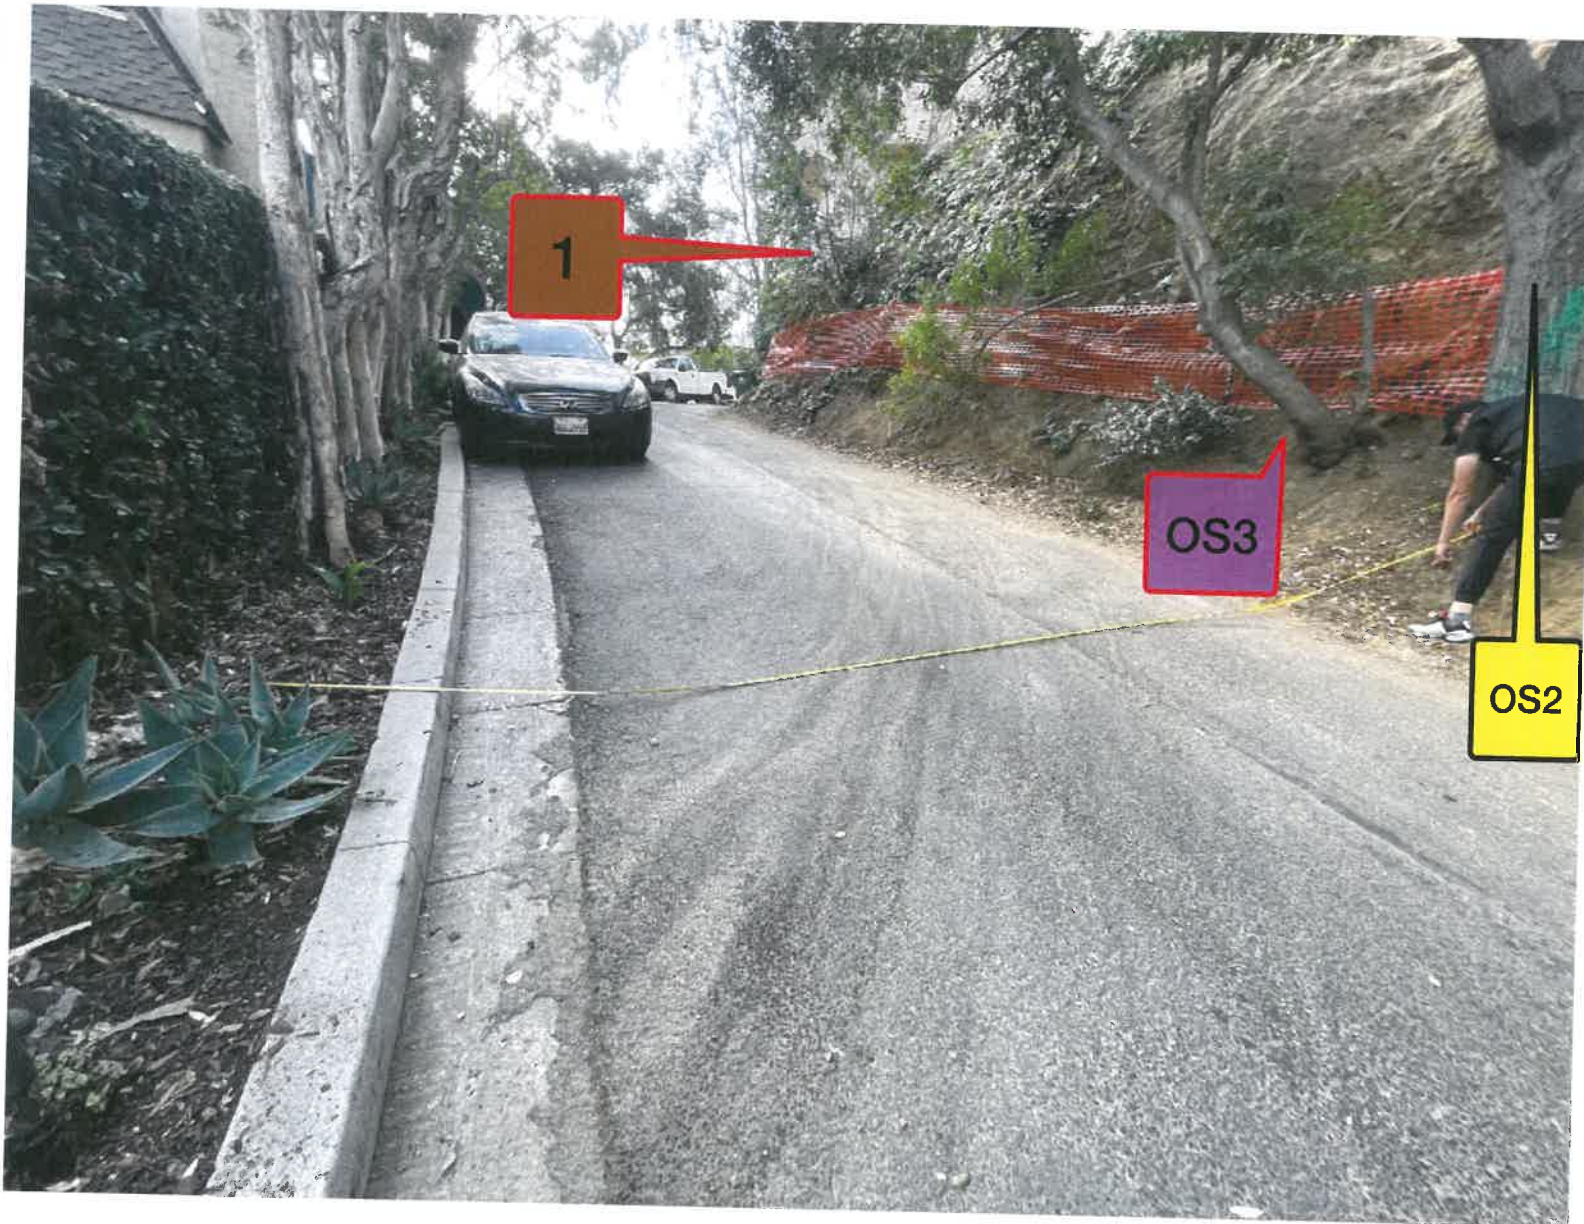
PHOTO 11 - Shows front slope and steep terrain. House will be built directly into hillside. The small Toyon shrub #1 is located directly on the steepest portion of the front slope. This photo is also showing the back of curb location of the required widening of the road.
