# 3433 W. 8th St. Arborist Report

Prepared for CORBeL Architects Inc.  
Mick Myungsik Choi  
3450 Wilshire Blvd., Suite 1000  
Los Angeles, CA 90010

**Prepared by James Komen**  
BCMA WE-9909B  
RCA #555

Mick Myungsik Choi of CORBeL Architects Inc. asked me to prepare a Protected Tree Report for the City of Los Angeles Urban Forestry Department documenting the trees on a property proposed for development. I visited the subject property alone on July 2, 2021 at 3:30pm to collect the data for this report.

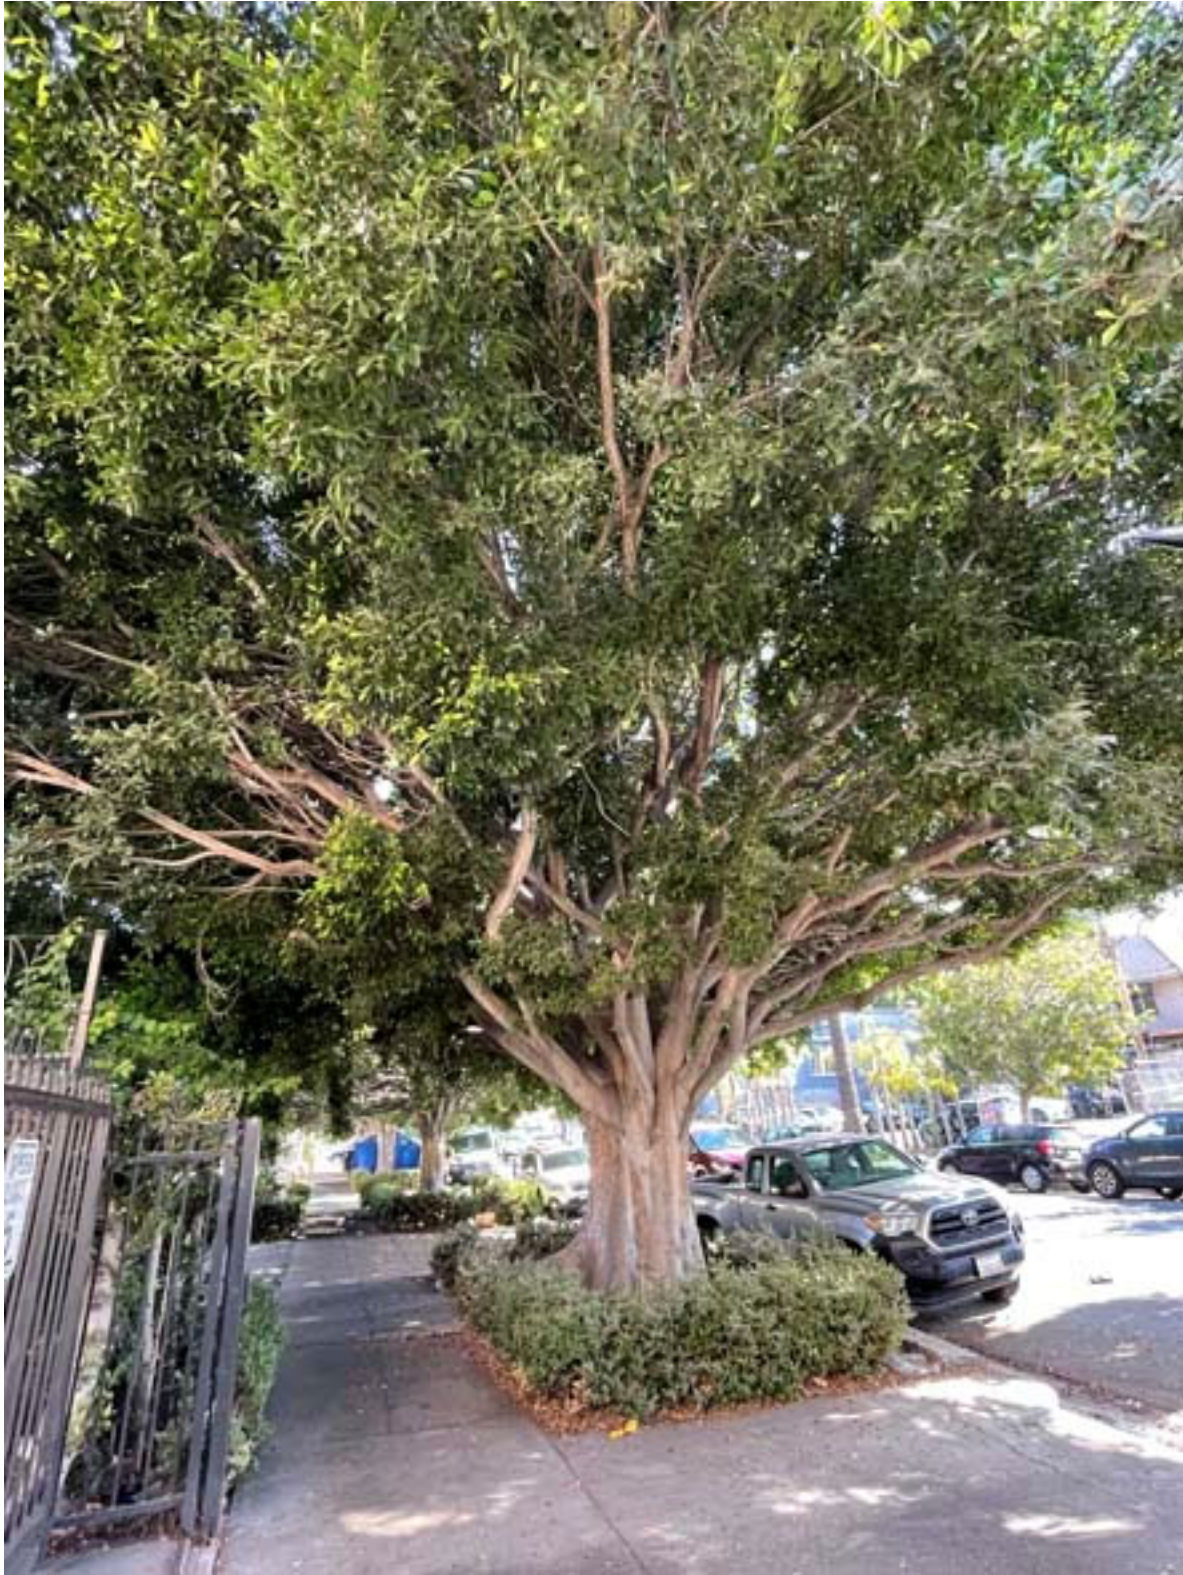
**Figure 1: Tree 1**

<p><b>Tree 1</b> <i>Ficus microcarpa</i> – Indian Laurel Fig</p> <p>This tree is a street tree, growing within the public right of way. It will be removed because it is growing too close to the footprint of the proposed driveway that it would not survive the root cuts that would result from the necessary excavation. Moreover, there is a fair probability that the root cutting that would result from the driveway's construction would destabilize the tree.</p> <p>This tree is currently lifting the adjacent sidewalk. It has been partially suppressed by competition with its neighbor, Tree 2. Overall, this tree is vigorous, but it has an asymmetrical canopy.</p> <p>If Tree 2 is removed, then Tree 1 would be exposed to new wind loads, and it would have an increased likelihood of failure. Thus, I recommend that Tree 1 and Tree 2 be treated as a unit together for purposes of determining which tree will be retained or removed.</p>

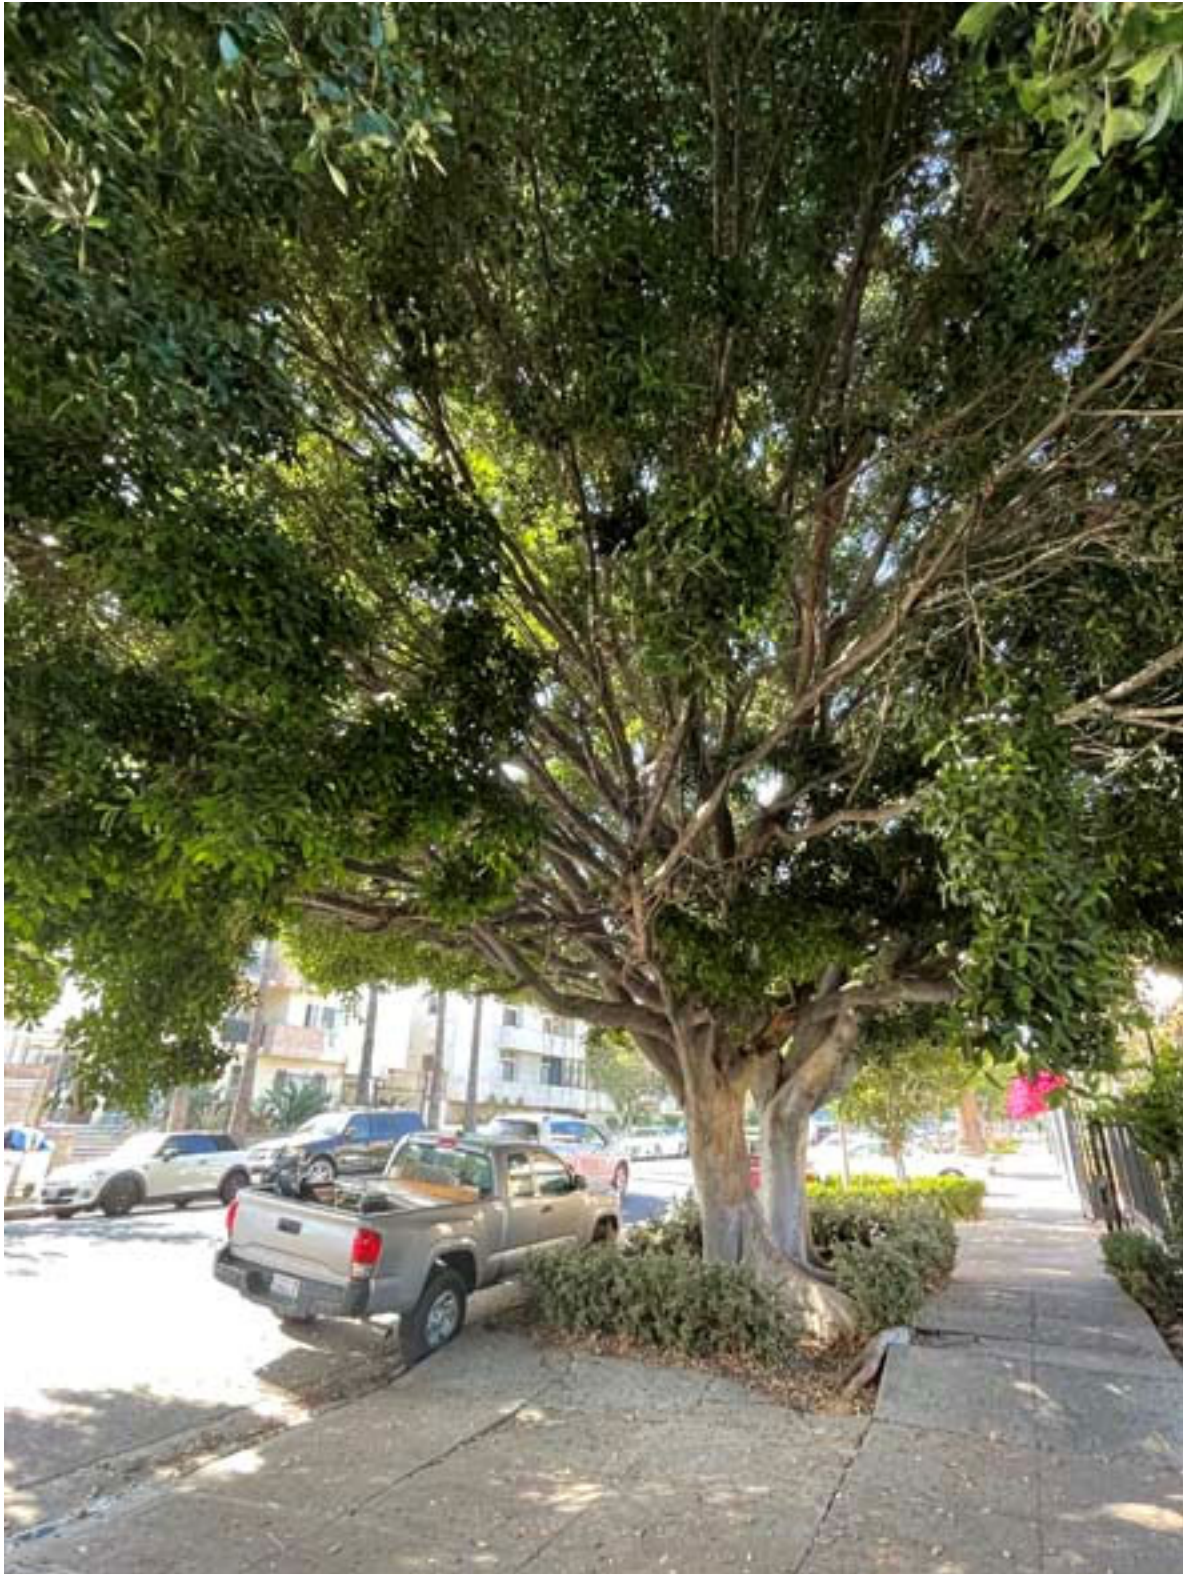
**Figure 2:** Tree 2

<p><b>Tree 2</b> <i>Ficus microcarpa</i> – Indian Laurel Fig</p> <p>This tree is a street tree, growing within the public right of way. It will be removed because it is growing too close to the footprint of the proposed driveway for it to survive the root cutting that would result. Also, the proposed building encroaches within the drip line of this tree, so substantial root cutting would result from excavating for the building's subterranean parking. This tree would not likely survive these impacts.</p> <p>This tree is currently lifting the adjacent sidewalk. It has been partially suppressed by competition with its neighbor, Tree 1. Overall, this tree is vigorous, but it has an asymmetrical canopy.</p>

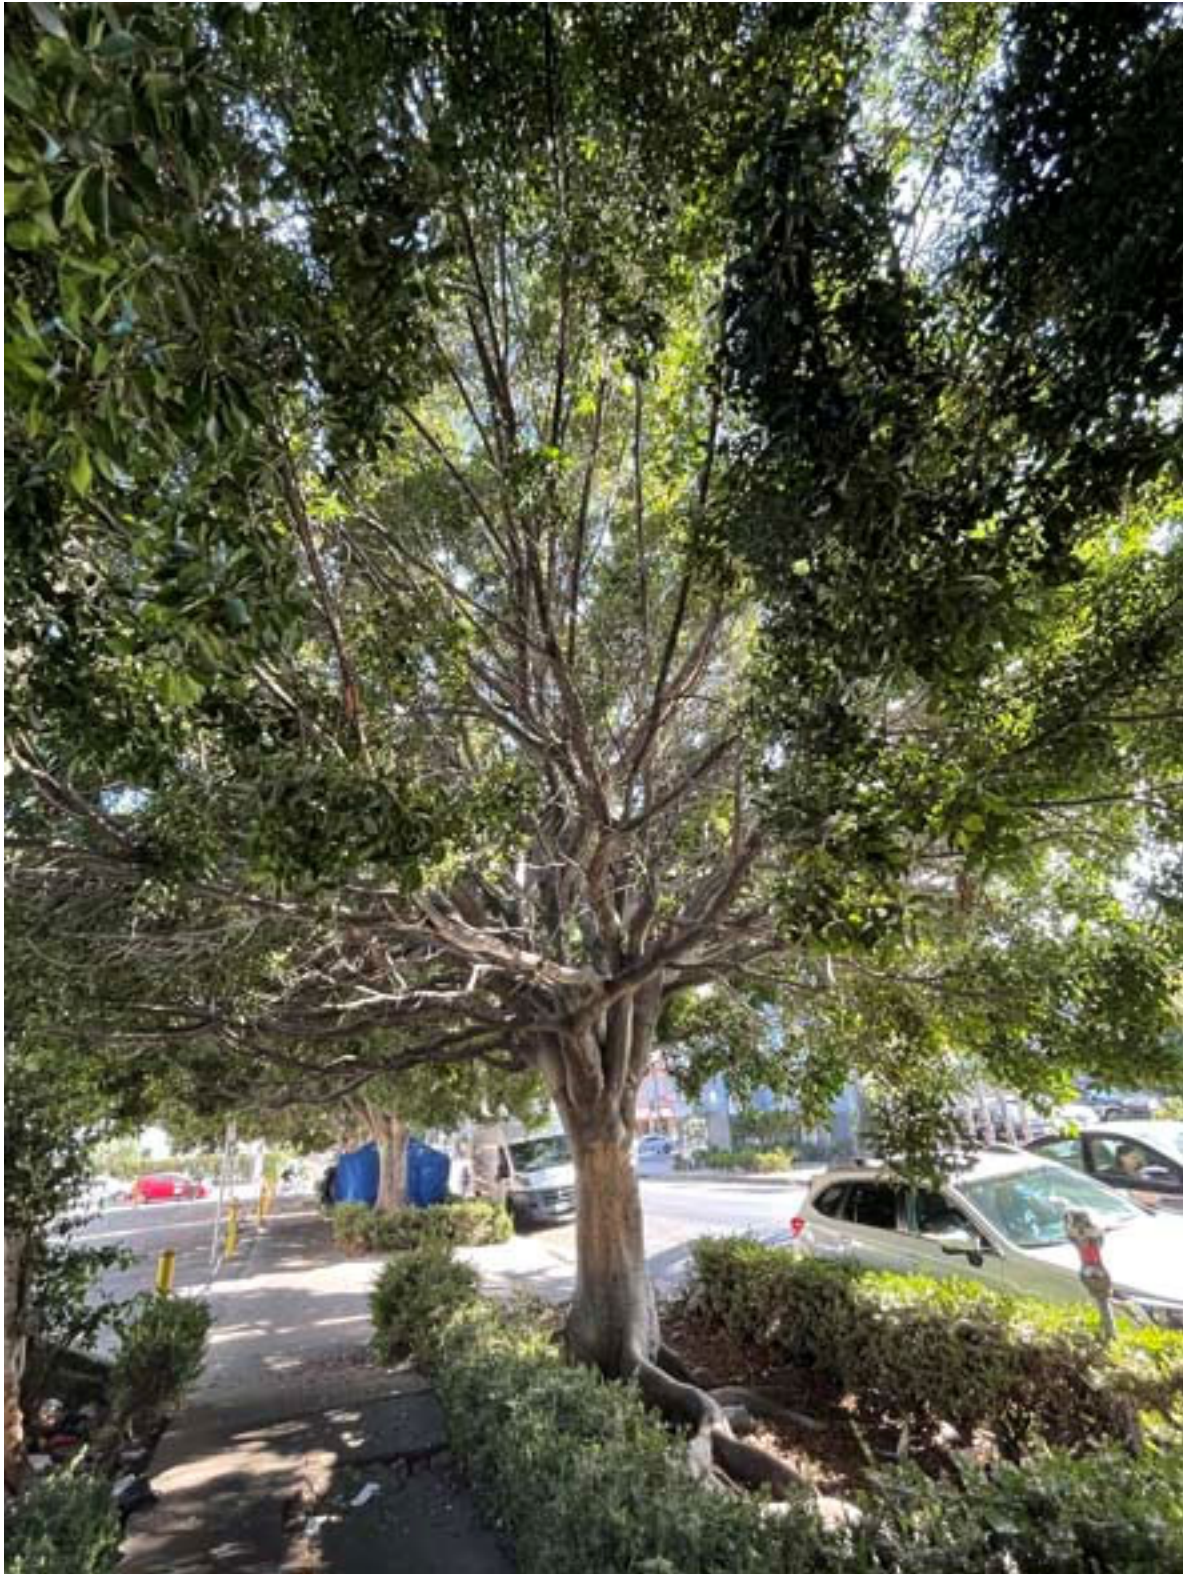
**Figure 3: Tree 3**

This tree is a street tree, growing within the public right of way. It will be removed because it is growing too close to the footprint of the proposed driveway for it to survive the root cutting that would result. Also, the proposed building encroaches within the drip line of this tree, so substantial root cutting would result from excavating for the building's subterranean parking. This tree would not likely survive these impacts.

This tree has a thinning canopy, but it is still in good condition.

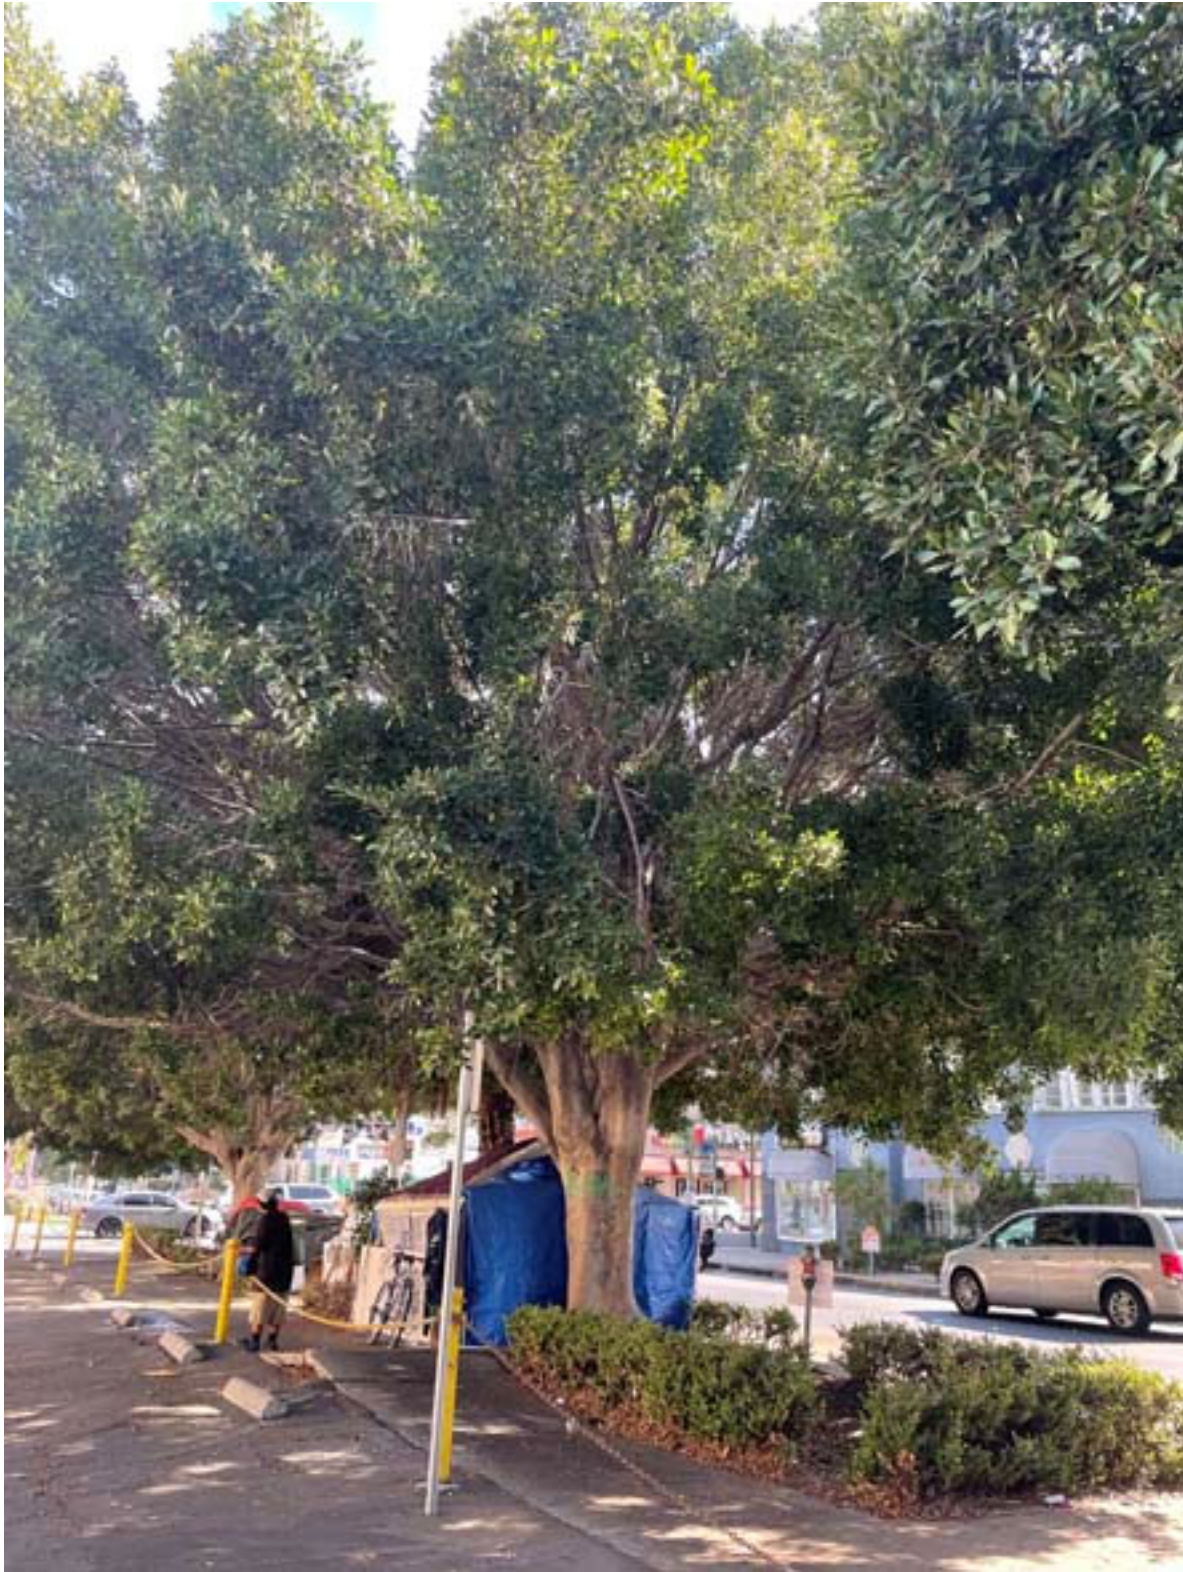
**Figure 4:** Tree 4

This tree has a thinning canopy, but it is still in good condition. I recommend pruning this tree's lowest branches for sidewalk clearance to a height of 8-10 feet. Pruning cuts should be no larger than 2 inches in diameter.

The proposed building and sidewalk repairs will encroach within the critical root zone of this tree. All project activity within the drip line of this tree should be directly supervised by a Certified Arborist. Some of this tree's root system may be impacted, but it is intended to be retained in place throughout the project.

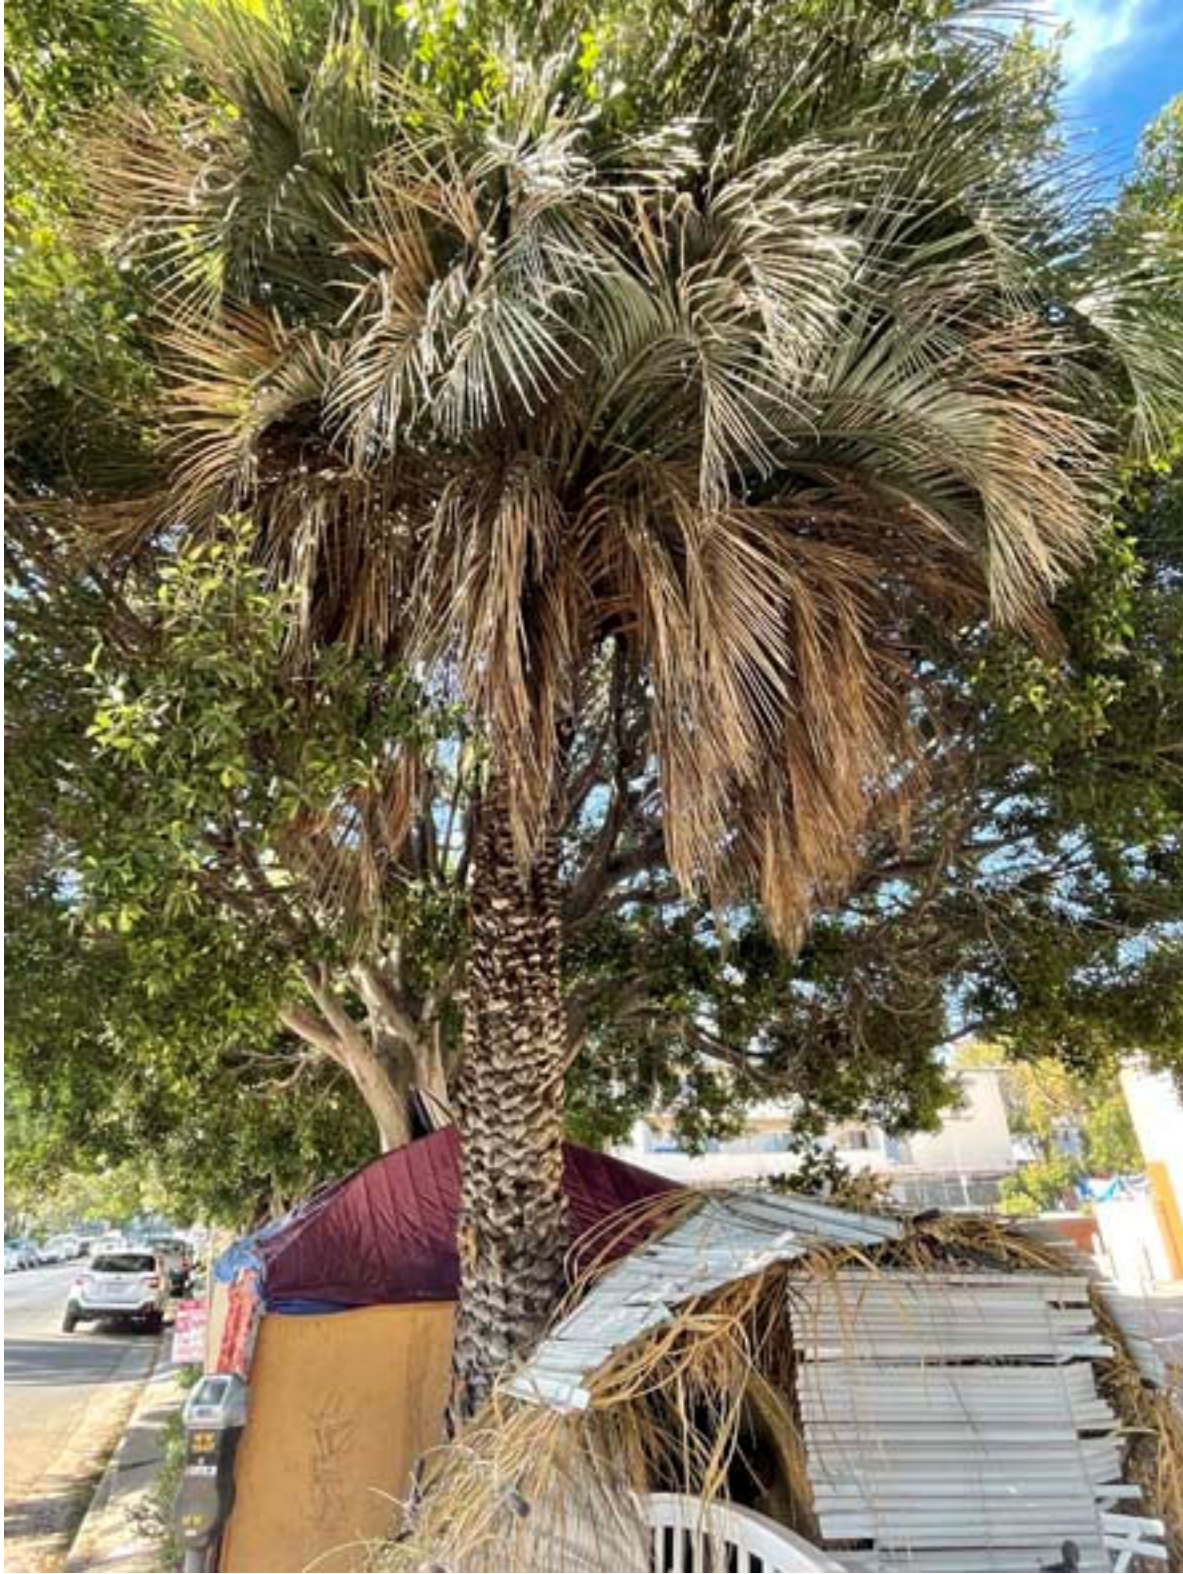
**Figure 5: Tree 5**

<p><b>Tree 5</b>  <i>Butia capitata</i> – Jelly Palm</p> <p>This tree is a street tree, growing within the public right of way. It will be retained in the landscape through the proposed project.</p> <p>This tree has been suppressed by competition with its neighbor, Tree 4. It is in average condition. I recommend pruning off its dead fronds.</p> <p>The proposed sidewalk repairs will encroach within the critical root zone of this tree. All project activity within 10 feet of this tree should be directly supervised by a Certified Arborist. Some of this tree's root system may be impacted, but it is intended to be retained in place throughout the project.</p>

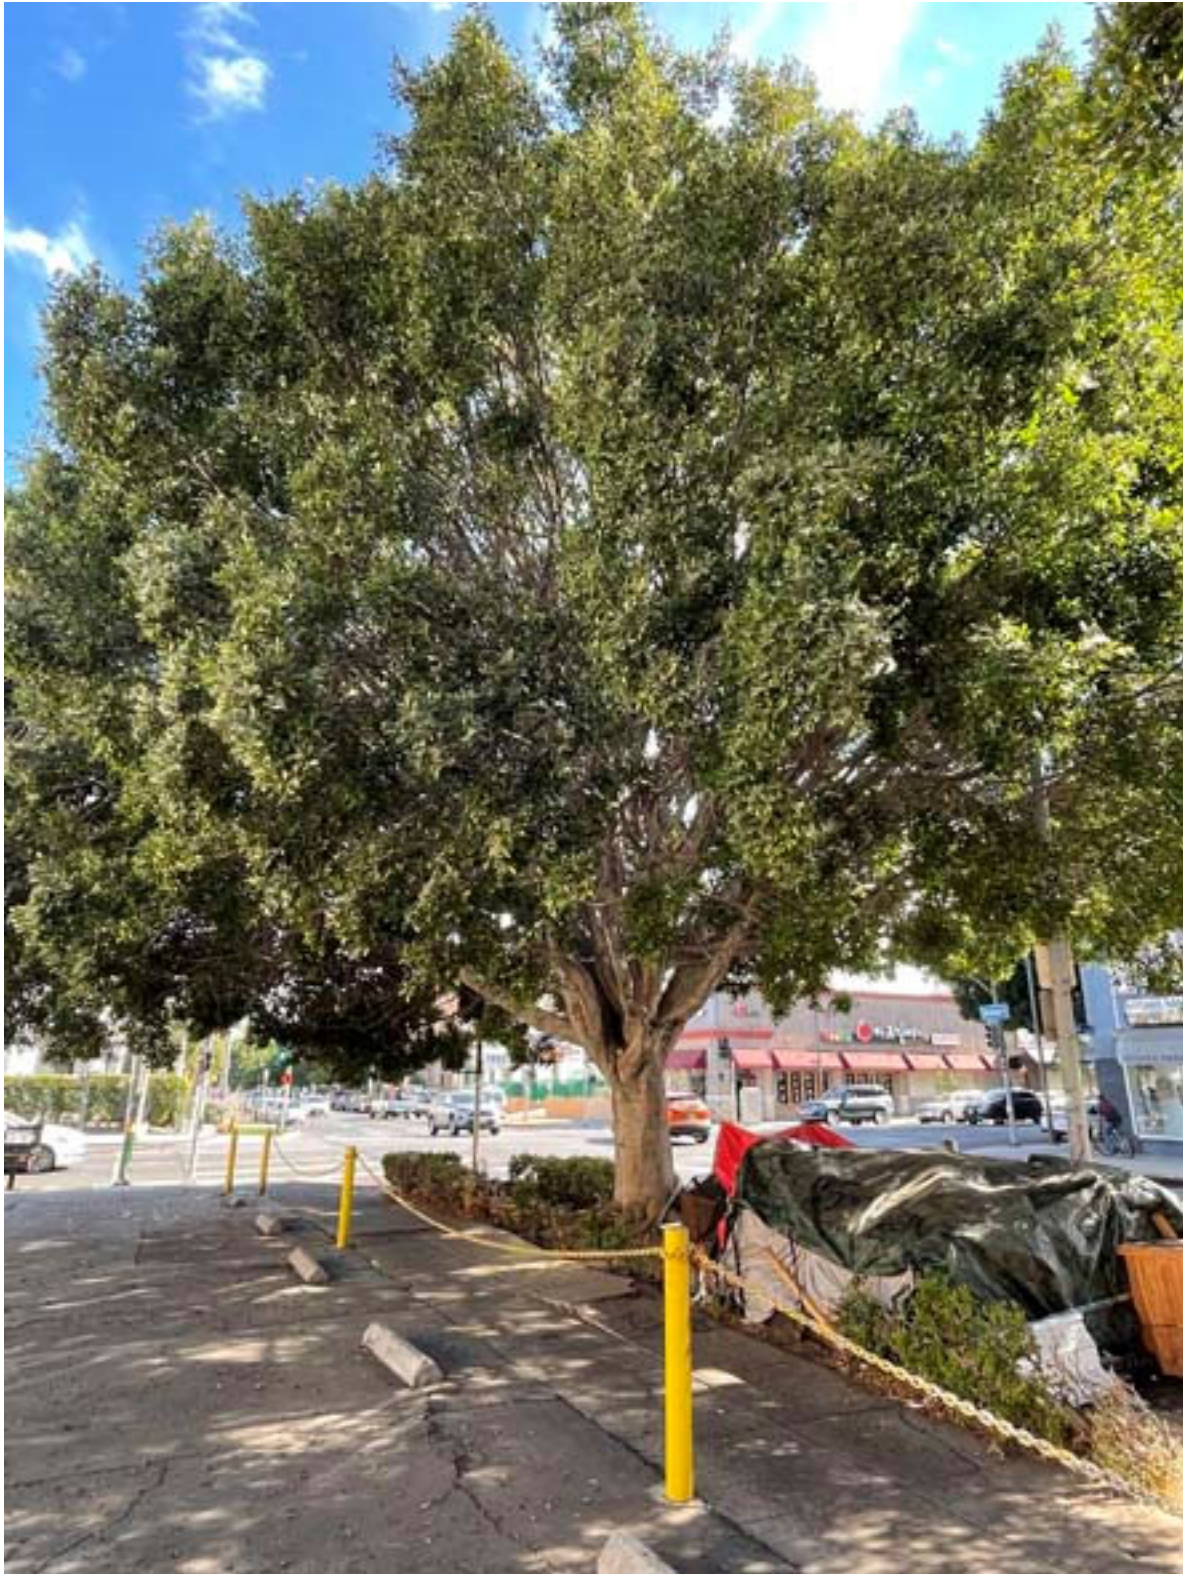
**Figure 6:** Tree 6

<p><b>Tree 6</b>  <i>Ficus microcarpa</i> – Indian Laurel Fig</p> <p>This tree is a street tree, growing within the public right of way. It will be retained in the landscape through the proposed project.</p> <p>This tree has a thinning canopy, but it is still in good condition. I recommend pruning this tree's lowest branches for sidewalk clearance.</p> <p>The proposed building and sidewalk repairs will encroach within the critical root zone of this tree. All project activity within the drip line of this tree should be directly supervised by a Certified Arborist. Some of this tree's root system may be impacted, but it is intended to be retained in place throughout the project.</p>

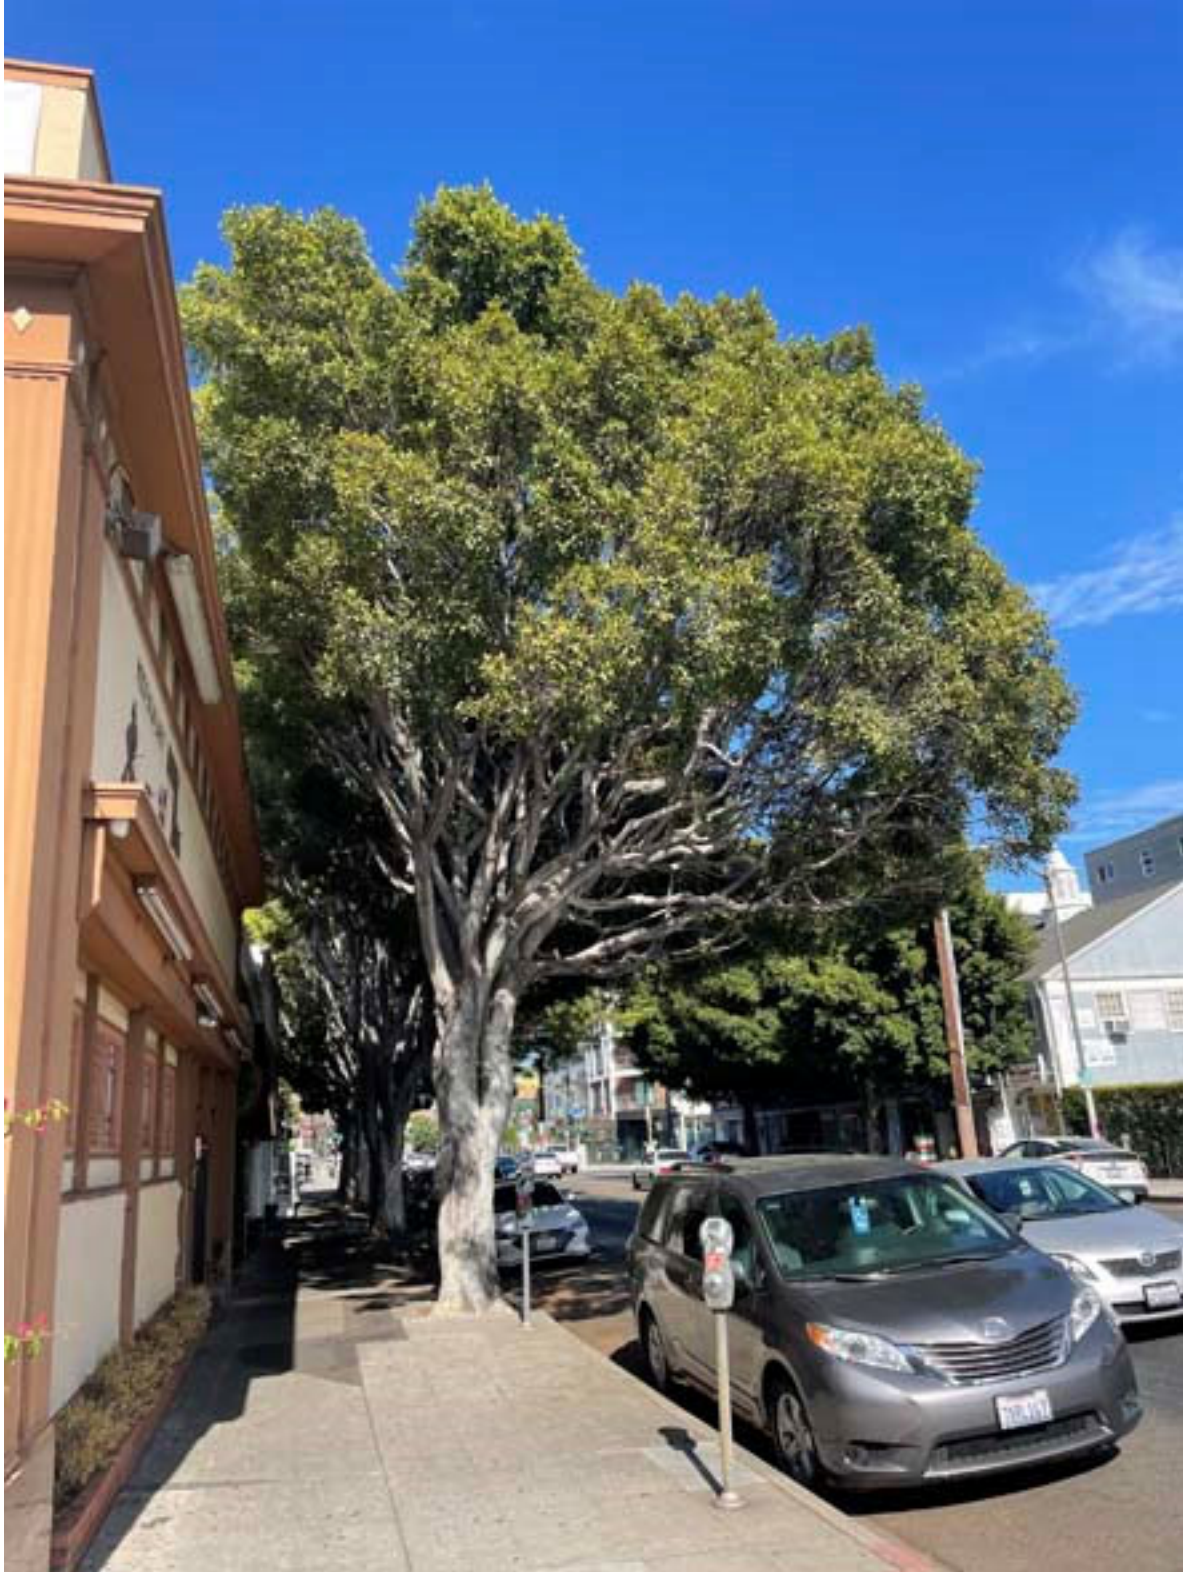
**Figure 7:** Tree 7

<p><b>Tree 7</b>  <i>Ficus microcarpa</i> – Indian Laurel Fig</p> <p>This tree is a street tree, growing within the public right of way. It will be retained in the landscape through the proposed project.</p> <p>This tree’s interior branches were removed in the past, leaving most of its foliage at the branch tips. The roots of this tree are lifting the sidewalk.</p> <p>The proposed building and sidewalk repairs will encroach within the critical root zone of this tree. All project activity within the drip line of this tree should be directly supervised by a Certified Arborist. Some of this tree's root system may be impacted, but it is intended to be retained in place throughout the project.</p>

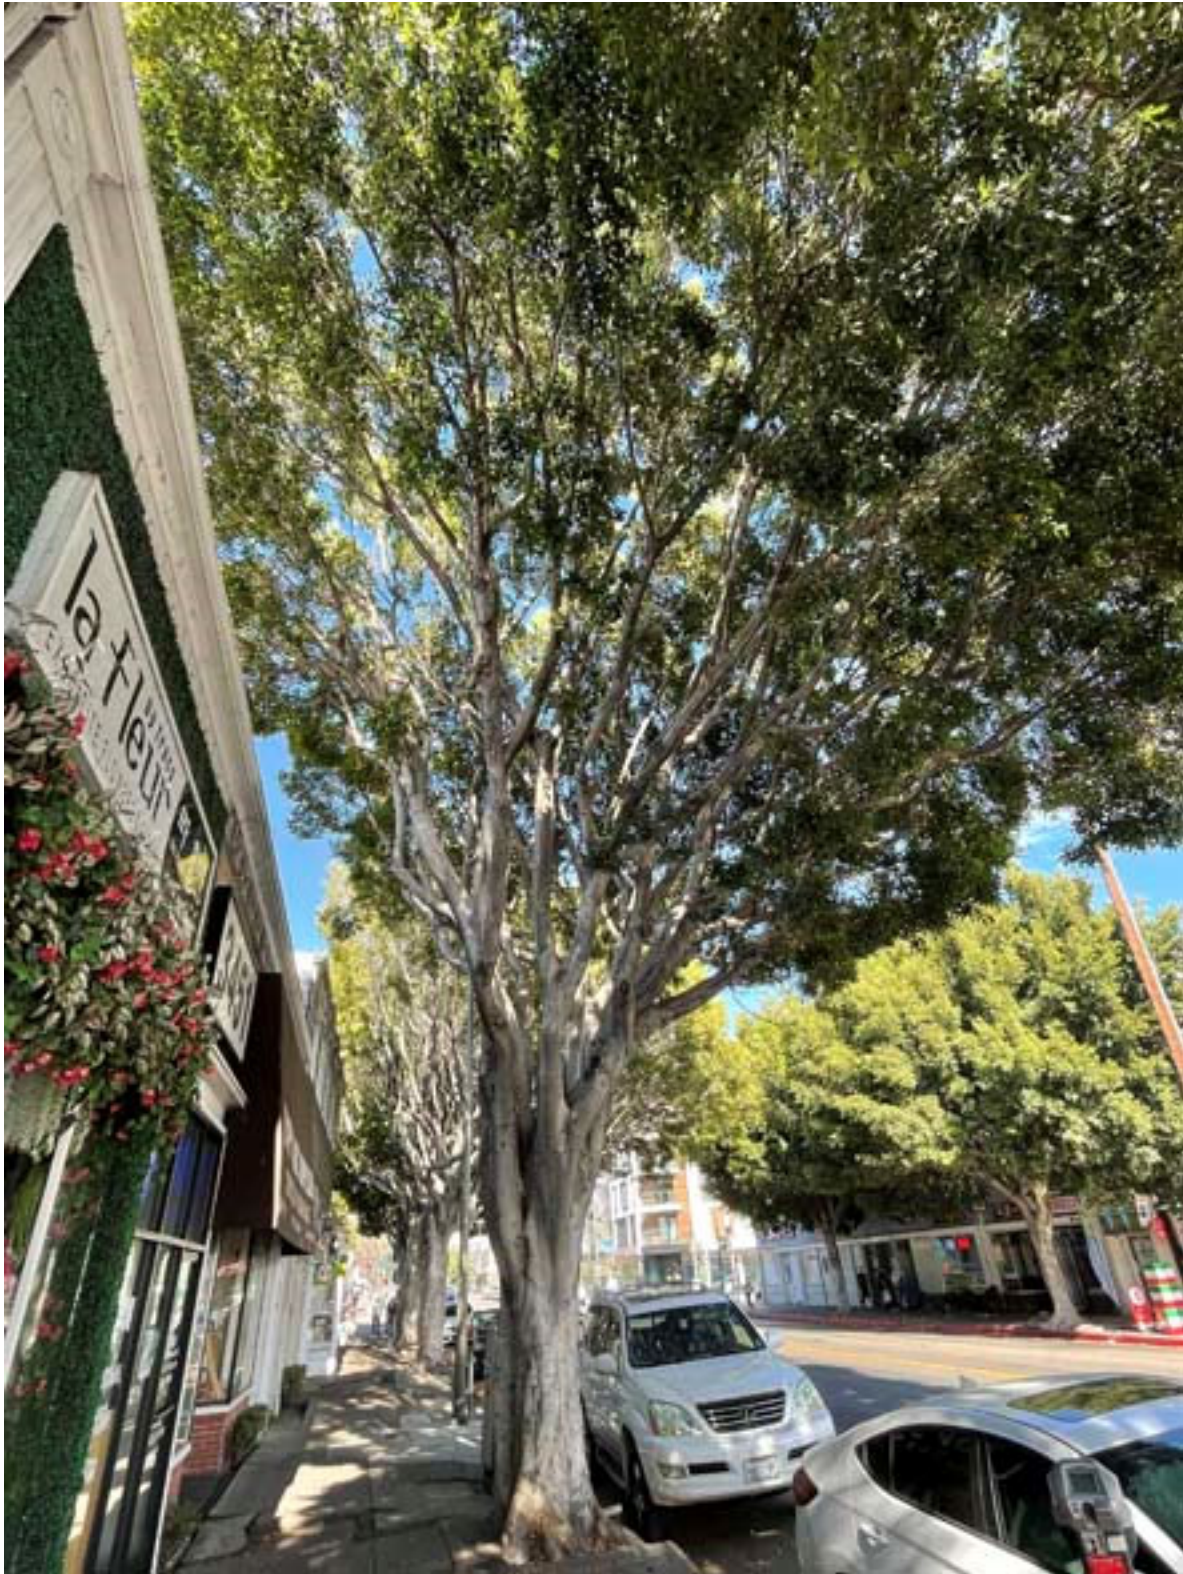
**Figure 8:** Tree 8

<p><b>Tree 8</b>  <i>Ficus microcarpa</i> – Indian Laurel Fig</p> <p>This tree is a street tree, growing within the public right of way. It will be retained in the landscape through the proposed project.</p> <p>This tree’s interior branches were removed in the past, leaving most of its foliage at the branch tips. The roots of this tree are lifting the sidewalk.</p> <p>The proposed building and sidewalk repairs will encroach within the critical root zone of this tree. All project activity within the drip line of this tree should be directly supervised by a Certified Arborist. Some of this tree's root system may be impacted, but it is intended to be retained in place throughout the project.</p>

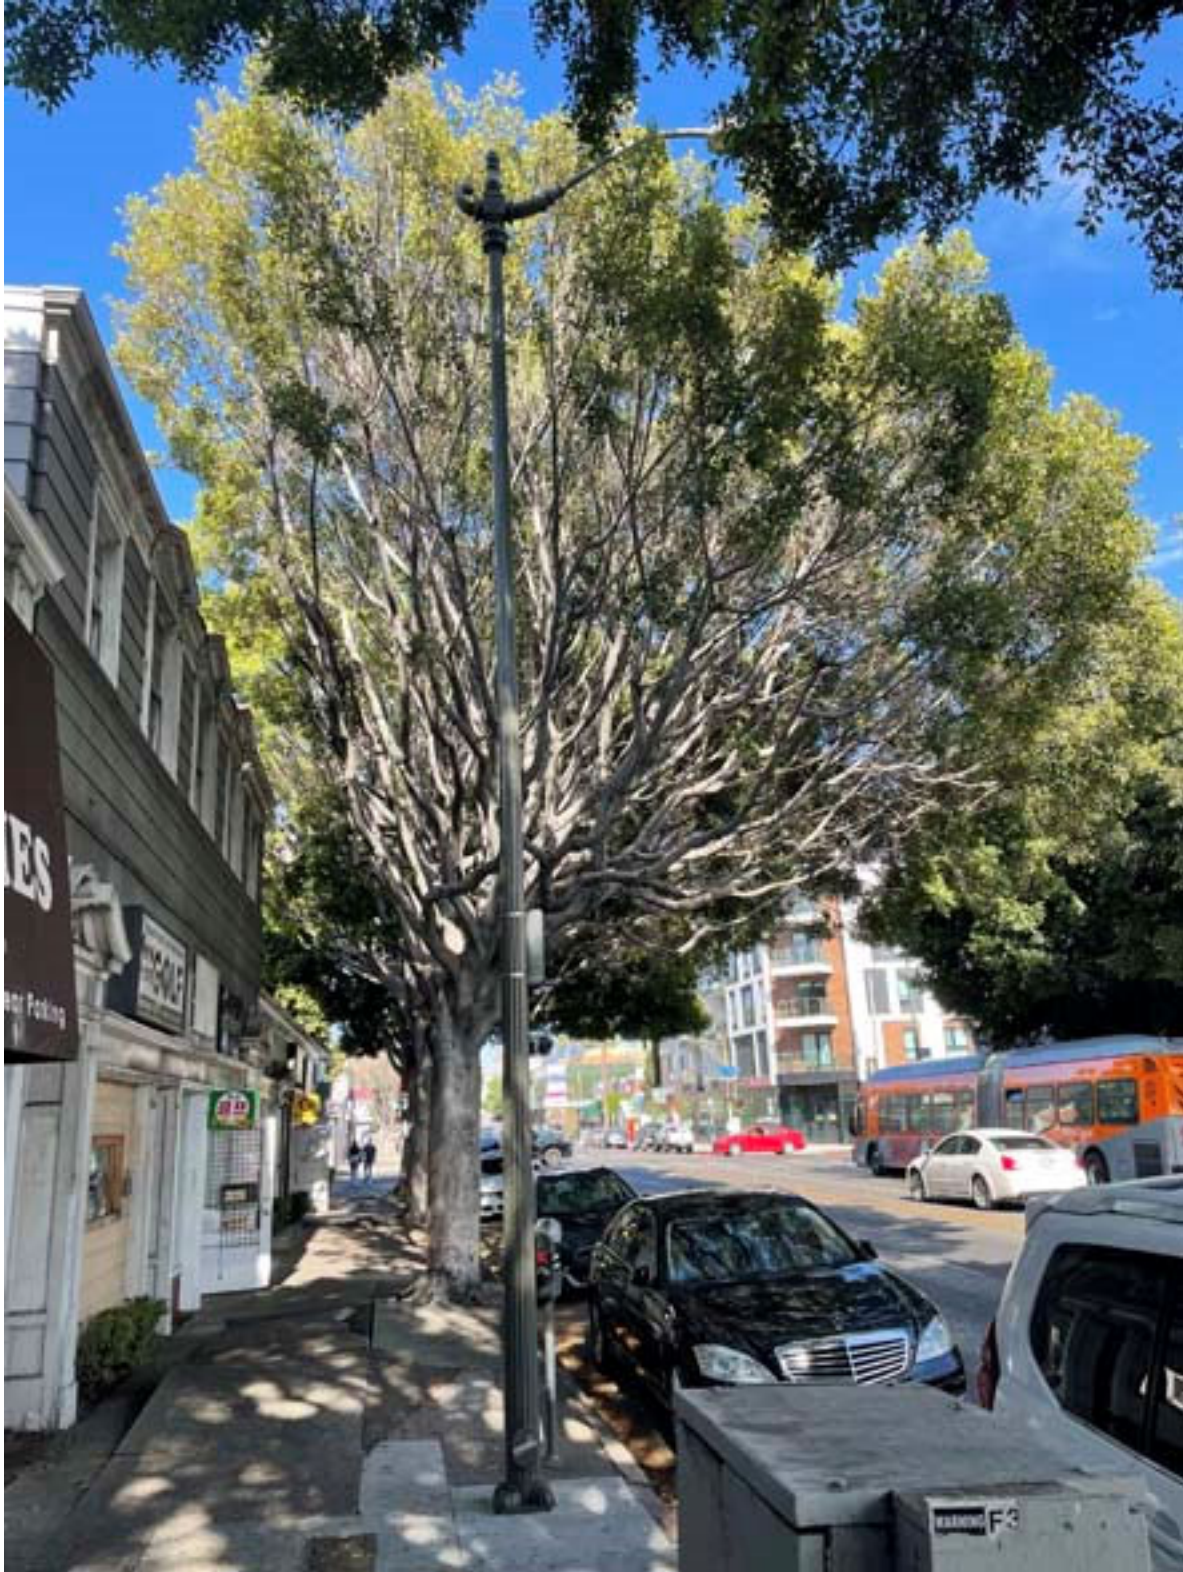
**Figure 9:** Tree 9

<p><b>Tree 9</b>  <i>Ficus microcarpa</i> – Indian Laurel Fig</p> <p>This tree is a street tree, growing within the public right of way. It will be retained in the landscape through the proposed project.</p> <p>This tree’s interior branches were removed in the past, leaving most of its foliage at the branch tips. The canopy is also thinning due to heat or drought stress. The roots of this tree are lifting the sidewalk.</p> <p>The proposed building and sidewalk repairs will encroach within the critical root zone of this tree. All project activity within the drip line of this tree should be directly supervised by a Certified Arborist. Some of this tree's root system may be impacted, but it is intended to be retained in place throughout the project.</p>

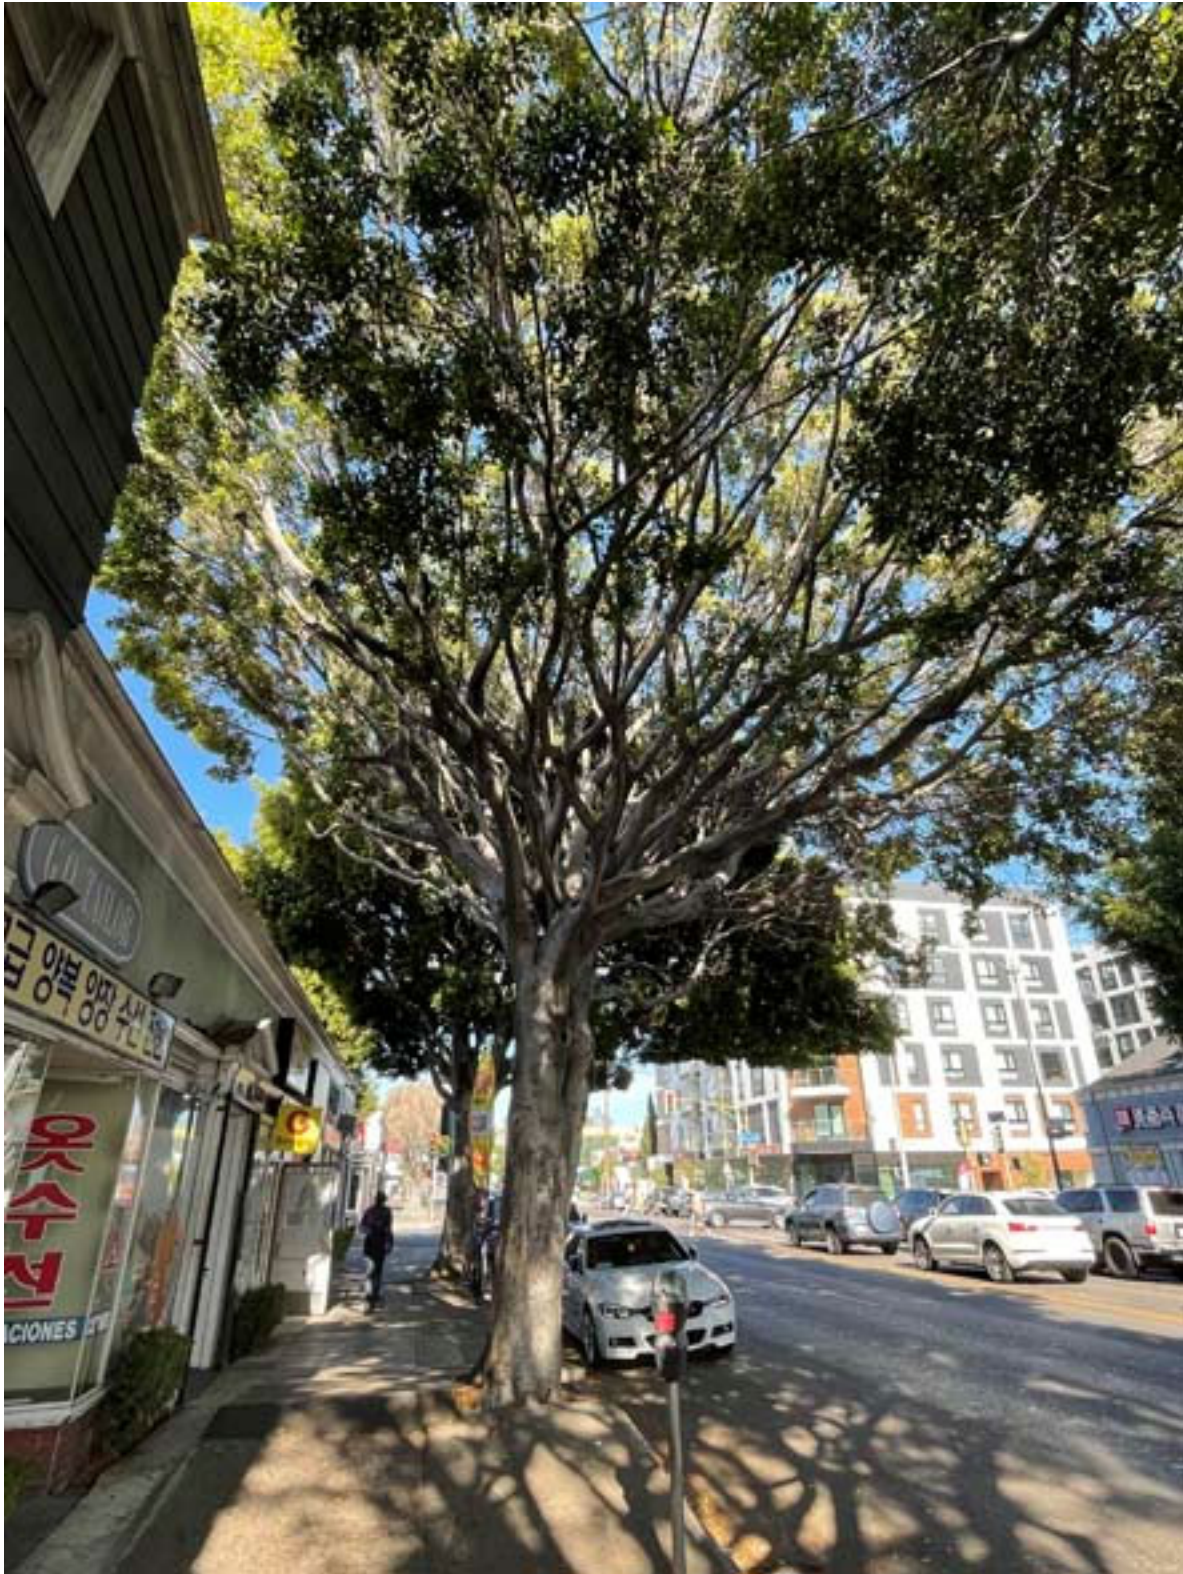
**Figure 10:** Tree 10

<p><b>Tree 10</b>  <i>Ficus microcarpa</i> – Indian Laurel Fig</p> <p>This tree is a street tree, growing within the public right of way. It will be retained in the landscape through the proposed project.</p> <p>This tree’s interior branches were removed in the past, leaving most of its foliage at the branch tips. The canopy is also thinning due to heat or drought stress. The roots of this tree are lifting the sidewalk.</p> <p>The proposed building and sidewalk repairs will encroach within the critical root zone of this tree. All project activity within the drip line of this tree should be directly supervised by a Certified Arborist. Some of this tree's root system may be impacted, but it is intended to be retained in place throughout the project.</p>

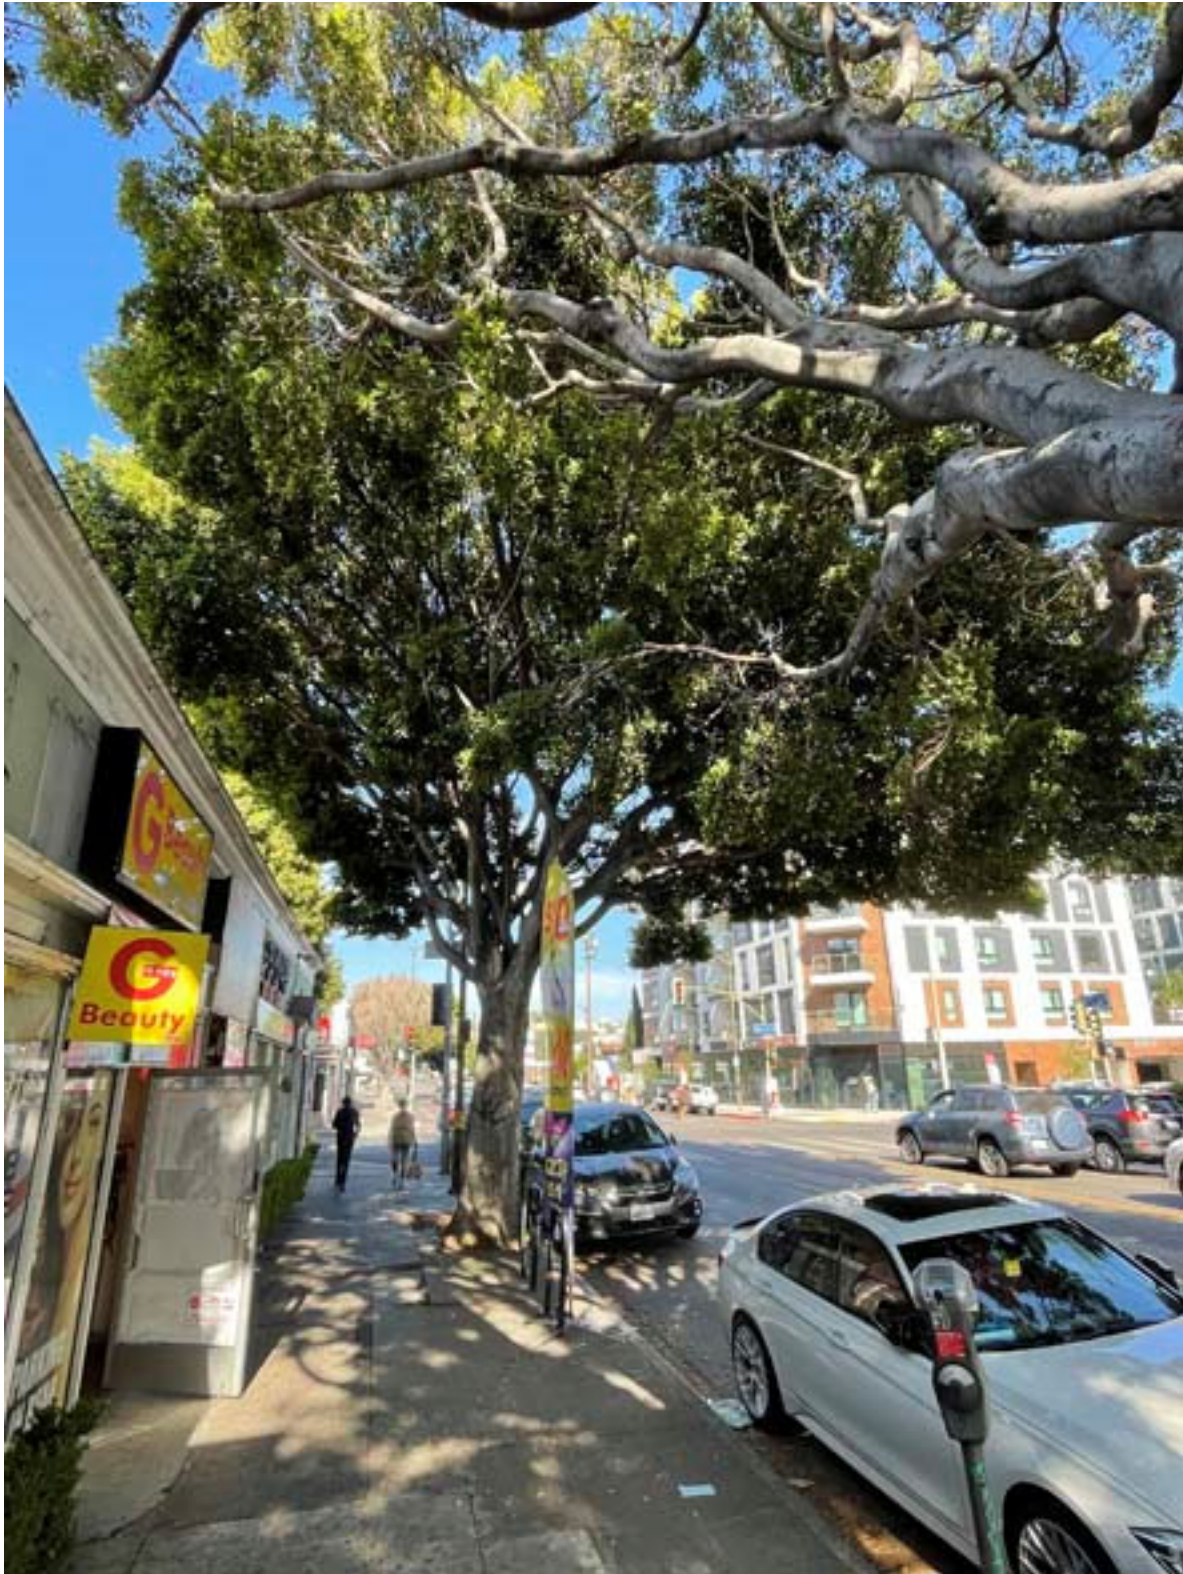
**Figure 11:** Tree 11

<p><b>Tree 11</b>  <i>Ficus microcarpa</i> – Indian Laurel Fig</p> <p>This tree is a street tree, growing within the public right of way. It will be retained in the landscape through the proposed project.</p> <p>This tree is currently lifting the sidewalk. Its canopy is healthy.</p> <p>The proposed building and sidewalk repairs will encroach within the critical root zone of this tree. All project activity within the drip line of this tree should be directly supervised by a Certified Arborist. Some of this tree's root system may be impacted, but it is intended to be retained in place throughout the project.</p>
