# 3433 W. 8th St. Arborist Report

Prepared for CORBeL Architects Inc.  
Mick Myungsik Choi  
3450 Wilshire Blvd., Suite 1000  
Los Angeles, CA 90010

**Prepared by James Komen**  
BCMA WE-9909B  
RCA #555

Mick Myungsik Choi of CORBeL Architects Inc. asked me to prepare a Protected Tree Report for the City of Los Angeles Urban Forestry Department documenting the trees on a property proposed for development. I visited the subject property alone on July 2, 2021 at 3:30pm to collect the data for this report.

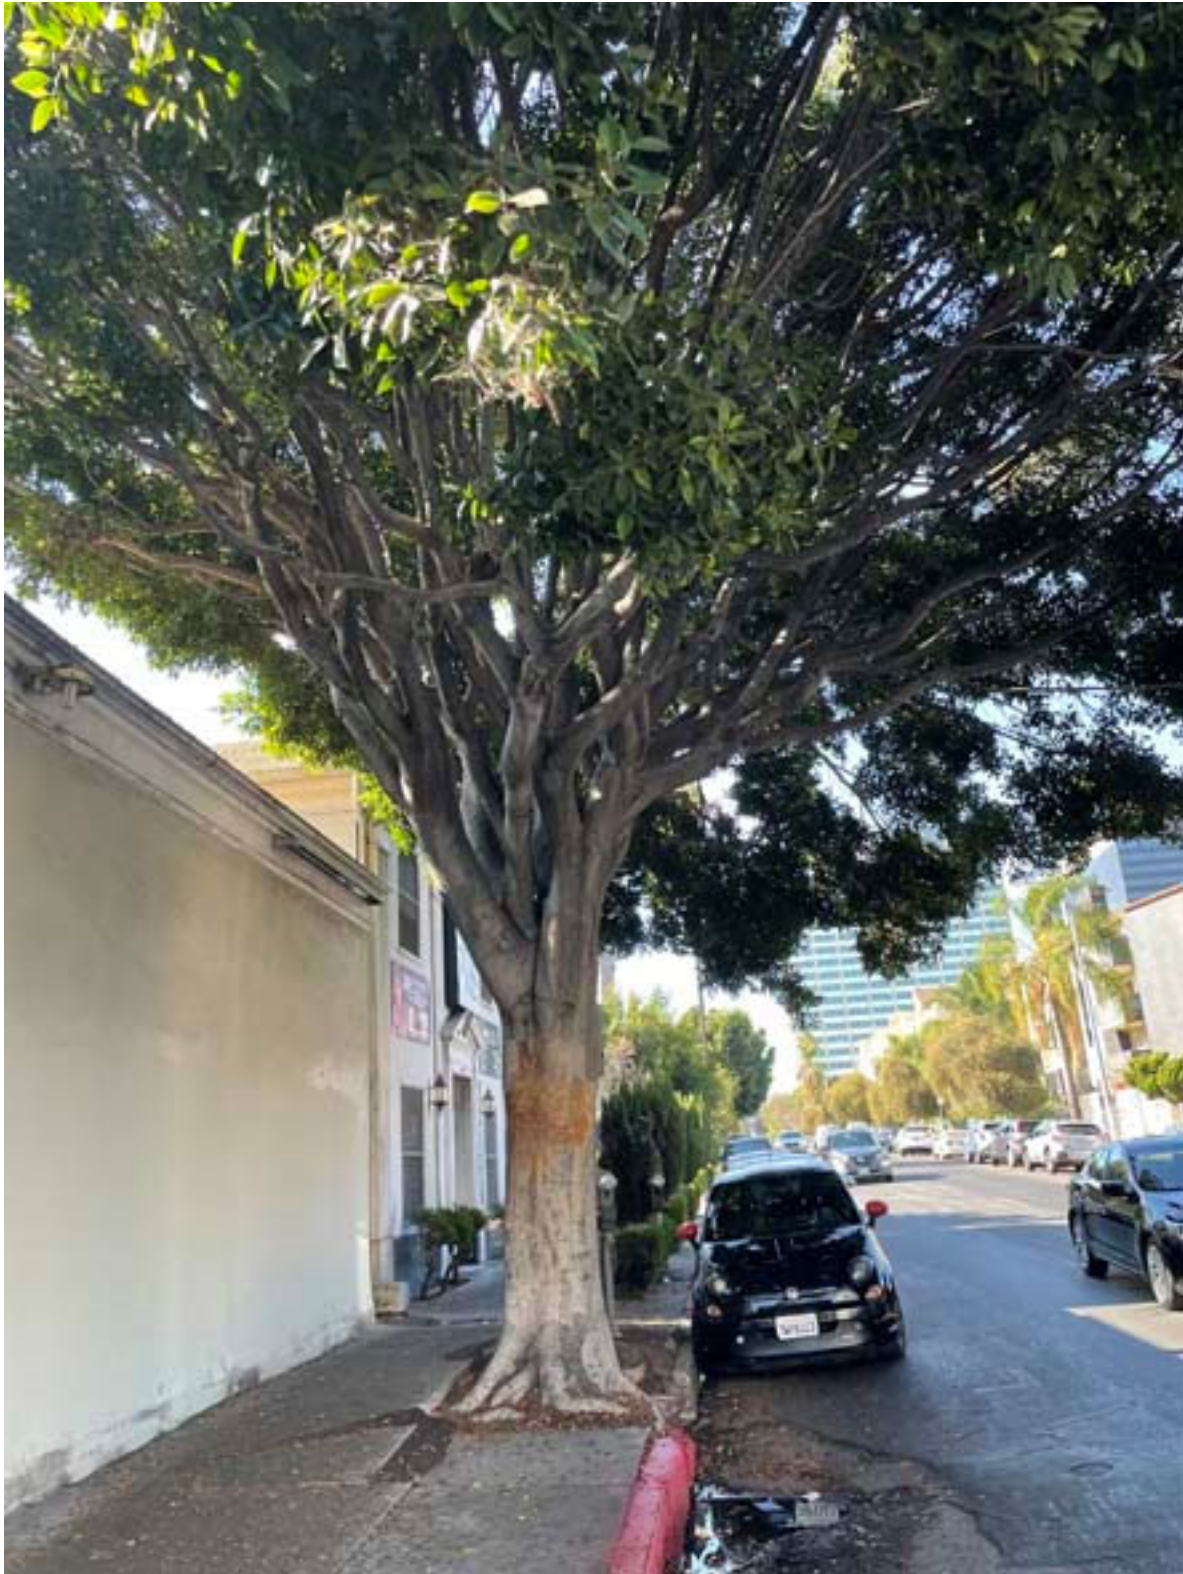
**Figure 12:** Tree 12

<p><b>Tree 12</b>  <i>Ficus microcarpa</i> – Indian Laurel Fig</p> <p>This tree is a street tree, growing within the public right of way. It will be retained in the landscape through the proposed project.</p> <p>This tree is currently lifting the sidewalk. Its canopy is healthy.</p> <p>The proposed building and sidewalk repairs will encroach within the critical root zone of this tree. All project activity within the drip line of this tree should be directly supervised by a Certified Arborist. Some of this tree's root system may be impacted, but it is intended to be retained in place throughout the project.</p>

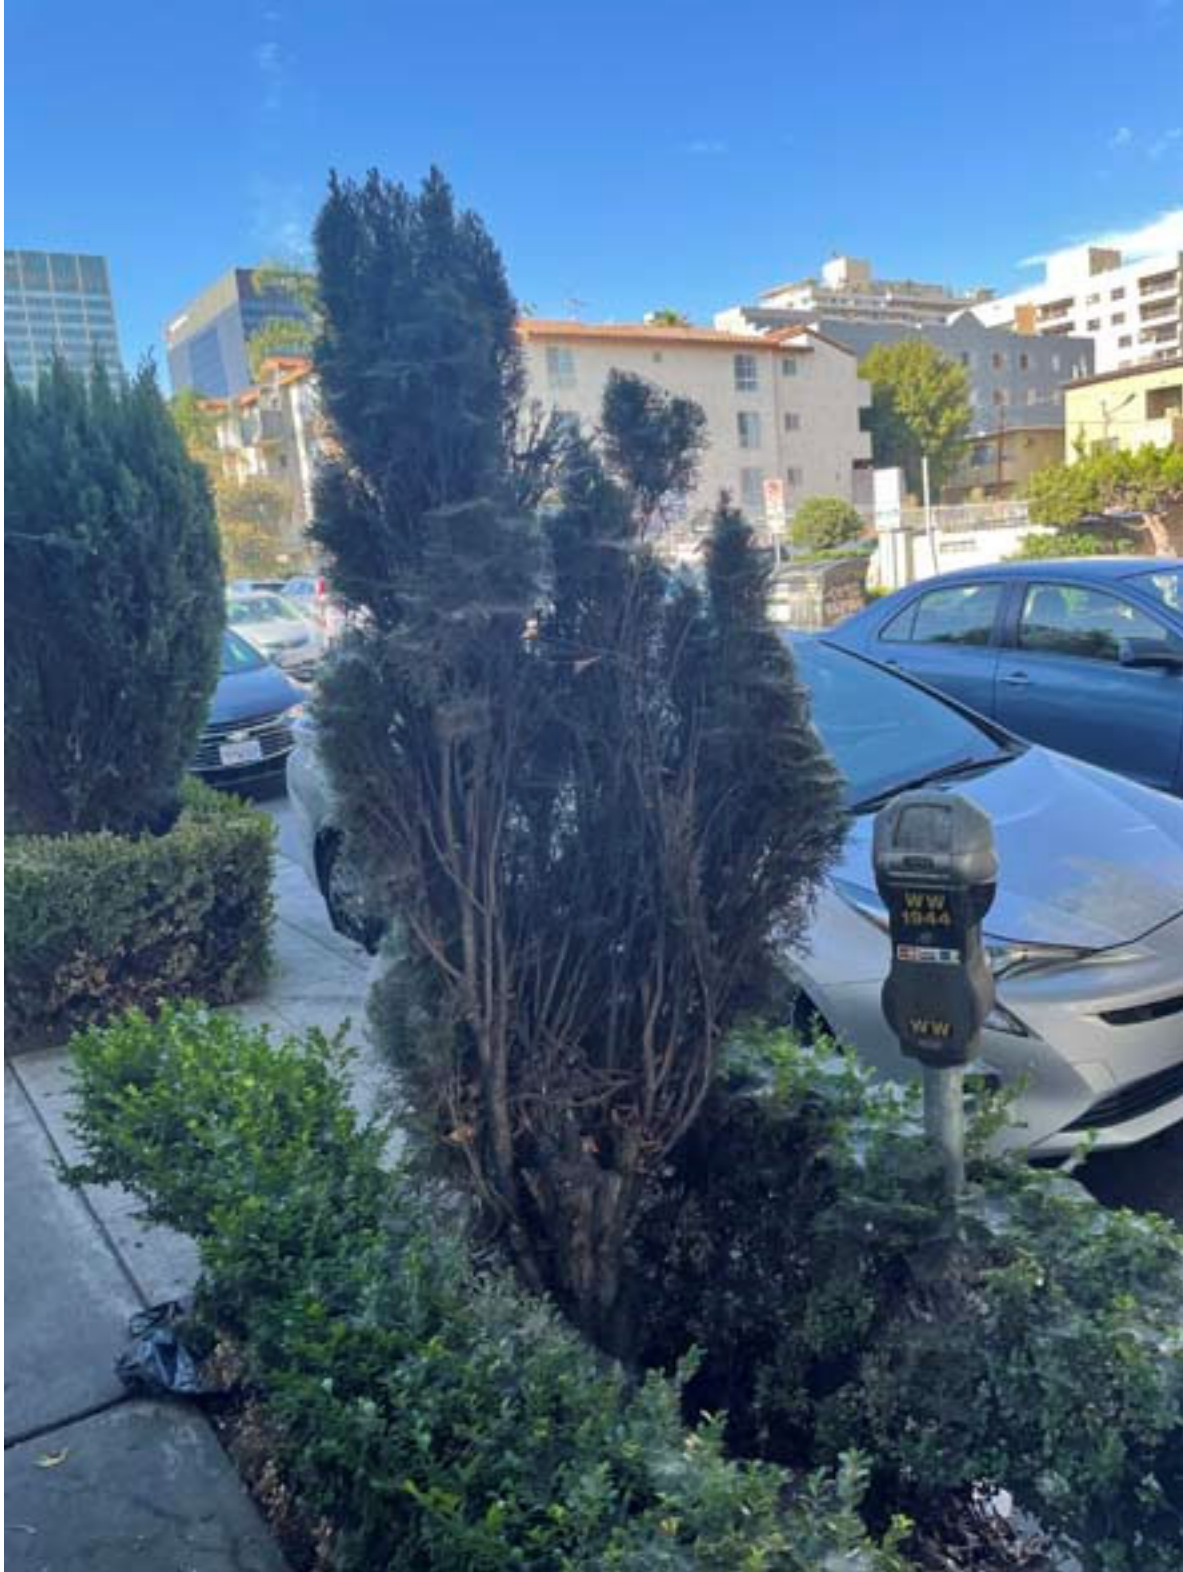
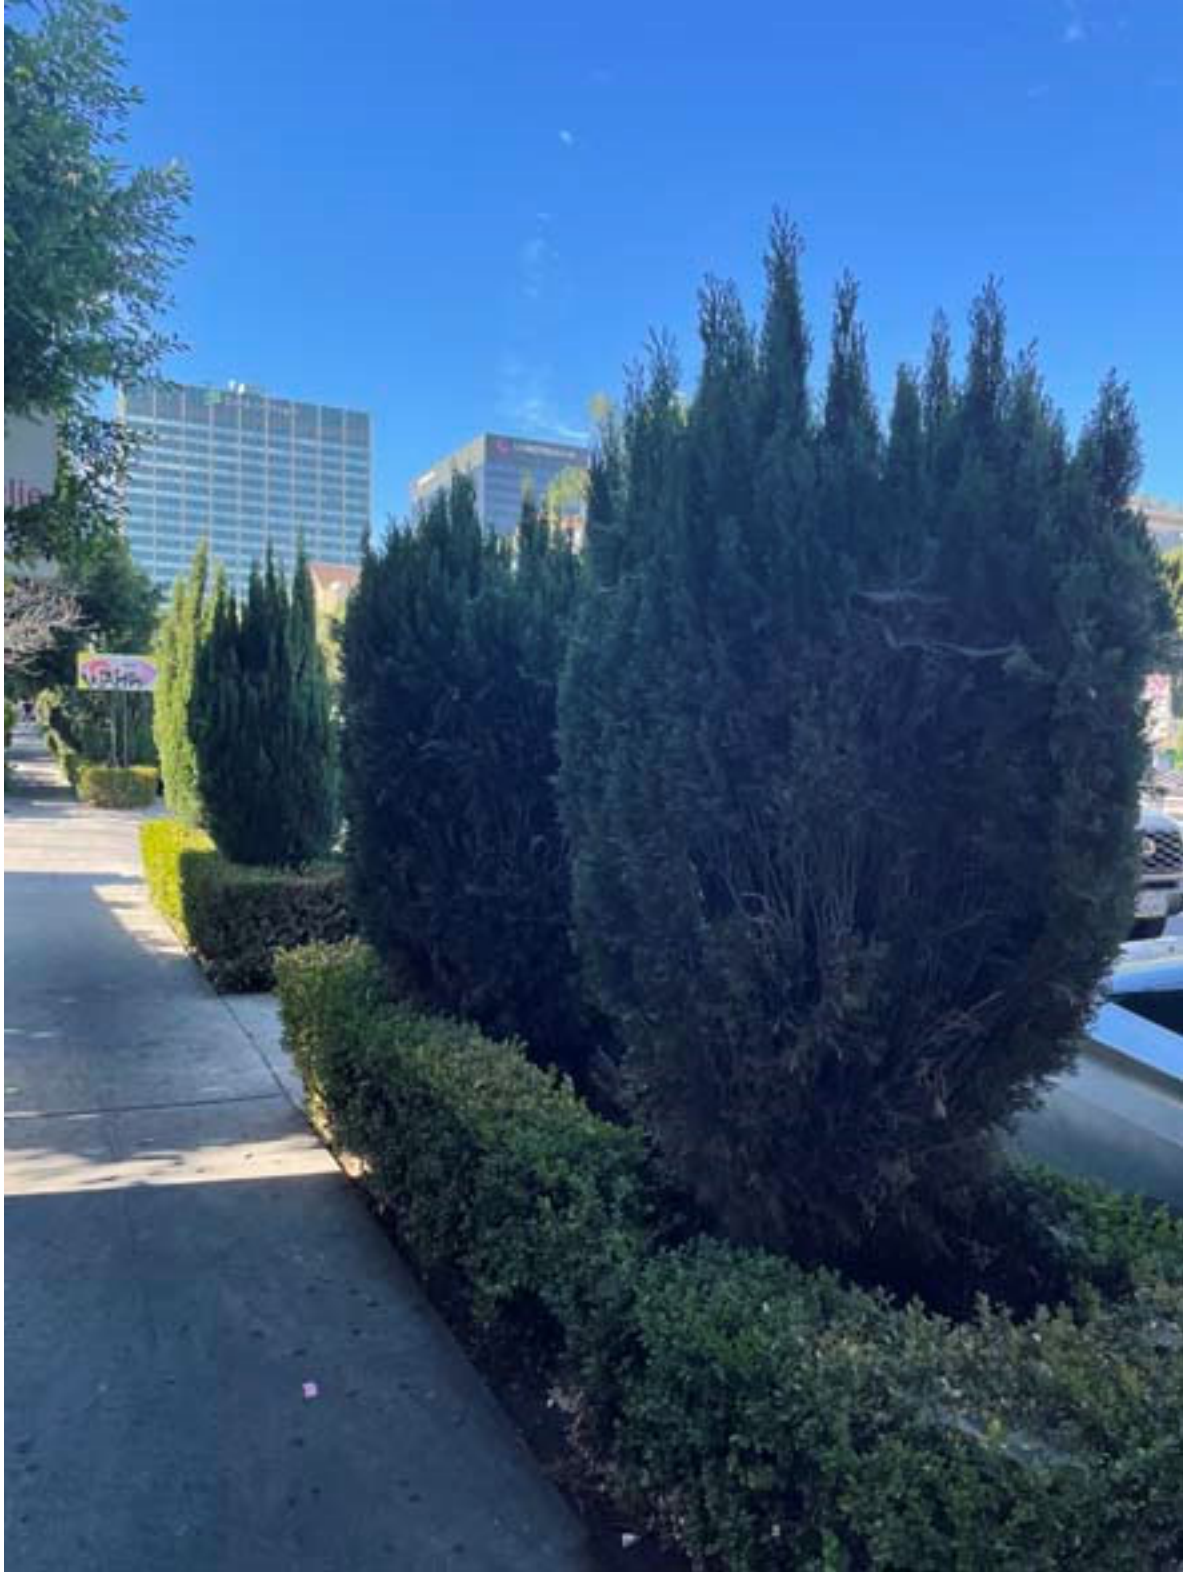
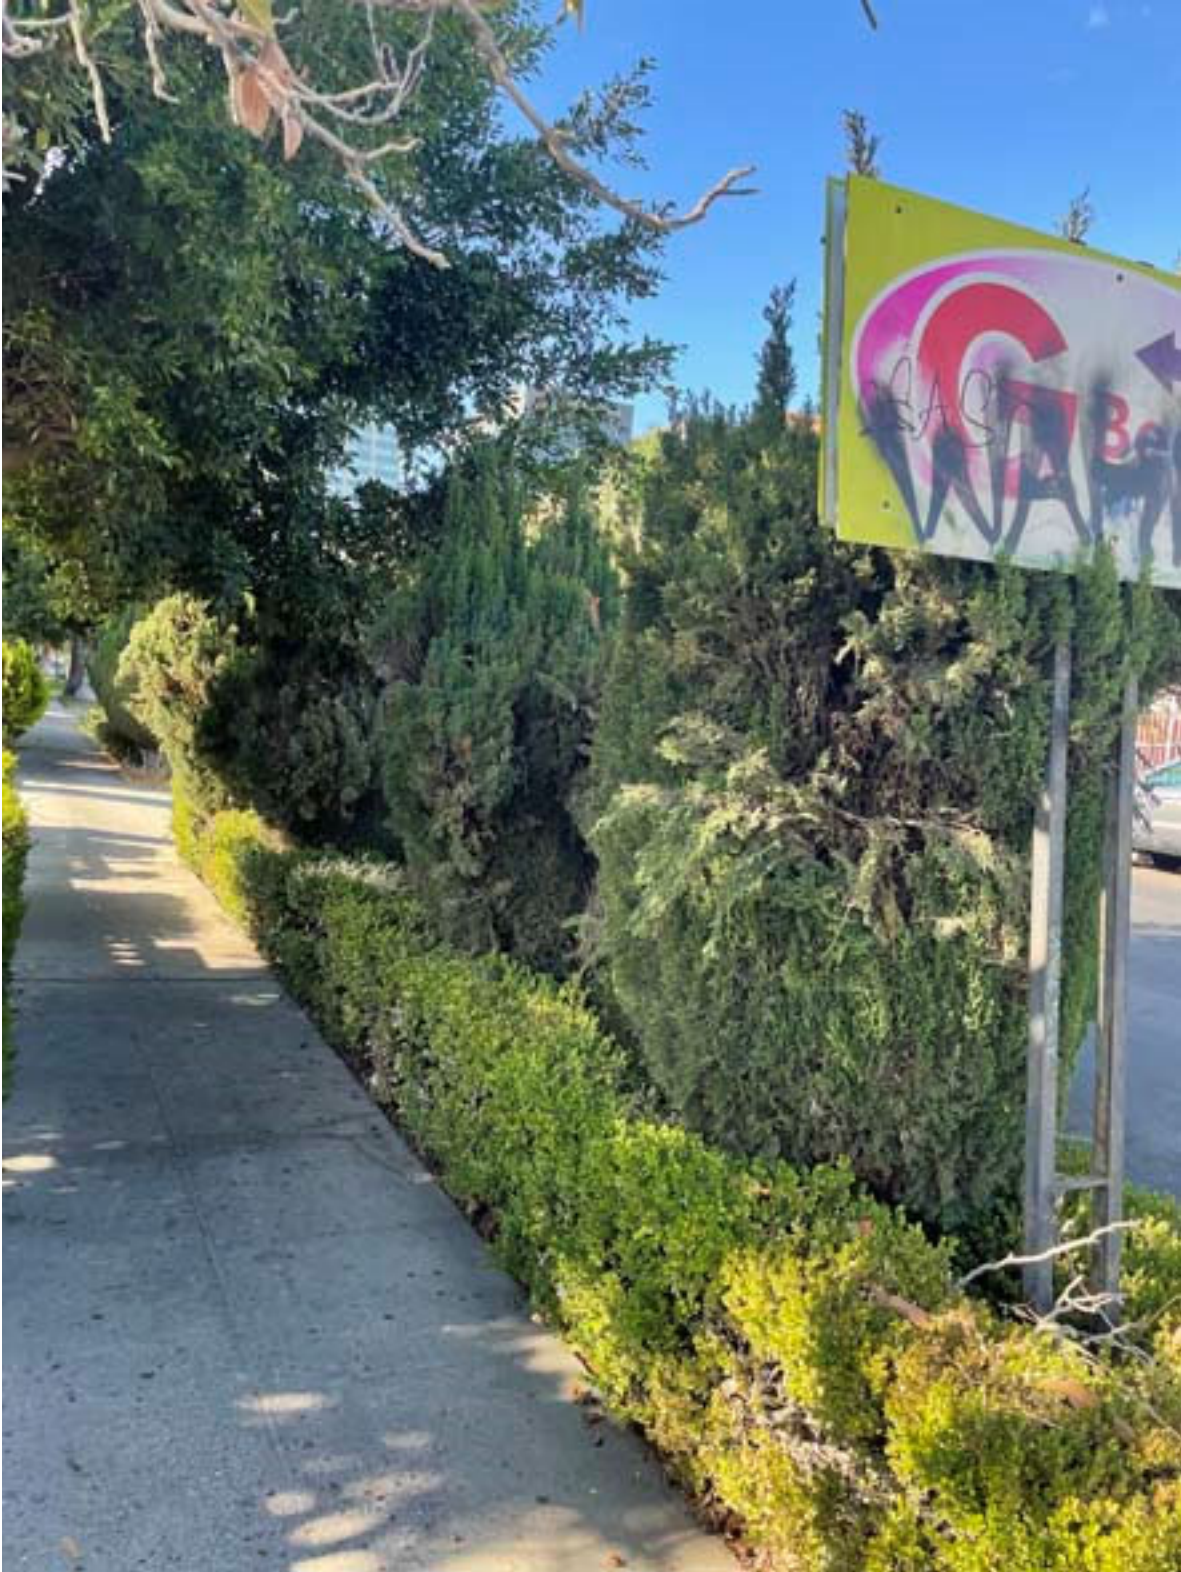
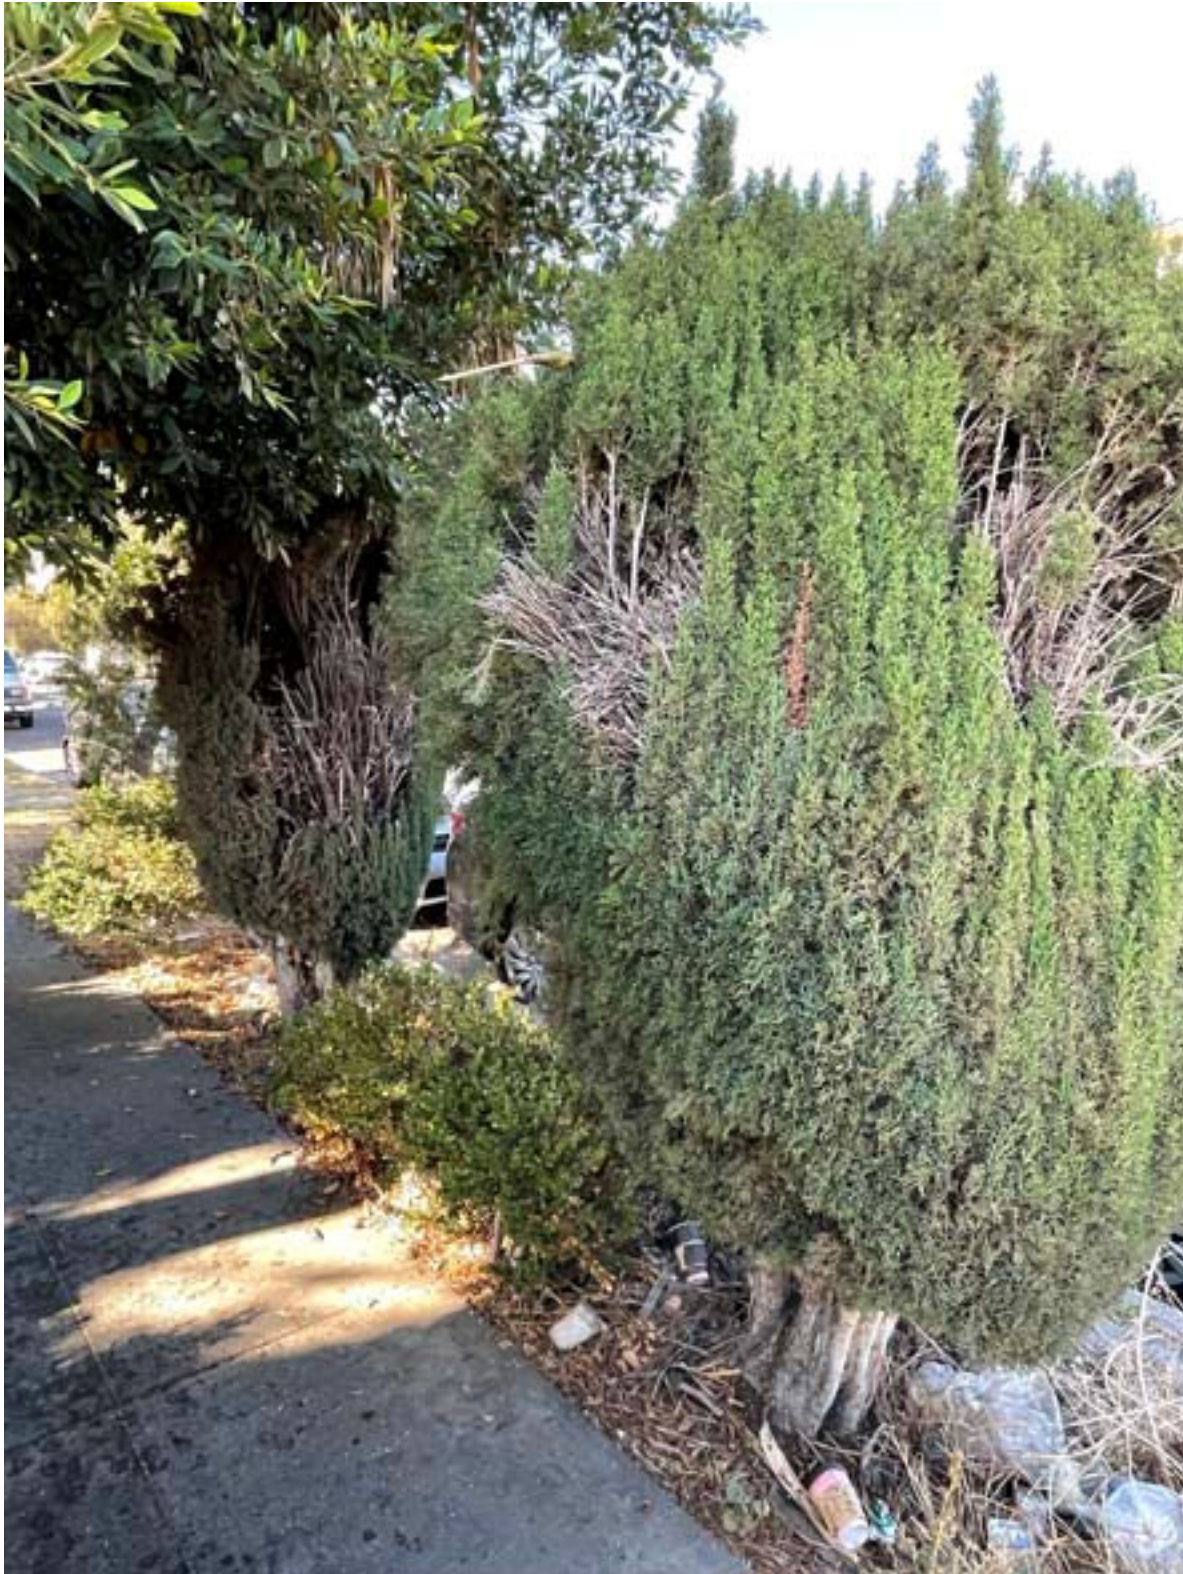
Tree 13 was topped at two feet above grade, but it is still alive. Trees 14-23 were topped at a height of seven feet above grade, but they are still vigorous. I observed spider webs in their canopies that I recommend brushing off for aesthetics.

The proposed sidewalk repairs will encroach within the critical root zones of these trees. All project activity within 5 feet of these trees should be directly supervised by a Certified Arborist. Some of these trees' root systems may be impacted, but they are intended to be retained in place throughout the project.

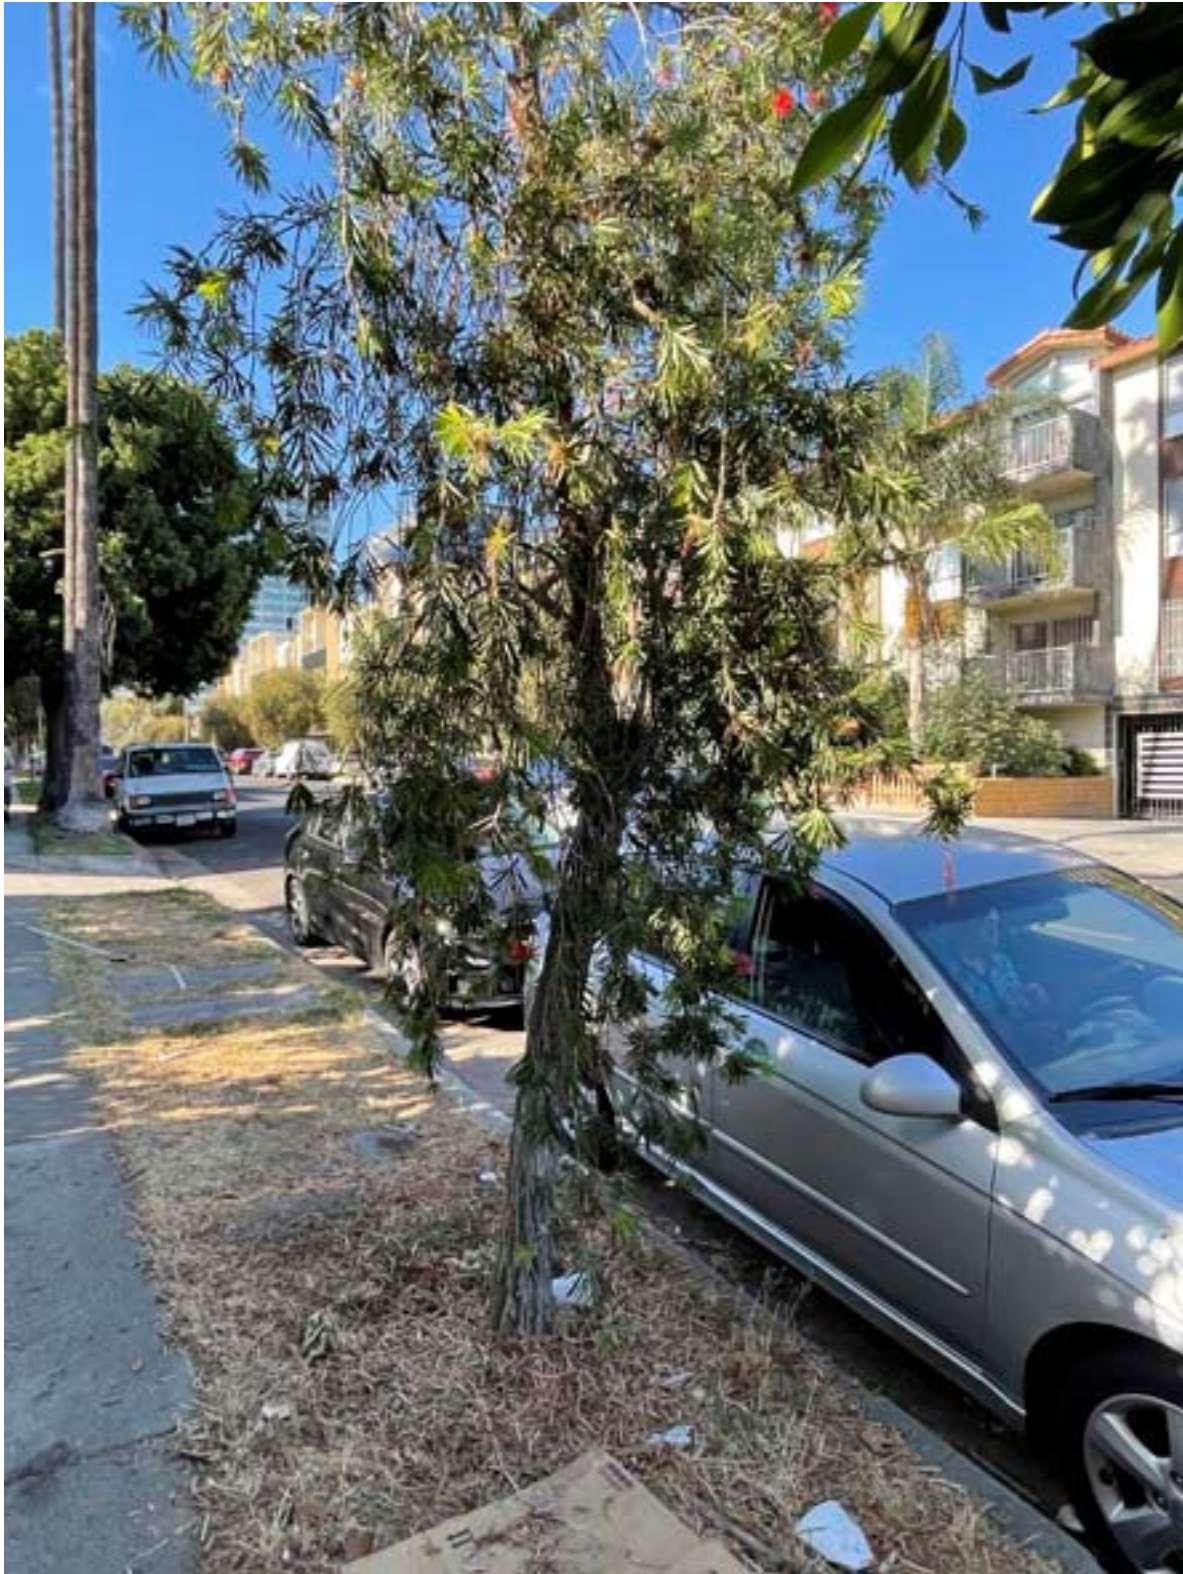
**Figure 17: Tree 24**

<p><b>Tree 24</b>  <i>Callistemon viminalis</i> – Weeping Bottlebrush</p> <p>This tree is a street tree, growing within the public right of way. It will be retained in the landscape through the proposed project.</p> <p>This tree is healthy. No treatment is recommended.</p> <p>The proposed sidewalk repairs will encroach within the critical root zone of this tree. All project activity within 8 feet of this tree should be directly supervised by a Certified Arborist. Some of this tree's root system may be impacted, but it is intended to be retained in place throughout the project.</p>

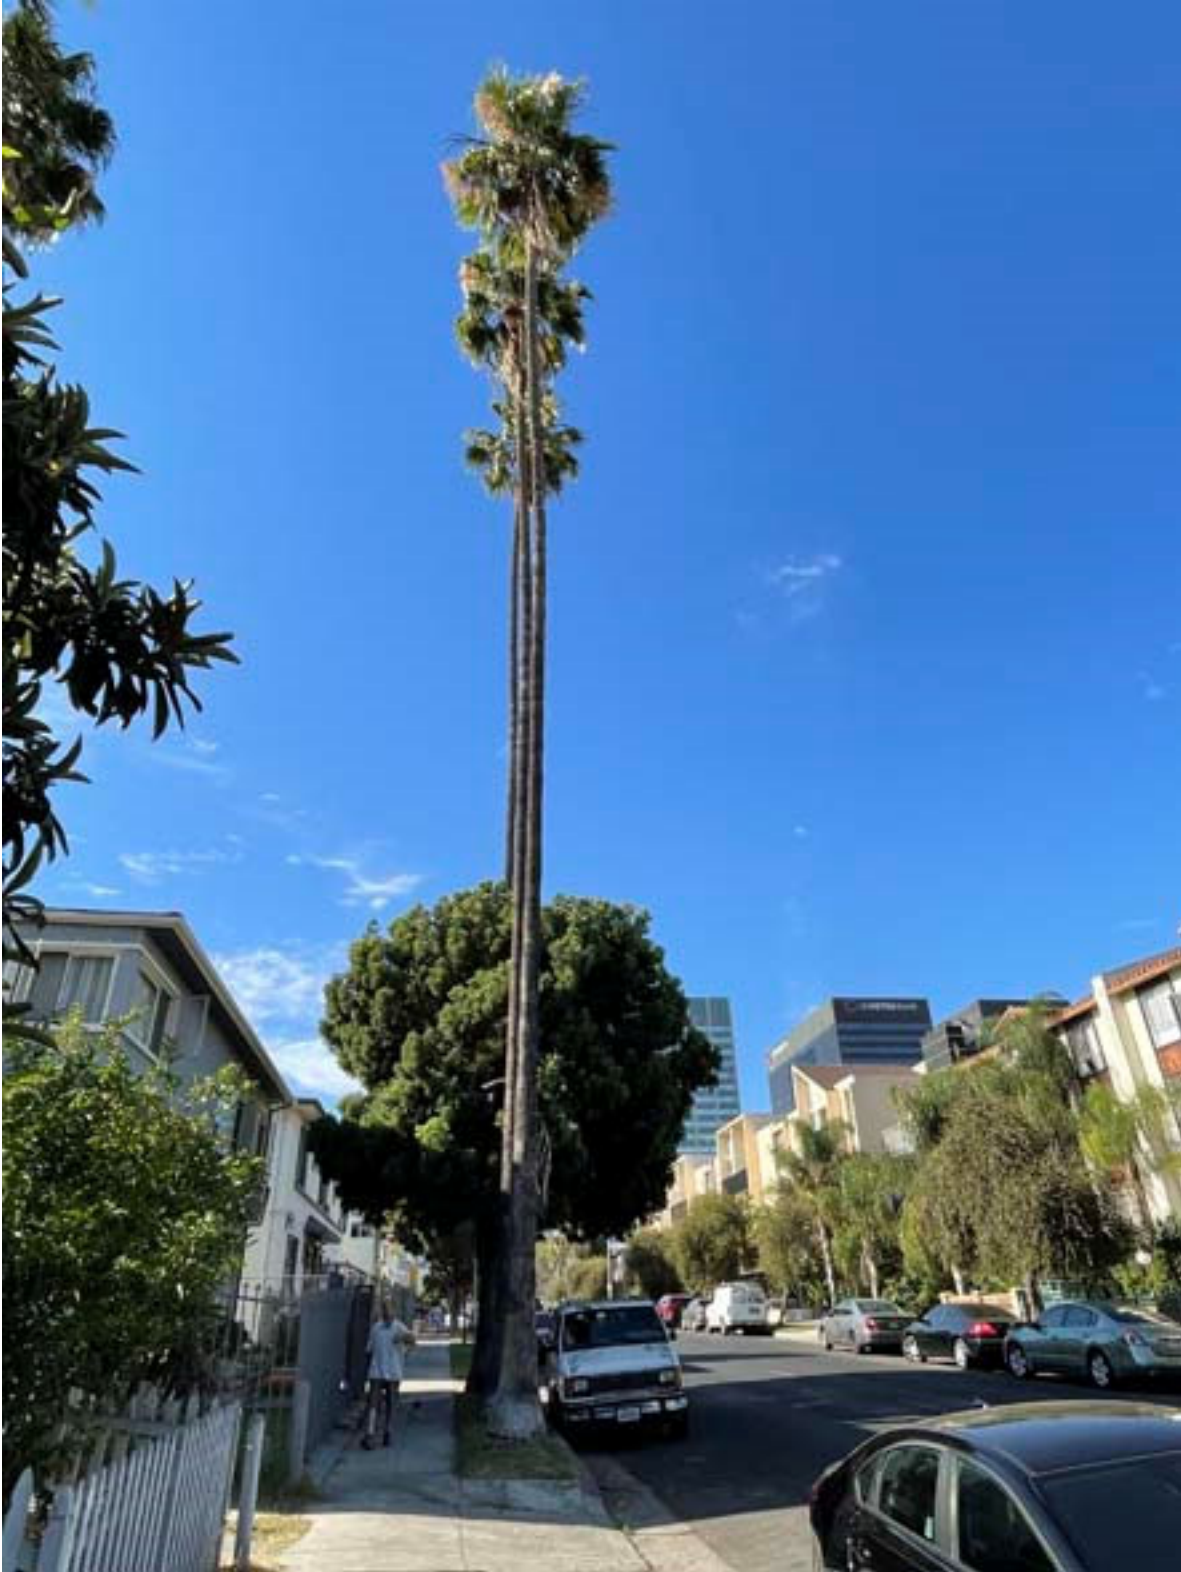
**Figure 18:** Tree OP25

<p><b>Tree OP25</b>  <i>Washingtonia robusta</i> – Mexican Fan Palm</p> <p>This tree is a street tree, growing within the public right of way in front of an adjacent property to the north. It will be retained in the landscape through the proposed project.</p> <p>This tree is healthy. No treatment is recommended.</p> <p>This tree is far enough from the proposed sidewalk repairs that it will not likely be significantly impacted.</p>

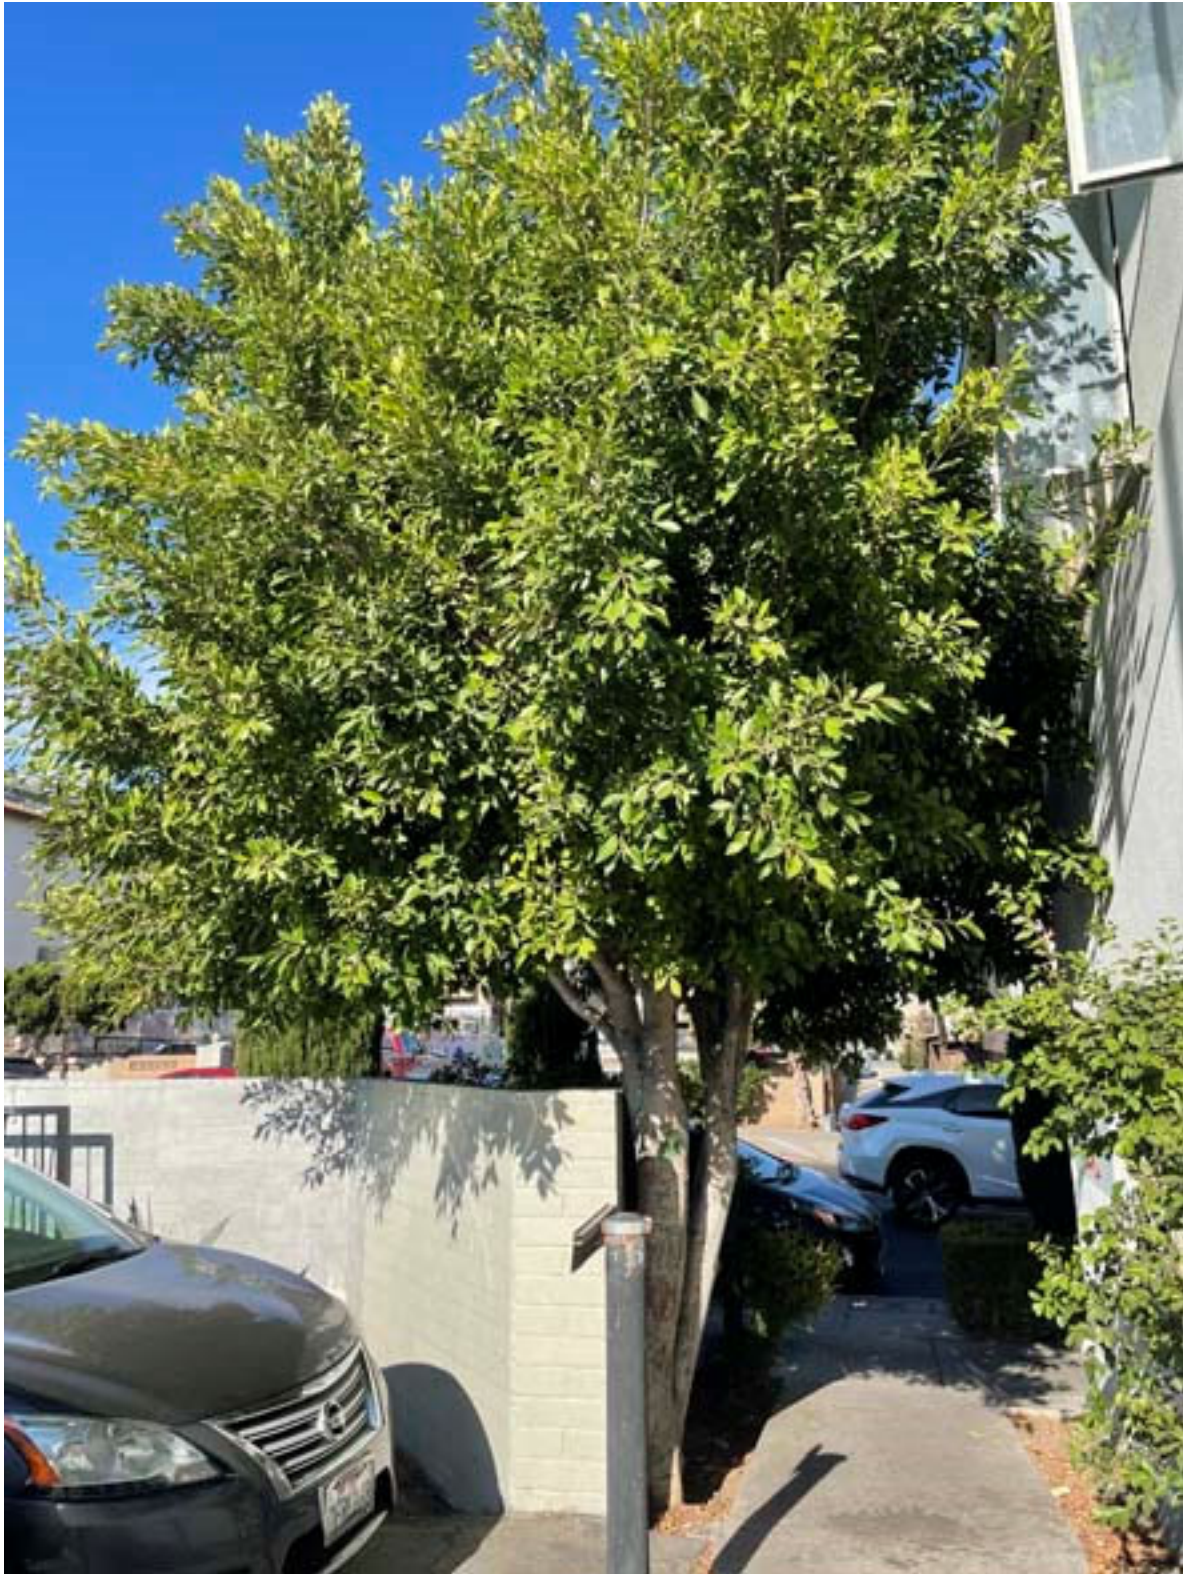
**Figure 19: Tree 26**

This tree has one dead branch that was partially cut at one time. However, the branch had pleached into another branch, and the half-severed branch was left to remain as an oddity in the scaffold of the tree.

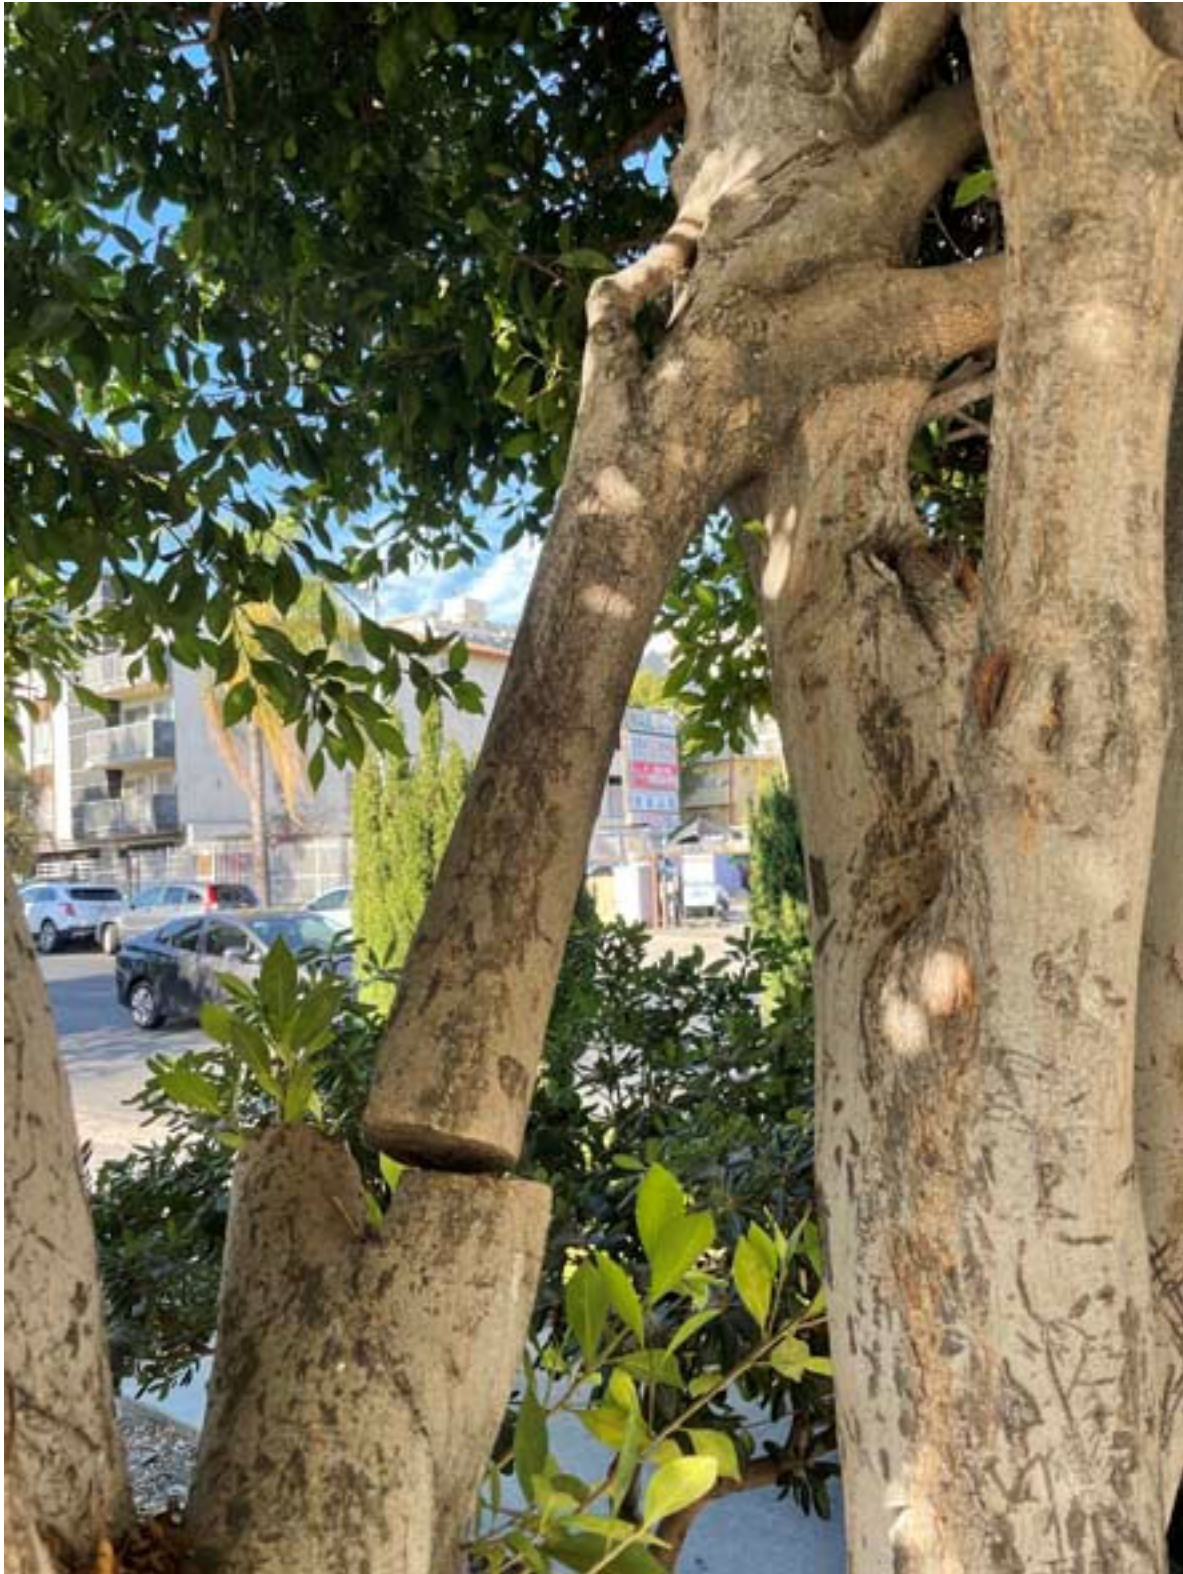
**Figure 20:** Close up of the severed branch on Tree 26 (foreground, left) that pleached into its trunk (right).

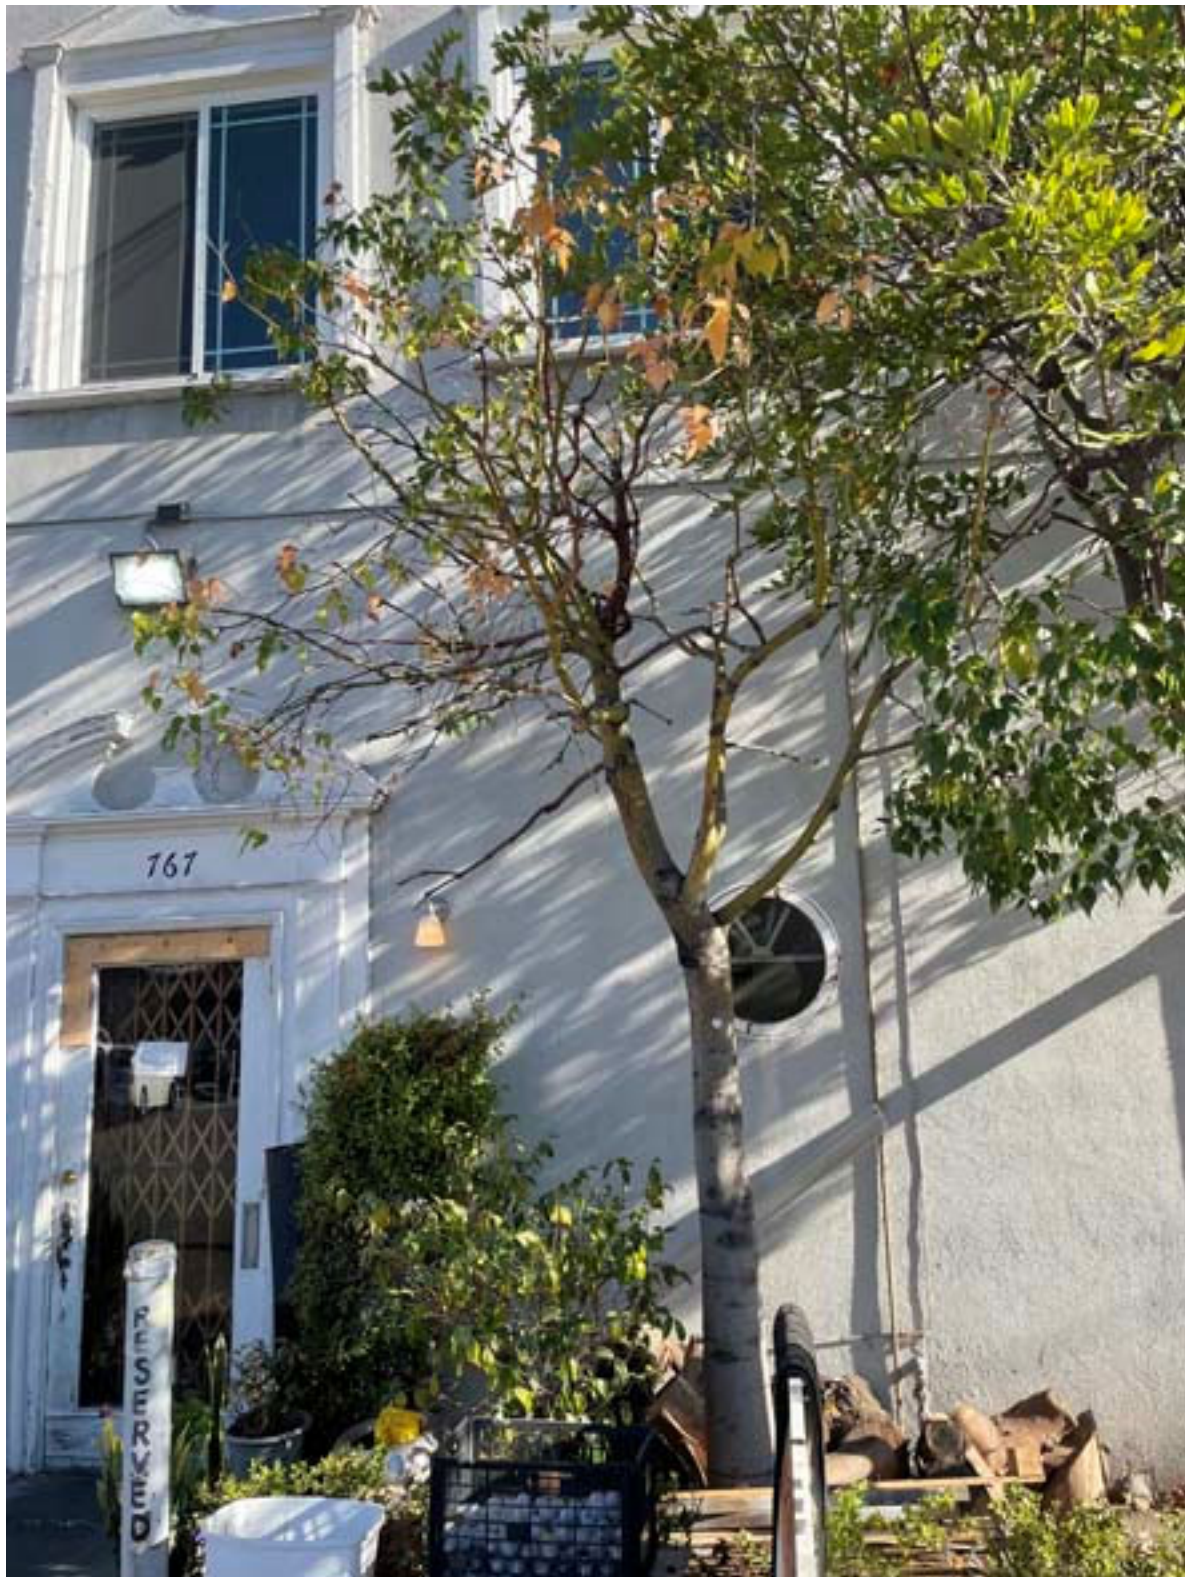
**Figure 21:** Tree 27

This tree is nearly dead due to heat and drought stress.

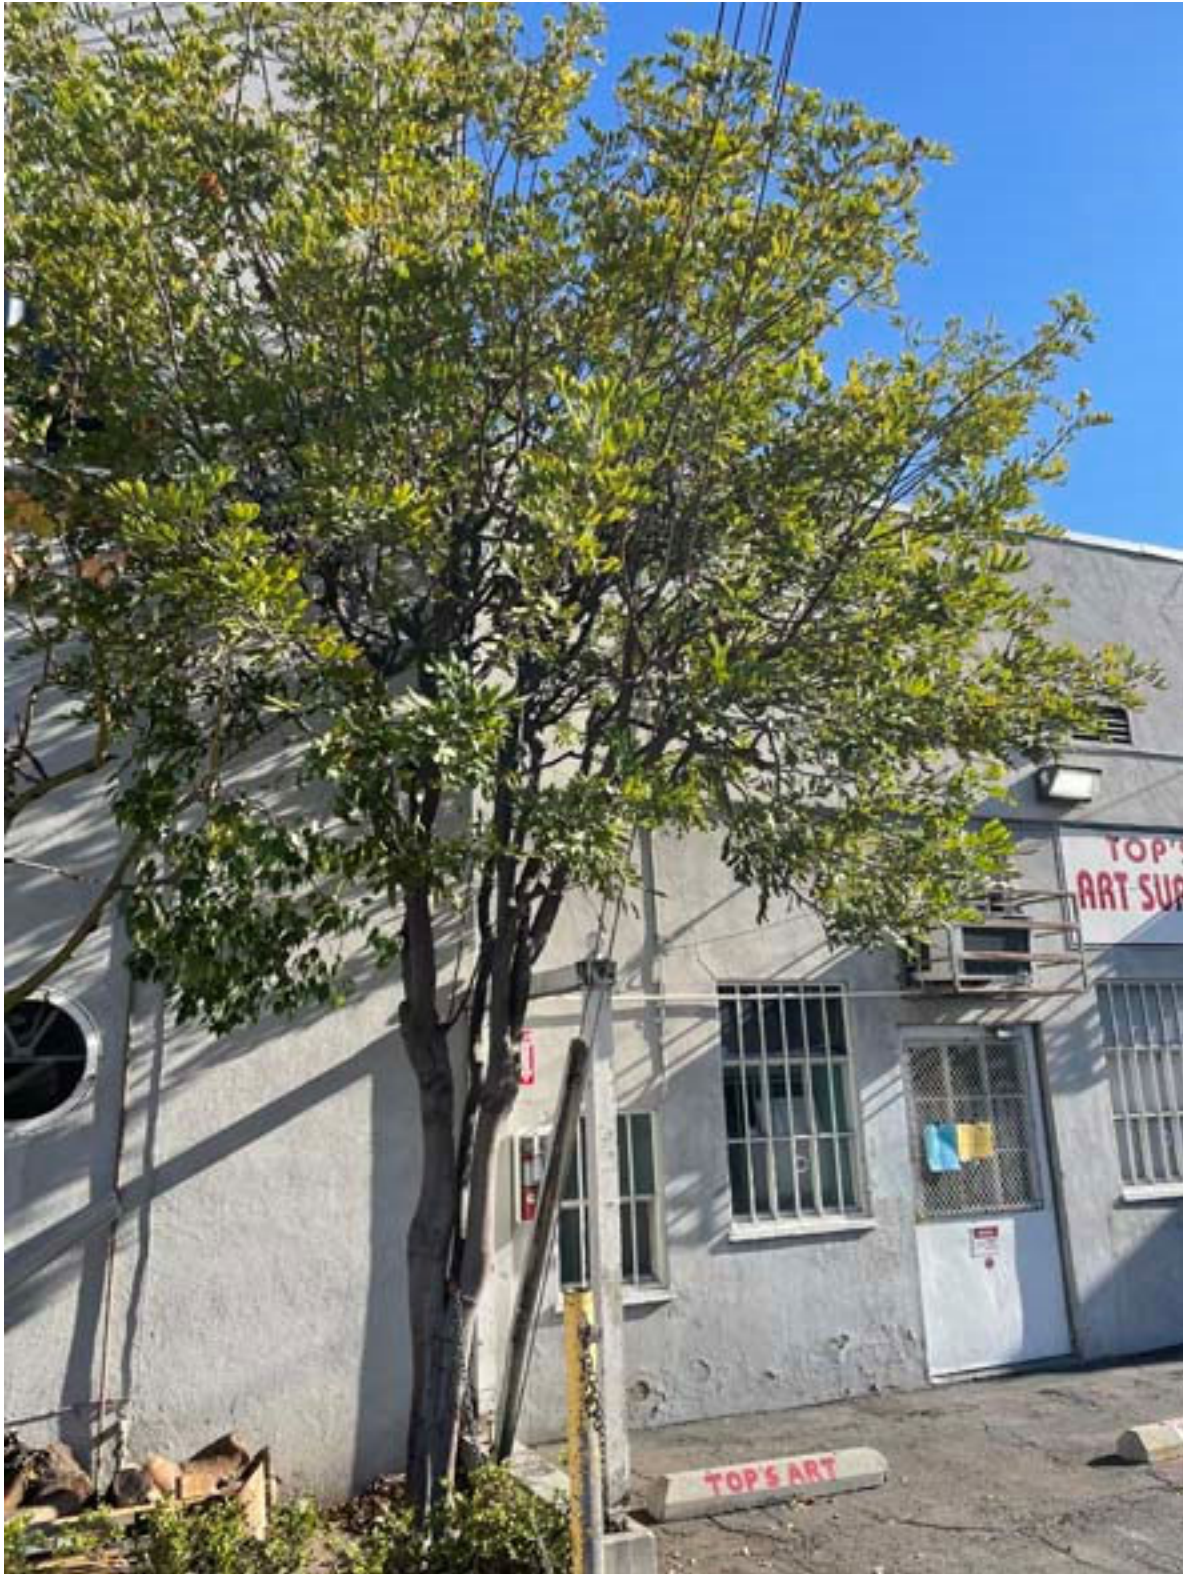
**Figure 22:** Tree 28

<p><b>Tree 28</b>  <i>Cupaniopsis anacardioides</i> – Carrotwood</p> <p>This tree is not protected by ordinance. It will be removed because it is growing within the footprint of the proposed building.</p> <p>This tree has a thinning canopy due to heat stress. Despite this, it is still in good condition.</p>
