# 3433 W. 8th St. Arborist Report

Prepared for CORBeL Architects Inc.  
Mick Myungsik Choi  
3450 Wilshire Blvd., Suite 1000  
Los Angeles, CA 90010

**Prepared by James Komen**  
BCMA WE-9909B  
RCA #555

Mick Myungsik Choi of CORBeL Architects Inc. asked me to prepare a Protected Tree Report for the City of Los Angeles Urban Forestry Department documenting the trees on a property proposed for development. I visited the subject property alone on July 2, 2021 at 3:30pm to collect the data for this report.

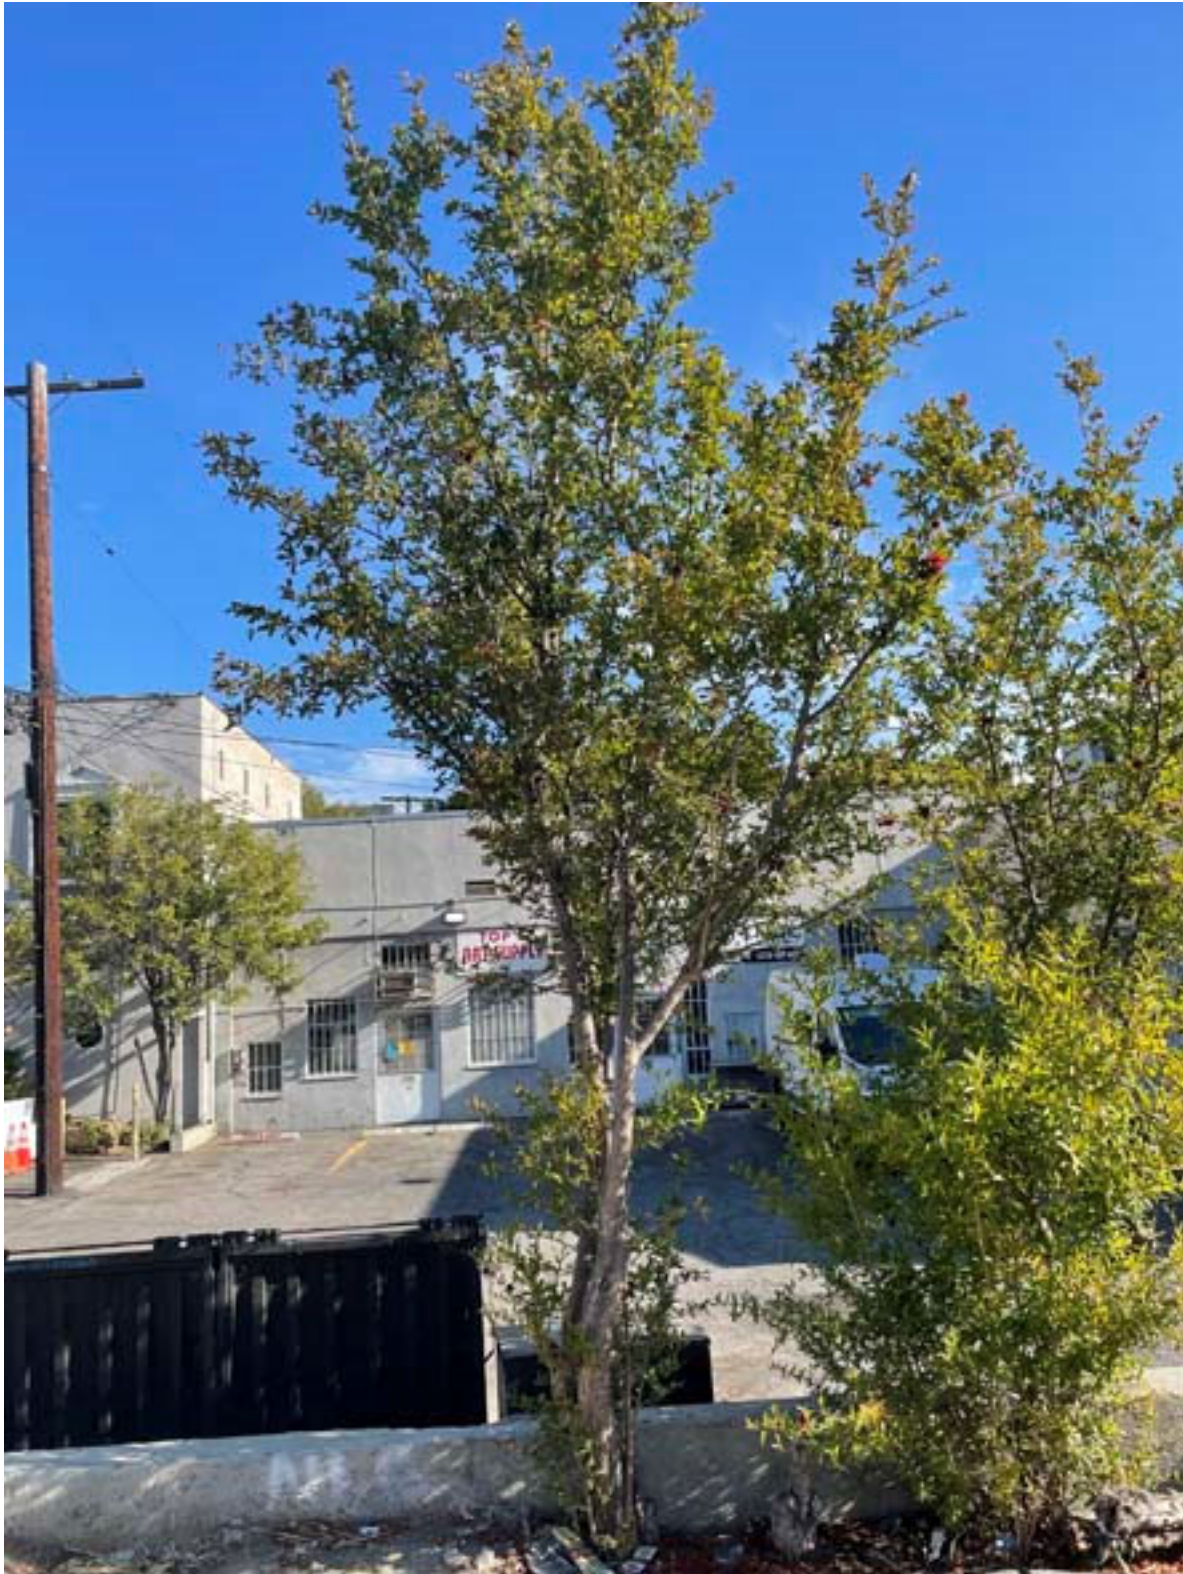
**Figure 23:** Tree 29

<p><b>Tree 29</b>  <i>Punica granatum</i> – Pomegranate</p> <p>This tree is not protected by ordinance. It will be removed because it is growing within the footprint of the proposed building.</p> <p>This tree is healthy, but it has a small root zone. It is in good condition.</p>

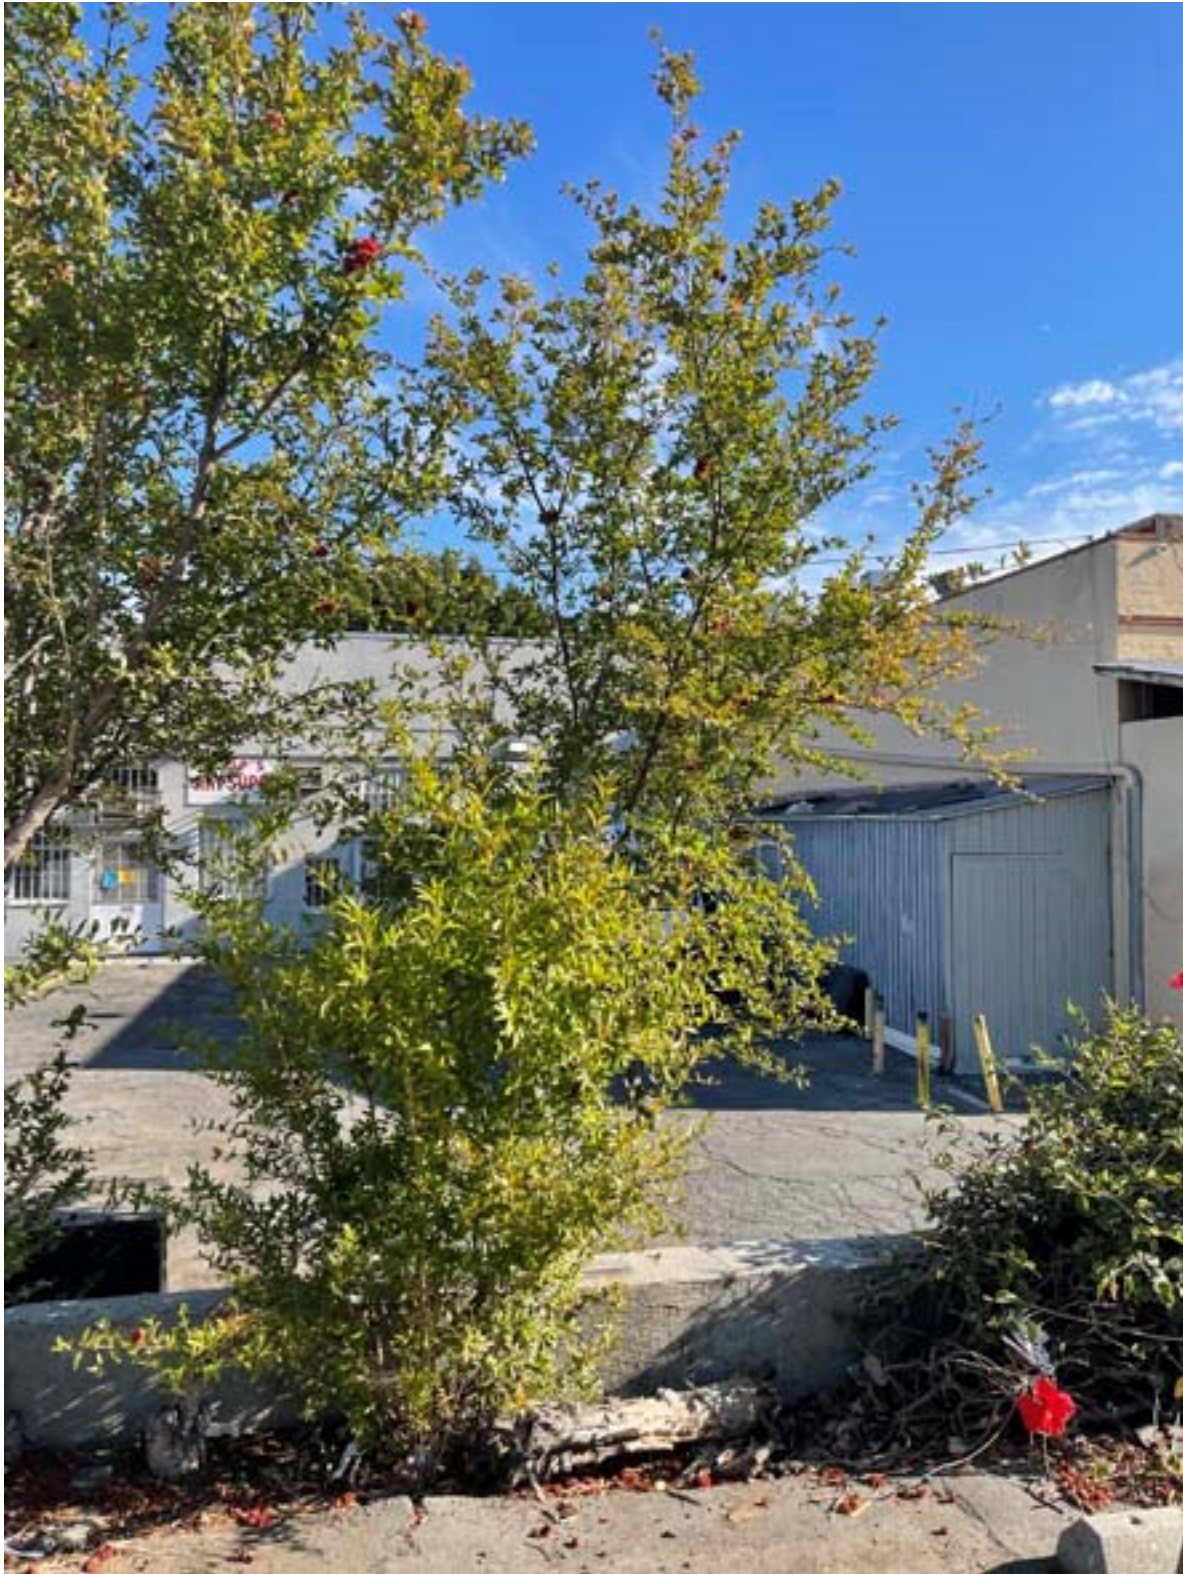
**Figure 24:** Tree 30

<p><b>Tree 30</b>  <i>Punica granatum</i> – Pomegranate</p> <p>This tree is not protected by ordinance. It will be removed because it is growing within the footprint of the proposed building.</p> <p>This tree is healthy, but it has a small root zone. It is in good condition.</p>

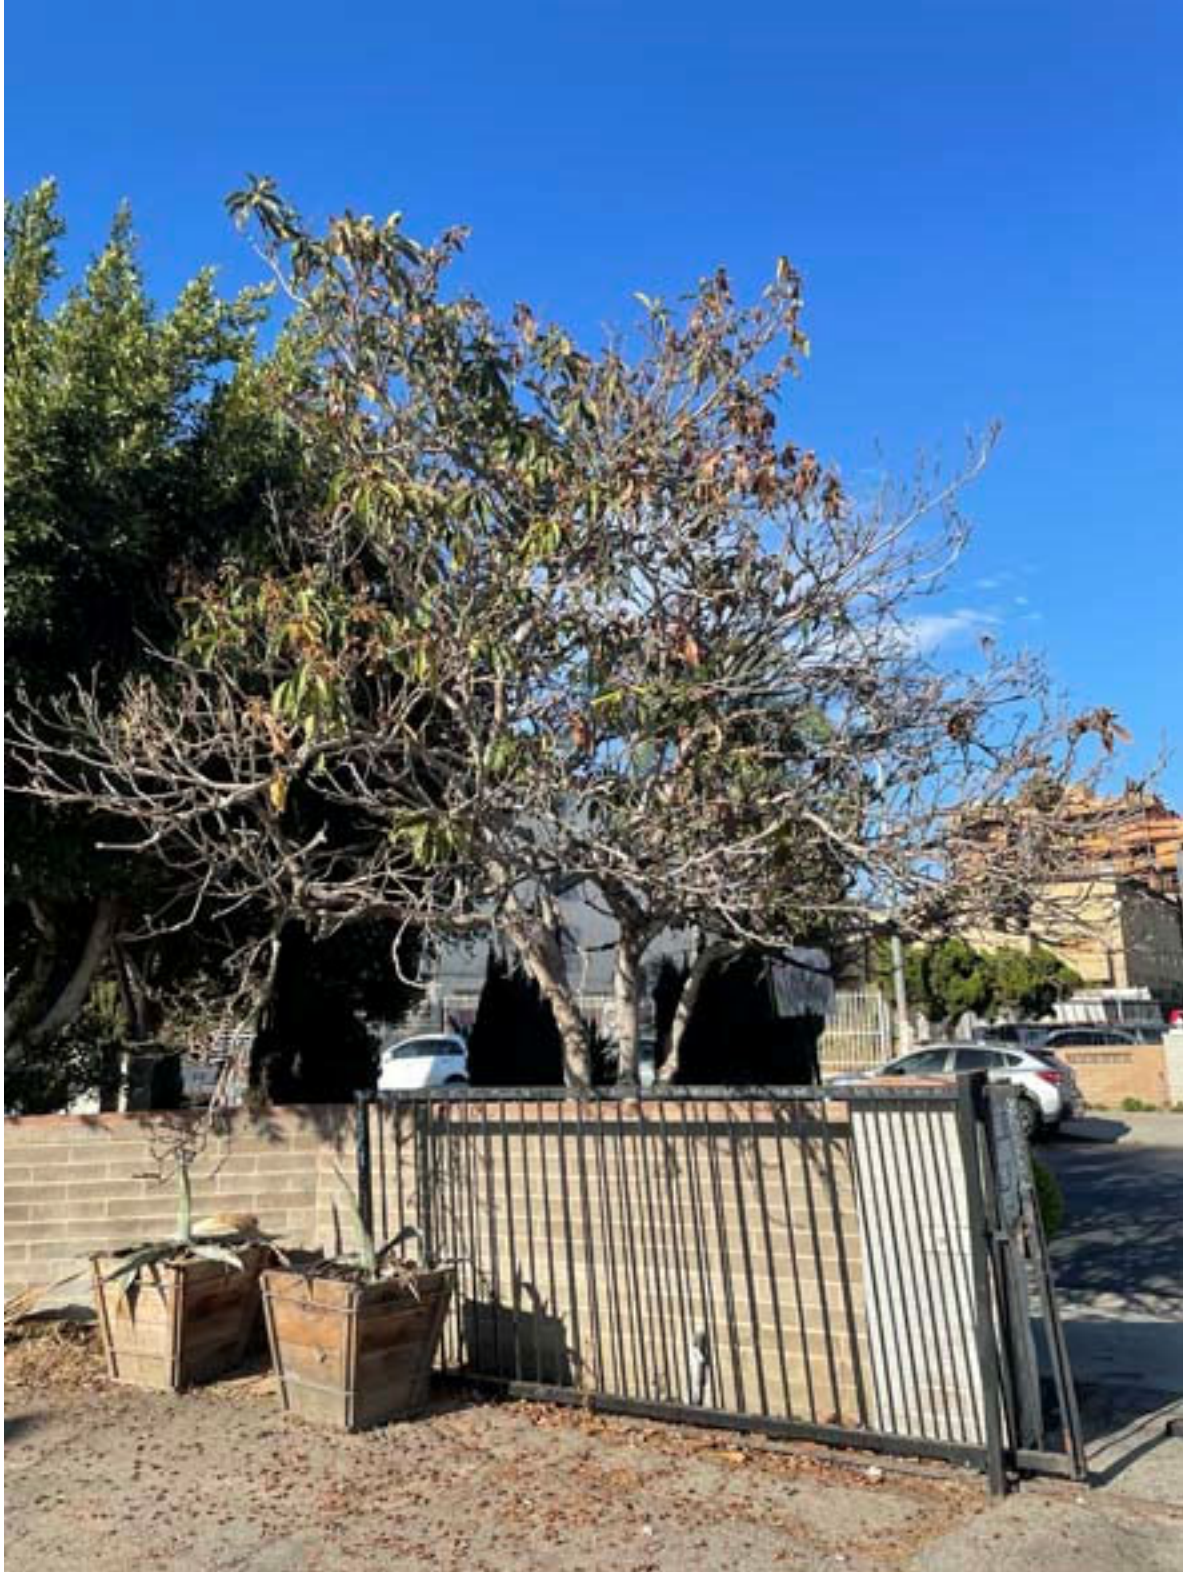
**Figure 25:** Tree 31

<p><b>Tree 31</b>  <i>Eriobotrya deflexa</i> – Bronze Loquat</p> <p>This tree is not protected by ordinance. It will be removed because it is growing too close to the footprint of the proposed building to survive the root cutting that would result.</p> <p>This tree is nearly dead. It is in poor condition.</p>

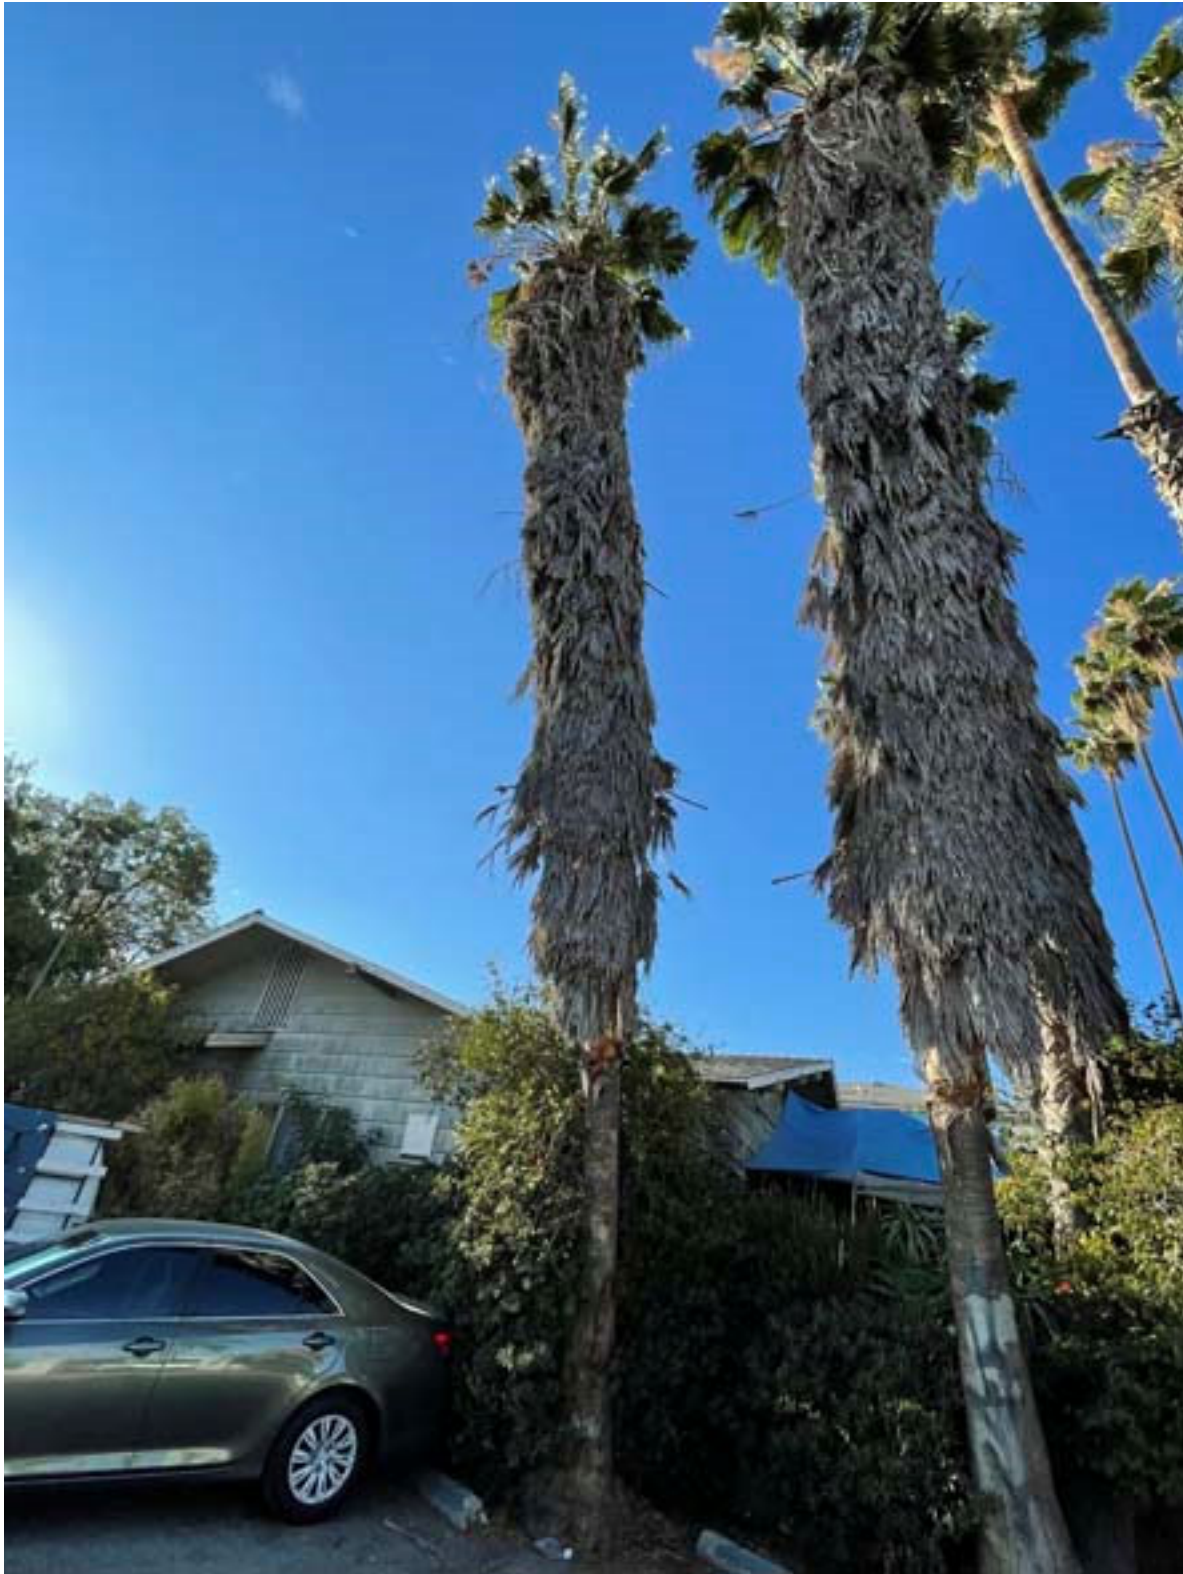
**Figure 28:** Tree 34

<p><b>Tree 34</b>  <i>Washingtonia robusta</i> – Mexican Fan Palm</p> <p>This tree is not protected by ordinance. It will be removed because it is growing within the footprint of the proposed building.</p> <p>This tree has accumulated dead fronds.</p>

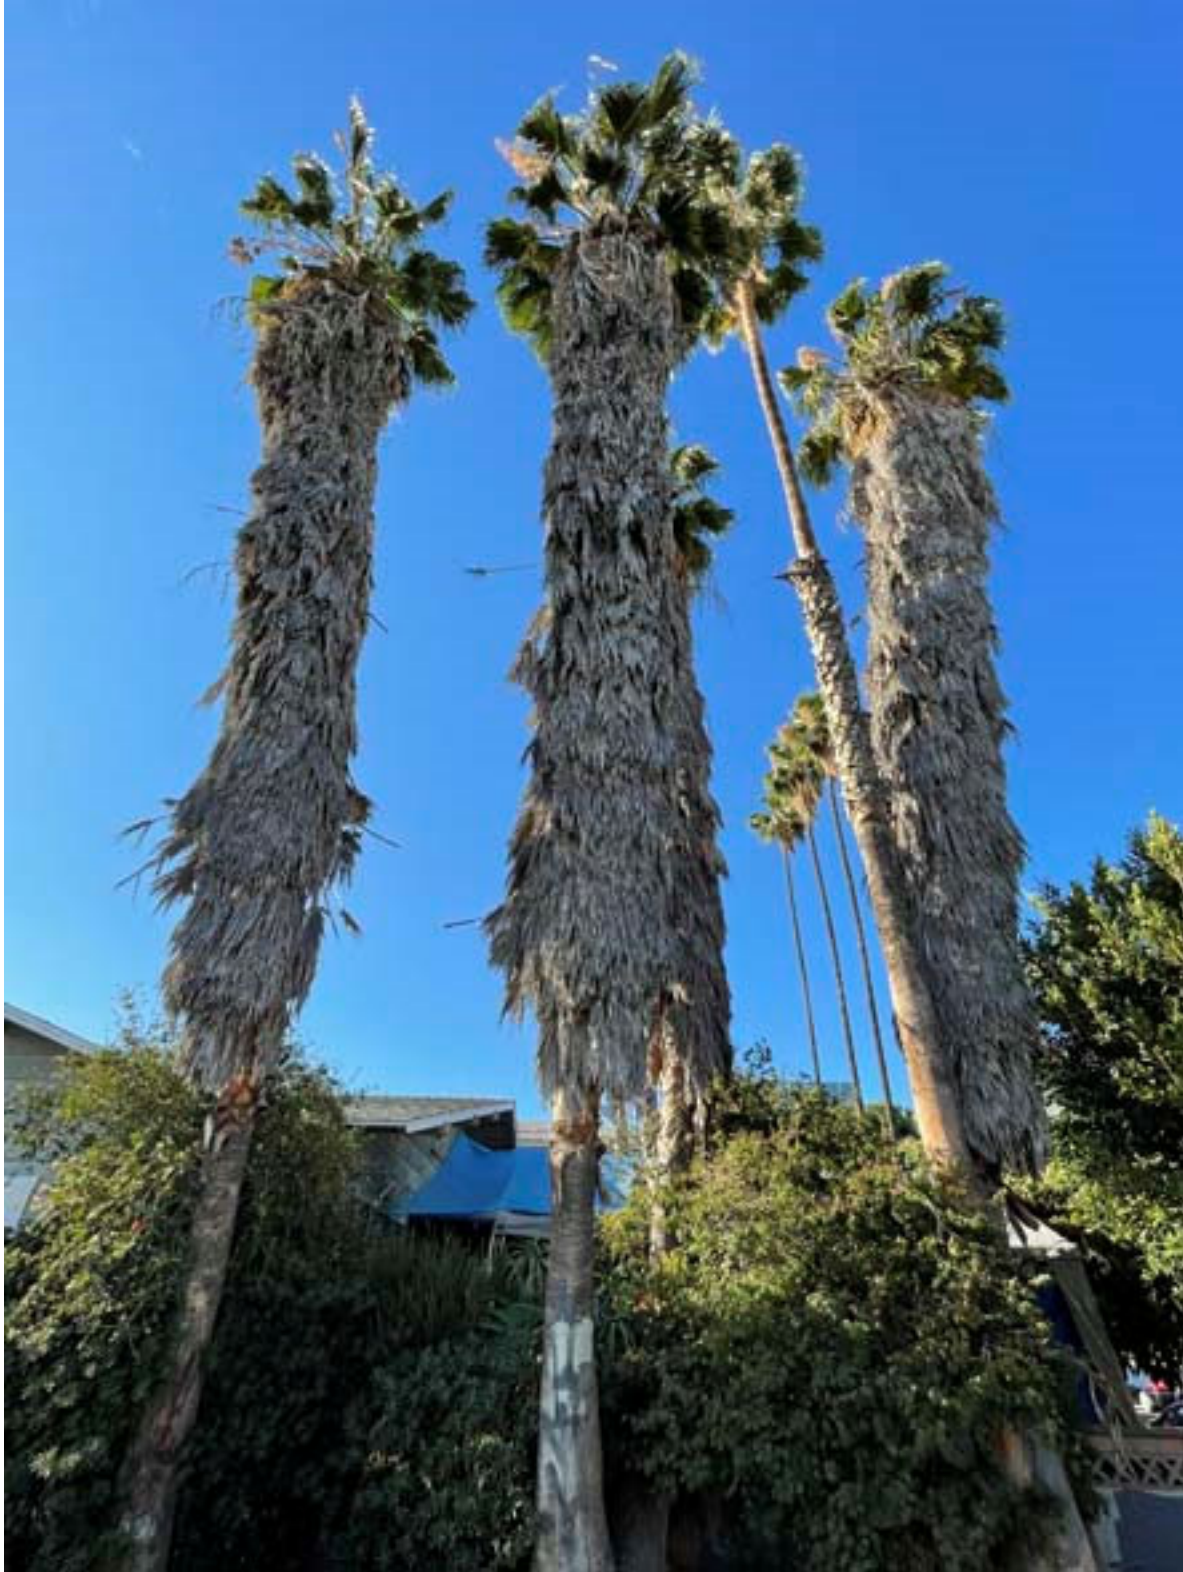
**Figure 29:** Tree 35

<p><b>Tree 35</b>  <i>Washingtonia robusta</i> – Mexican Fan Palm</p> <p>This tree is not protected by ordinance. It will be removed because it is growing within the footprint of the proposed building.</p> <p>This tree has accumulated dead fronds.</p>

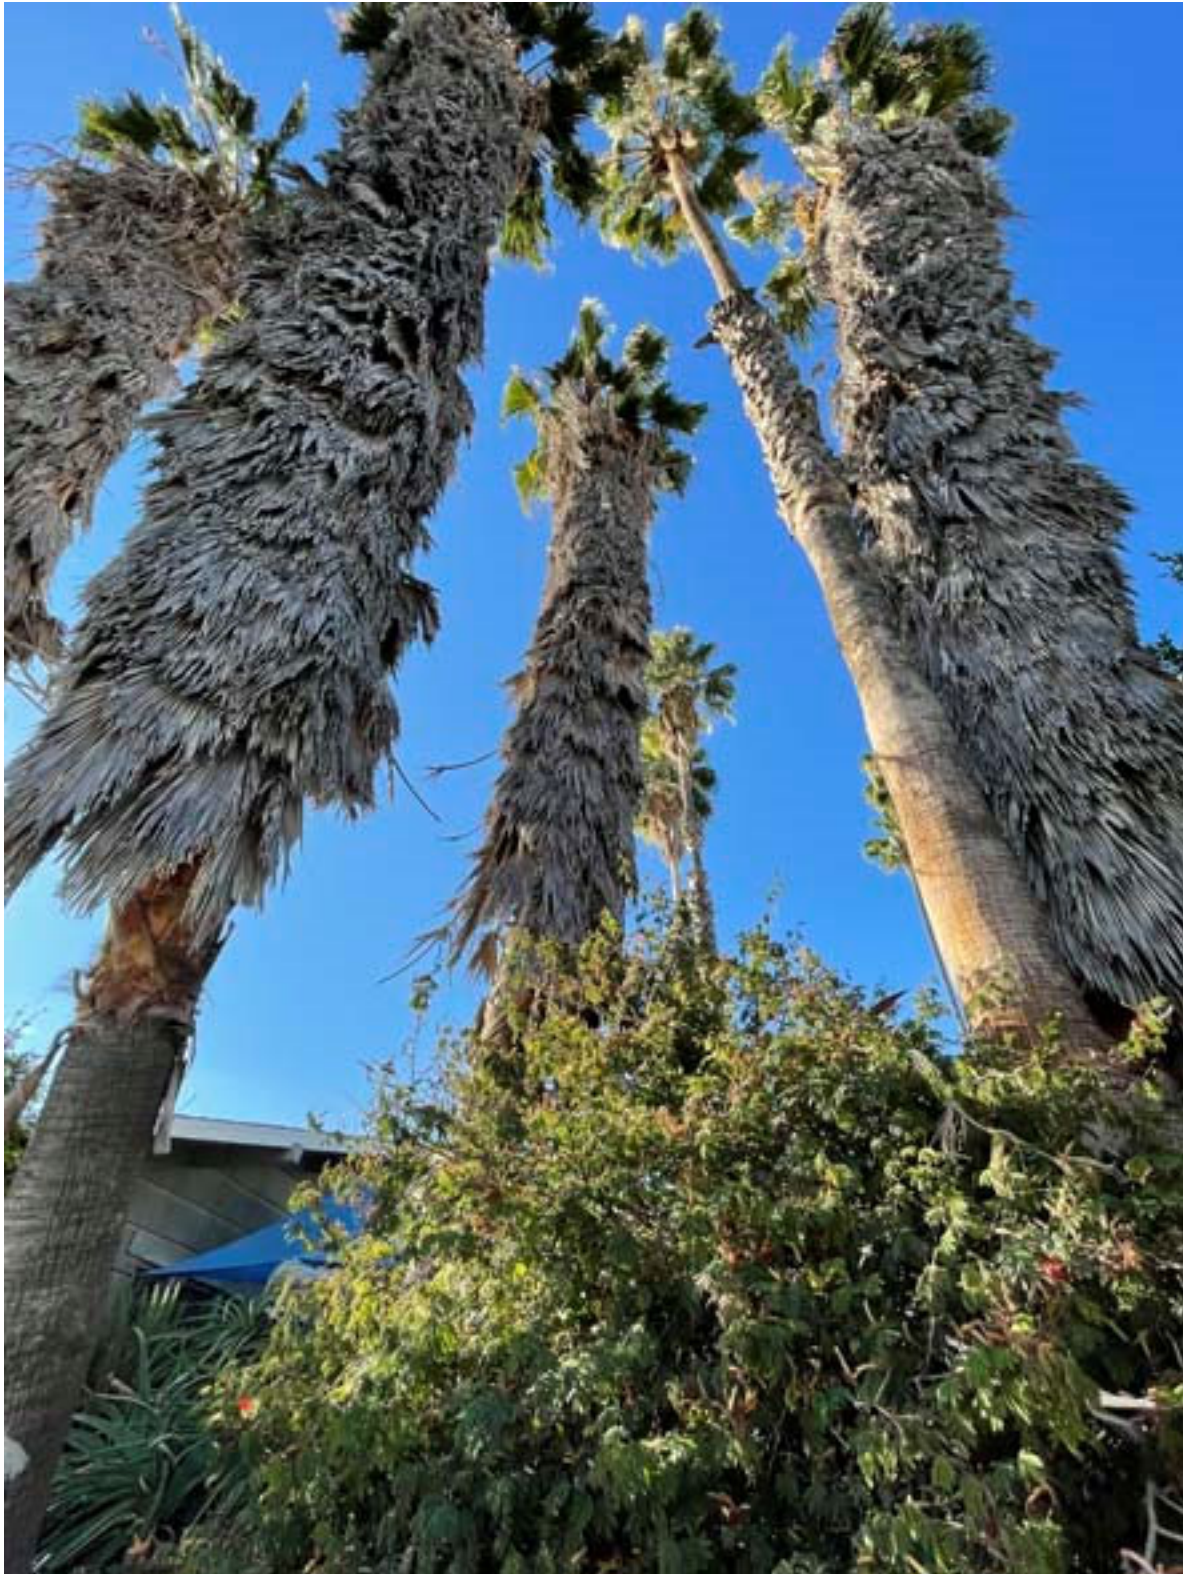
**Figure 30:** Tree 36

<p><b>Tree 36</b>  <i>Washingtonia robusta</i> – Mexican Fan Palm</p> <p>This tree is not protected by ordinance. It will be removed because it is growing within the footprint of the proposed building.</p> <p>This tree has accumulated dead fronds.</p>

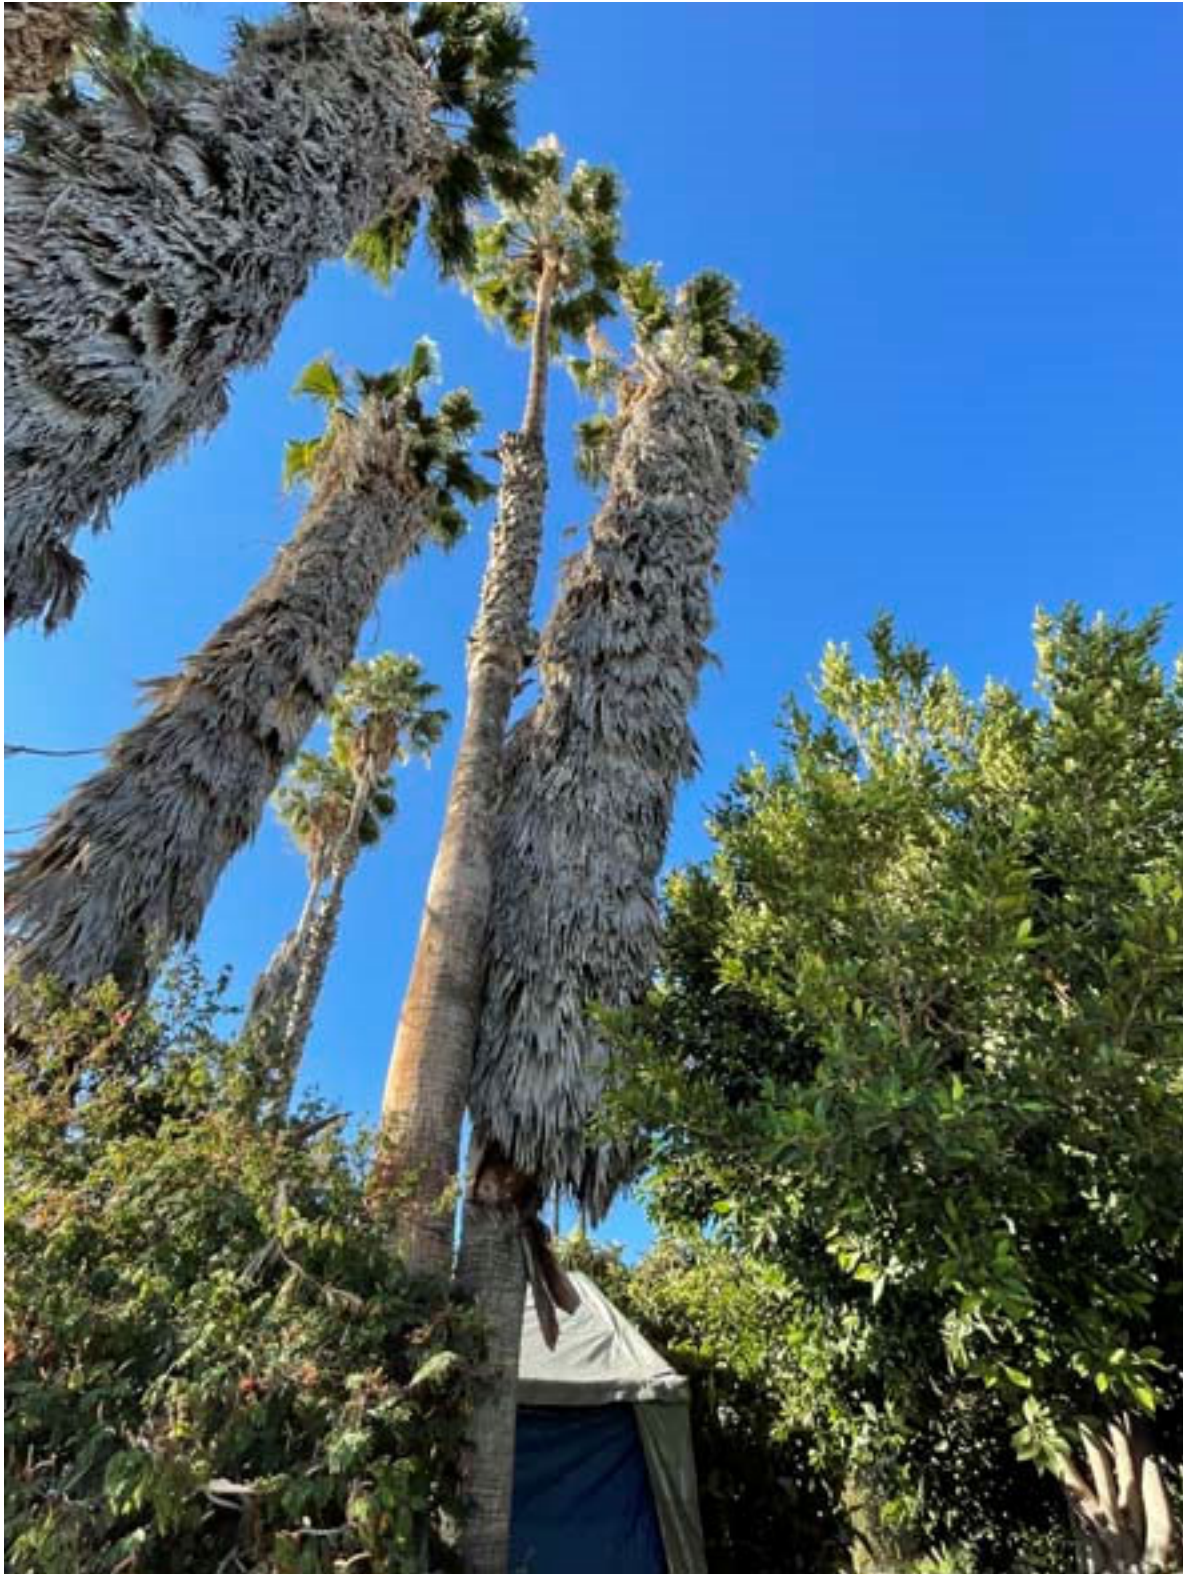
**Figure 32:** Tree 38

<p><b>Tree 38</b>  <i>Washingtonia robusta</i> – Mexican Fan Palm</p> <p>This tree is not protected by ordinance. It will be removed because it is growing too close to the footprint of the proposed building to survive the root cutting that would result.</p> <p>This tree has accumulated dead fronds.</p>

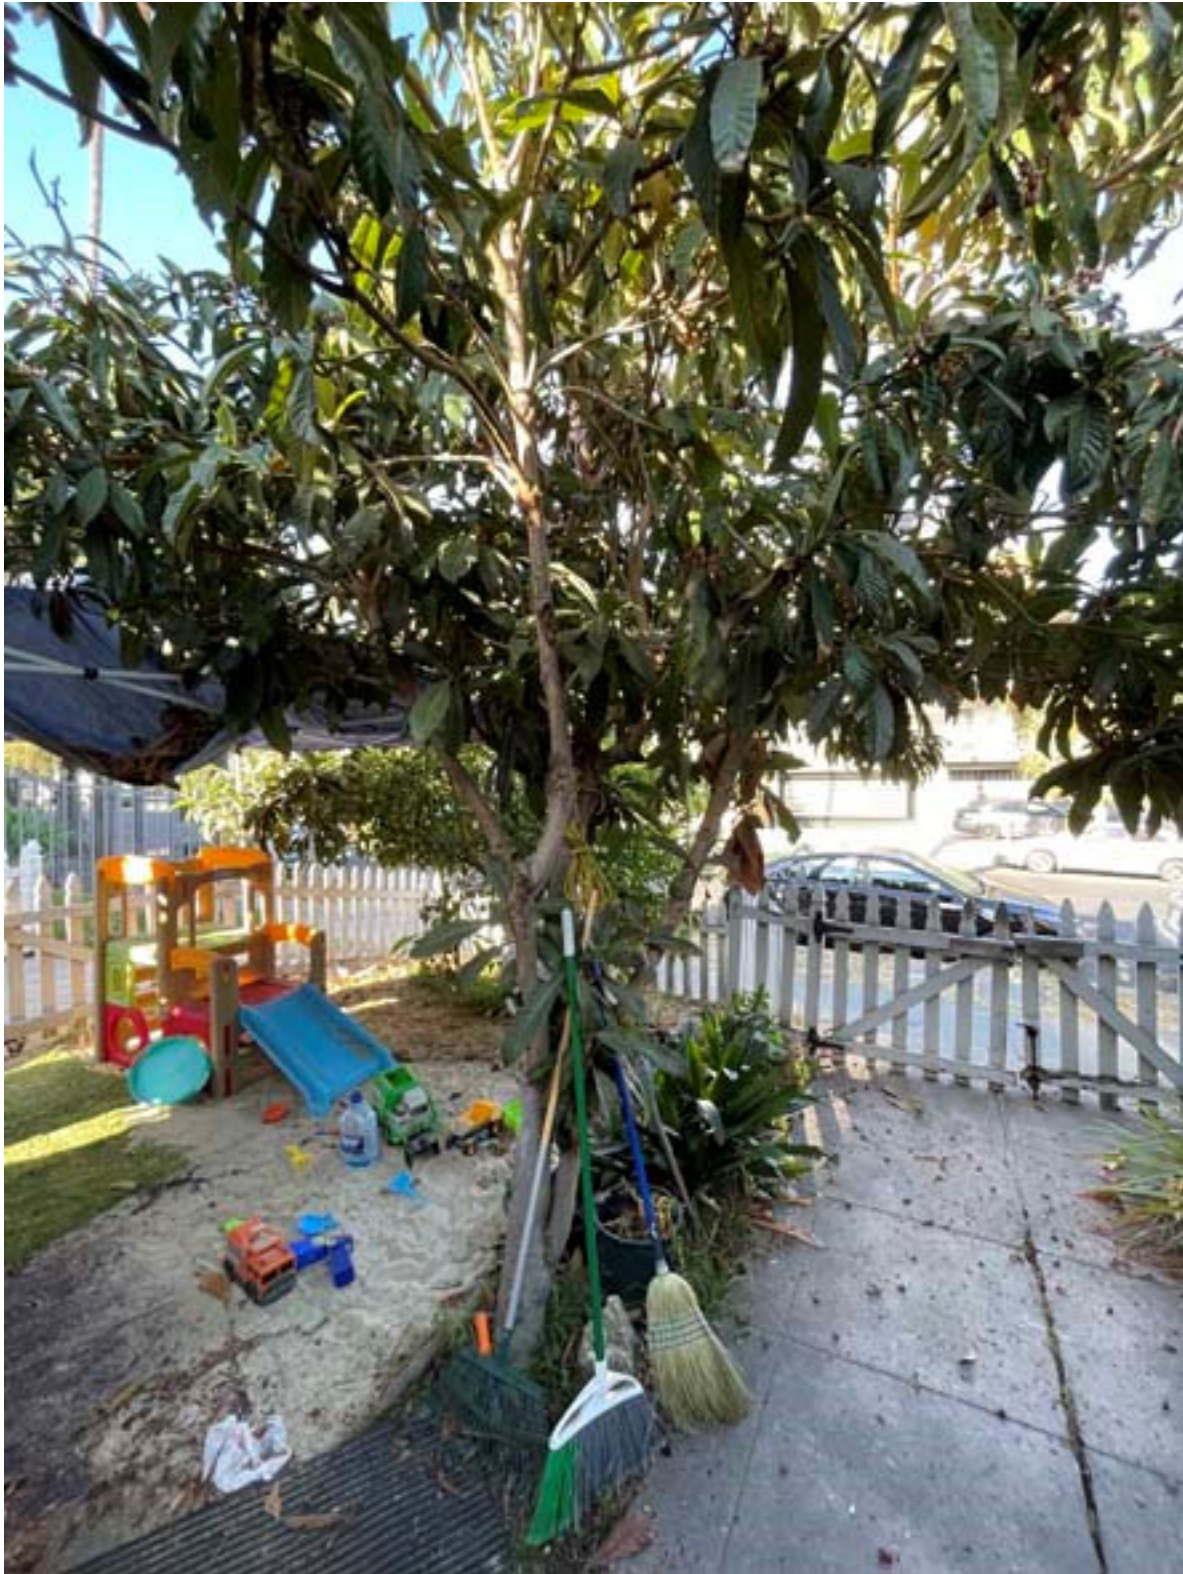
**Figure 37:** Tree 43

<p><b>Tree 43</b>  <i>Eriobotrya japonica</i> – Loquat</p> <p>This tree is not protected by ordinance. It will be removed because it is growing within the footprint of the proposed building.</p> <p>This tree is healthy.</p>
 	<p><b>Tree 44</b>  <i>Eriobotrya japonica</i> – Loquat</p> <p>This tree is not protected by ordinance. It will be removed because it is growing within the footprint of the proposed building.</p> <p>This tree is healthy.</p>
 	<p><b>Tree 45</b>  <i>Citrus sp.</i> – Citrus</p> <p>This tree is not protected by ordinance. It will be removed because it is growing within the footprint of the proposed building.</p> <p>This tree has symptoms of drought stress. However, it is still in good condition.</p>

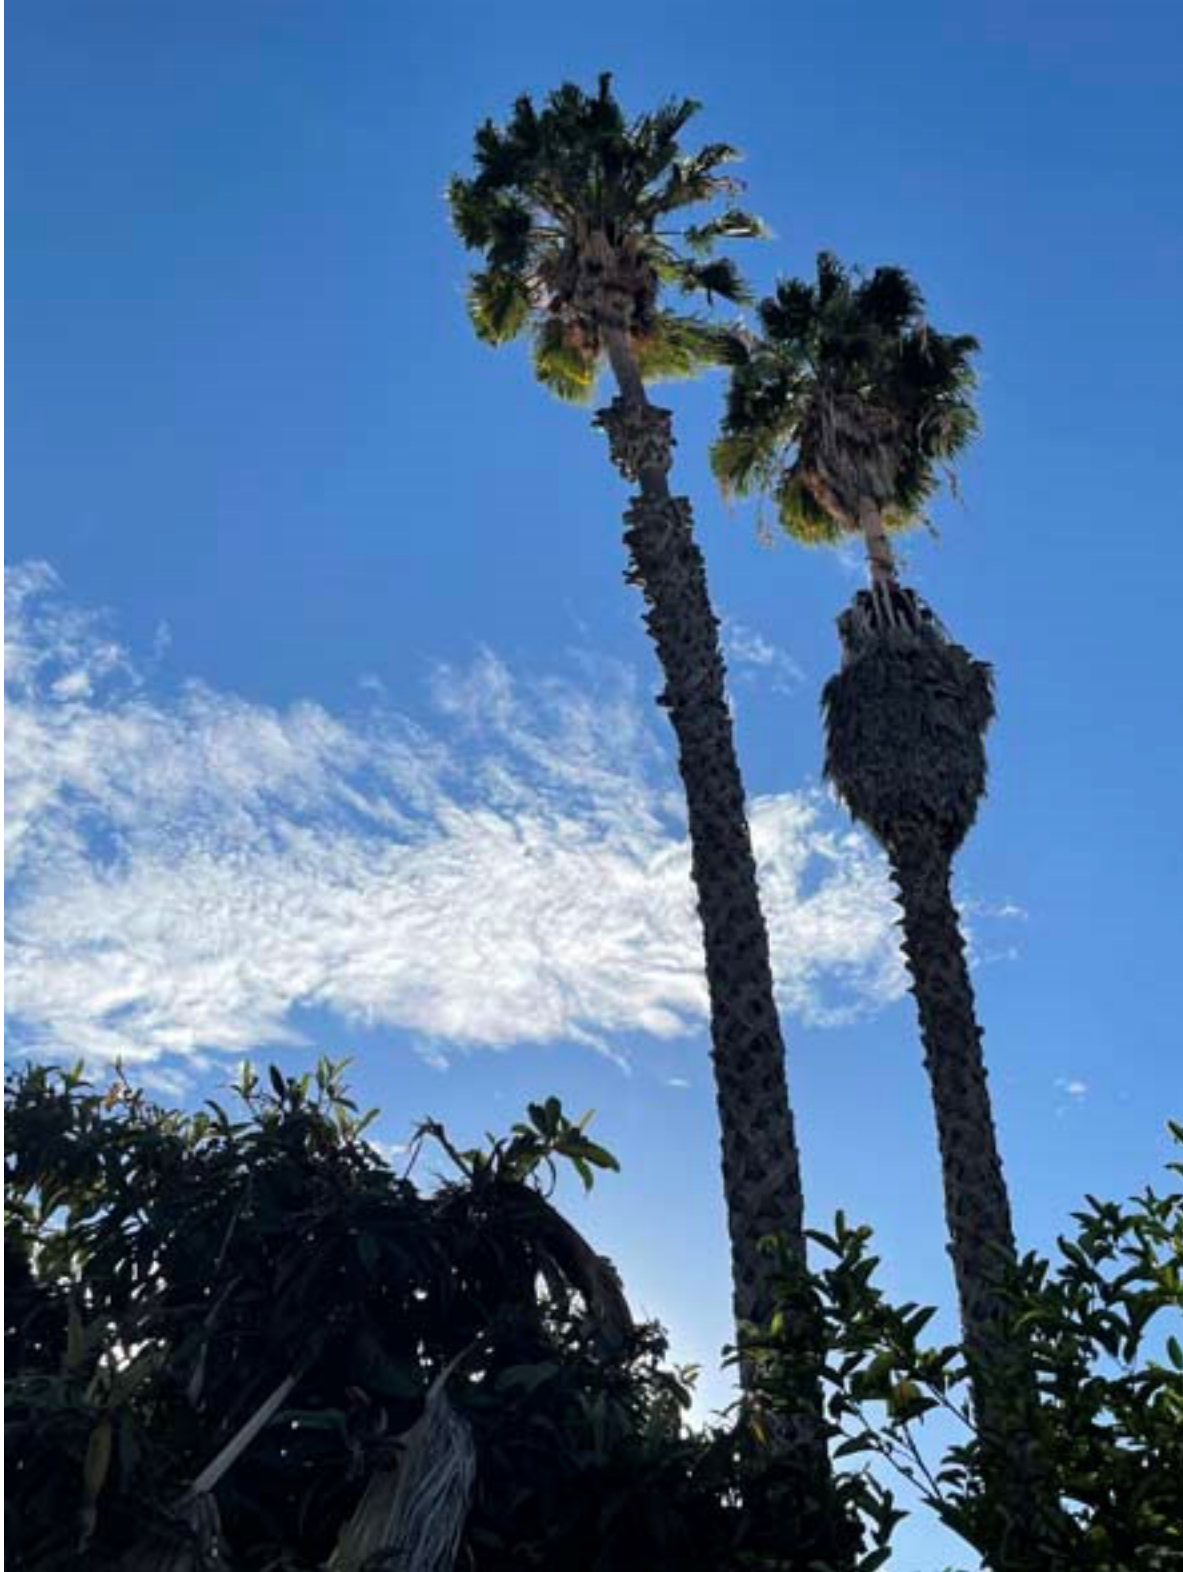
**Figure 40:** Tree 46

<p><b>Tree 46</b>  <i>Washingtonia robusta</i> – Mexican Fan Palm</p> <p>This tree is not protected by ordinance. It will be removed because it is growing within the footprint of the proposed building.</p> <p>This tree has accumulated dead fronds.</p>

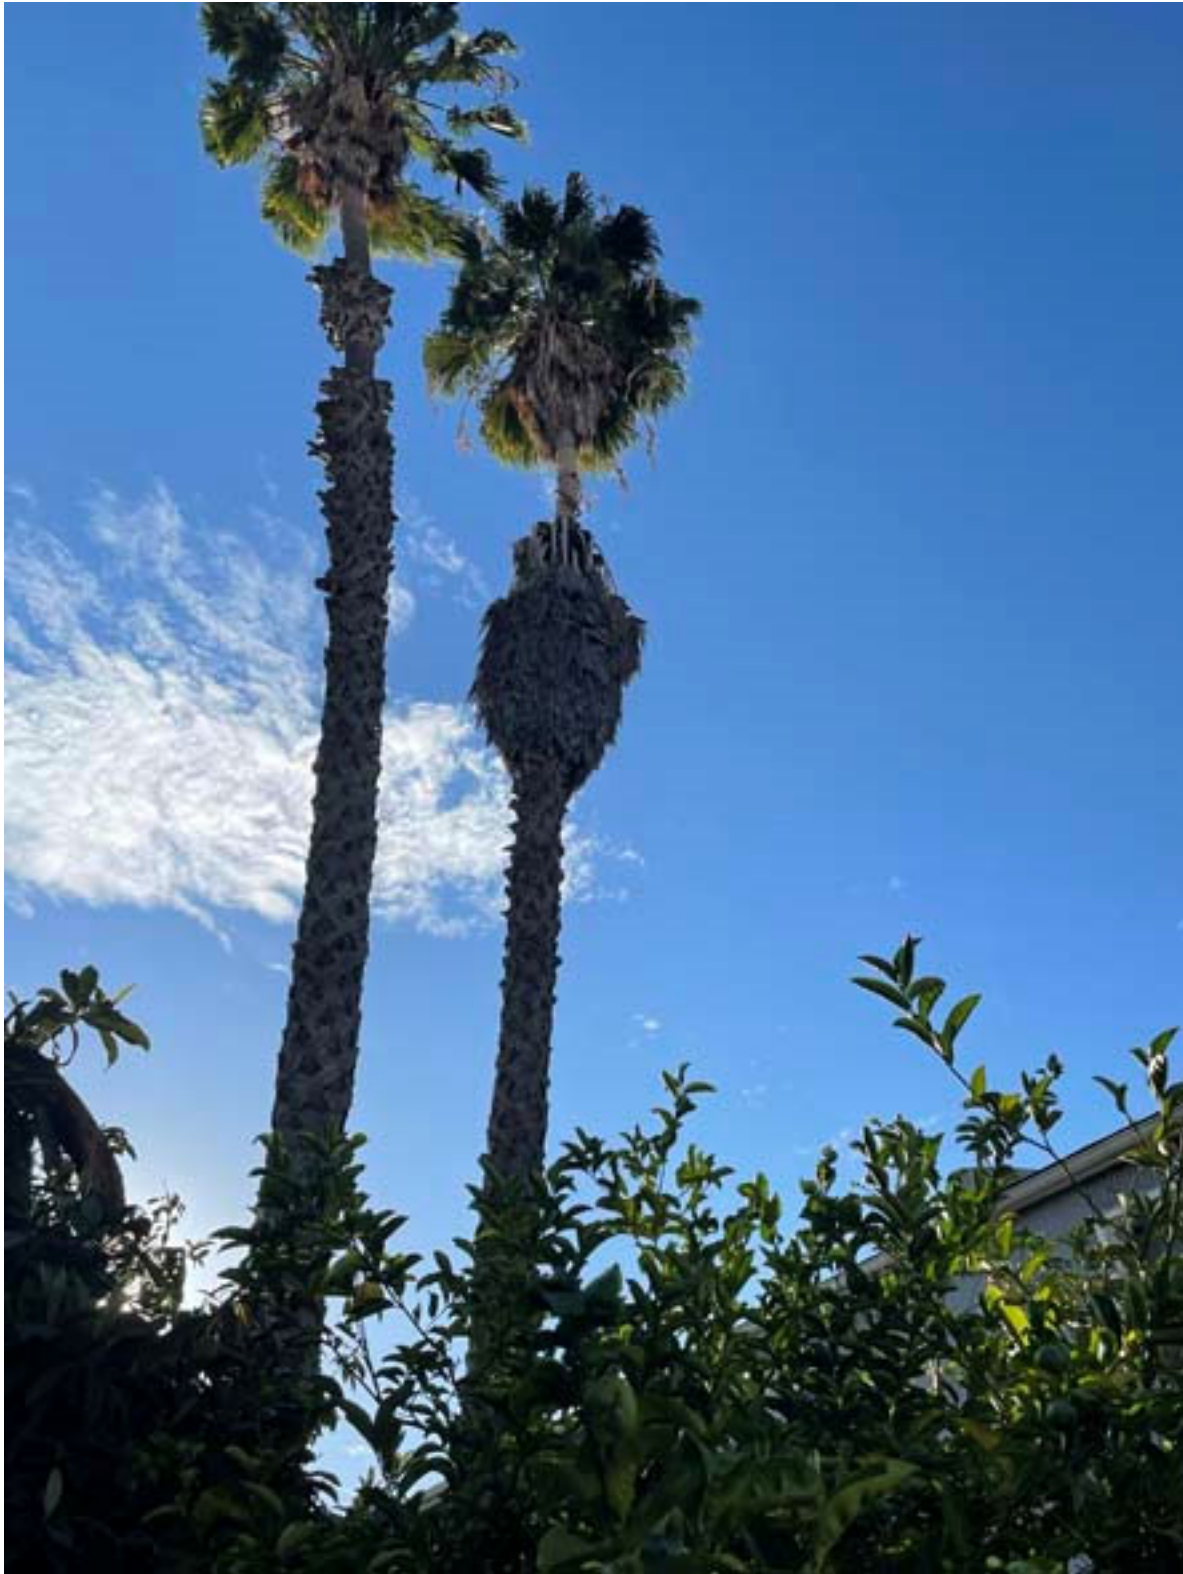
**Figure 41:** Tree 47

<p><b>Tree 47</b>  <i>Washingtonia robusta</i> – Mexican Fan Palm</p> <p>This tree is not protected by ordinance. It will be removed because it is growing within the footprint of the proposed building.</p> <p>This tree has accumulated dead fronds.</p>

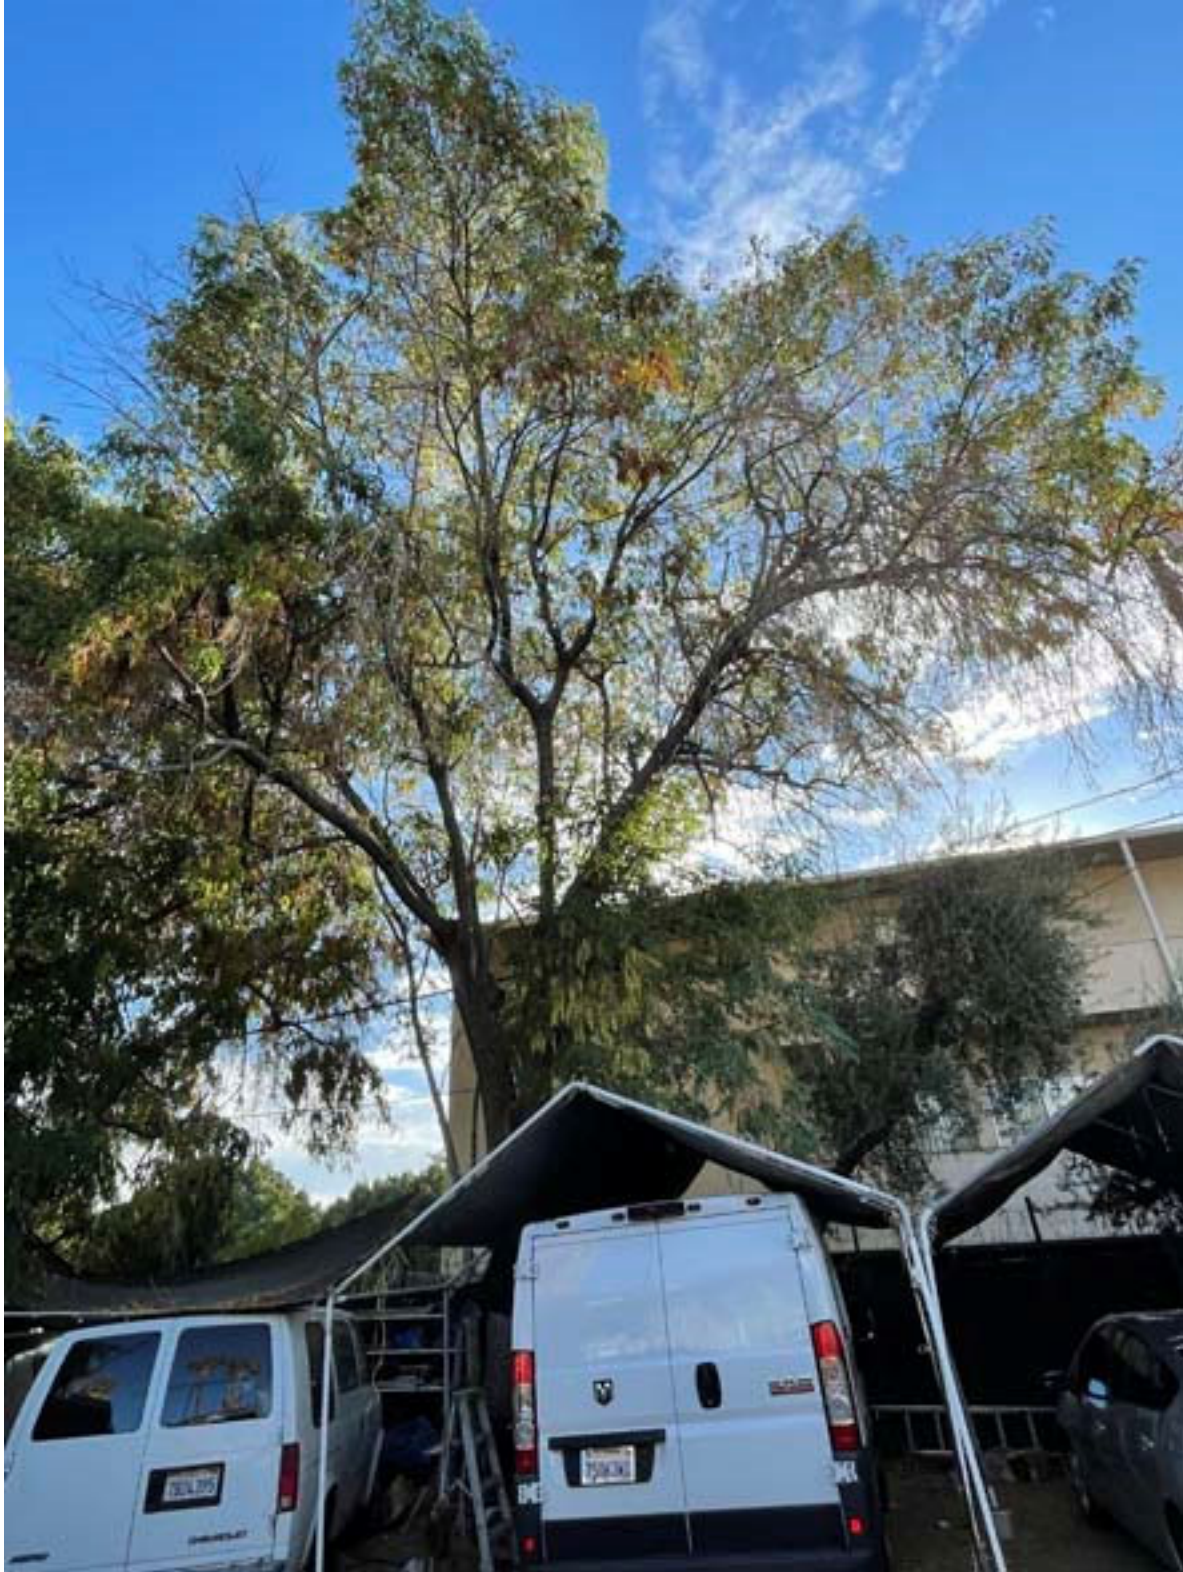
**Figure 43:** Tree 49

<p><b>Tree 49</b>  <i>Fraxinus uhdei</i> – Shamel Ash</p> <p>This tree is not protected by ordinance. It will be removed because it is growing too close to the footprint of the proposed building to survive the root cutting that would result.</p> <p>This tree has dead branches in its canopy. I observed dieback due to drought and heat stress.</p>
