# 3433 W. 8th St. Arborist Report

Prepared for CORBeL Architects Inc.  
Mick Myungsik Choi  
3450 Wilshire Blvd., Suite 1000  
Los Angeles, CA 90010

**Prepared by James Komen**  
BCMA WE-9909B  
RCA #555

Mick Myungsik Choi of CORBeL Architects Inc. asked me to prepare a Protected Tree Report for the City of Los Angeles Urban Forestry Department documenting the trees on a property proposed for development. I visited the subject property alone on July 2, 2021 at 3:30pm to collect the data for this report.

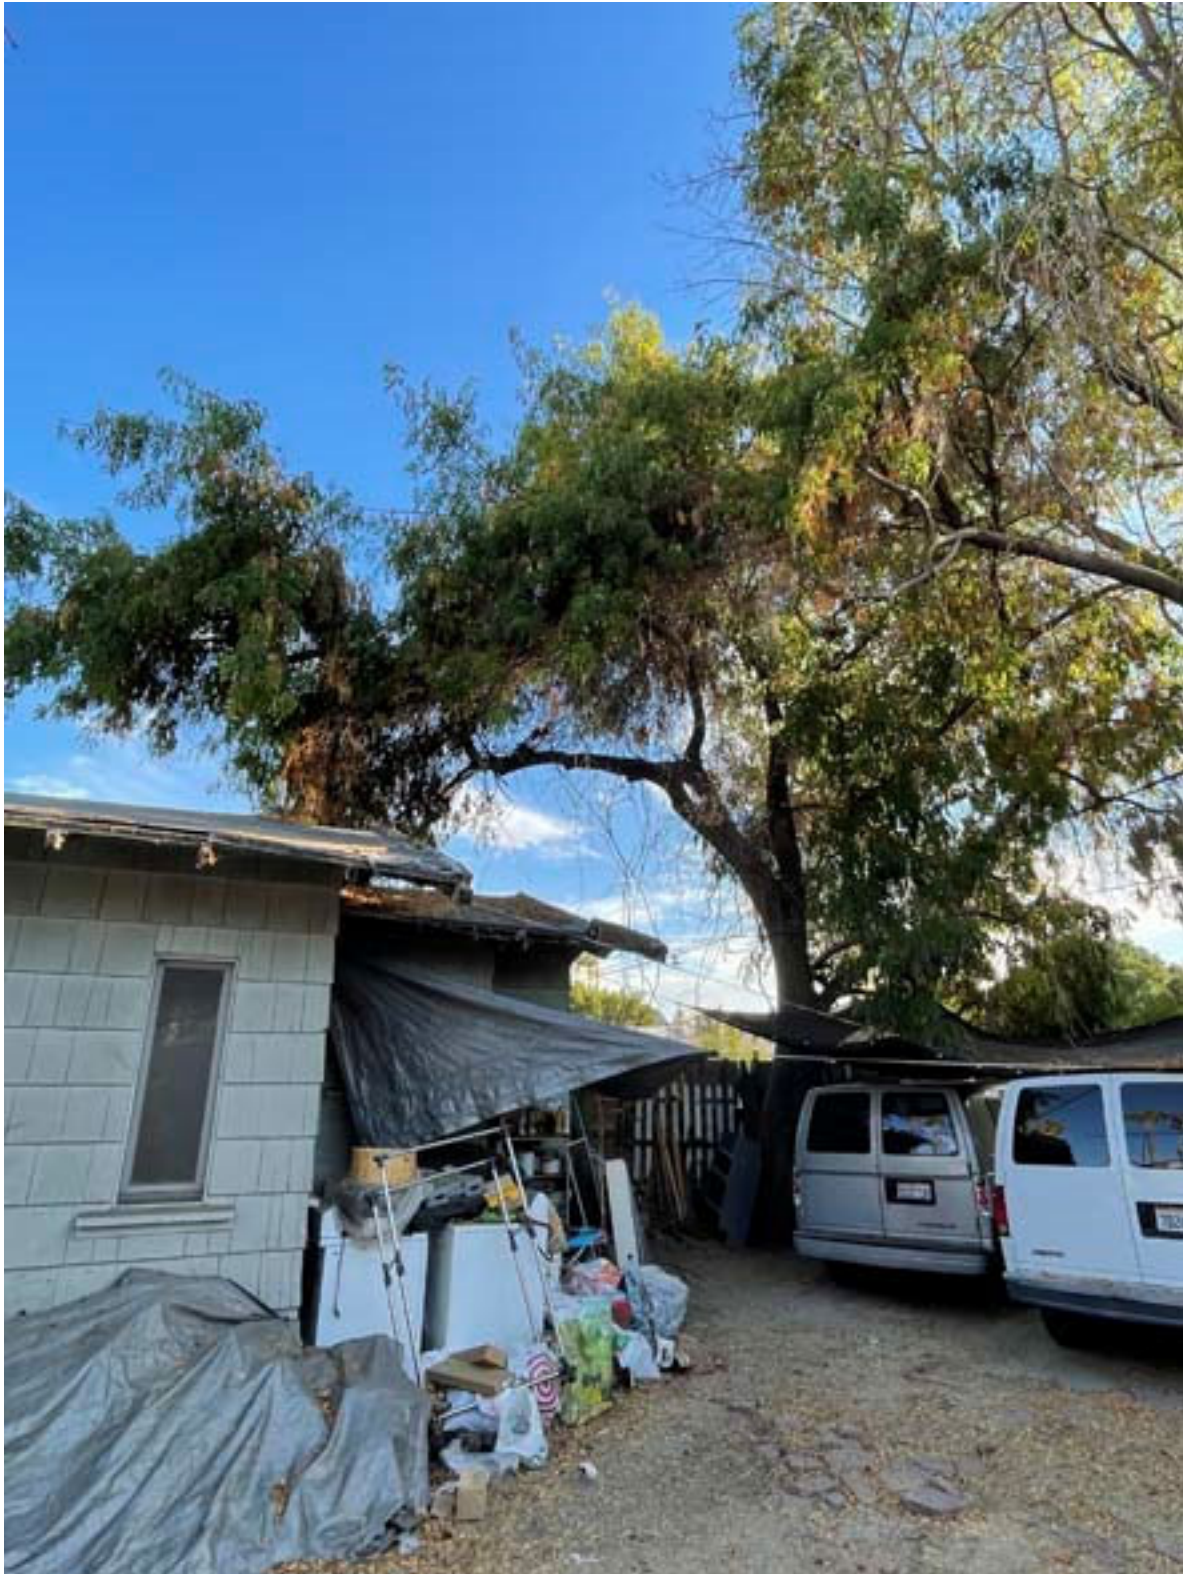
**Figure 44:** Tree 50

<p><b>Tree 50</b>  <i>Fraxinus uhdei</i> – Shamel Ash</p> <p>This tree is not protected by ordinance. It will be removed because it is growing within the footprint of the proposed building.</p> <p>This tree has dead branches and symptoms of dieback in its canopy. One of its branches is overextended in cantilever over the existing single family house.</p>
