Protected Tree Report

1200 Vine Street
Los Angeles, CA 90038

Ted Lubeshkoff
Registered Consulting Arborist

May 25, 2023

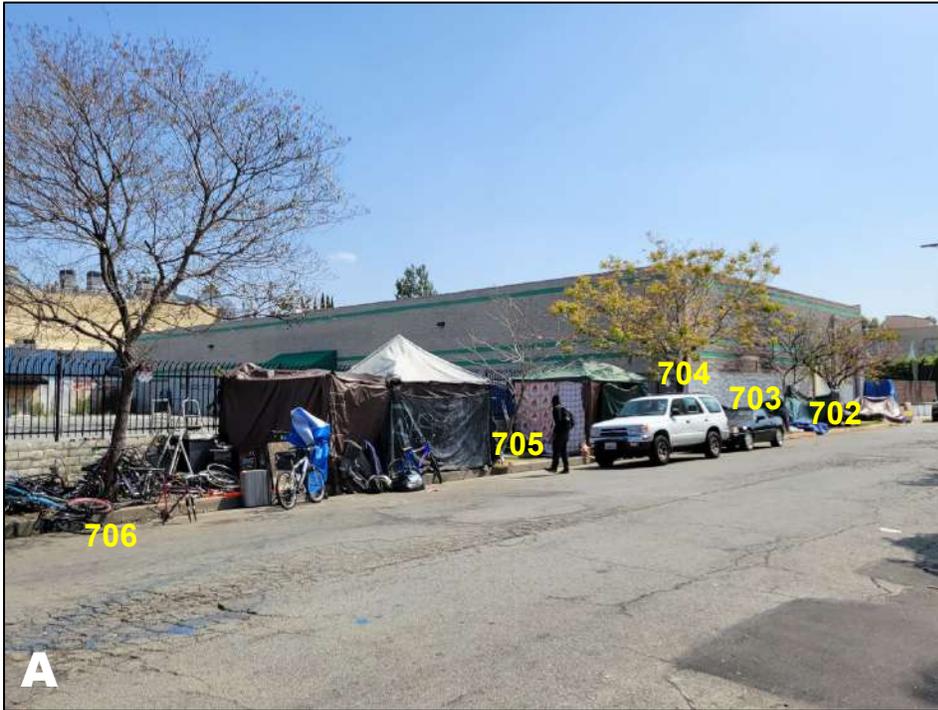
| | Tree # | Scientific Name Common Name | Photo | Size | Condition | Comments |
|---|---|--|---|---|---|---|
| 1 | 702 | <i>Handroanthus heptaphyllus</i> Pink trumpet | A, C | DBH: 6" Height: 20' Width: 25' | Poor | Partially burned. Proposed to be removed. |
| 2 | 703 | <i>Handroanthus heptaphyllus</i> Pink trumpet | A, D | DBH: 4" Height: 20' Width: 25' | Dead | No living tissue. Proposed to be removed. |
| 3 | 704 | <i>Handroanthus heptaphyllus</i> Pink trumpet | A, E | DBH: 8" Height: 12' Width: 25' | Fair | Branch tear-out. Poor branch structure. |
| 4 | 705 | <i>Handroanthus heptaphyllus</i> Pink trumpet | A, F | DBH: 3" Height: 15' Width: 10' | Dead | No living tissue. Proposed to be removed. |
| 5 | 706 | <i>Handroanthus heptaphyllus</i> Pink trumpet | A, G | DBH: 8" Height: 25' Width: 25' | Fair | One broken branch Poor branch structure. |

Photo A, facing northeast, showing Trees 702-706 on Lexington Avenue.

1. Install tree protection fencing around the street trees at locations shown on the Site Plan.
 - a. Chain-link fencing will be at least five-feet tall. This fencing will remain in place through the duration of the construction. Orange flexible fencing will not be used.

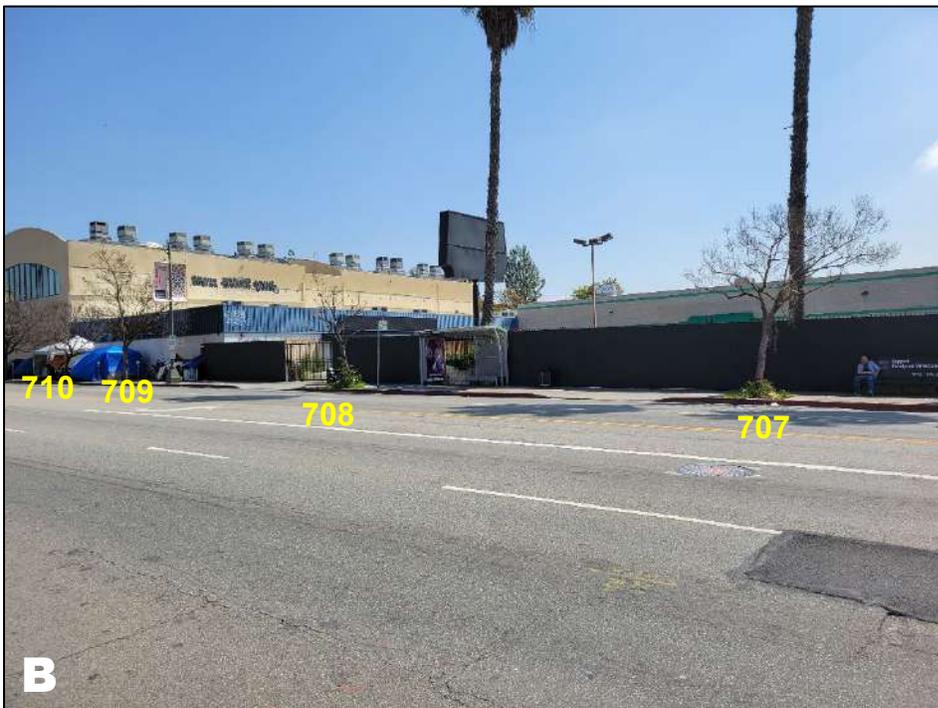
| | Tree # | Scientific Name Common Name | Photo | Size | Condition | Comments |
|---|---|--|---|---|---|---|
| 6 | 707 | <i>Jacaranda mimosifolia</i> Jacaranda | B, H | DBH: 8" Height: 25' Width: 25' | Poor | Poor pruning cuts. Poor branch structure. |
| 7 | 708 | <i>Jacaranda mimosifolia</i> Jacaranda | B, I | DBH: 5" Height: 20' Width: 20' | Poor | Poor pruning cuts Mechanical damage on trunk. |
| 8 | 709 | <i>Jacaranda mimosifolia</i> Jacaranda | B, J | DBH: 9" Height: 25' Width: 25' | Poor | Poor pruning cuts Mechanical damage on trunk. Proposed to be removed. |
| 9 | 710 | <i>Jacaranda mimosifolia</i> Jacaranda | B, K | DBH: 8" Height: 20' Width: 25' | Poor | Poor branch structure. Leaning. |

Photo B, facing east, showing Trees 707-710 on Vine Street.

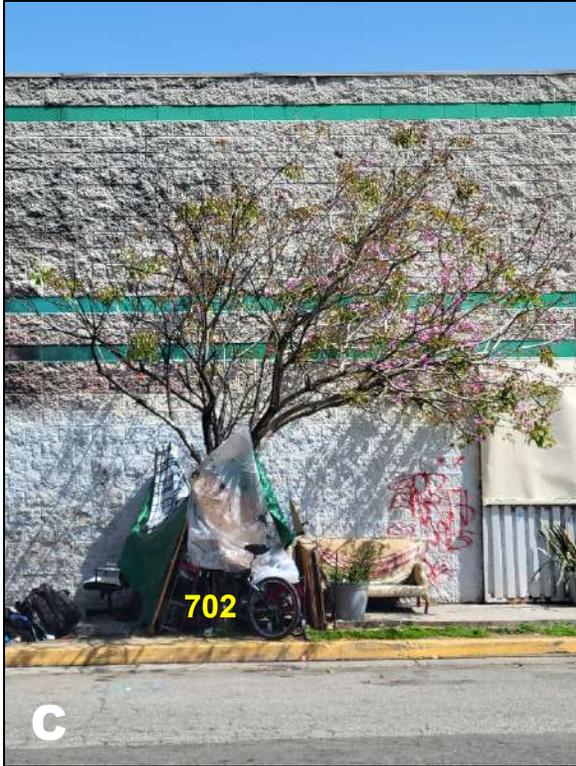
Photo C, facing north, showing Tree 702.

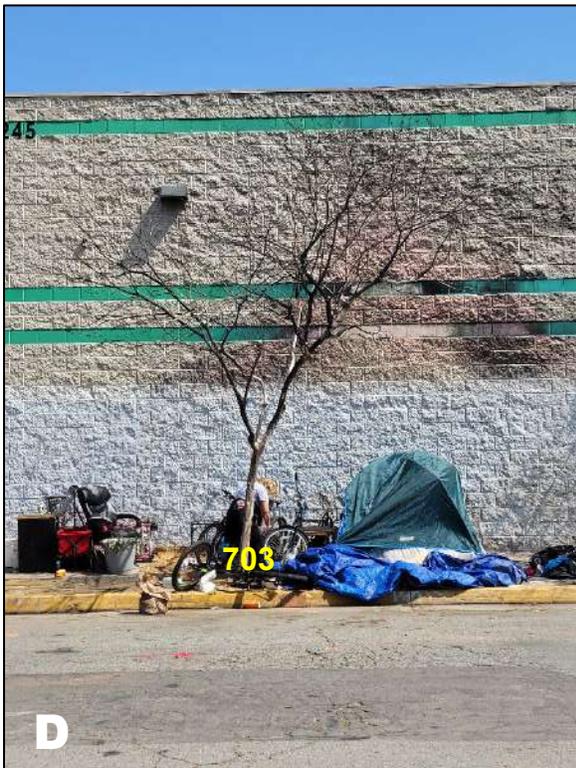
Photo D, facing north, showing Tree 703.

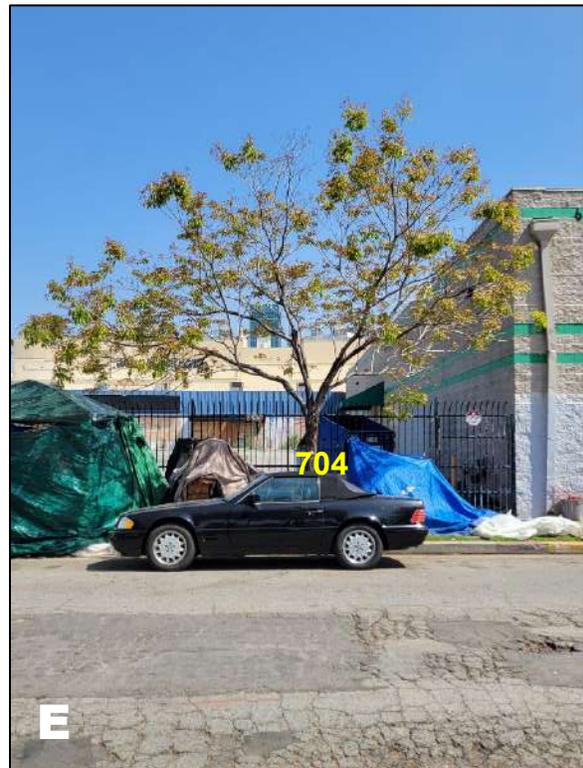
Photo E, facing north, showing Tree 704.

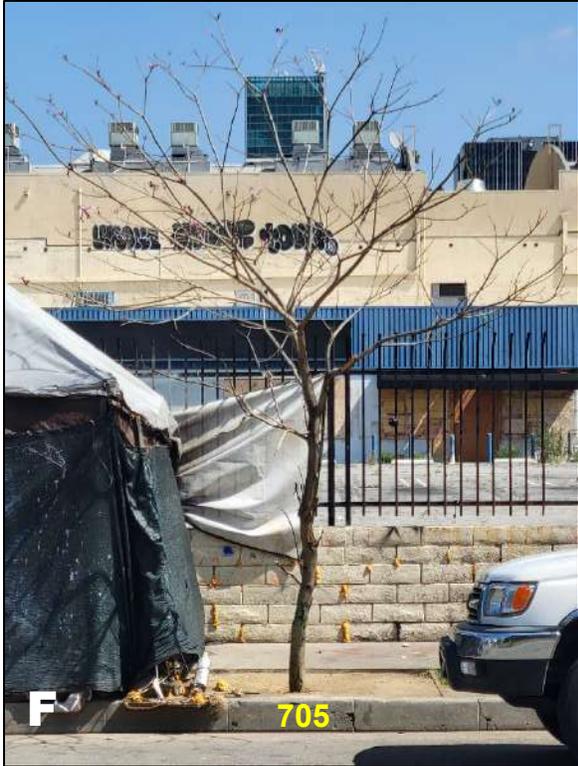
Photo C, facing north, showing Tree 705.

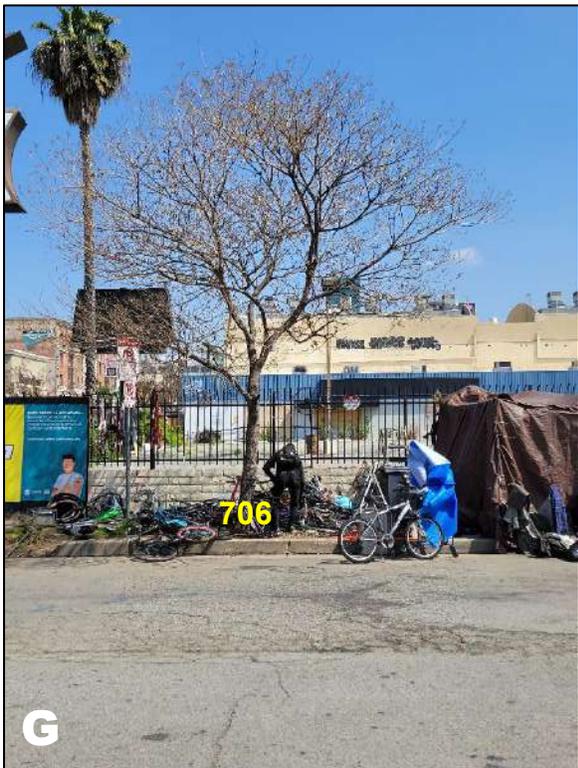
Photo D, facing north, showing Tree 706.

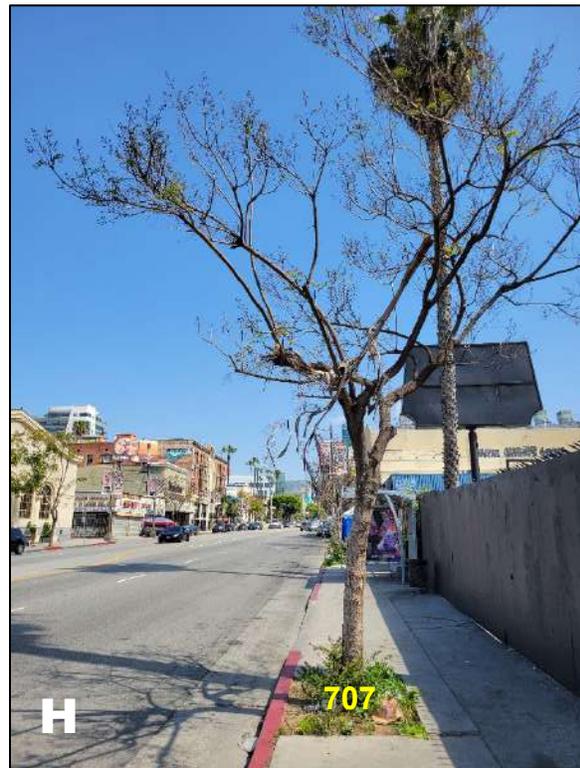
Photo E, facing north, showing Tree 707.

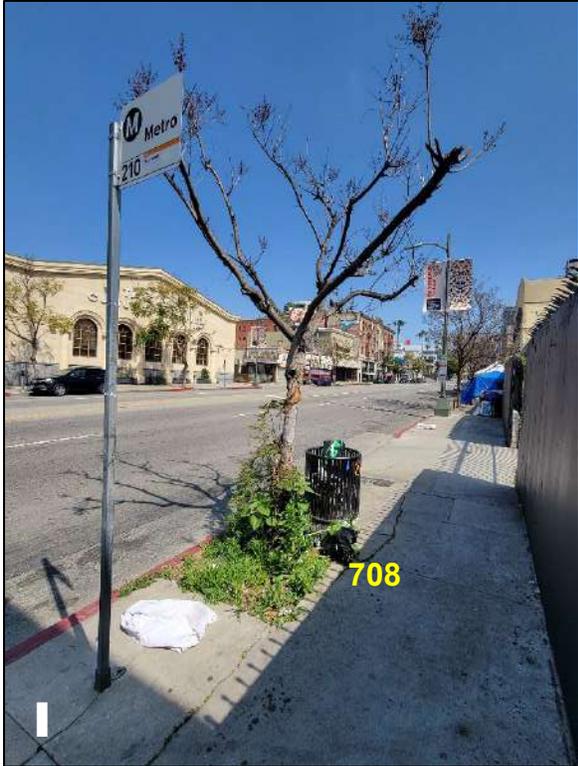
Photo C, facing north, showing Tree 708.

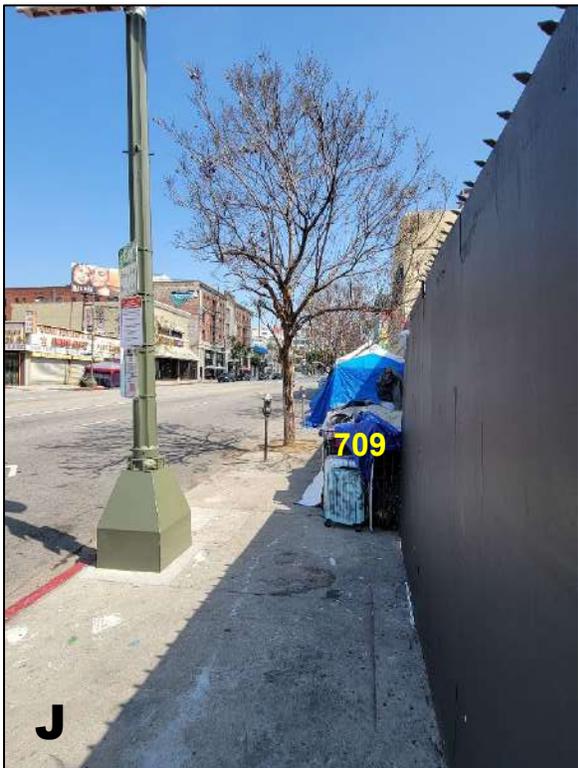
Photo D, facing north, showing Tree 709.

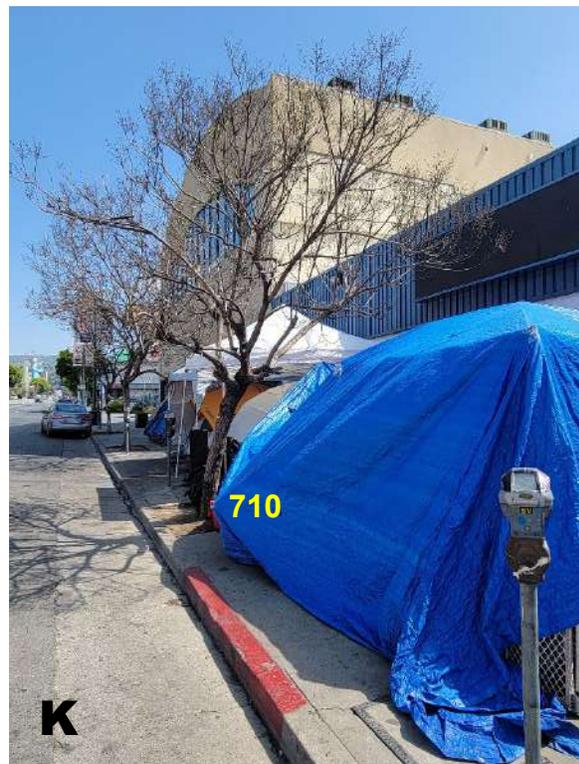
Photo E, facing north, showing Tree 710.
