Mature Tree Report

*122- Unit Mixed Use Building
FDC 4311 West Sunset
4301, 4303 and 4311 West Sunset Boulevard
4300, 4306 -4308 and 4312 - 4314 Effie Street
Los Angeles, California 90029*

April 6, 2016

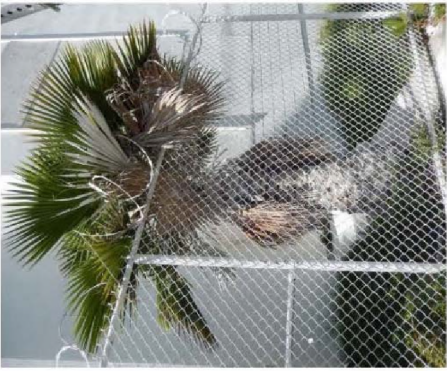
<p>Tree #34</p>

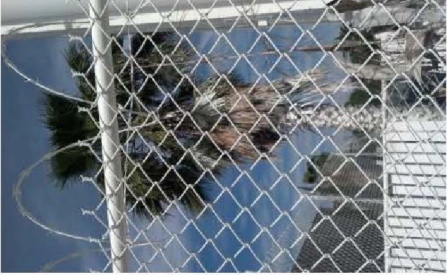
Tree #'s 33 through 37 – These five mature Mexican fan palm trees are within the proposed footprint of the mixed-use structure and would therefore need to be removed to construct the project as proposed.

<p>Tree #37</p>
 	<p>Tree #33</p>

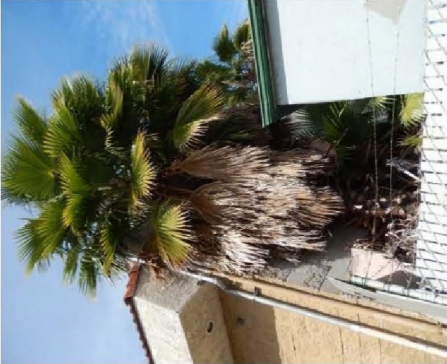
<p>Tree #32</p>

Tree #'s 30 through 32 – These three mature Mexican fan palm trees are located within the proposed footprint of the mixed-use structure and would therefore need to be removed to construct the project as proposed.

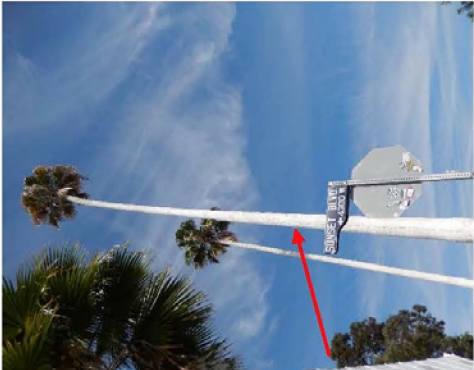
<p>Tree #47</p>

Tree #'s 45 through 48 – These four mature Mexican fan palm trees are street trees. They are located within the right-of-way at the front and easterly sides of the property. Construction of the new public sidewalk and new curb and gutter would occur approximately one foot from the trunks on opposite sides of the trees. Due to the nature

and configuration of palm roots, if the portions of the sidewalk and curb and gutter within approximately five feet of the trunks are excavated by hand under observation by this office, impacts to the trees can be limited and they can likely be preserved with no long-term adverse impacts to their health.
