Revello Drive and Tramonto Drive Residential Project

ENV-2019-5520-MND

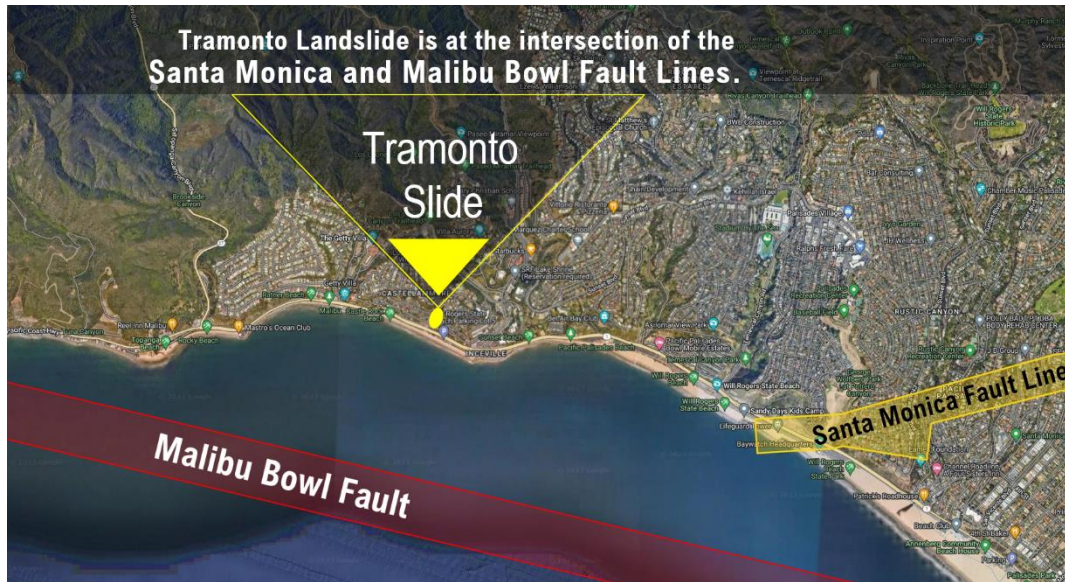
The URS report suggested using solid reinforced concrete to the elevation of the hydraugers. The report showed that there should be structural-support elements in place besides just excavating to the level of the bedrock. The cost to reinforce that Tramonto slide area was estimated to be about \$25 million in July 2010. The report showed a deep-bedrock failure plane between Posetano and Tramonto. That bedrock plane also feeds into the Malibu Coast-Santa Monica Earthquake Fault Line. The URS Corporation concludes with its "Tramonto Landslide Stabilization Study" on behalf of the City of Los Angeles and Caltrans with the goal of developing landslide stabilization measures. Unfortunately, the City of Los Angeles has ignored these findings and recommendations.

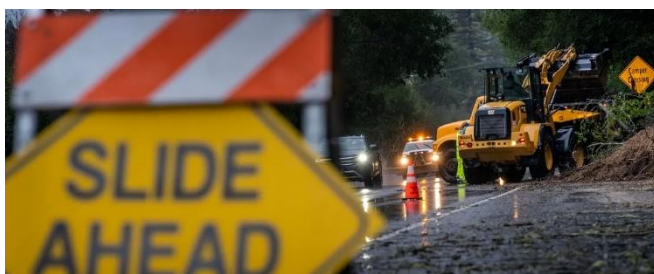
ARTIFICIAL INTELLIGENCE SEARCHES THE INTERNET TO FIND THE ANSWER TO COMPLEX QUESTIONS. HERE IS WHAT IT HAS TO SAY ABOUT **BUILDING ON AN ACTIVE LANDSLIDE.**
