Re: **Council File:** 20-0246
Hearing Date: June 29, 2021
Site Address: 12244-12248 West Pico Boulevard

November 2, 2020
Project No. 2339-006
Historic Preservation Services for
12244 Pico Boulevard, Los Angeles, CA

MEMORANDUM FOR THE RECORD

SUBJECT: Historic Preservation Services for 12244 Pico Boulevard, Los Angeles, California

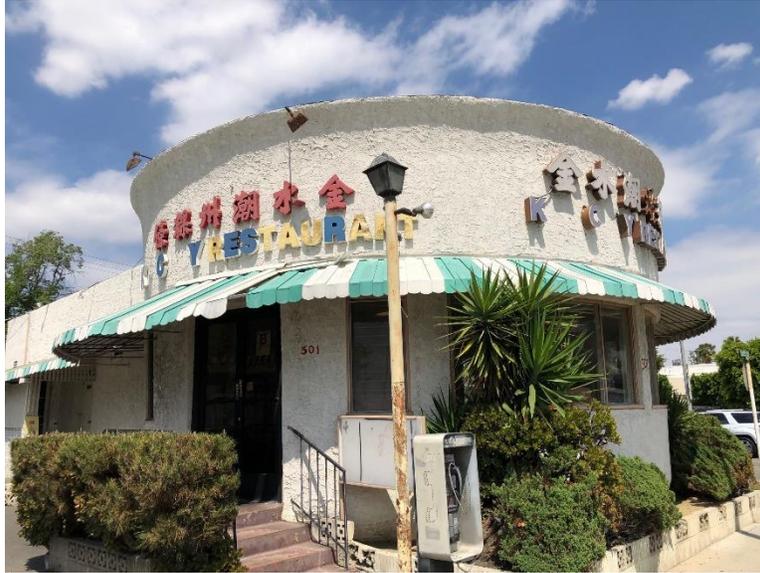
Of the five extant Chili Bowl Restaurants that Whizin commissioned, four are located in Alhambra, Glendale, Huntington Park, and the subject property. Although the Alhambra Chili Bowl Restaurant has been re-clad in rough textured stucco and some windows on the rectangular bay have been infilled, the Alhambra example generally retains integrity and reflects the design of the original prototype (Figure 1, *Chili Bowl Restaurant, Alhambra*; Figure 2, *Chili Bowl Restaurant, Alhambra*).

Figure 1. Chili Bowl Restaurant, Alhambra
SOURCE: Sapphos Environmental, Inc., 2019

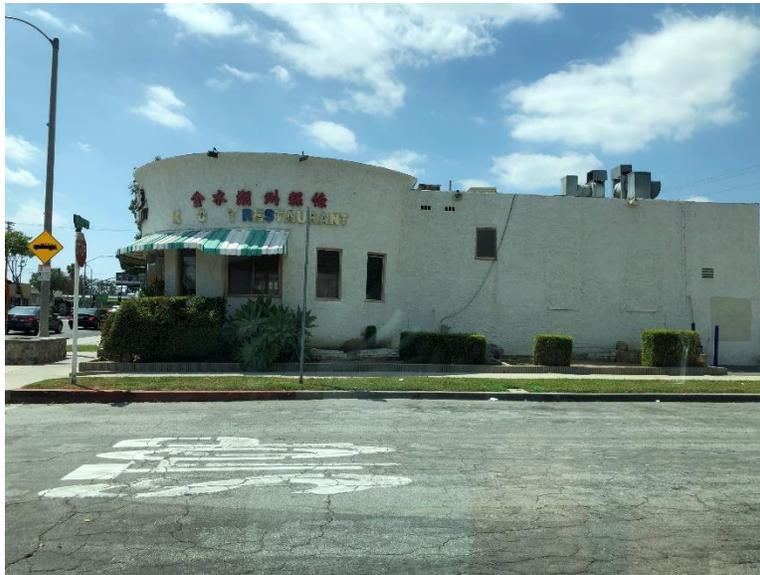
Figure 2. Chili Bowl Restaurant, Alhambra
SOURCE: Sapphos Environmental, Inc., 2019

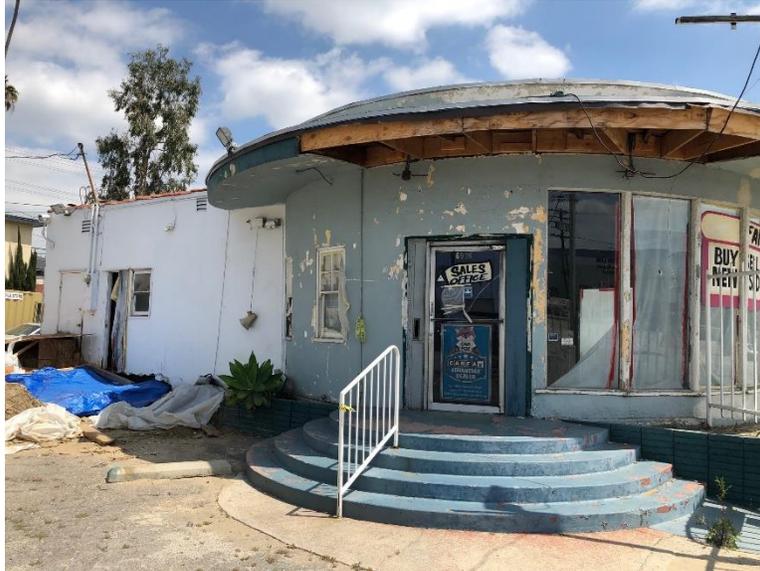
The Glendale Chili Bowl Restaurant has been substantially altered. It was converted to a car dealership at an unknown date. The windows, window openings, and entries have been altered over the course of time (Figure 3, *Chili Bowl Restaurant, Glendale*).

Figure 3. Chili Bowl Restaurant, Glendale
SOURCE: Sapphos Environmental, Inc., 2019

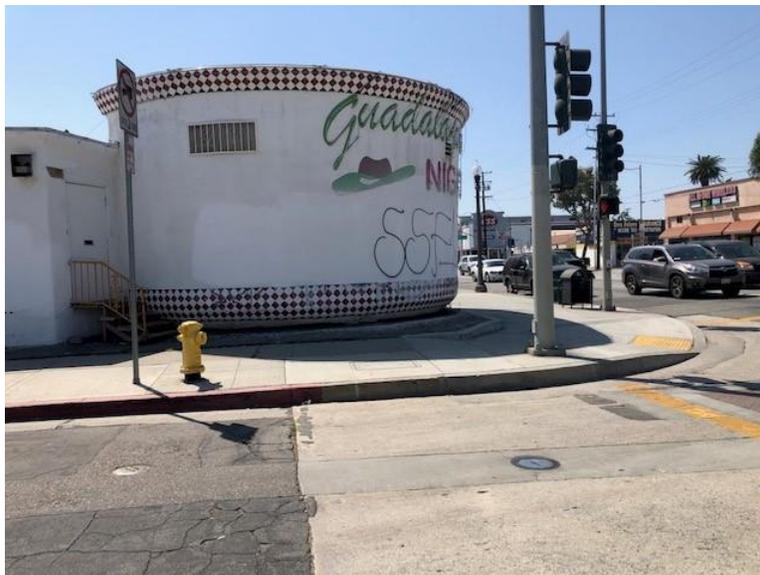
The Huntington Park Chili Bowl Restaurant retains its prominently placed curved bowl bay and rectangular bay. The Huntington Park example generally retains integrity with the exception that all of the windows have been infilled or modified. The building reflects the design of the original prototype (Figure 4, *Chili Bowl Restaurant, Huntington Park*).

Figure 4. Chili Bowl Restaurant, Huntington Park
SOURCE: Sapphos Environmental, Inc., 2019

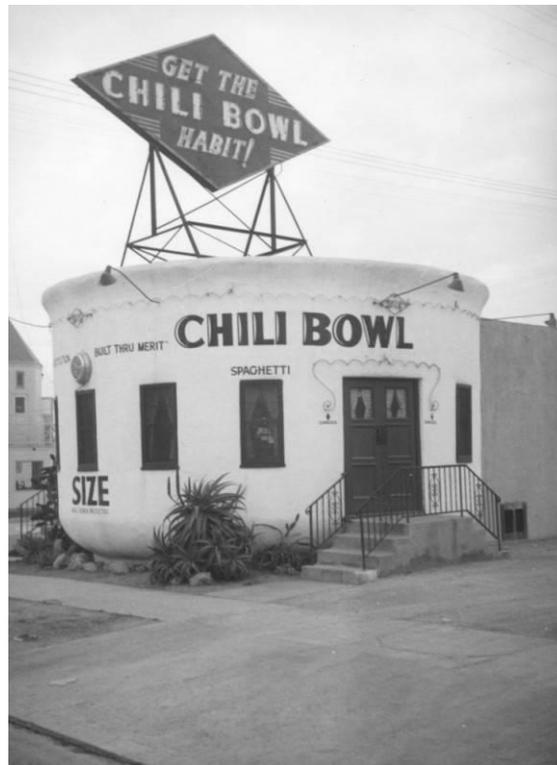
The Chili Bowl Restaurant prototype featured a rounded bay with a convex curved base and concave curved parapet to mimic the shape of a bowl for serving chili. Landscaping was minimal in order to emphasize the curviness of the rounded bay. The one-over-one wood sash windows featured wood window surrounds. The public entrances were accessed via raised cast concrete steps with decorative metal railings and allowed egress to each side of the rounded bay. Narrative descriptions of the restaurant describe the interior as having a standing counter for food service without table seating. A rectangular rear bay presumably housed the kitchen for cooking. The Chili Bowl Restaurant in Figure 5, *Historic Photograph of the Chili Bowl Restaurant* was reportedly located at 801 N. La Brea Avenue; however, based upon the shape and design of the rooftop sign, it is assumed the restaurant located at the subject property was identical in design and materials.

Figure 5. Historic Photograph of the Chili Bowl Restaurant
SOURCE: *Herman Schutheis, Circa 1937*²

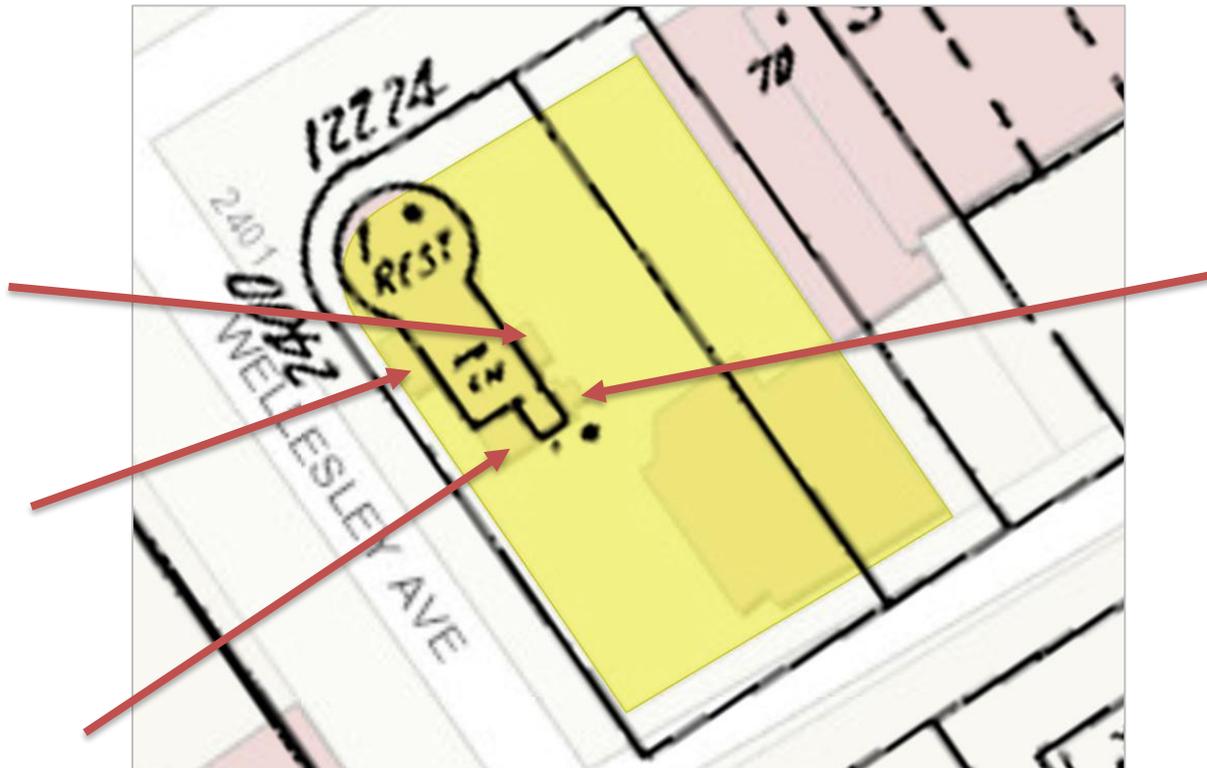
Based upon a review of the historic Sanborn Fire Insurance Maps and the current Los Angeles County Assessor map, the Chili Bowl has been substantially altered over the course of time. As shown in Figure 6, the footprint of the Chili Bowl no longer reflects the historical footprint of the building. The historic Sanborn Fire Insurance Map was overlain on the current footprint as documented by the Assessor. Several side and rear additions, both permitted and unpermitted, are clearly visible and are highlighted with red arrows. The additions are incompatible in terms of materials and design (Figure 7, *Southern and Western Additions*).

Figure 6. 12244 Pico Boulevard

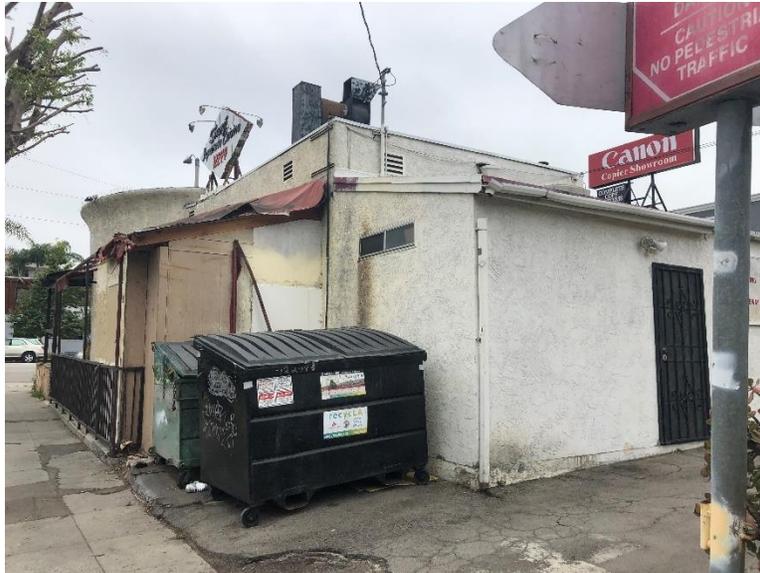
Figure 7. Southern and Western Additions
SOURCE: Sapphos Environmental, Inc., 2020

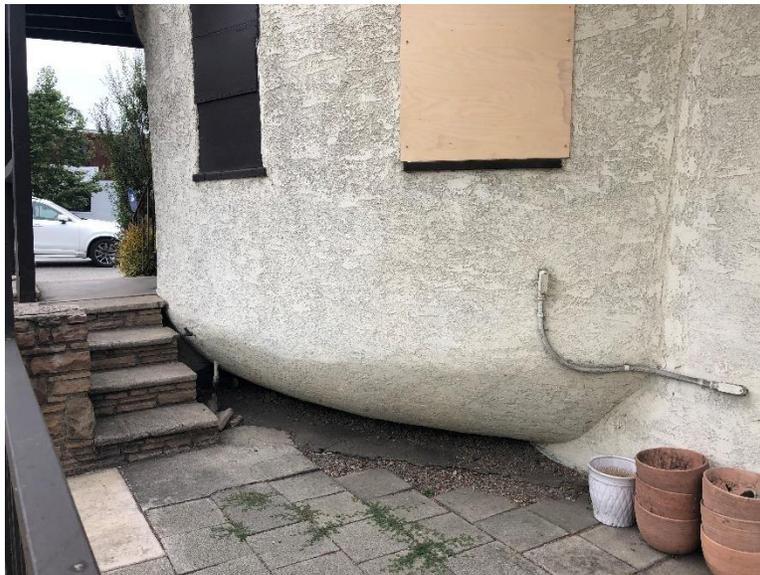
In addition, the building is reclad in rough textured stucco and the original smooth-textured stucco is no longer extant. Some of windows have been boarded up and infilled. The steps and landings were reclad in Roman brick and stone veneer (Figure 8, *Detail of Rough Textured Stucco, Brick and Stone Veneer, and Boarded-Up Windows*).

Figure 8. Detail of Rough Textured Stucco, Brick and Stone Veneer, and Boarded-Up Windows
SOURCE: Sapphos Environmental, Inc., 2020

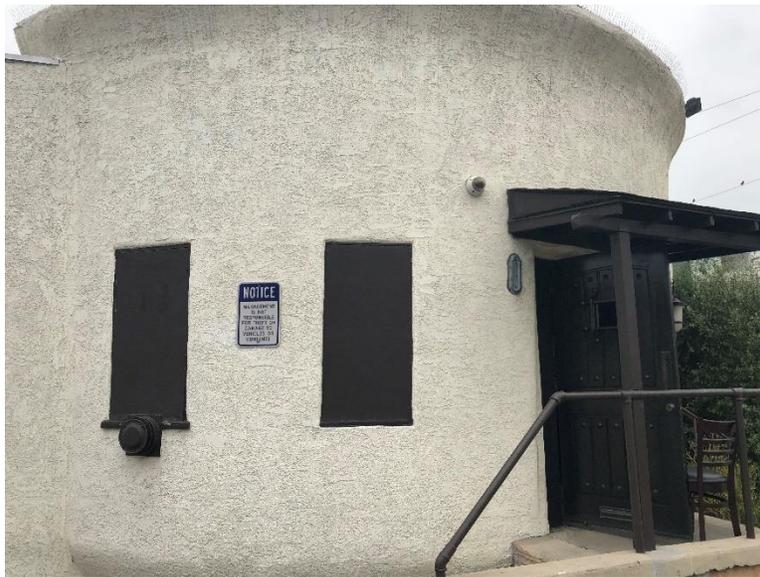
The doors were replaced with Mission-style doors that are not in keeping with Programmatic architecture and are incompatible with the Chile Bowl. All other doors have been replaced with modern units. The goose-neck lighting attached to the parapet wall was removed at an unknown date and was not replaced. Additionally, large metal spikes intended to deter roosting birds was installed at an unknown date and further detracts from the historic design of the curved parapet (Figure 9, *Mission-Style Door*).

Figure 9. Mission-Style Door
SOURCE: *Sapphos Environmental, Inc., 2020*

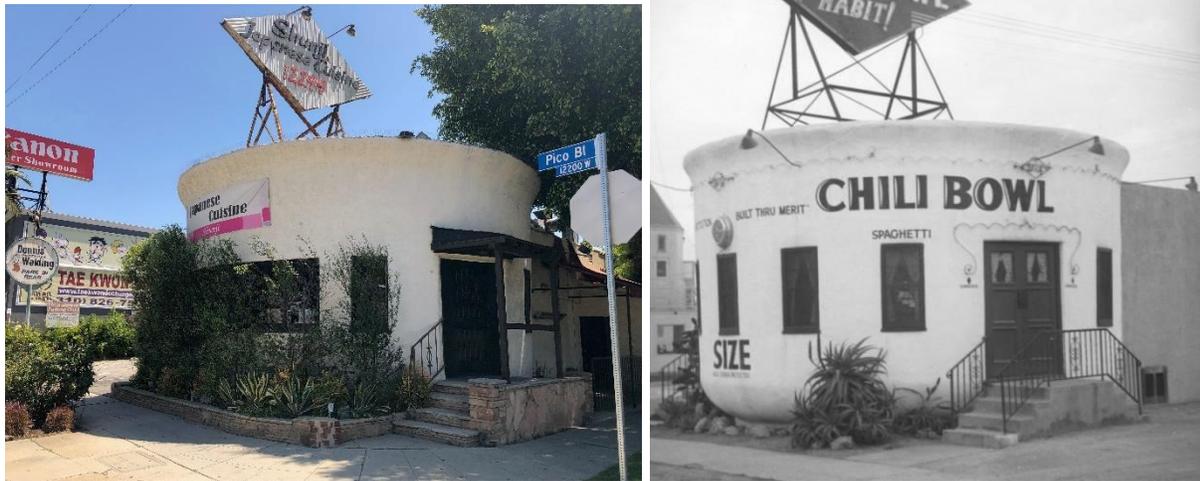
The ribbon of windows on the bowl is dissimilar to the prototype, meaning the window openings have been substantially altered and the windows have been replaced with modern fixed-pane units (Figure 10, *Side by Side Comparison to Demonstrate Window Alterations*).

Figure 10. Side by Side Comparison to Demonstrate Window Alterations
 SOURCE: Sapphos Environmental, Inc., 2019; Herman Schutheis, Circa 1937³

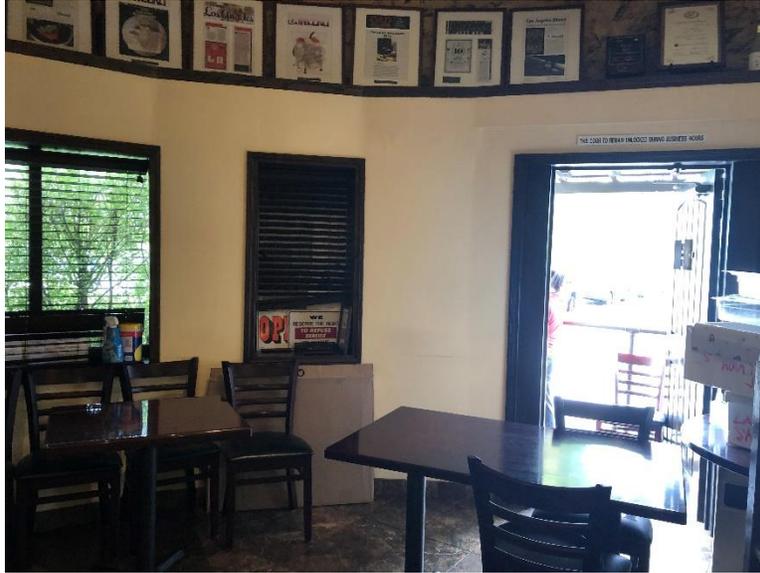
As seen in Figure 11A, the interior features modern fixed-pane anodized aluminum windows. The tile on the floor is modern.

Figure 11A. Interior Detail (facing northeast)
SOURCE: *Sapphos Environmental, Inc., 2020*

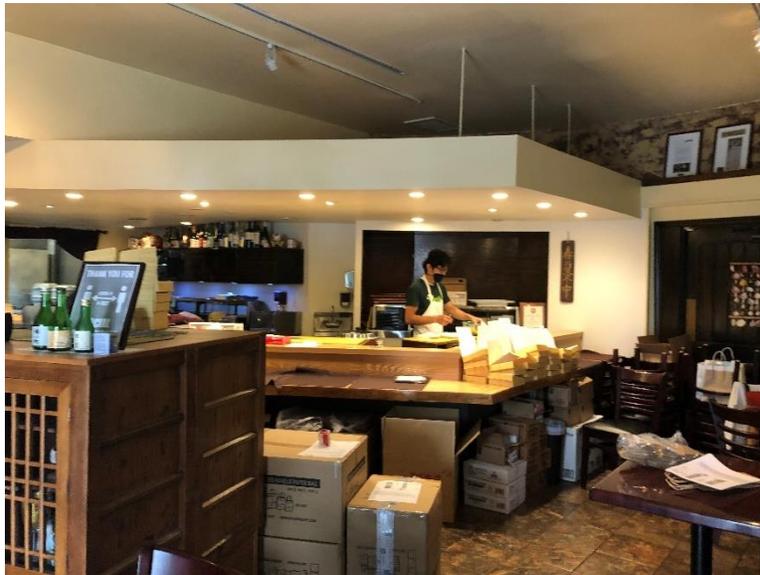
The interior configuration of the Chili Bowl is unknown because no floor plans are known to be available. However, based upon the can lights, suspended flat plane of the lowered ceiling, and the Japanese-style counter, none of these features date to the period of significance for the Chili Bowl (Figure 11B, *Interior Detail*).

Figure 11B. Interior Detail (facing southwest)
SOURCE: *Sapphos Environmental, Inc., 2020*

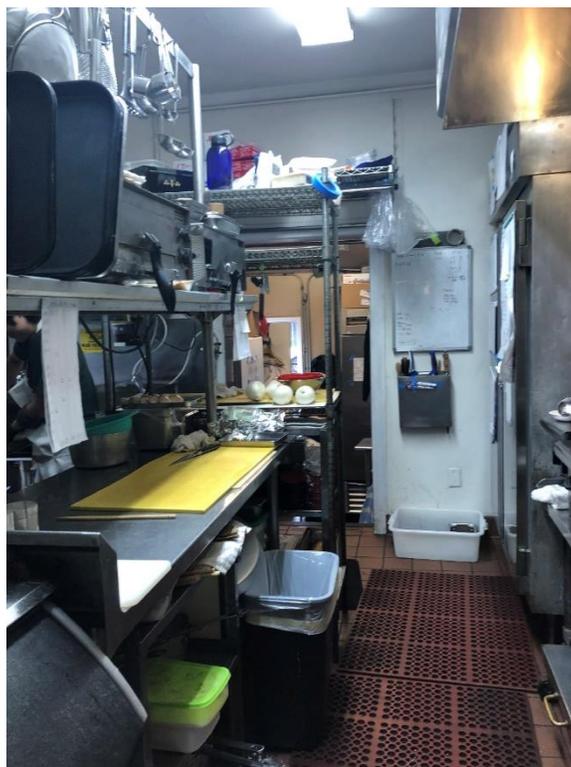
The kitchen features modern equipment that does not date to the period of significance (Figure 12, *Kitchen Detail*).

Figure 12. Kitchen Detail
