**RE: CF-22-0652 - 2345 S. Santa Fe Avenue, Los Angeles, CA 90058**  
**Case No: ENV-2019-7193-CE-2A; Related Case No: ZA 2019-7192-ZAD-1A;**  
**Supplemental Response to Appeal from Sylvia Tidwell**

Three6ixty represents the Applicant, Art Colony Property LLC ("Applicant"), and owner of the property located at 2349 S. Santa Fe Avenue, Los Angeles, CA 90058 ("Project Site") that is the subject of Case Number ENV-2019-7193-CE-2A and related Case No: ZA 2019-7192-ZAD- 1A. The Applicant only received notice of the appeal filed by Ms. Sylvia Tidwell in late-October, after the original notice of the PLUM meeting was issued. Accordingly, the Applicant now submits this letter as a supplement to its previous October 21, 2022 response, attached hereto as Exhibit 1, to respond directly to Ms. Tidwell's May 19, 2022 appeal filing.

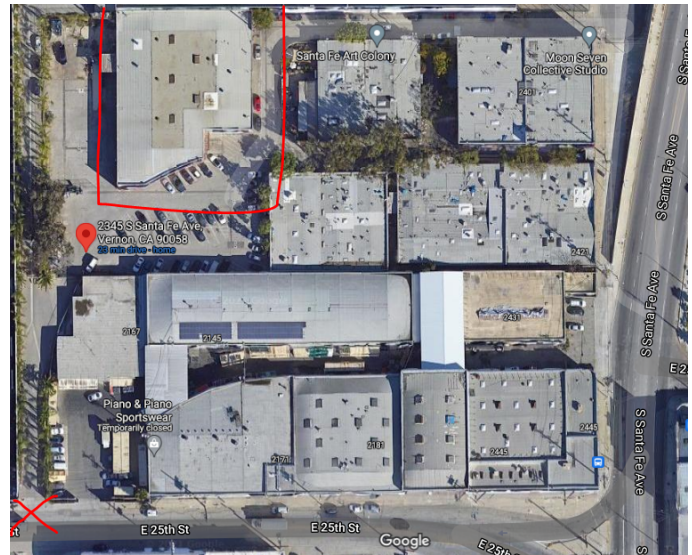
- (2) **Location:** Delivery drivers are inhibited by the narrow driveways and adjacent tenant parking, which causes various operational difficulties. Truck drivers and customers are often disoriented or lost upon searching for the warehouse entrance given the location in the rear of the larger residential Art Colony. See immediately below for a depiction of the warehouse, outlined in red, entry point for the driveway (marked with a red "X"), and the Google Maps address location.
