Re: **Council File: 20-0246 & April 17, 2020, Order Tolling Deadlines**  
12244-12248 West Pico Boulevard / Chili Bowl / Historic-Cultural  
Monument

November 2, 2020  
Project No. 2339-006  
Historic Preservation Services for  
12244 Pico Boulevard, Los Angeles, CA

**MEMORANDUM FOR THE RECORD**

SUBJECT: Historic Preservation Services for 12244 Pico Boulevard, Los Angeles, California

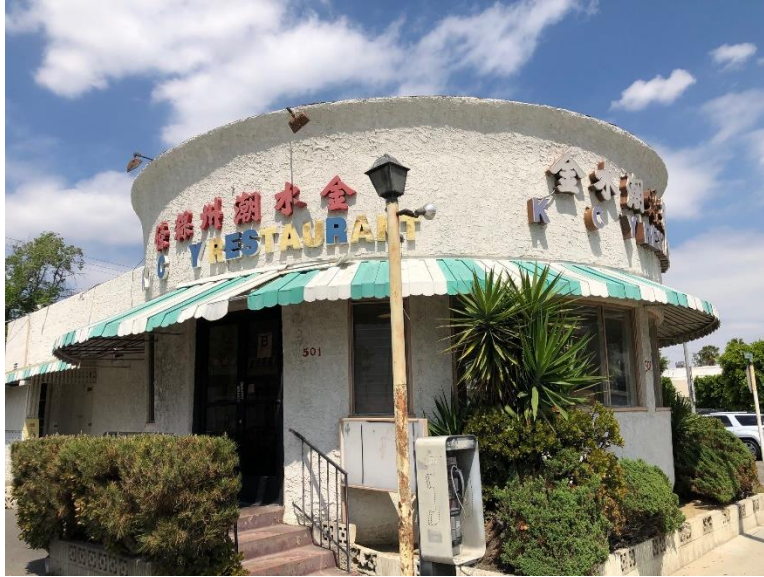
**Figure 1. Chili Bowl Restaurant, Alhambra**  
SOURCE: Sapphos Environmental, Inc., 2019

Of the five extant Chili Bowl Restaurants that Whizin commissioned, four are located in Alhambra, Glendale, Huntington Park, and the subject property. Although the Alhambra Chili Bowl Restaurant has been re-clad in rough textured stucco and some windows on the rectangular bay have been infilled, the Alhambra example generally retains integrity and reflects the design of the original prototype (Figure 1, *Chili Bowl Restaurant, Alhambra*; Figure 2, *Chili Bowl Restaurant, Alhambra*).

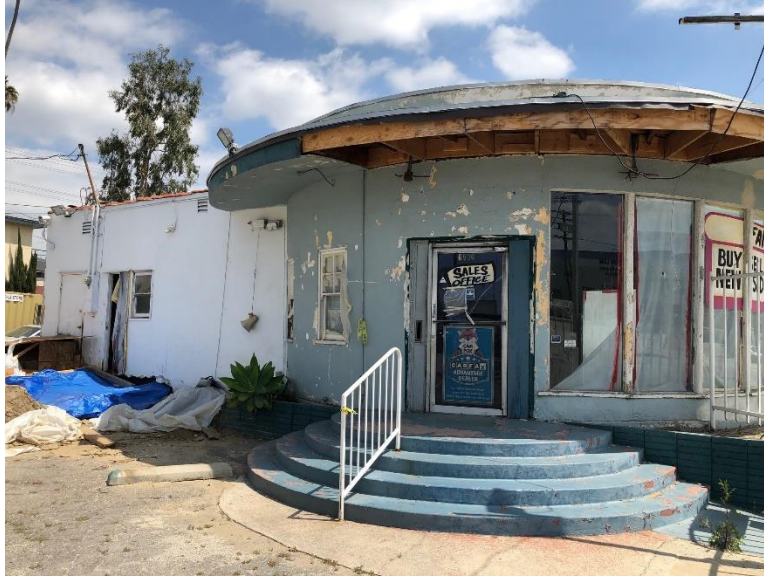
**Figure 3. Chili Bowl Restaurant, Glendale**  
SOURCE: Sapphos Environmental, Inc., 2019

The Glendale Chili Bowl Restaurant has been substantially altered. It was converted to a car dealership at an unknown date. The windows, window openings, and entries have been altered over the course of time (Figure 3, *Chili Bowl Restaurant, Glendale*).

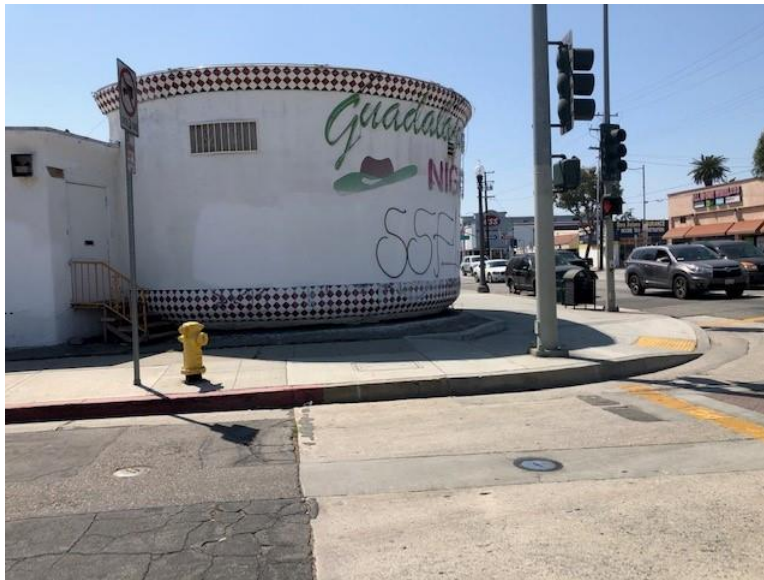
**Figure 4. Chili Bowl Restaurant, Huntington Park**  
SOURCE: Sapphos Environmental, Inc., 2019

The Huntington Park Chili Bowl Restaurant retains its prominently placed curved bowl bay and rectangular bay. The Huntington Park example generally retains integrity with the exception that all of the windows have been infilled or modified. The building reflects the design of the original prototype (Figure 4, *Chili Bowl Restaurant, Huntington Park*).

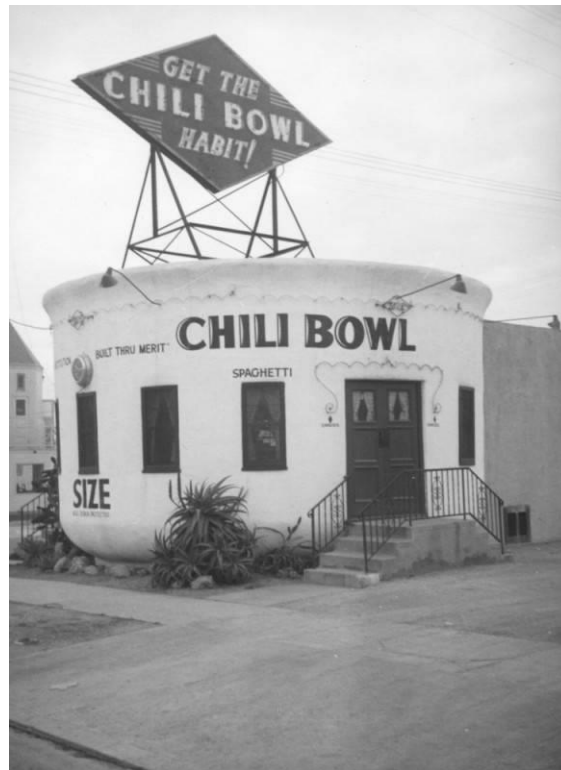
**Figure 5. Historic Photograph of the Chili Bowl Restaurant**  
SOURCE: *Herman Schutheis, Circa 1937*<sup>2</sup>

The Chili Bowl Restaurant prototype featured a rounded bay with a convex curved base and concave curved parapet to mimic the shape of a bowl for serving chili. Landscaping was minimal in order to emphasize the curviness of the rounded bay. The one-over-one wood sash windows featured wood window surrounds. The public entrances were accessed via raised cast concrete steps with decorative metal railings and allowed egress to each side of the rounded bay. Narrative descriptions of the restaurant describe the interior as having a standing counter for food service without table seating. A rectangular rear bay presumably housed the kitchen for cooking. The Chili Bowl Restaurant in Figure 5, *Historic Photograph of the Chili Bowl Restaurant* was reportedly located at 801 N. La Brea Avenue; however, based upon the shape and design of the rooftop sign, it is assumed the restaurant located at the subject property was identical in design and materials.

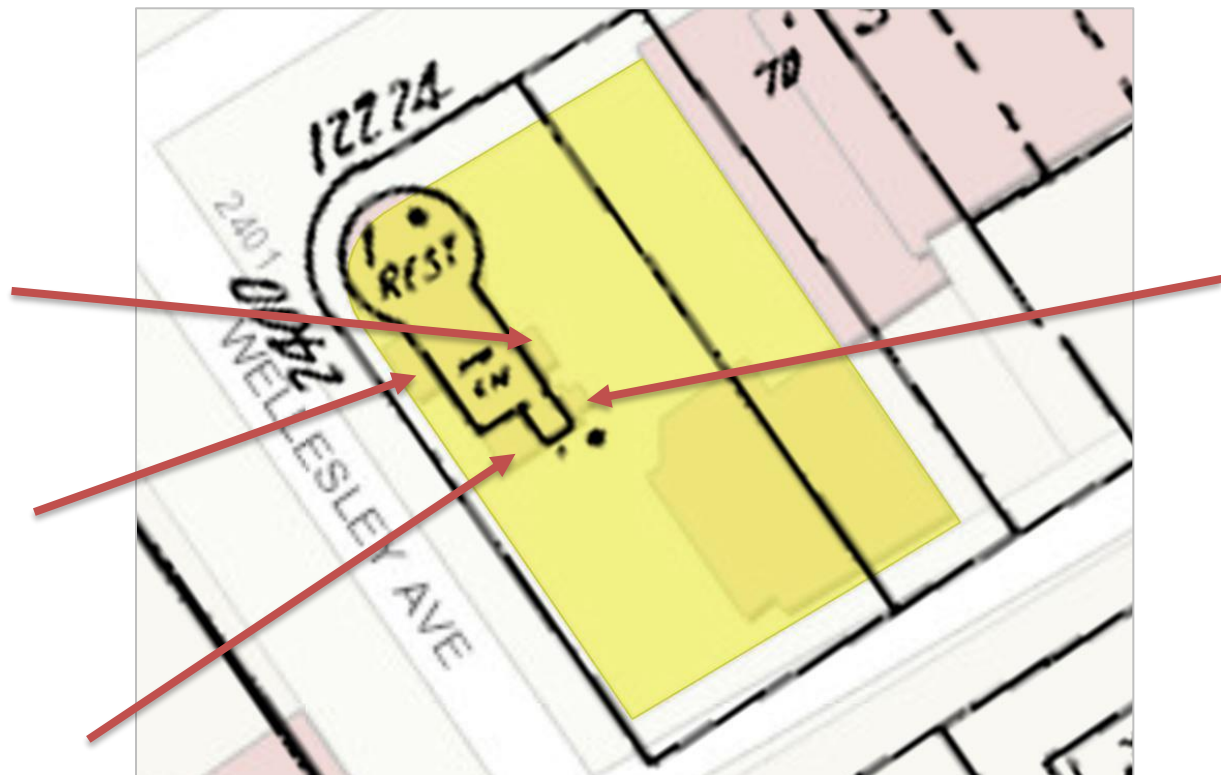
**Figure 6. 12244 Pico Boulevard**

Based upon a review of the historic Sanborn Fire Insurance Maps and the current Los Angeles County Assessor map, the Chili Bowl has been substantially altered over the course of time. As shown in Figure 6, the footprint of the Chili Bowl no longer reflects the historical footprint of the building. The historic Sanborn Fire Insurance Map was overlain on the current footprint as documented by the Assessor. Several side and rear additions, both permitted and unpermitted, are clearly visible and are highlighted with red arrows. The additions are incompatible in terms of materials and design (Figure 7, *Southern and Western Additions*).

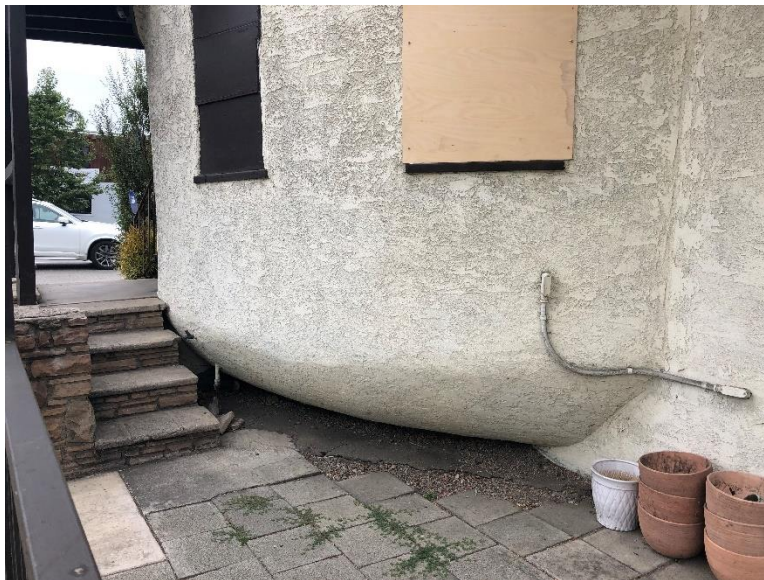
**Figure 8. Detail of Rough Textured Stucco, Brick and Stone Veneer, and Boarded-Up Windows**  
SOURCE: Sapphos Environmental, Inc., 2020

In addition, the building is re clad in rough textured stucco and the original smooth-textured stucco is no longer extant. Some of windows have been boarded up and infilled. The steps and landings were re clad in Roman brick and stone veneer (Figure 8, *Detail of Rough Textured Stucco, Brick and Stone Veneer, and Boarded-Up Windows*).

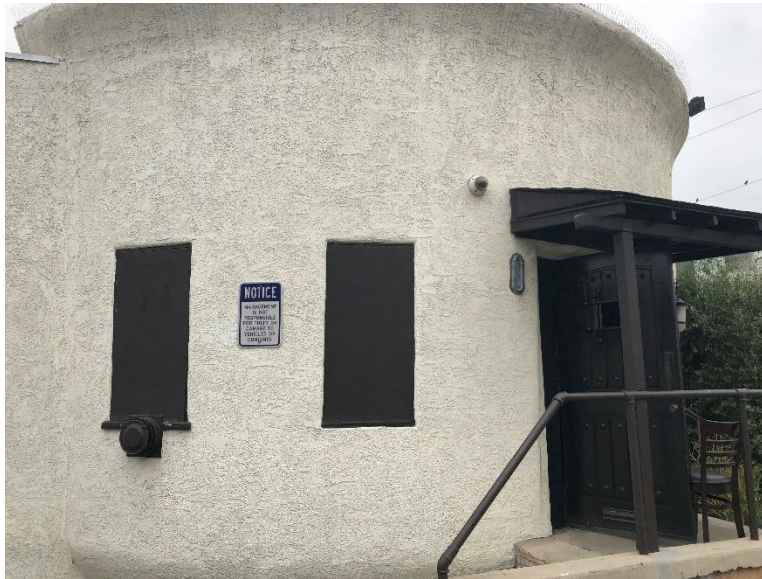
**Figure 9. Mission-Style Door**  
SOURCE: *Sapphos Environmental, Inc., 2020*

The doors were replaced with Mission-style doors that are not in keeping with Programmatic architecture and are incompatible with the Chile Bowl. All other doors have been replaced with modern units. The goose-neck lighting attached to the parapet wall was removed at an unknown date and was not replaced. Additionally, large metal spikes intended to deter roosting birds was installed at an unknown date and further detracts from the historic design of the curved parapet (Figure 9, *Mission-Style Door*).

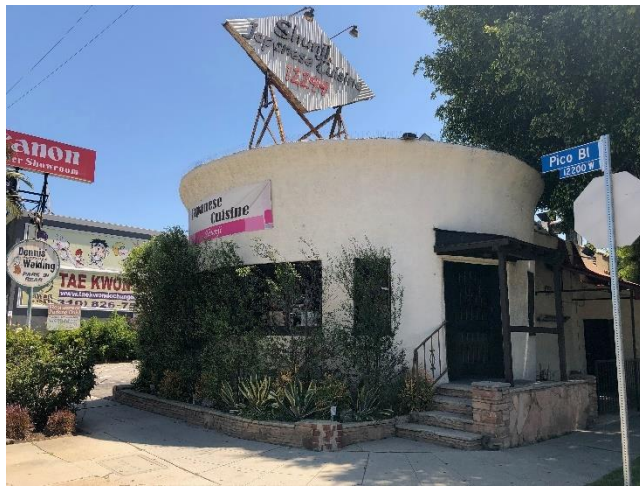
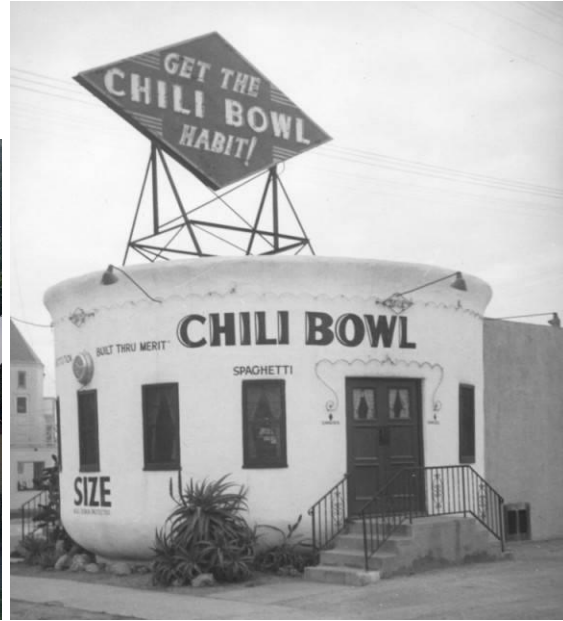
**Figure 10. Side by Side Comparison to Demonstrate Window Alterations**  
SOURCE: Sapphos Environmental, Inc., 2019; Herman Schutheis, Circa 1937<sup>3</sup>

The ribbon of windows on the bowl is dissimilar to the prototype, meaning the window openings have been substantially altered and the windows have been replaced with modern fixed-pane units (Figure 10, *Side by Side Comparison to Demonstrate Window Alterations*).

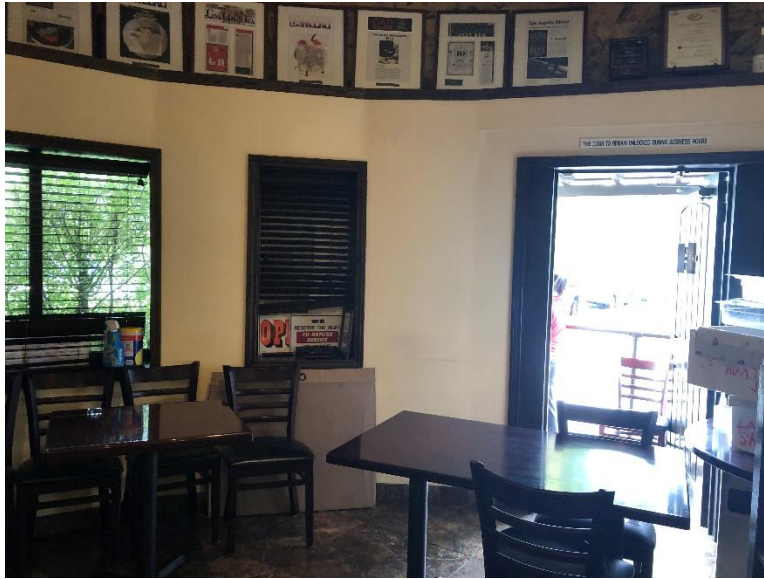
**Figure 11A. Interior Detail (facing northeast)**

As seen in Figure 11A, the interior features modern fixed-pane anodized aluminum windows. The tile on the floor is modern.

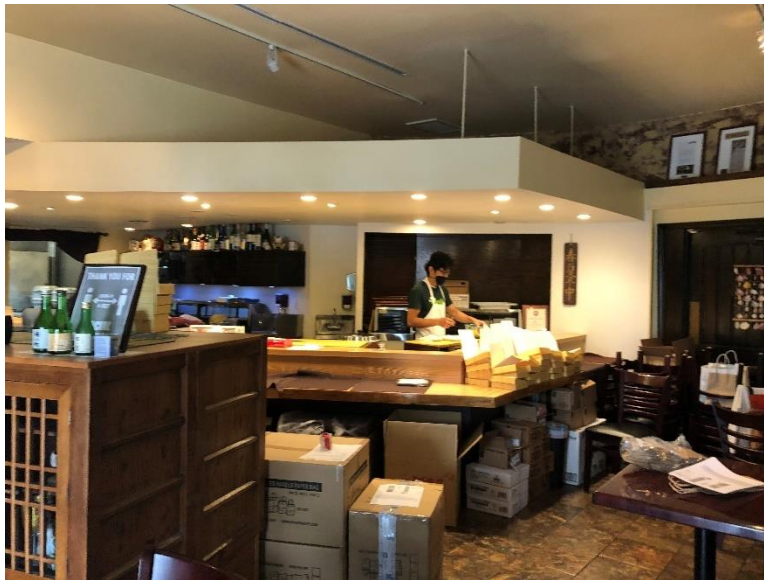
**Figure 11B. Interior Detail (facing southwest)**

The interior configuration of the Chili Bowl is unknown because no floor plans are known to be available. However, based upon the can lights, suspended flat plane of the lowered ceiling, and the Japanese-style counter, none of these features date to the period of significance for the Chili Bowl (Figure 11B, *Interior Detail*).

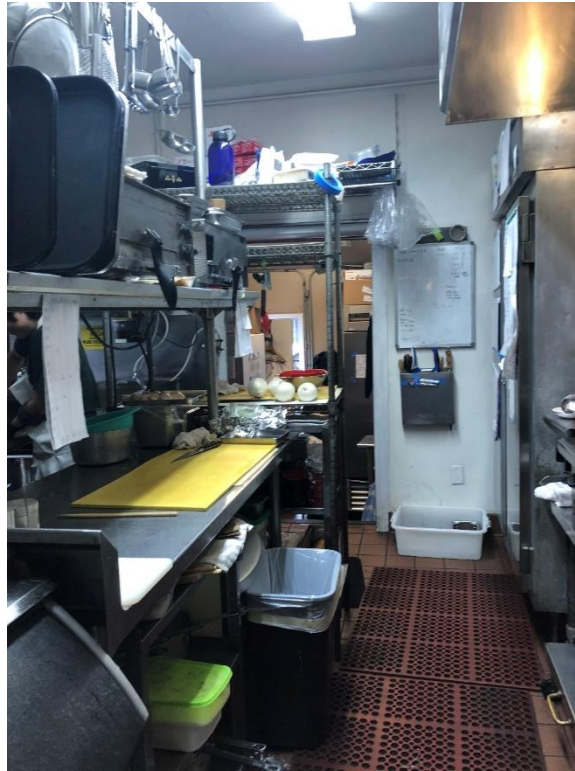
**Figure 12. Kitchen Detail**

The kitchen features modern equipment that does not date to the period of significance (Figure 12, *Kitchen Detail*).
