Site Accessibility Evaluation

**L. Ron Hubbard Way to N.
Catalina Street
East Hollywood, CA 90027**

CASp Evaluation

Inspection Date: 02/27/2025

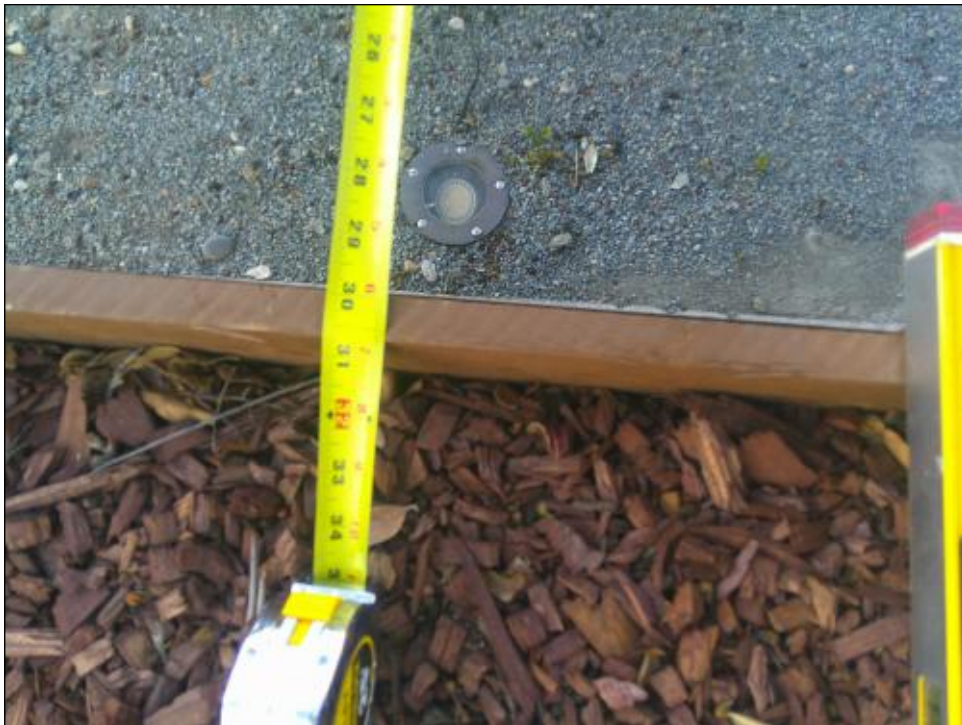
Finding: 11 Additional Finding Photos

When, because of right-of-way restrictions, natural barriers or other existing conditions, the enforcing agency determines that compliance with the 48-inch clear sidewalk width would create an unreasonable hardship, the clear width may be reduced to 36 inches.

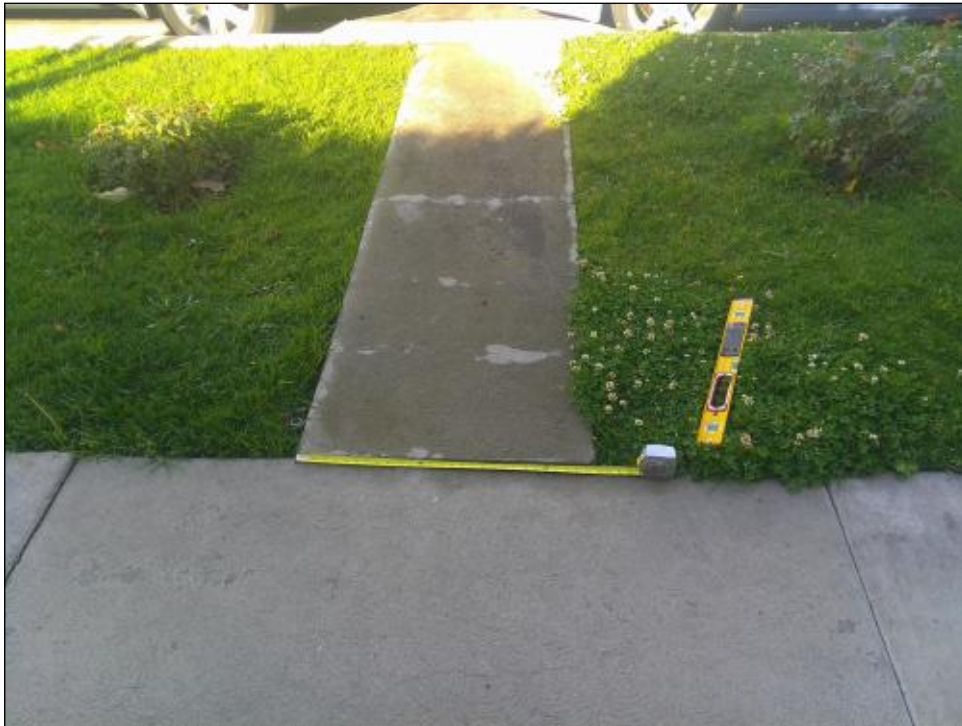
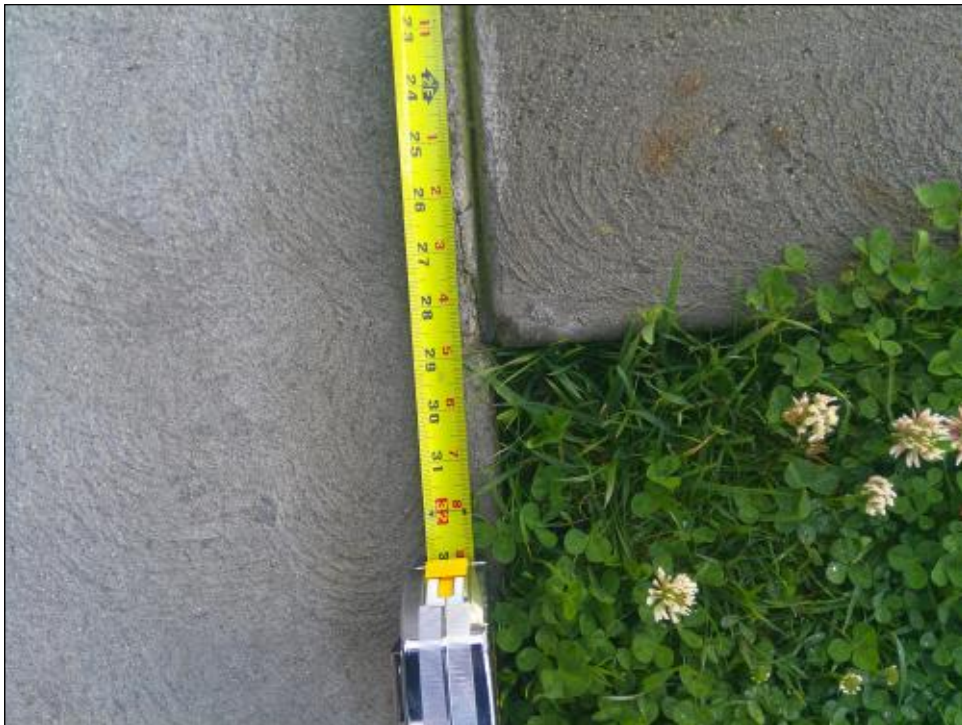
Finding: 27 Additional Finding Photos

When, because of right-of-way restrictions, natural barriers or other existing conditions, the enforcing agency determines that compliance with the 48-inch clear sidewalk width would create an unreasonable hardship, the clear width may be reduced to 36 inches.
