**PHASE I ENVIRONMENTAL
SITE ASSESSMENT REPORT**

1155 and 1165 South Main Street
Los Angeles, California 90015
Assessor's Parcel Numbers: 5139-017-015 and 5139-017-016

Jade Enterprises
888 South Figueroa Street
Los Angeles, California 90017

March 14, 2014

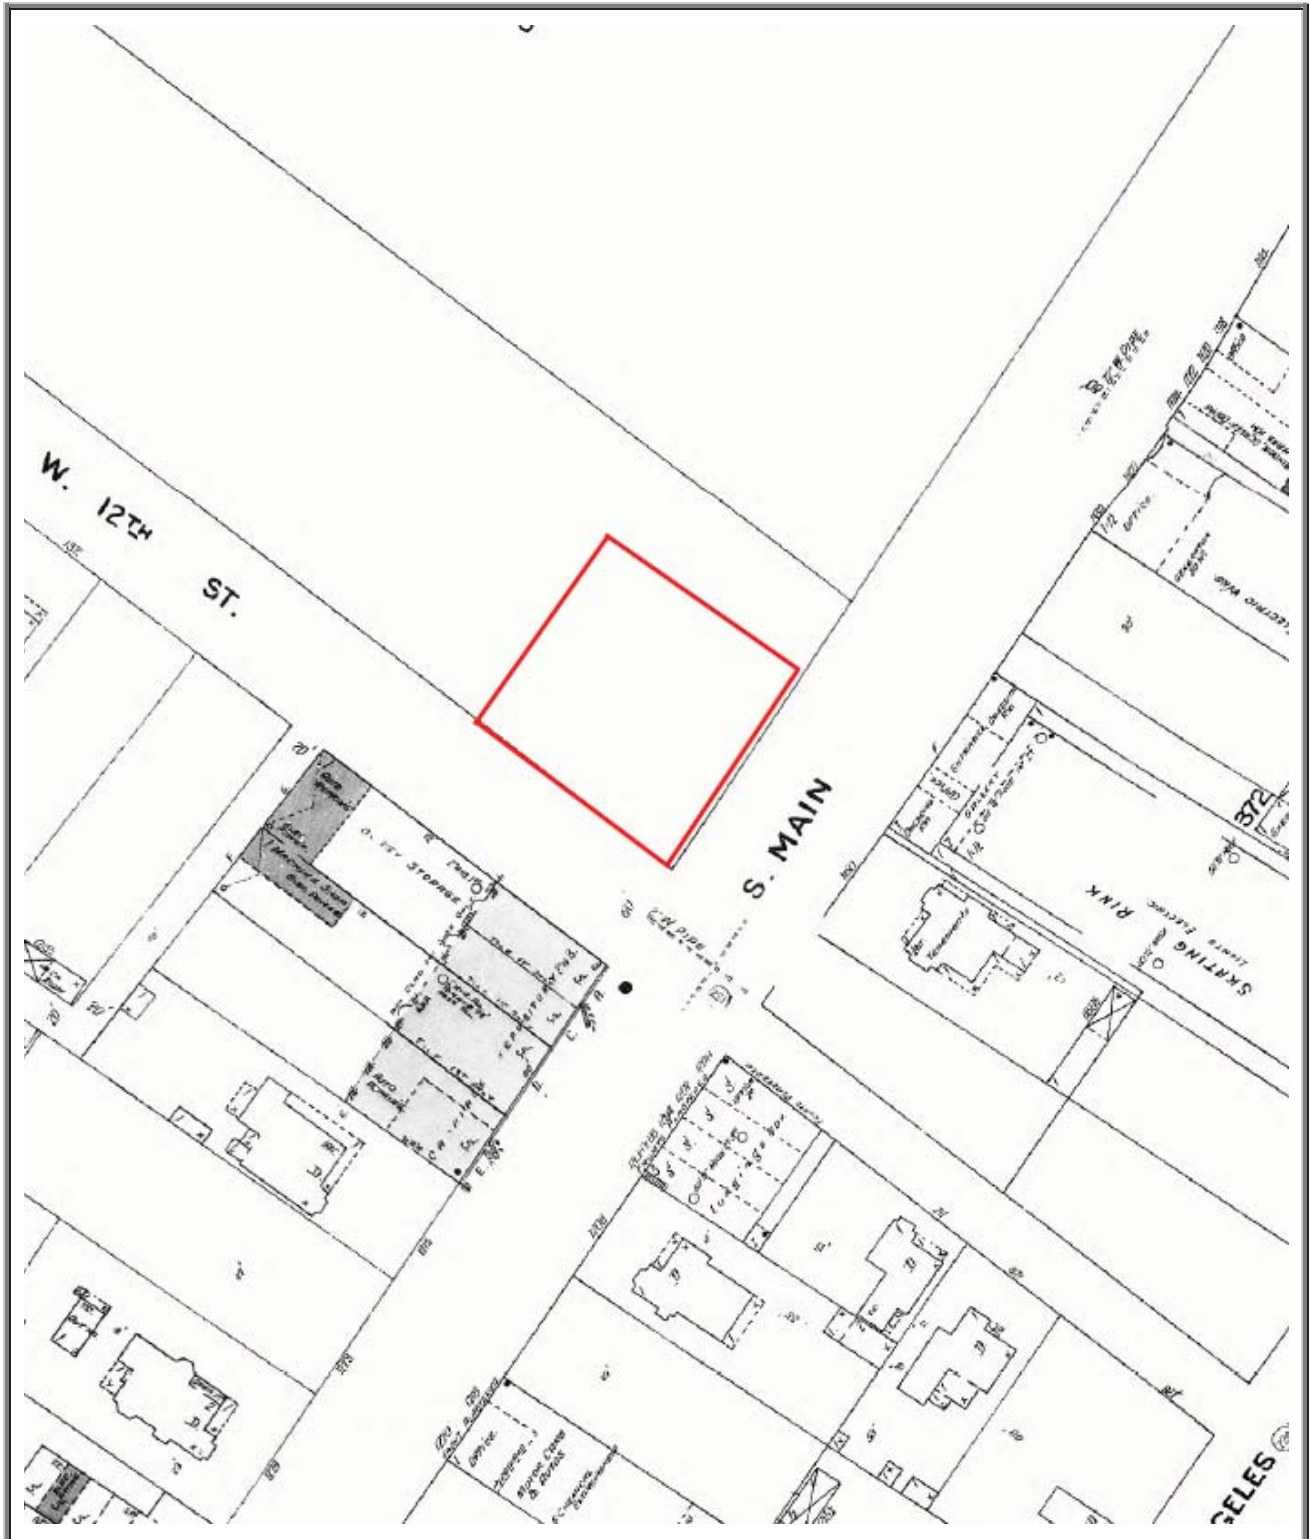
Figure 5D: 1906 SANBORN MAP

- The subject property was historically utilized for auto repair operations including tire rebuilding from 1906 to 2004. For more information, please refer to the Environmental Data Search Section below.
