MEMORANDUM

DATE: DECEMBER 13, 2021

SUBJECT: Surface Expression, Pacific Coast Energy Company LP, 9151 West Pico Boulevard, Los Angeles, CA 90035

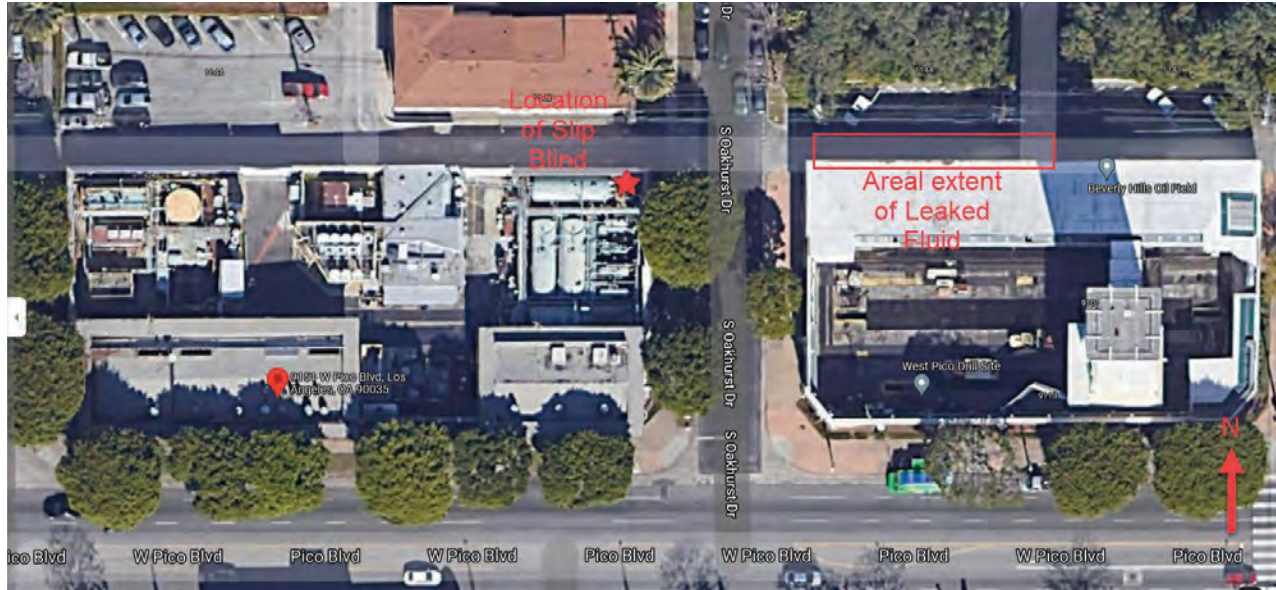
Figure 1. Map of Drill site and facility compounds. Drill site is the right most building centered in map, facility compound is leftmost building centered in map.
