# 3433 W. 8th St. Arborist Report

Prepared for CORBeL Architects Inc.  
Mick Myungsik Choi  
3450 Wilshire Blvd., Suite 1000  
Los Angeles, CA 90010

**Prepared by James Komen**  
BCMA WE-9909B  
RCA #555

Mick Myungsik Choi of CORBeL Architects Inc. asked me to prepare a Protected Tree Report for the City of Los Angeles Urban Forestry Department documenting the trees on a property proposed for development. I visited the subject property alone on July 2, 2021 at 3:30pm to collect the data for this report.

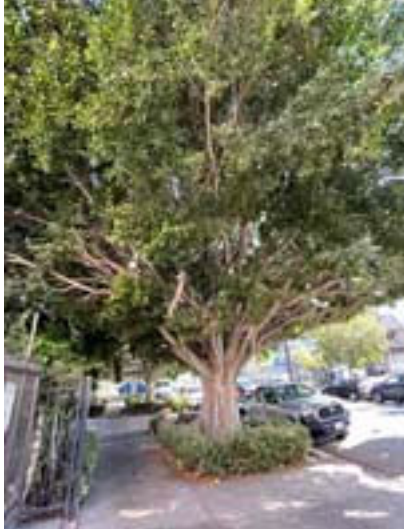
<p><b>Tree 1</b> <i>Ficus microcarpa</i> – Indian Laurel Fig</p> <p>This tree is a street tree, growing within the public right of way. It will be removed because it is growing too close to the footprint of the proposed driveway that it would not survive the root cuts that would result from the necessary excavation. Moreover, there is a fair probability that the root cutting that would result from the driveway's construction would destabilize the tree.</p> <p>This tree is currently lifting the adjacent sidewalk. It has been partially suppressed by competition with its neighbor, Tree 2. Overall, this tree is vigorous, but it has an asymmetrical canopy.</p> <p>If Tree 2 is removed, then Tree 1 would be exposed to new wind loads, and it would have an increased likelihood of failure. Thus, I recommend that Tree 1 and Tree 2 be treated as a unit together for purposes of determining which tree will be retained or removed.</p>

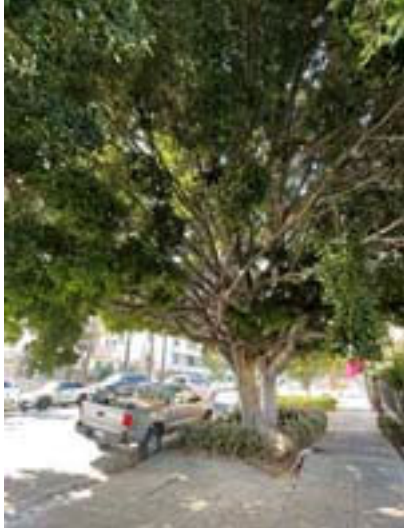
<p><b>Tree 2</b> <i>Ficus microcarpa</i> – Indian Laurel Fig</p> <p>This tree is a street tree, growing within the public right of way. It will be removed because it is growing too close to the footprint of the proposed driveway for it to survive the root cutting that would result. Also, the proposed building encroaches within the drip line of this tree, so substantial root cutting would result from excavating for the building's subterranean parking. This tree would not likely survive these impacts.</p> <p>This tree is currently lifting the adjacent sidewalk. It has been partially suppressed by competition with its neighbor, Tree 1. Overall, this tree is vigorous, but it has an asymmetrical canopy.</p>

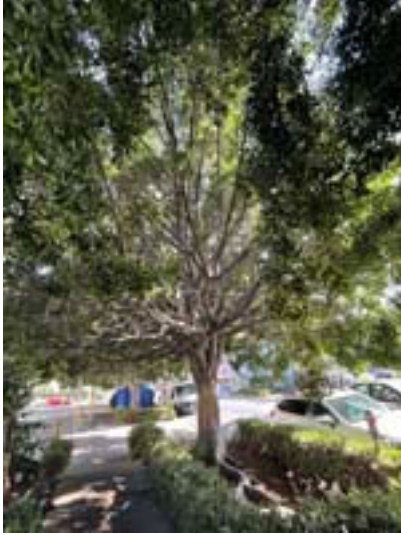
### **Tree 3**

This tree is a street tree, growing within the public right of way. It will be removed because it is growing too close to the footprint of the proposed driveway for it to survive the root cutting that would result. Also, the proposed building encroaches within the drip line of this tree, so substantial root cutting would result from excavating for the building's subterranean parking. This tree would not likely survive these impacts.

This tree has a thinning canopy, but it is still in good condition.

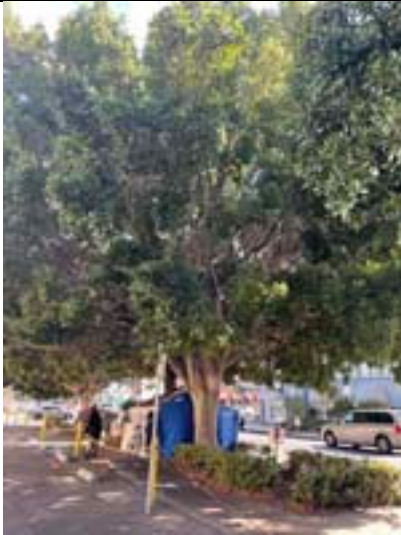
### **Tree 4**

This tree is a street tree, growing within the public right of way. It will be retained in the landscape through the proposed project.

The proposed building and sidewalk repairs will encroach within the critical root zone of this tree. All project activity within the drip line of this tree should be directly supervised by a Certified Arborist. Some of this tree's root system may be impacted, but it is intended to be retained in place throughout the project.

This tree has a thinning canopy, but it is still in good condition. I recommend pruning this tree's lowest branches for sidewalk clearance to a height of 8-10 feet. Pruning cuts should be no larger than 2 inches in diameter.

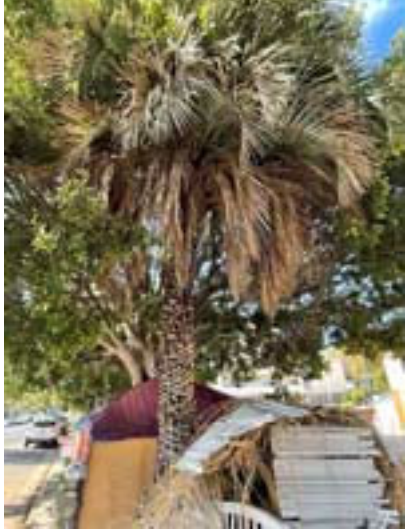
<p><b>Tree 5</b>  <i>Butia capitata</i> – Jelly Palm</p> <p>This tree is a street tree, growing within the public right of way. It will be retained in the landscape through the proposed project.</p> <p>This tree has been suppressed by competition with its neighbor, Tree 4. It is in average condition. I recommend pruning off its dead fronds.</p> <p>The proposed sidewalk repairs will encroach within the critical root zone of this tree. All project activity within 10 feet of this tree should be directly supervised by a Certified Arborist. Some of this tree's root system may be impacted, but it is intended to be retained in place throughout the project.</p>

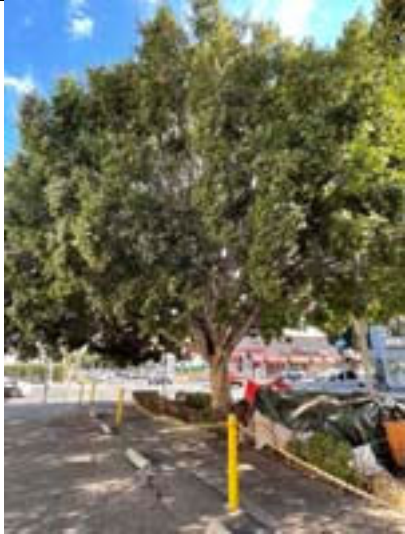
<p><b>Tree 6</b>  <i>Ficus microcarpa</i> – Indian Laurel Fig</p> <p>This tree is a street tree, growing within the public right of way. It will be retained in the landscape through the proposed project.</p> <p>This tree has a thinning canopy, but it is still in good condition. I recommend pruning this tree's lowest branches for sidewalk clearance.</p> <p>The proposed building and sidewalk repairs will encroach within the critical root zone of this tree. All project activity within the drip line of this tree should be directly supervised by a Certified Arborist. Some of this tree's root system may be impacted, but it is intended to be retained in place throughout the project.</p>

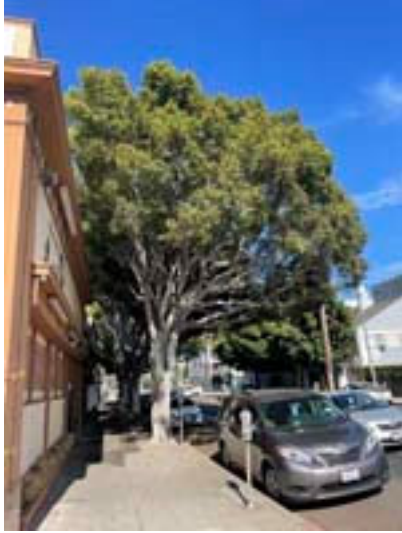
<p><b>Tree 7</b>  <i>Ficus microcarpa</i> – Indian Laurel Fig</p> <p>This tree is a street tree, growing within the public right of way. It will be retained in the landscape through the proposed project.</p> <p>This tree’s interior branches were removed in the past, leaving most of its foliage at the branch tips. The roots of this tree are lifting the sidewalk.</p> <p>The proposed building and sidewalk repairs will encroach within the critical root zone of this tree. All project activity within the drip line of this tree should be directly supervised by a Certified Arborist. Some of this tree's root system may be impacted, but it is intended to be retained in place throughout the project.</p>

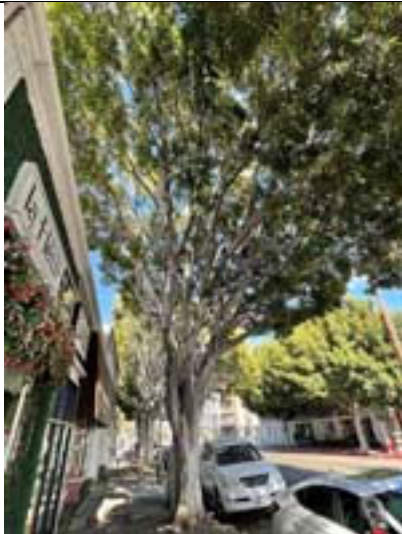
<p><b>Tree 8</b>  <i>Ficus microcarpa</i> – Indian Laurel Fig</p> <p>This tree is a street tree, growing within the public right of way. It will be retained in the landscape through the proposed project.</p> <p>This tree’s interior branches were removed in the past, leaving most of its foliage at the branch tips. The roots of this tree are lifting the sidewalk.</p> <p>The proposed building and sidewalk repairs will encroach within the critical root zone of this tree. All project activity within the drip line of this tree should be directly supervised by a Certified Arborist. Some of this tree's root system may be impacted, but it is intended to be retained in place throughout the project.</p>

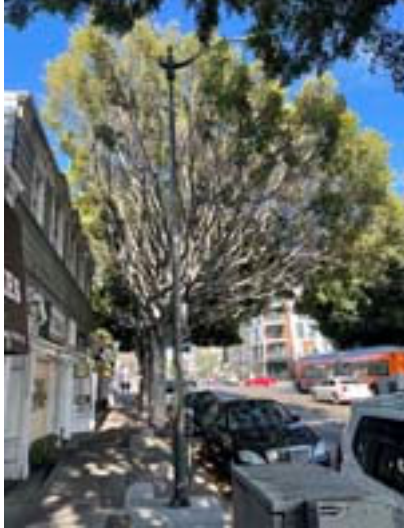
<p><b>Tree 9</b>  <i>Ficus microcarpa</i> – Indian Laurel Fig</p> <p>This tree is a street tree, growing within the public right of way. It will be retained in the landscape through the proposed project.</p> <p>This tree’s interior branches were removed in the past, leaving most of its foliage at the branch tips. The canopy is also thinning due to heat or drought stress. The roots of this tree are lifting the sidewalk.</p> <p>The proposed building and sidewalk repairs will encroach within the critical root zone of this tree. All project activity within the drip line of this tree should be directly supervised by a Certified Arborist. Some of this tree's root system may be impacted, but it is intended to be retained in place throughout the project.</p>

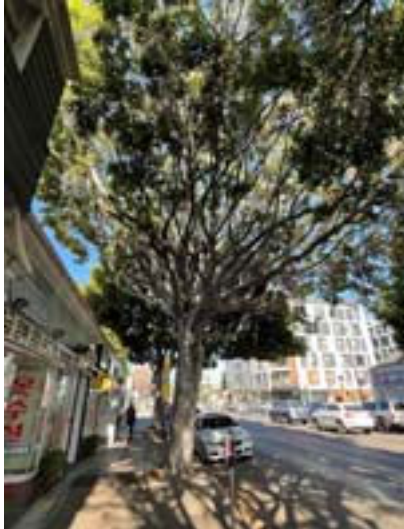
<p><b>Tree 10</b>  <i>Ficus microcarpa</i> – Indian Laurel Fig</p> <p>This tree is a street tree, growing within the public right of way. It will be retained in the landscape through the proposed project.</p> <p>This tree’s interior branches were removed in the past, leaving most of its foliage at the branch tips. The canopy is also thinning due to heat or drought stress. The roots of this tree are lifting the sidewalk.</p> <p>The proposed building and sidewalk repairs will encroach within the critical root zone of this tree. All project activity within the drip line of this tree should be directly supervised by a Certified Arborist. Some of this tree's root system may be impacted, but it is intended to be retained in place throughout the project.</p>

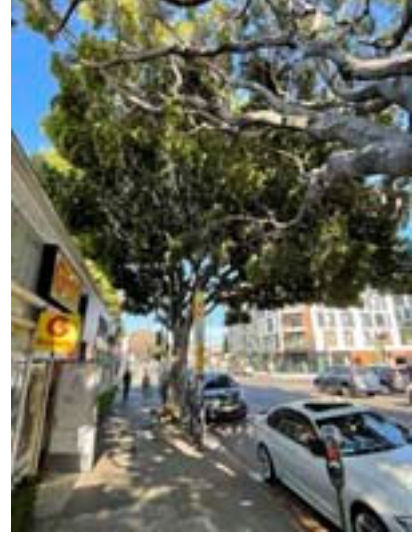
<p><b>Tree 11</b>  <i>Ficus microcarpa</i> – Indian Laurel Fig</p> <p>This tree is a street tree, growing within the public right of way. It will be retained in the landscape through the proposed project.</p> <p>This tree is currently lifting the sidewalk. Its canopy is healthy.</p> <p>The proposed building and sidewalk repairs will encroach within the critical root zone of this tree. All project activity within the drip line of this tree should be directly supervised by a Certified Arborist. Some of this tree's root system may be impacted, but it is intended to be retained in place throughout the project.</p>

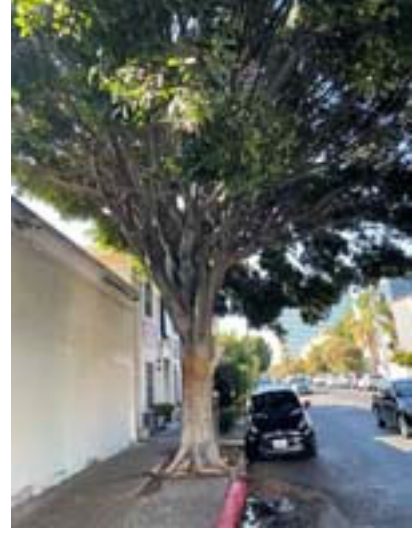
<p><b>Tree 12</b>  <i>Ficus microcarpa</i> – Indian Laurel Fig</p> <p>This tree is a street tree, growing within the public right of way. It will be retained in the landscape through the proposed project.</p> <p>This tree is currently lifting the sidewalk. Its canopy is healthy.</p> <p>The proposed building and sidewalk repairs will encroach within the critical root zone of this tree. All project activity within the drip line of this tree should be directly supervised by a Certified Arborist. Some of this tree's root system may be impacted, but it is intended to be retained in place throughout the project.</p>

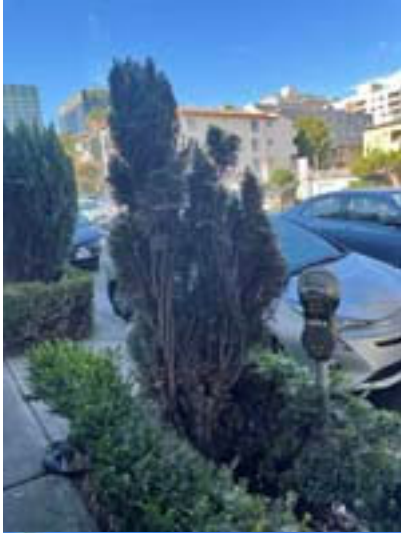
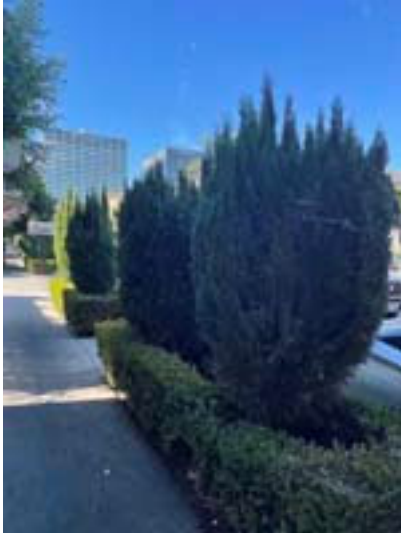
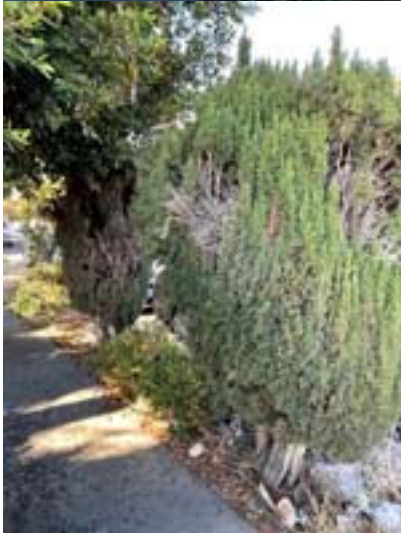
### **Trees 13-23**

These trees are street trees, growing within the public right of way. They will be retained in the landscape through the proposed project.

Tree 13 was topped at two feet above grade, but it is still alive. Trees 14-23 were topped at a height of seven feet above grade, but they are still vigorous. I observed spider webs in their canopies that I recommend brushing off for aesthetics.

The proposed sidewalk repairs will encroach within the critical root zones of these trees. All project activity within 5 feet of these trees should be directly supervised by a Certified Arborist. Some of these trees' root systems may be impacted, but they are intended to be retained in place throughout the project.

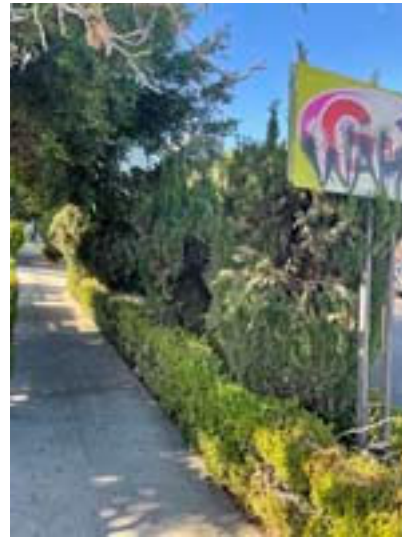
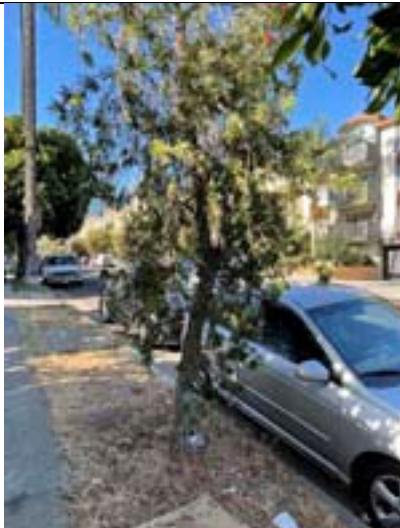
<p><b>Tree 24</b>  <i>Callistemon viminalis</i> – Weeping Bottlebrush</p> <p>This tree is a street tree, growing within the public right of way. It will be retained in the landscape through the proposed project.</p> <p>This tree is healthy. No treatment is recommended.</p> <p>The proposed sidewalk repairs will encroach within the critical root zone of this tree. All project activity within 8 feet of this tree should be directly supervised by a Certified Arborist. Some of this tree's root system may be impacted, but it is intended to be retained in place throughout the project.</p>

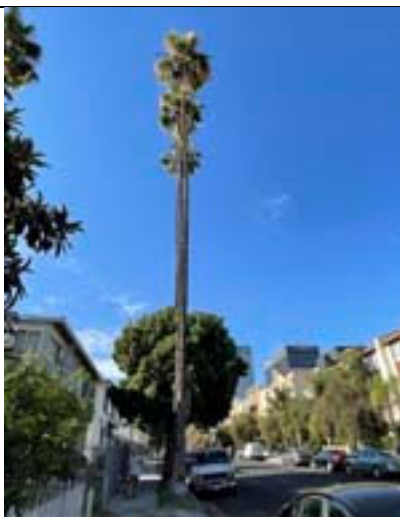
<p><b>Tree OP25</b>  <i>Washingtonia robusta</i> – Mexican Fan Palm</p> <p>This tree is a street tree, growing within the public right of way in front of an adjacent property to the north. It will be retained in the landscape through the proposed project.</p> <p>This tree is healthy. No treatment is recommended.</p> <p>This tree is far enough from the proposed sidewalk repairs that it will not likely be significantly impacted.</p>

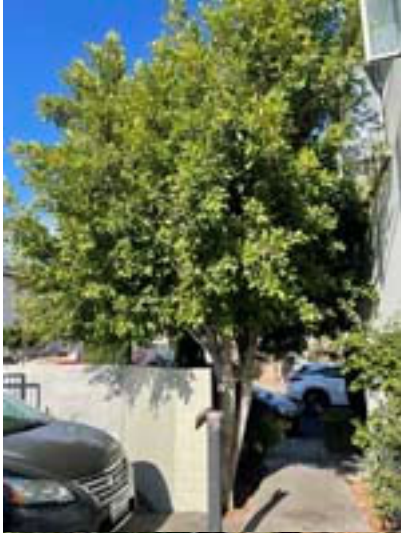
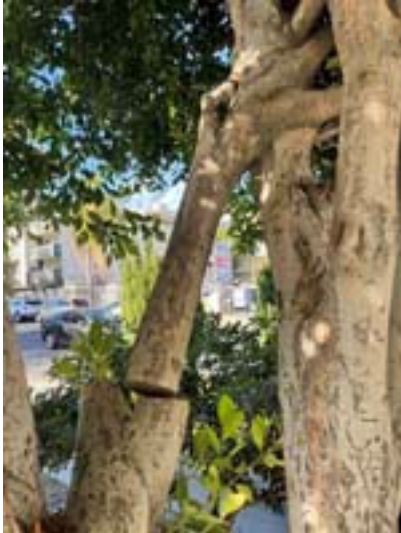
### **Tree 26**

This tree is not protected by ordinance. It will be removed because it is growing within the footprint of the proposed building.

This tree has one dead branch that was partially cut at one time. However, the branch had pleached into another branch, and the half-severed branch was left to remain as an oddity in the scaffold of the tree.

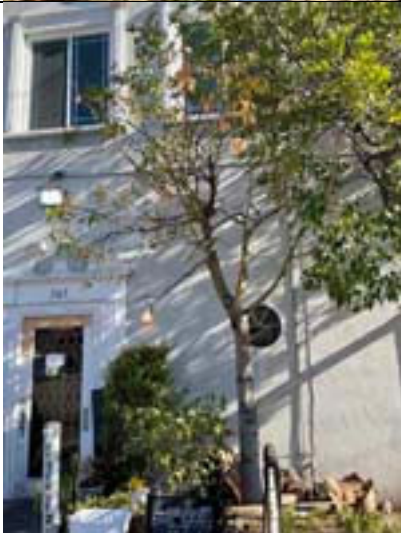
### **Tree 27**

This tree is not protected by ordinance. It will be removed because it is growing within the footprint of the proposed building.

This tree is nearly dead due to heat and drought stress.

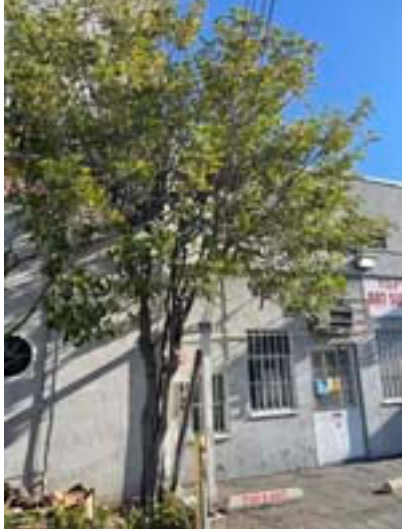
<p><b>Tree 28</b>  <i>Cupaniopsis anacardioides</i> – Carrotwood</p> <p>This tree is not protected by ordinance. It will be removed because it is growing within the footprint of the proposed building.</p> <p>This tree has a thinning canopy due to heat stress. Despite this, it is still in good condition.</p>

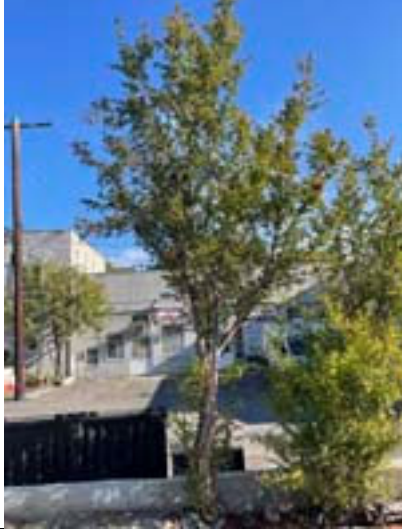
<p><b>Tree 29</b>  <i>Punica granatum</i> – Pomegranate</p> <p>This tree is not protected by ordinance. It will be removed because it is growing within the footprint of the proposed building.</p> <p>This tree is healthy, but it has a small root zone. It is in good condition.</p>

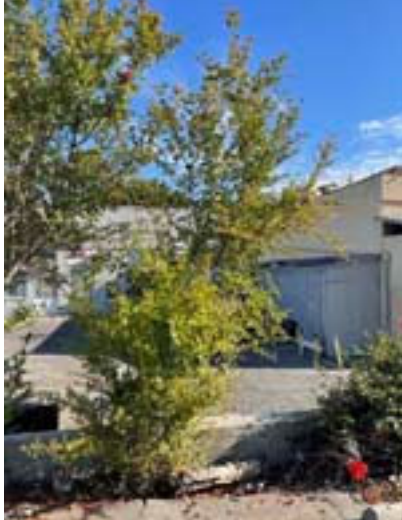
<p><b>Tree 30</b>  <i>Punica granatum</i> – Pomegranate</p> <p>This tree is not protected by ordinance. It will be removed because it is growing within the footprint of the proposed building.</p> <p>This tree is healthy, but it has a small root zone. It is in good condition.</p>

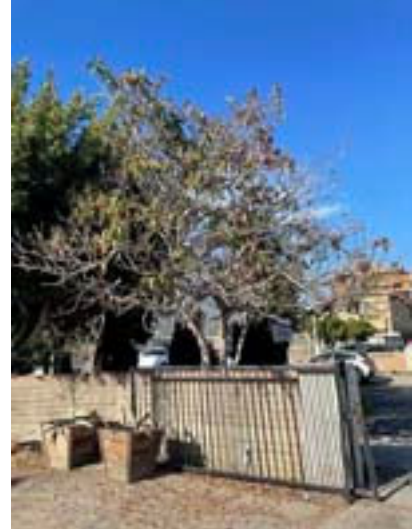
<p><b>Tree 31</b>  <i>Eriobotrya deflexa</i> – Bronze Loquat</p> <p>This tree is not protected by ordinance. It will be removed because it is growing too close to the footprint of the proposed building to survive the root cutting that would result.</p> <p>This tree is nearly dead. It is in poor condition.</p>

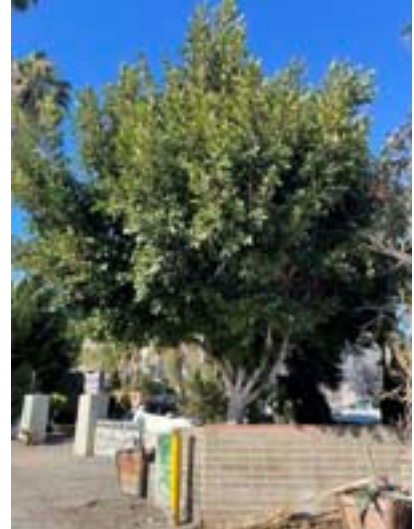
<p><b>Tree 32</b>  <i>Ficus microcarpa</i> – Indian Laurel Fig</p> <p>This tree is not protected by ordinance. It will be removed because it is growing within the footprint of the proposed building.</p> <p>This tree is healthy.</p>

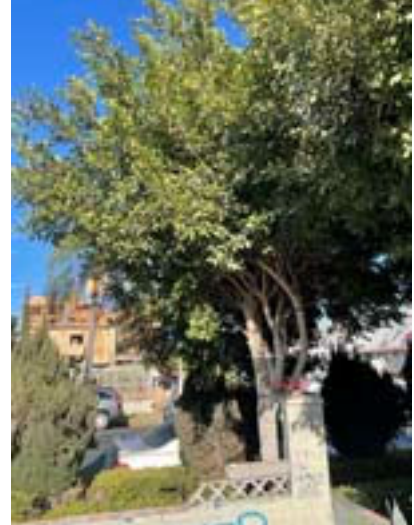
<p><b>Tree 33</b>  <i>Ficus microcarpa</i> – Indian Laurel Fig</p> <p>This tree is not protected by ordinance. It will be removed because it is growing too close to the footprint of the proposed building to survive the root cutting that would result.</p> <p>This tree is healthy.</p>

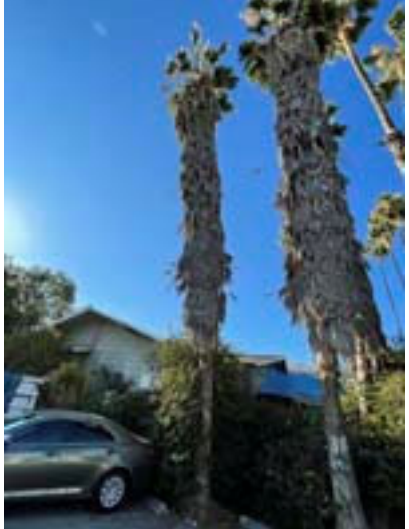
<p><b>Tree 34</b>  <i>Washingtonia robusta</i> – Mexican Fan Palm</p> <p>This tree is not protected by ordinance. It will be removed because it is growing within the footprint of the proposed building.</p> <p>This tree has accumulated dead fronds.</p>

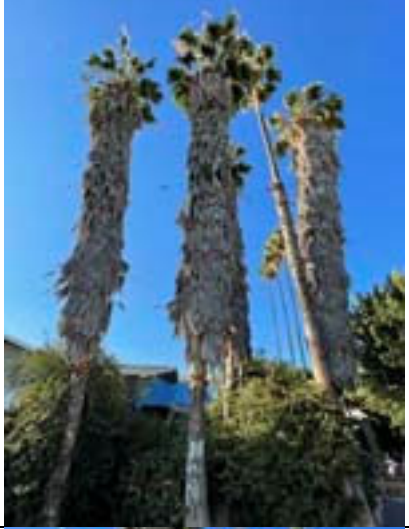
<p><b>Tree 35</b>  <i>Washingtonia robusta</i> – Mexican Fan Palm</p> <p>This tree is not protected by ordinance. It will be removed because it is growing within the footprint of the proposed building.</p> <p>This tree has accumulated dead fronds.</p>

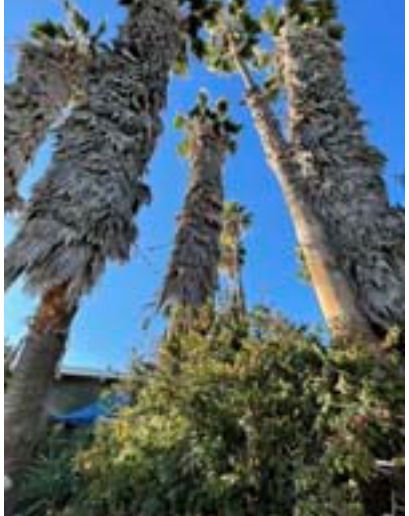
<p><b>Tree 36</b>  <i>Washingtonia robusta</i> – Mexican Fan Palm</p> <p>This tree is not protected by ordinance. It will be removed because it is growing within the footprint of the proposed building.</p> <p>This tree has accumulated dead fronds.</p>

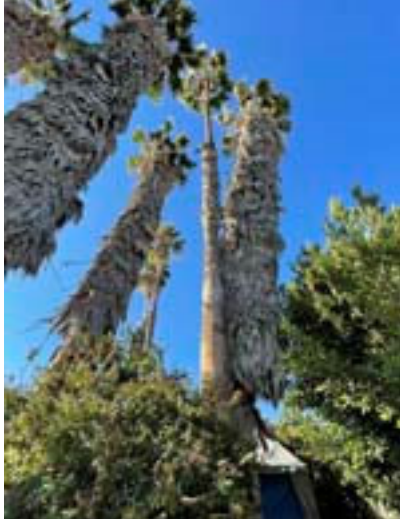
<p><b>Tree 37</b>  <i>Washingtonia robusta</i> – Mexican Fan Palm</p> <p>This tree is not protected by ordinance. It will be removed because it is growing too close to the footprint of the proposed building to survive the root cutting that would result.</p> <p>This tree is healthy.</p>

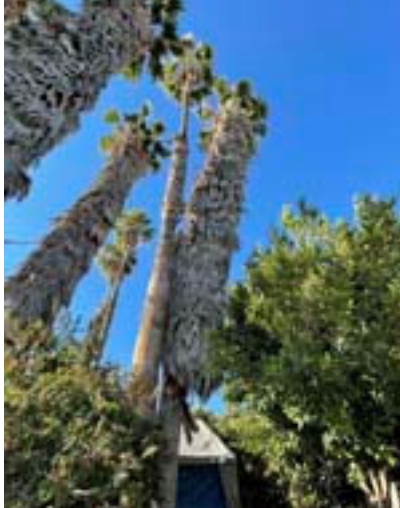
<p><b>Tree 38</b>  <i>Washingtonia robusta</i> – Mexican Fan Palm</p> <p>This tree is not protected by ordinance. It will be removed because it is growing too close to the footprint of the proposed building to survive the root cutting that would result.</p> <p>This tree has accumulated dead fronds.</p>

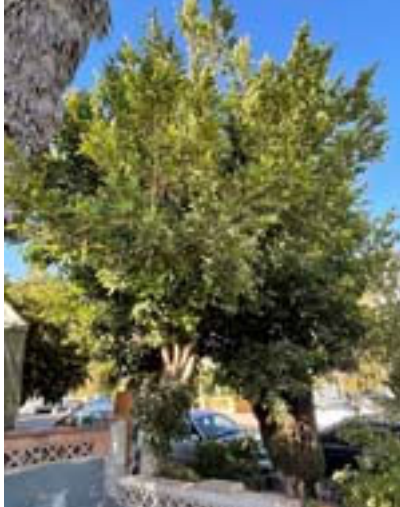
<p><b>Tree 39</b>  <i>Ficus microcarpa</i> – Indian Laurel Fig</p> <p>This tree is not protected by ordinance. It will be removed because it is growing too close to the footprint of the proposed building to survive the root cutting that would result.</p> <p>This tree is healthy.</p>

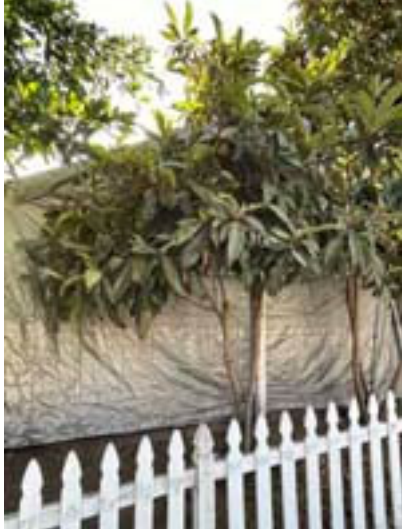
<p><b>Tree 40</b>  <i>Eriobotrya japonica</i> – Loquat</p> <p>This tree is not protected by ordinance. It will be removed because it is growing within the footprint of the proposed building.</p> <p>This tree is healthy.</p>

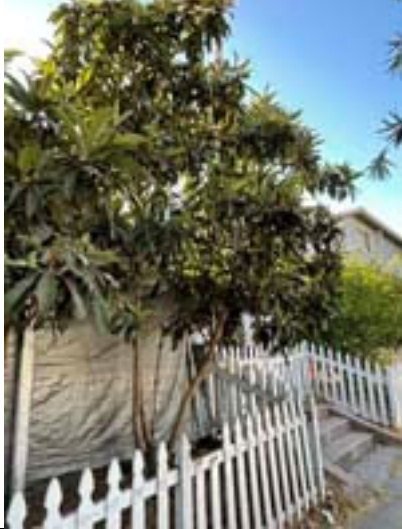
<p><b>Tree 41</b>  <i>Eriobotrya japonica</i> – Loquat</p> <p>This tree is not protected by ordinance. It will be removed because it is growing within the footprint of the proposed building.</p> <p>This tree is healthy.</p>

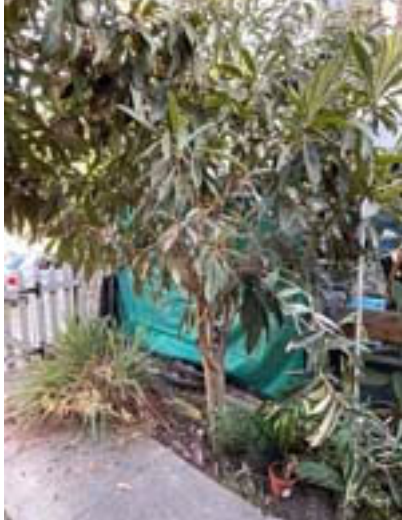
<p><b>Tree 42</b>  <i>Eriobotrya japonica</i> – Loquat</p> <p>This tree is not protected by ordinance. It will be removed because it is growing within the footprint of the proposed building.</p> <p>This tree is healthy.</p>

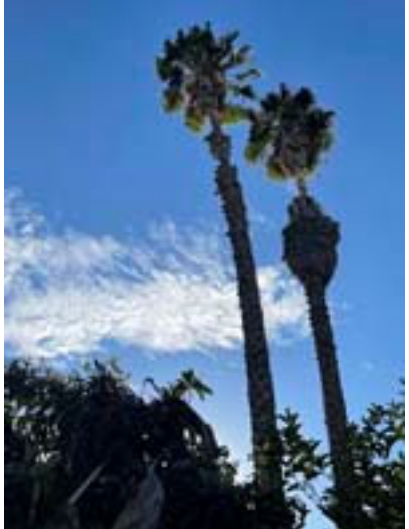
<p><b>Tree 46</b>  <i>Washingtonia robusta</i> – Mexican Fan Palm</p> <p>This tree is not protected by ordinance. It will be removed because it is growing within the footprint of the proposed building.</p> <p>This tree has accumulated dead fronds.</p>

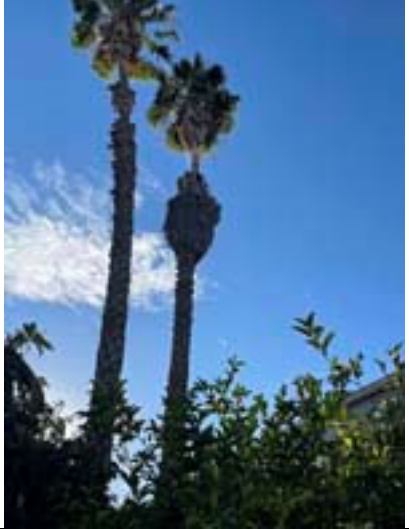
<p><b>Tree 47</b>  <i>Washingtonia robusta</i> – Mexican Fan Palm</p> <p>This tree is not protected by ordinance. It will be removed because it is growing within the footprint of the proposed building.</p> <p>This tree has accumulated dead fronds.</p>

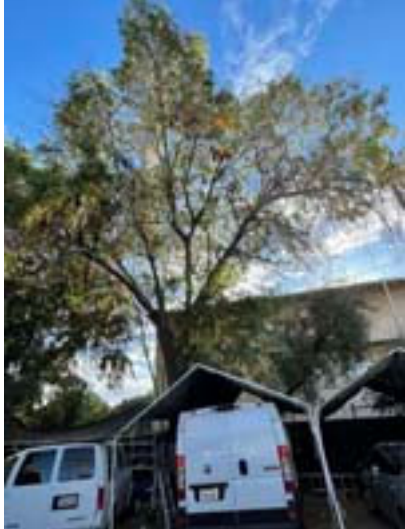
<p><b>Tree 48</b>  <i>Eriobotrya japonica</i> – Loquat</p> <p>This tree is not protected by ordinance. It will be removed because it is growing within the footprint of the proposed building.</p> <p>This tree is healthy.</p>

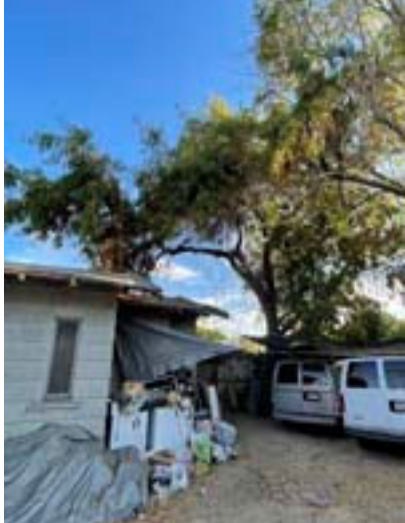
<p><b>Tree 49</b>  <i>Fraxinus uhdei</i> – Shamel Ash</p> <p>This tree is not protected by ordinance. It will be removed because it is growing too close to the footprint of the proposed building to survive the root cutting that would result.</p> <p>This tree has dead branches in its canopy. I observed dieback due to drought and heat stress.</p>

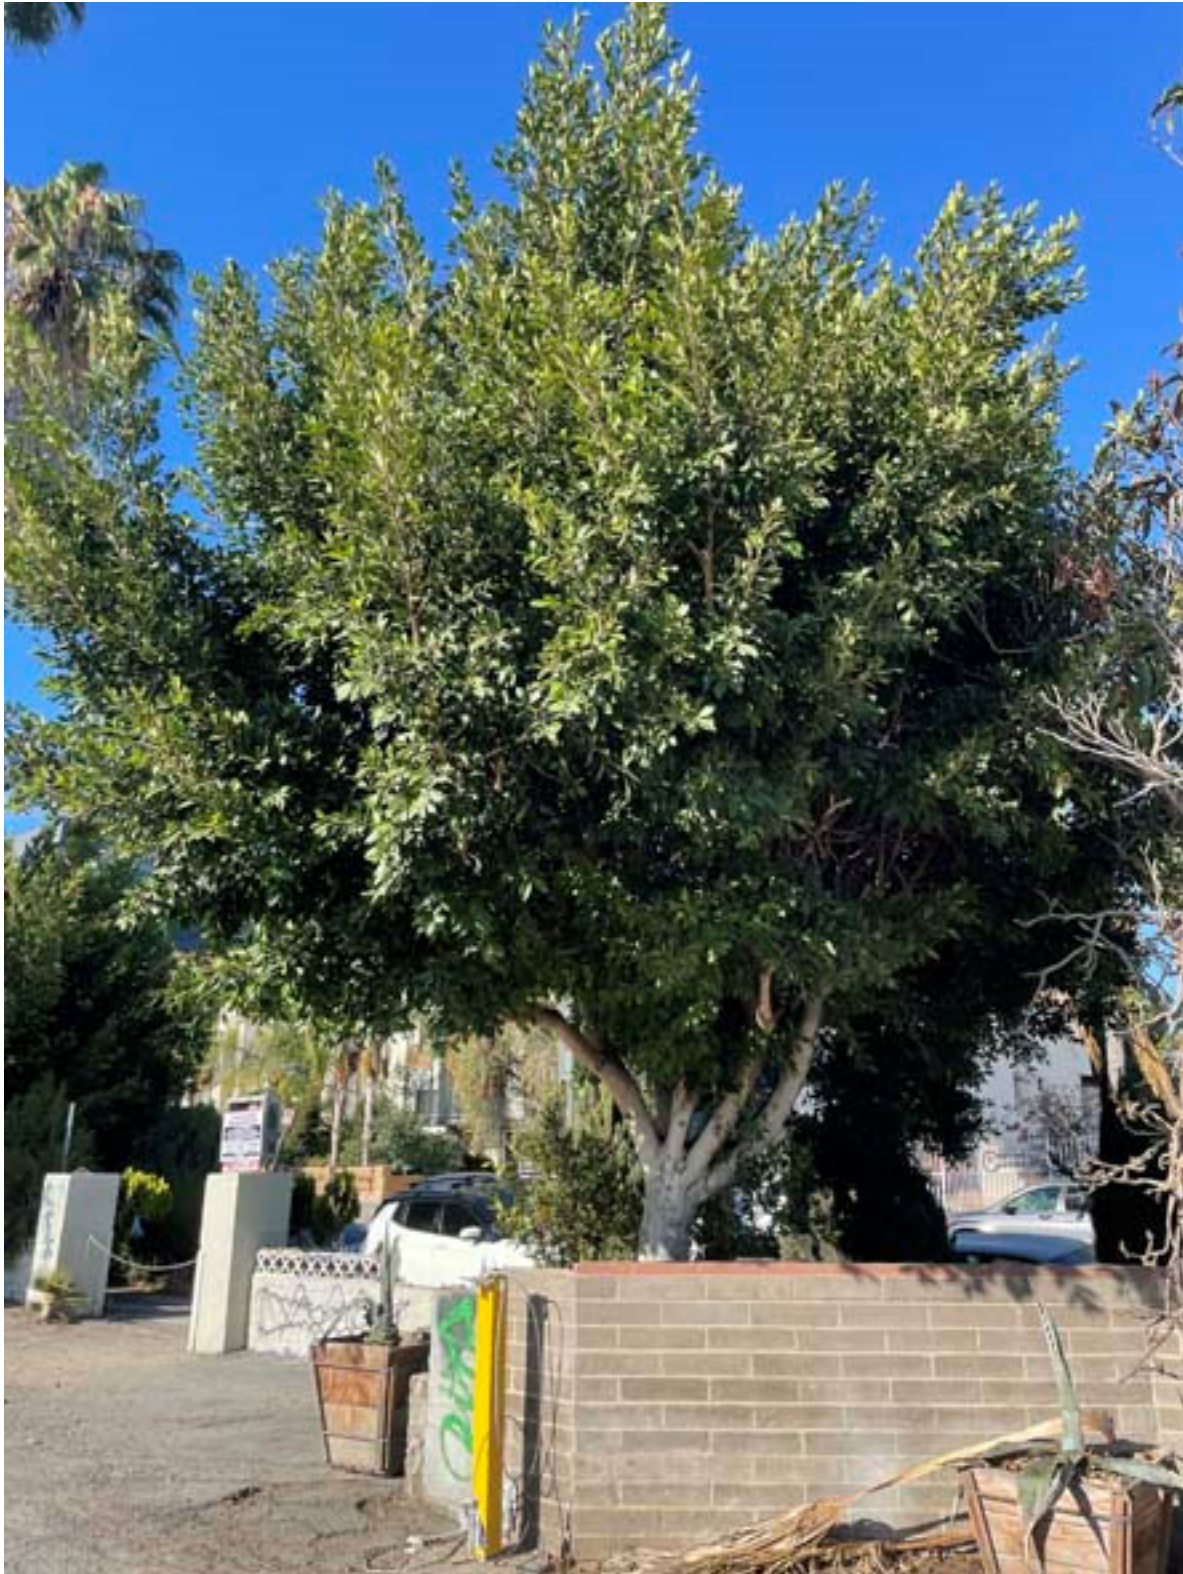
**Figure 25:** Tree 31

Tree #	Tag #	Species	Common Name	DBH	Height	Spread	Condition	Treatment	Rate	Protected?	Remove?	Natural?	Encroach?	Impact Activity
31	9450	<i>Eriobotrya deflexa</i>	Bronze Loquat	8"	15'	15'	nearly dead	Remove	D-	No	Yes	No	Yes	building
32	9451	<i>Ficus microcarpa</i>	Indian Laurel Fig	9", 5", 5"	20'	18'	healthy	Remove	A	No	Yes	No	Yes	building
33	9452	<i>Ficus microcarpa</i>	Indian Laurel Fig	10"	20'	18'	healthy	Remove	A	No	Yes	No	Yes	building
34	9453	<i>Washingtonia robusta</i>	Mexican Fan Palm	14"	48' B/T	12'	accumulated dead fronds	Remove	A-	No	Yes	No	Yes	building
35	9454	<i>Washingtonia robusta</i>	Mexican Fan Palm	14"	42' B/T	12'	accumulated dead fronds	Remove	A-	No	Yes	No	Yes	building
36	9455	<i>Washingtonia robusta</i>	Mexican Fan Palm	16"	45' B/T	12'	accumulated dead fronds	Remove	A-	No	Yes	No	Yes	building
37	9456	<i>Washingtonia robusta</i>	Mexican Fan Palm	19"	60' B/T	12'	healthy	Remove	A	No	Yes	No	Yes	building
