Geotechnical Report and LADBS Approval Letter

GEOLOGY AND SOILS REPORT APPROVAL LETTER

This report provides an assessment of geologic conditions as well as foundation design information and geotechnical recommendations for the proposed Belmont Village project at the Westwood Presbyterian Church located at 10822 Wilshire Boulevard and the residential property at 10812 Ashton Avenue in the Westwood District of Los Angeles, California. The location of the project site is illustrated on Figure 1, Vicinity Map. The locations of the proposed project and our recent and relevant prior exploration borings are shown on Figure 2, Plot Plan.

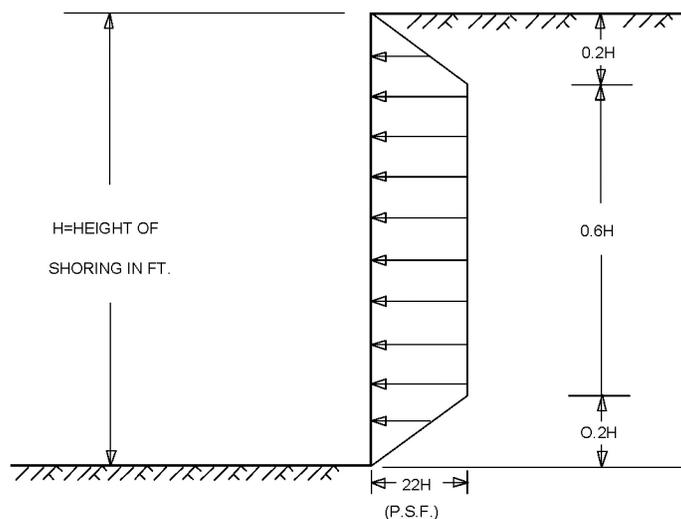
For the design of tied-back or braced shoring, we recommend the use of a trapezoidal distribution of earth pressure. The recommended pressure distribution, for the case where the grade is level behind the shoring, is illustrated in the following diagram with the maximum pressure equal to $22H$ in pounds per square foot, where H is the height of the shoring in feet. Where a combination of sloped embankment and shoring is used, the pressure would be greater and must be determined for each combination.

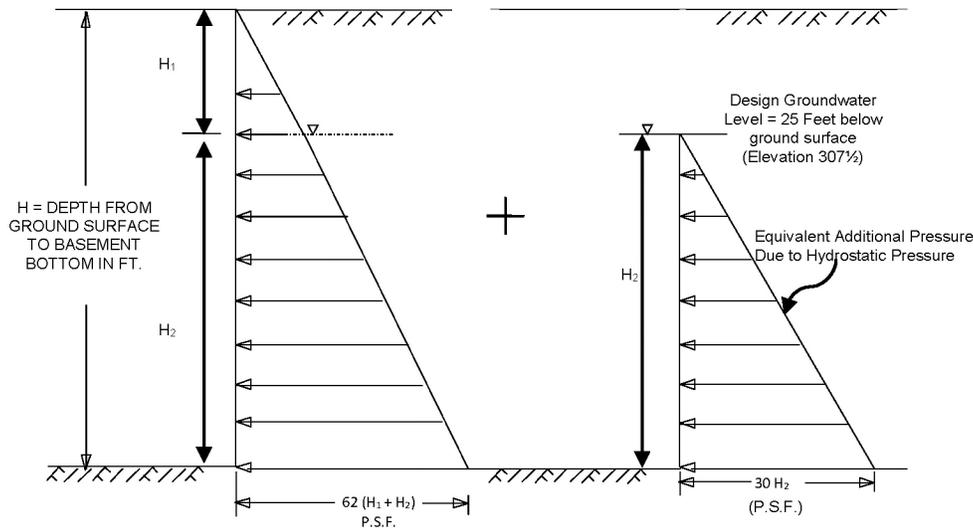
historic-high depth of 25 feet below the existing grade, corresponding to Elevation 307½. Therefore, subterranean walls below Elevation 307½ should be designed to resist the resulting external hydrostatic pressure in addition to the lateral earth pressure and other lateral surcharge pressures discussed above. The recommended lateral pressure for this condition is shown in the following diagram.

If the permanent subdrain system is not installed beneath the basement level, the basement walls and lower slabs should be waterproofed and designed to support the hydrostatic pressure of groundwater rising to the

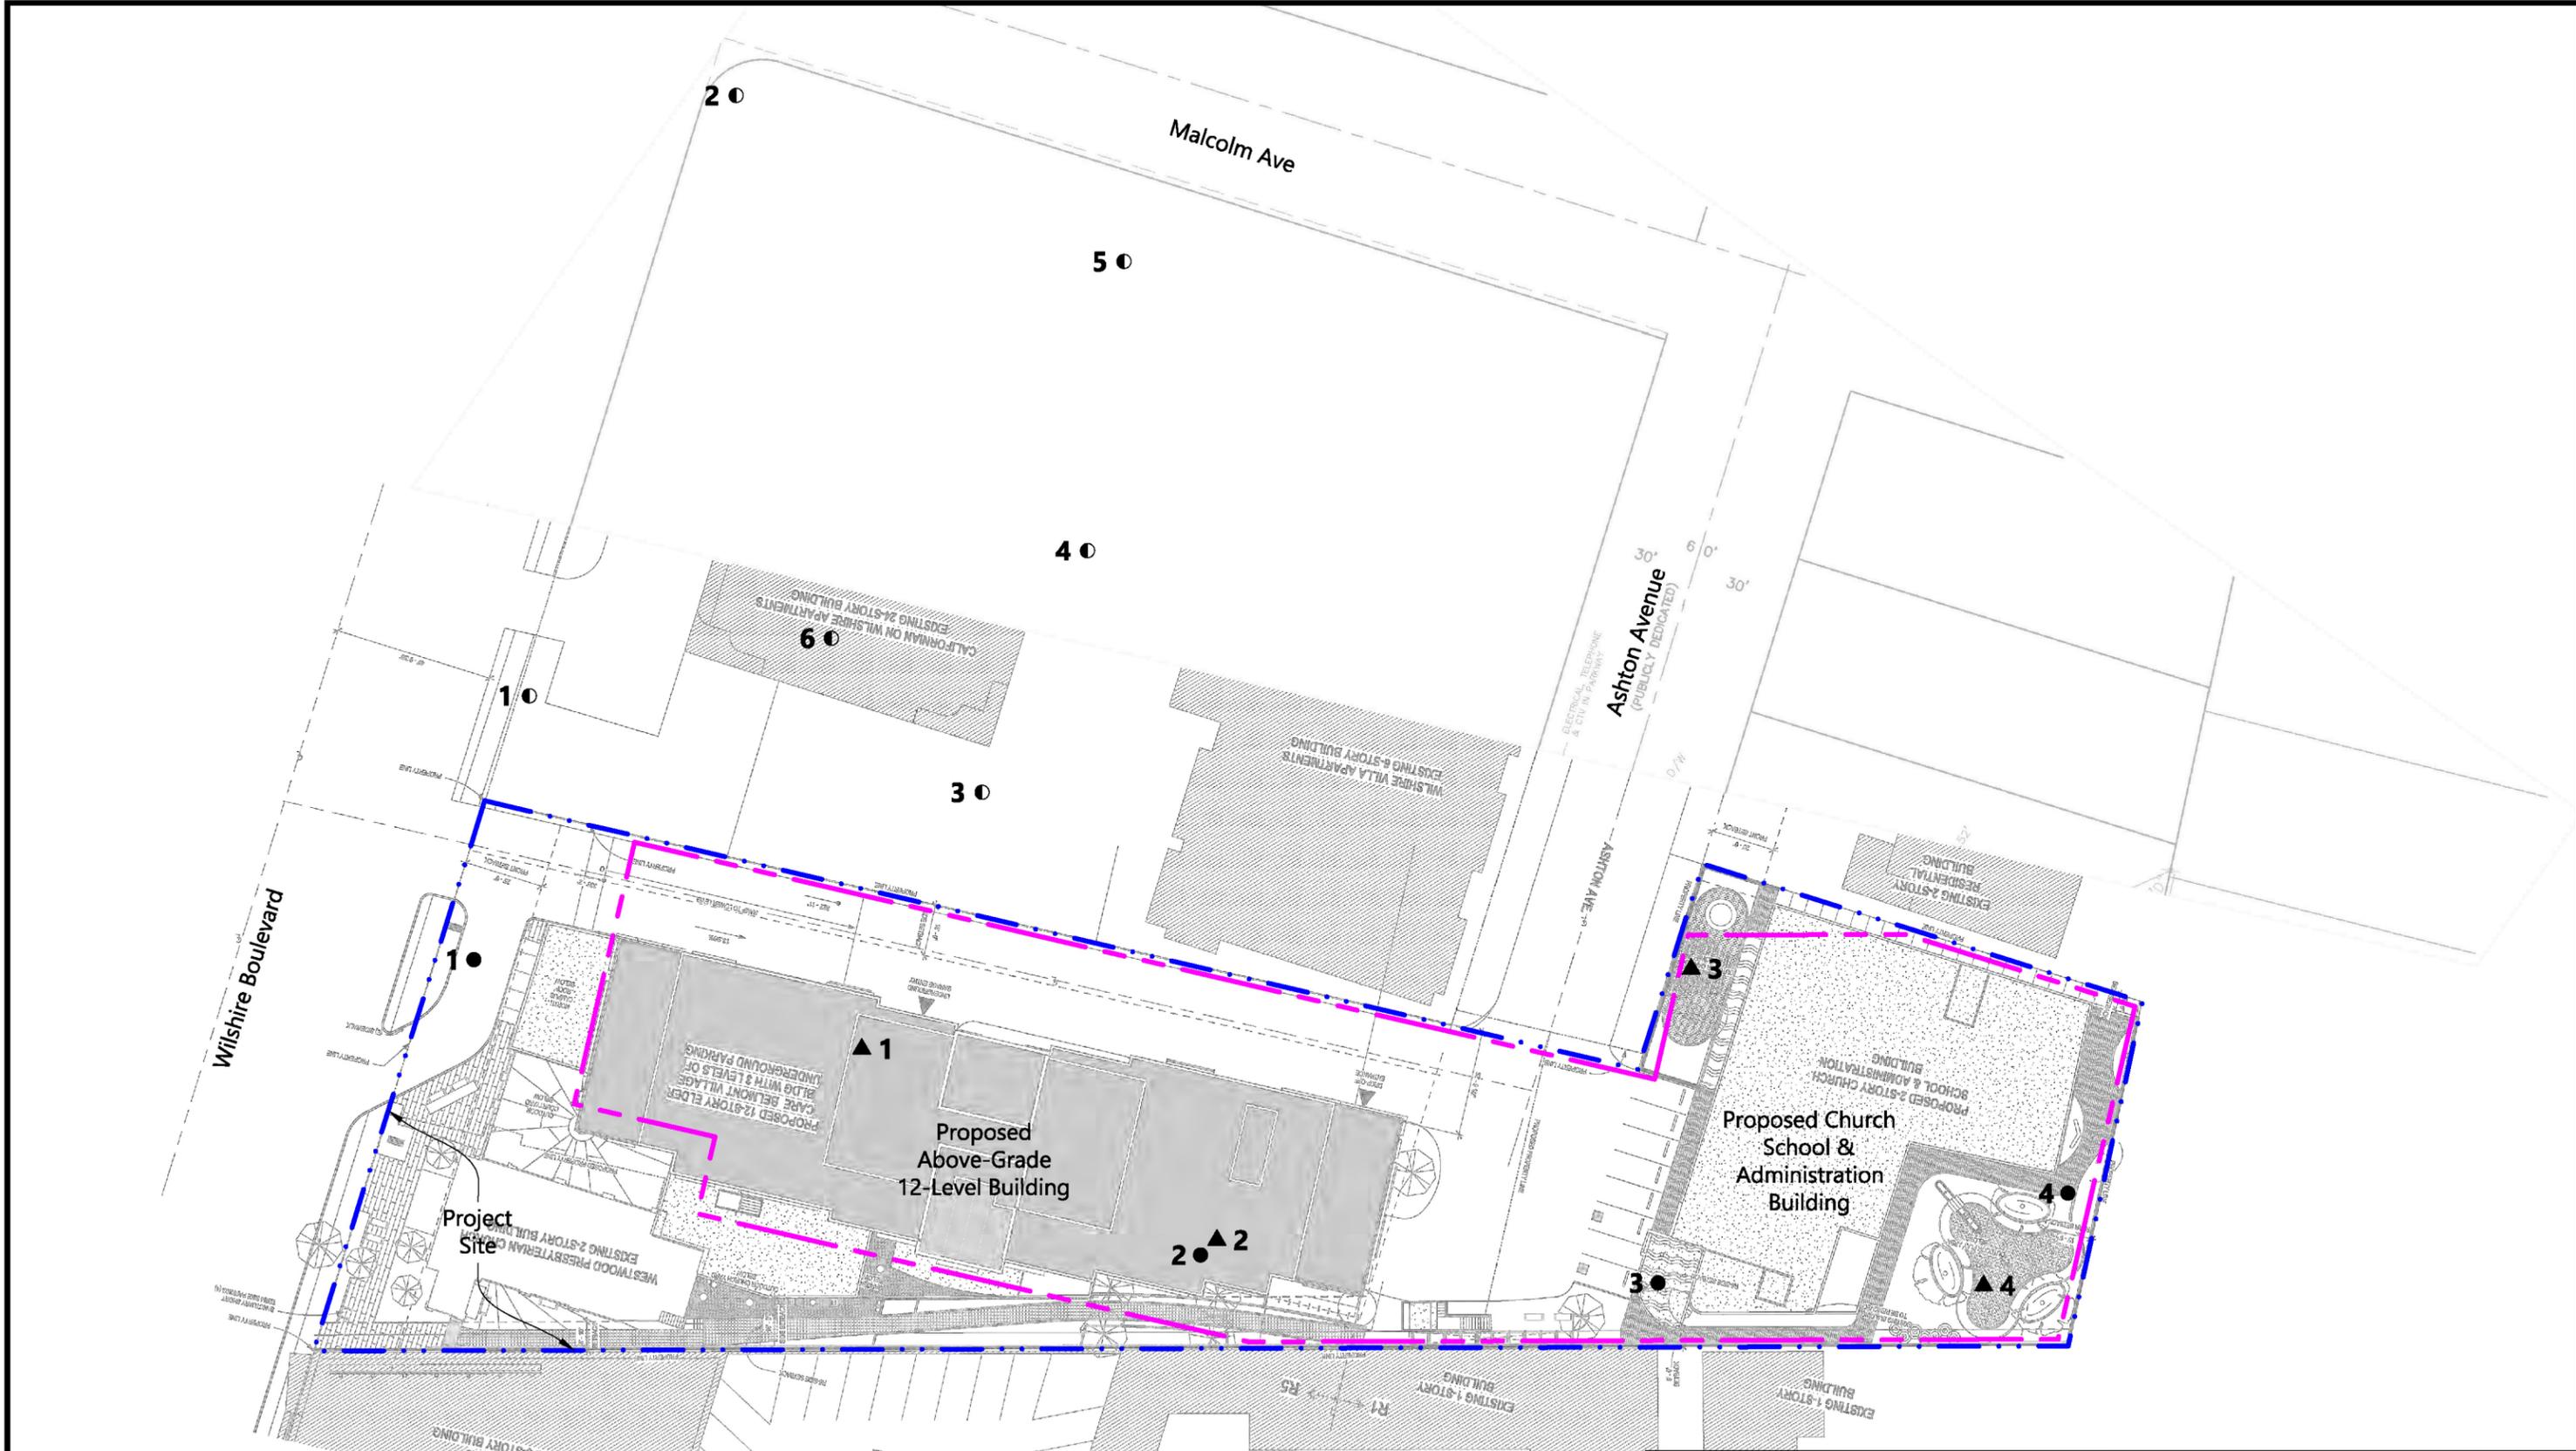
Figure 2
Plot Plan

Proposed Belmont Village - Westwood 10822 Wilshire Boulevard Los Angeles, California		FIGURE NO. 2
Plot Plan		
PROJECT NO. 4953-16-0251	DATE: 04/09/2019

The soil conditions beneath the site were explored by drilling four borings at the locations shown on Figure 2. The borings were drilled to depths of between 51 and 61½ feet below the existing grade using 8 inch diameter truck mounted hollow-stem auger drilling equipment.

To supplement the exploratory borings, four cone penetration tests (CPTs) were performed to the depth of 60 feet below the existing grade. The locations of the CPTs are presented on Figures 2. The results of the CPTs are presented in Appendix C.

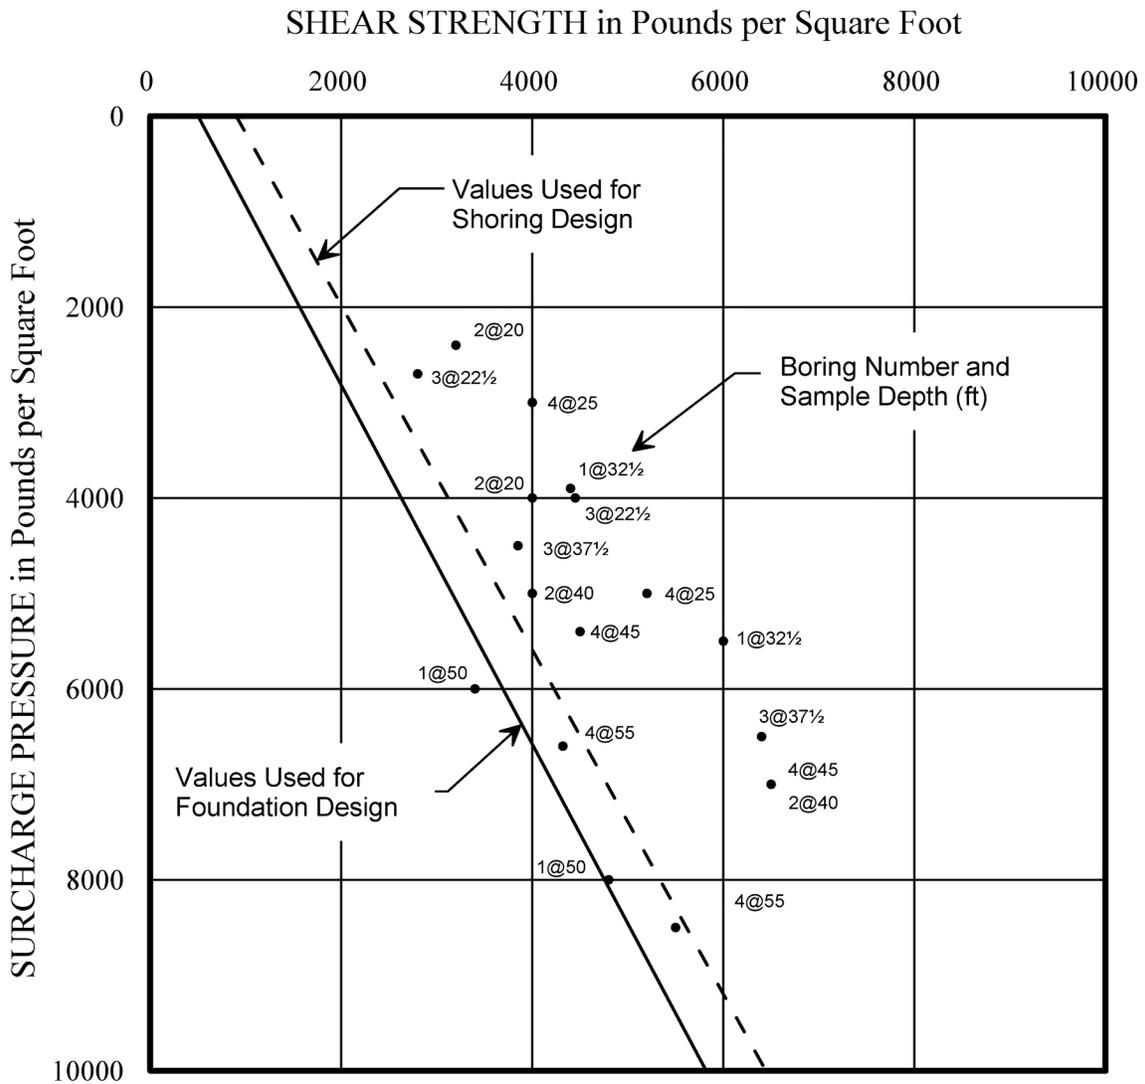
Figure A-2

● Samples tested at field moisture content
 L Natural Soils

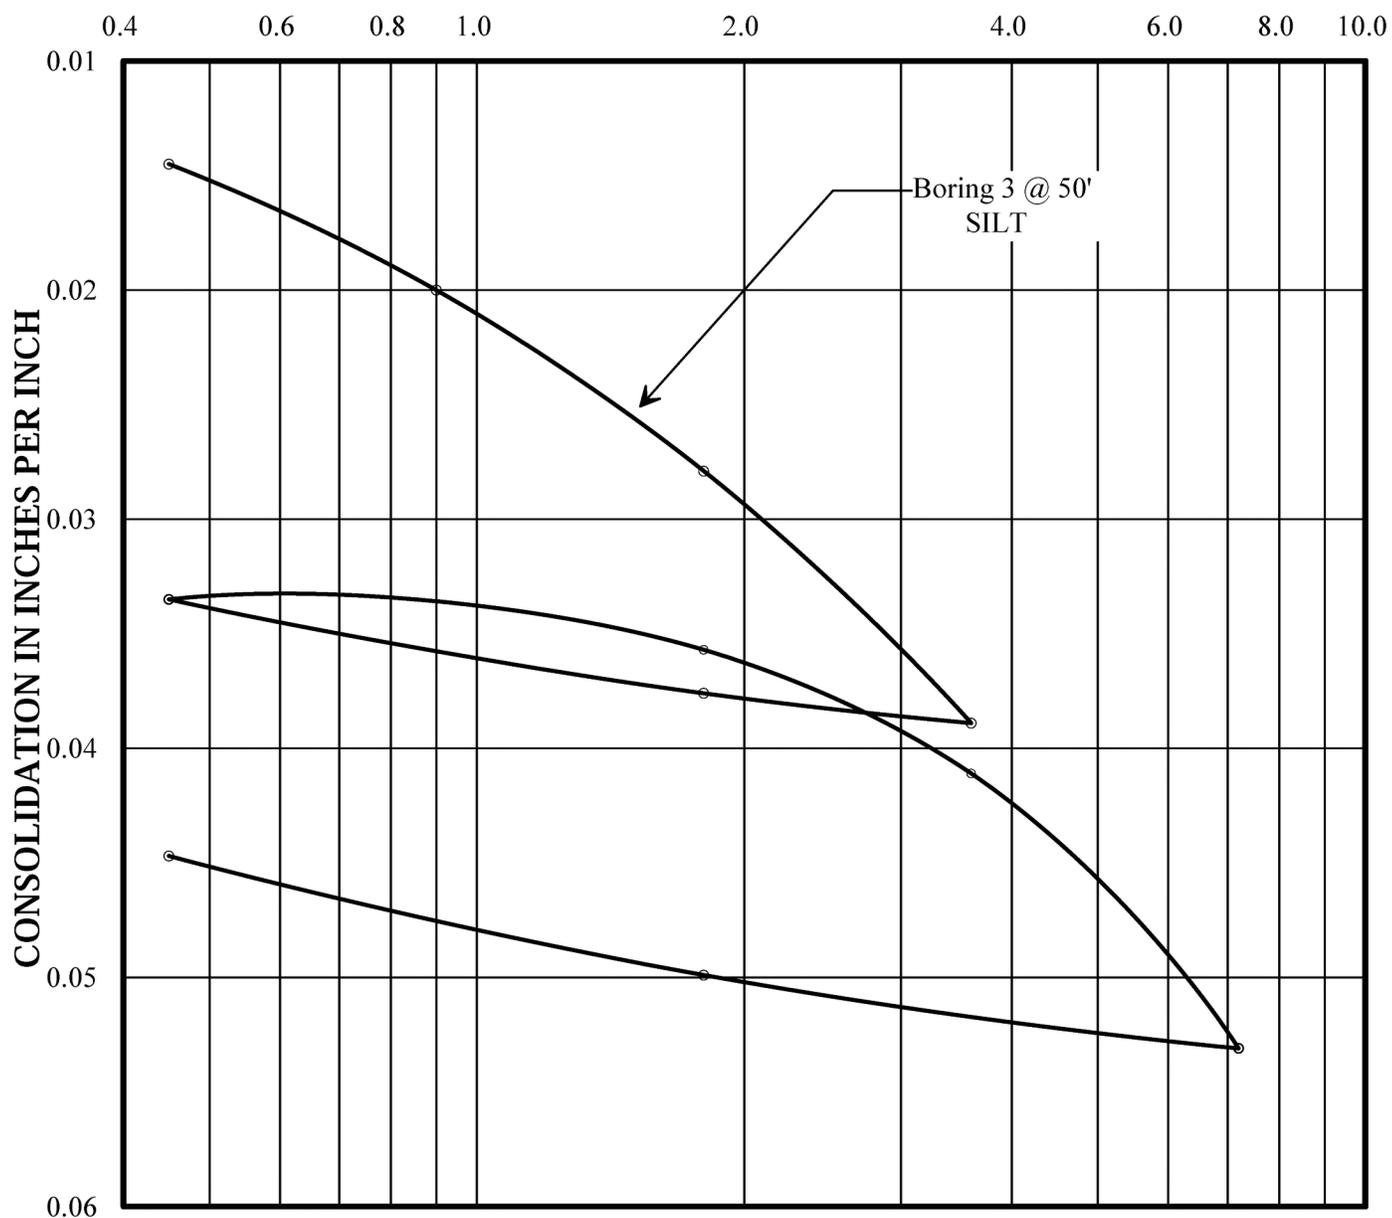
CONSOLIDATION TEST DATA
Project 4953-16-0251
Figure A-4.1

Note: Tests run at field moisture content.

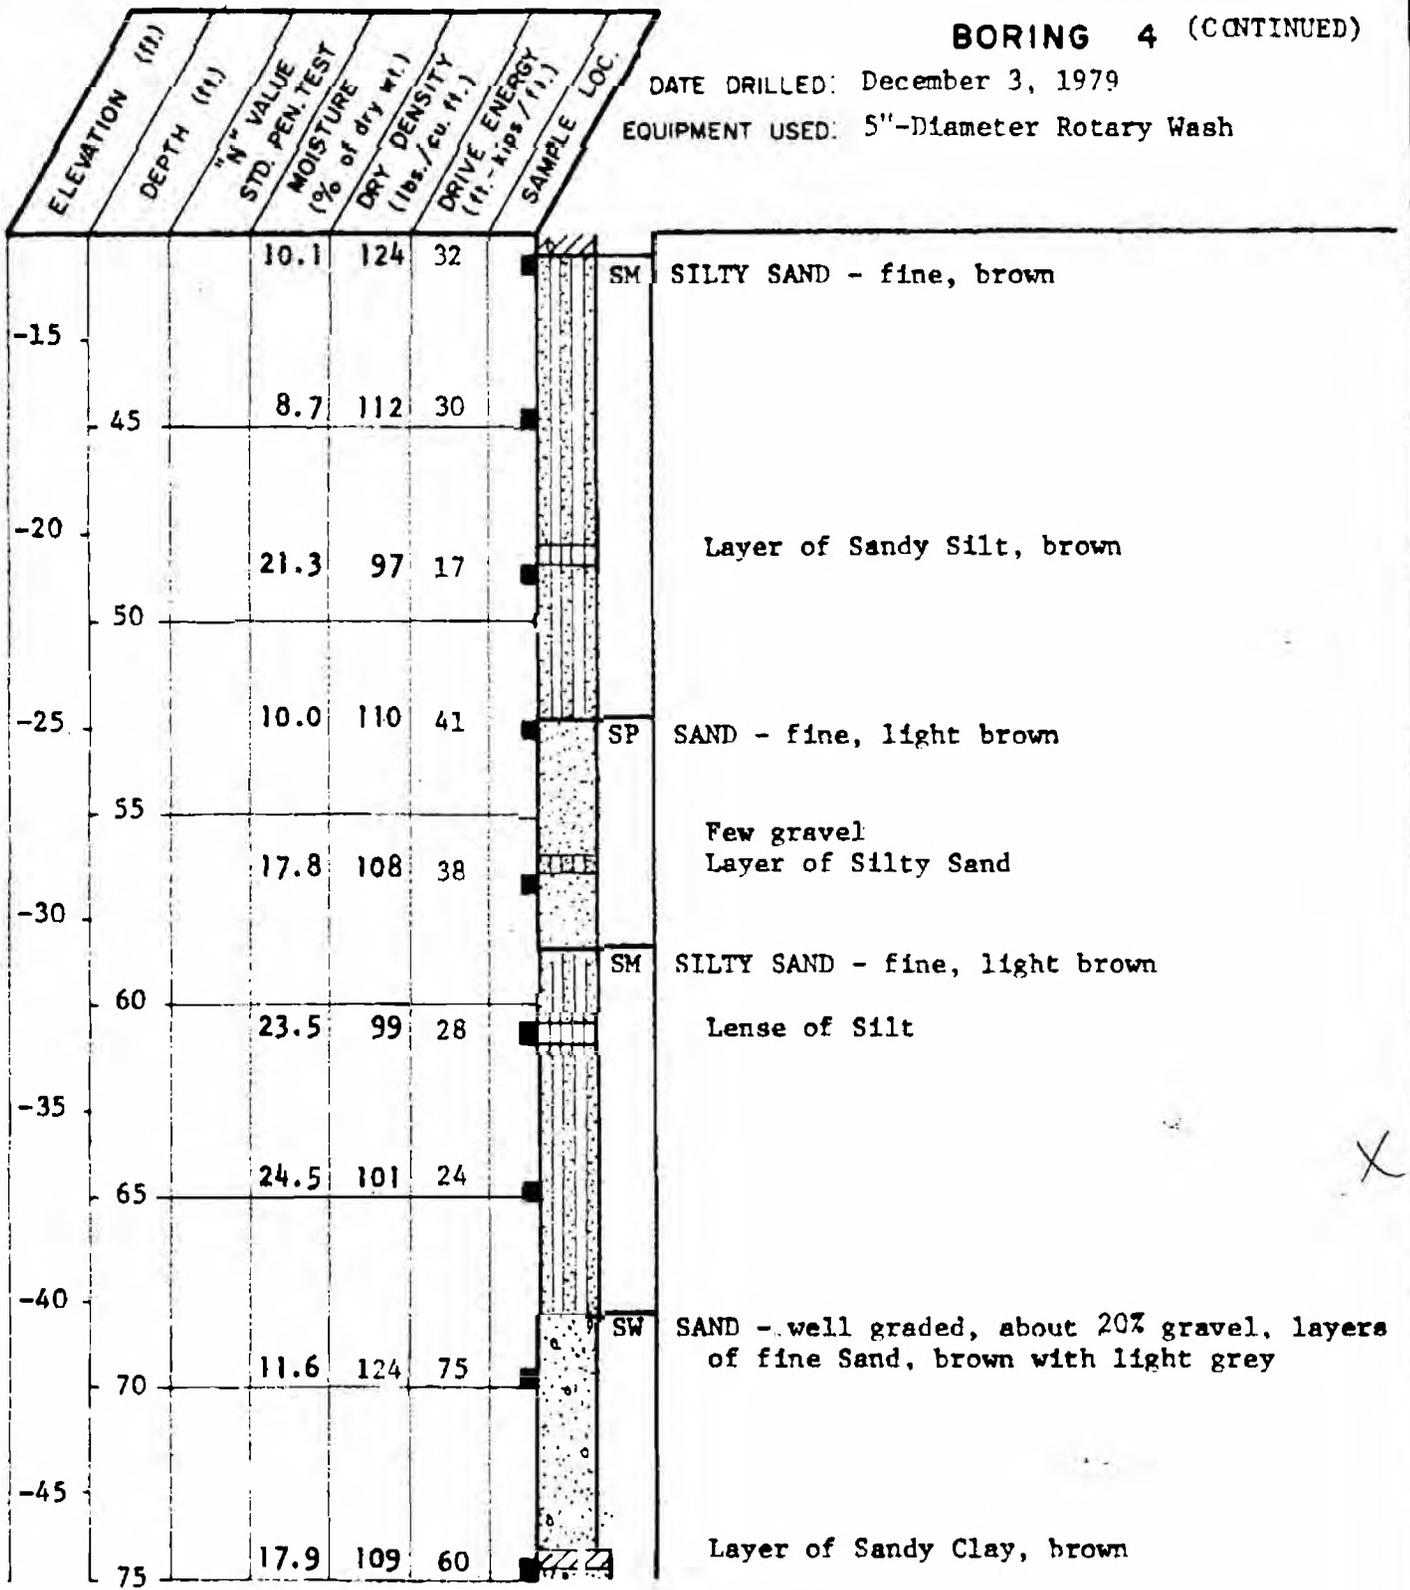
LOG OF BORING

EQUIPMENT USED: 5"-Diameter Rotary Wash

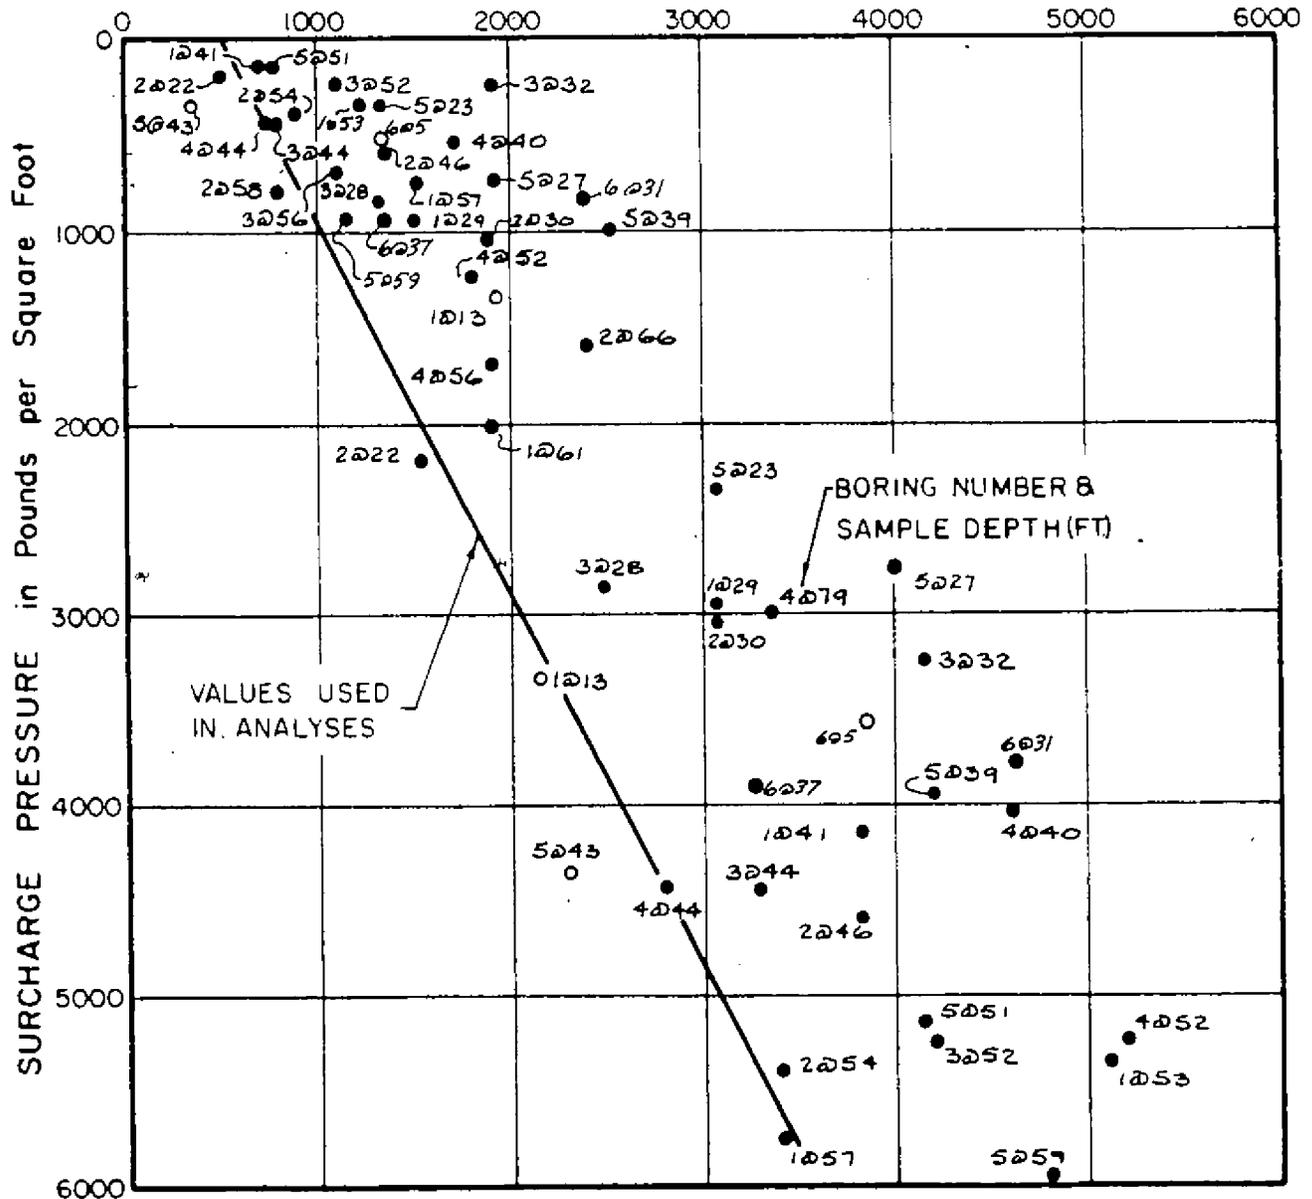
FIGURE B-2

SHEAR STRENGTH in Pounds per Square Foot

- Tests at field moisture content
- Tests at increased moisture content

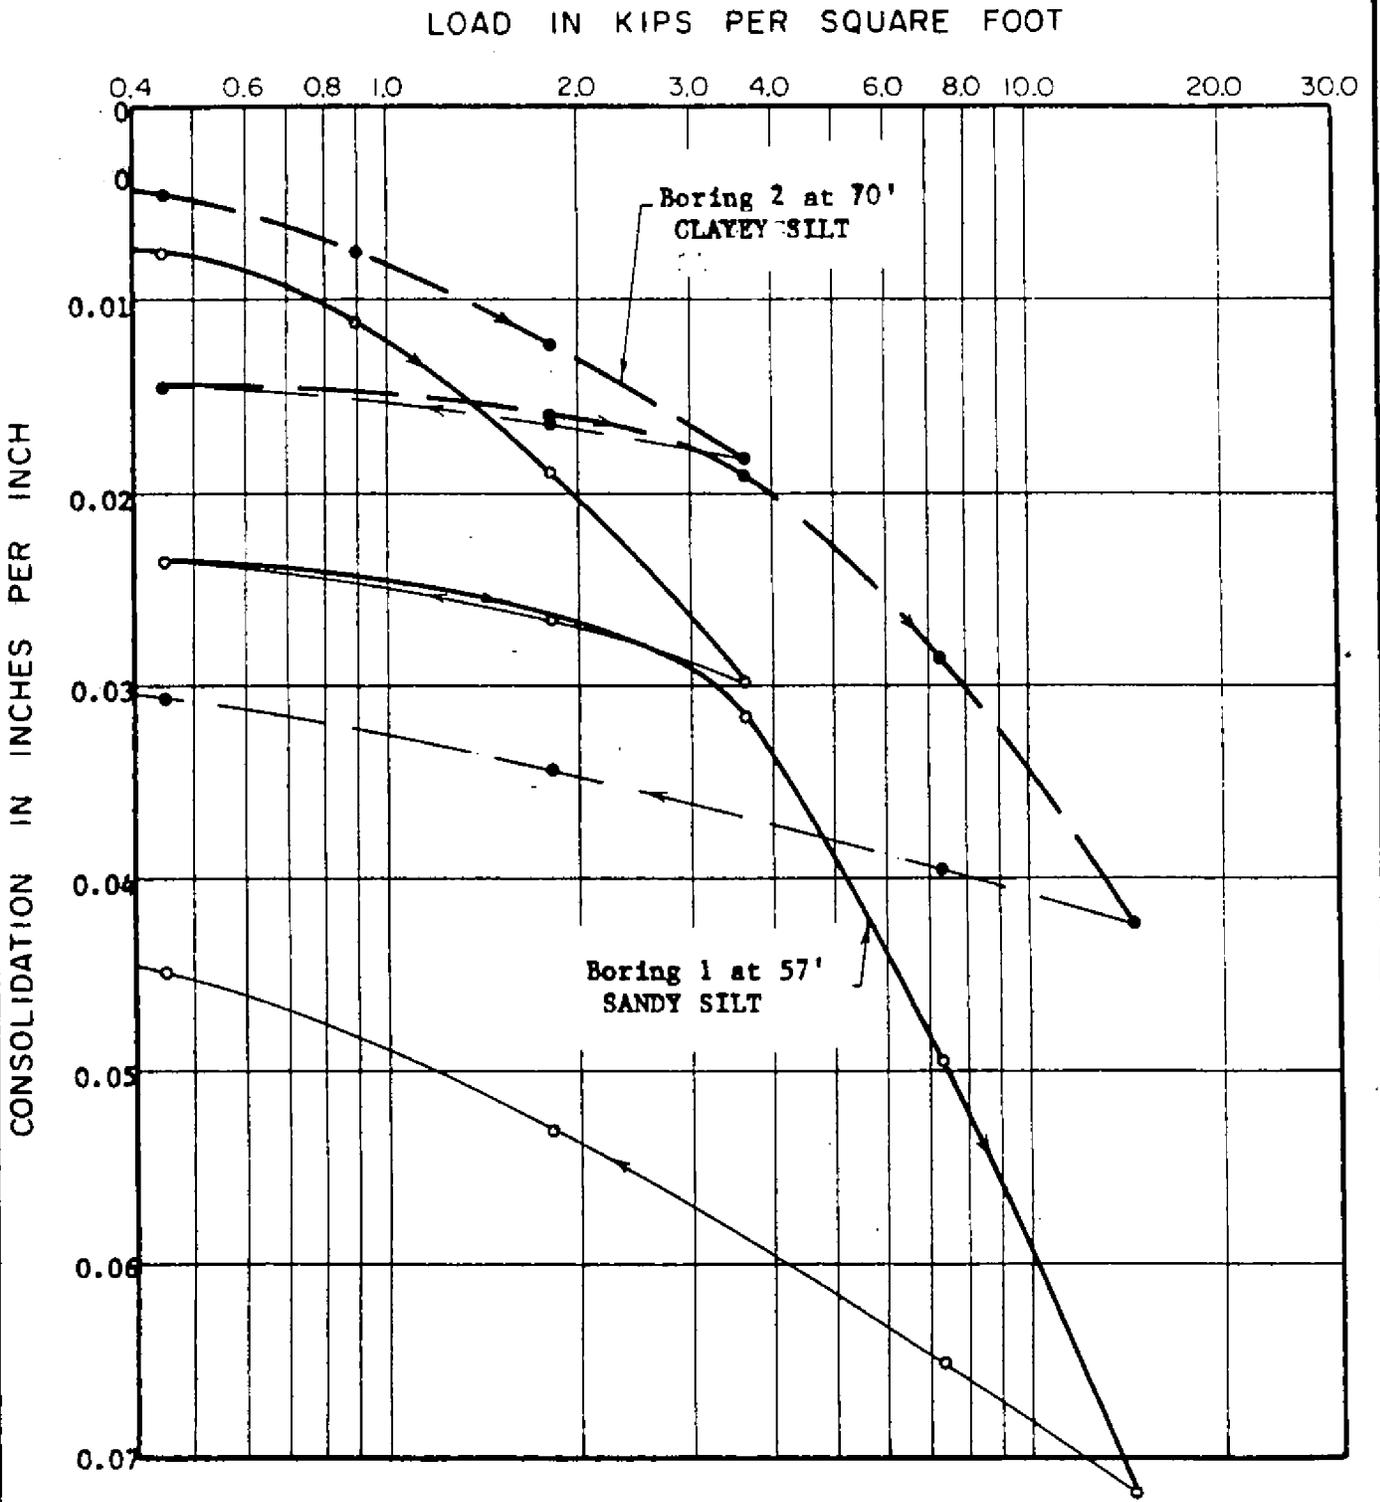
NOTE: Samples tested at field moisture content.

CONSOLIDATION TEST DATA

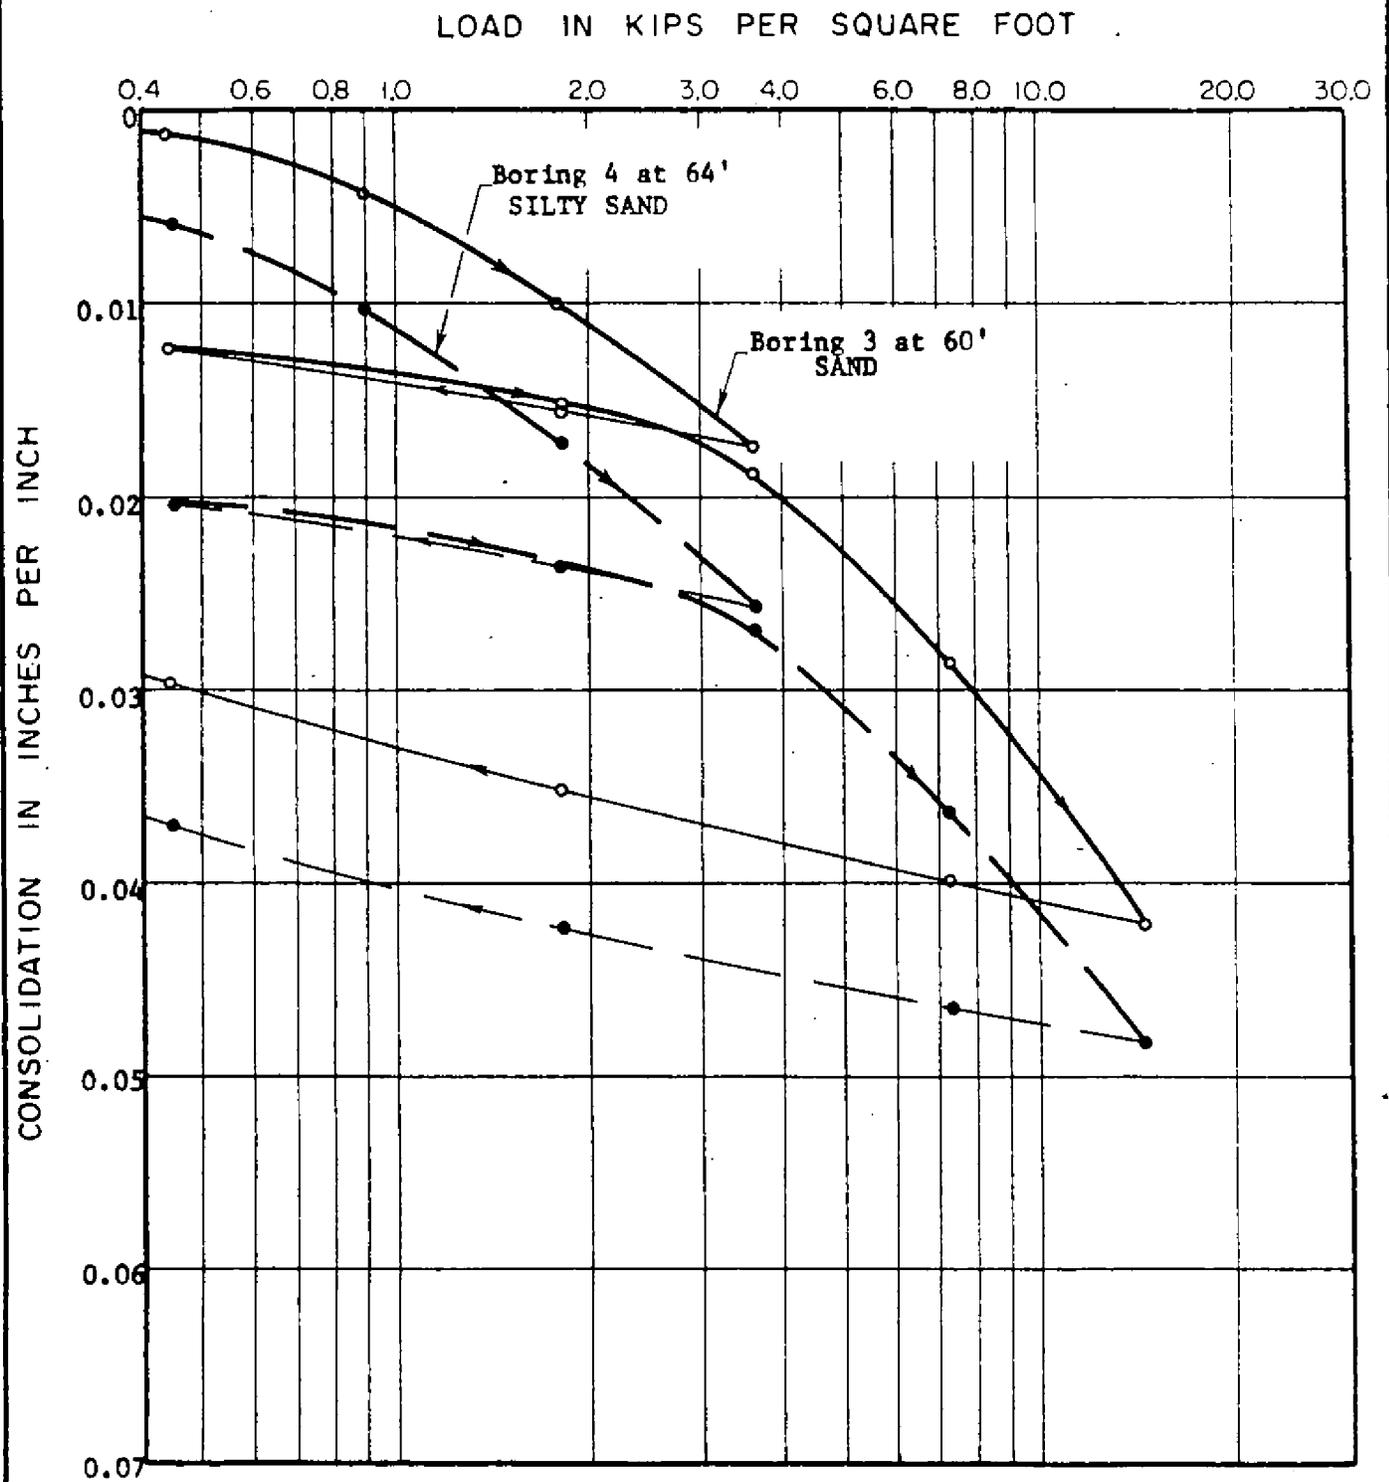
NOTE: Samples tested at field moisture content.

CONSOLIDATION TEST DATA

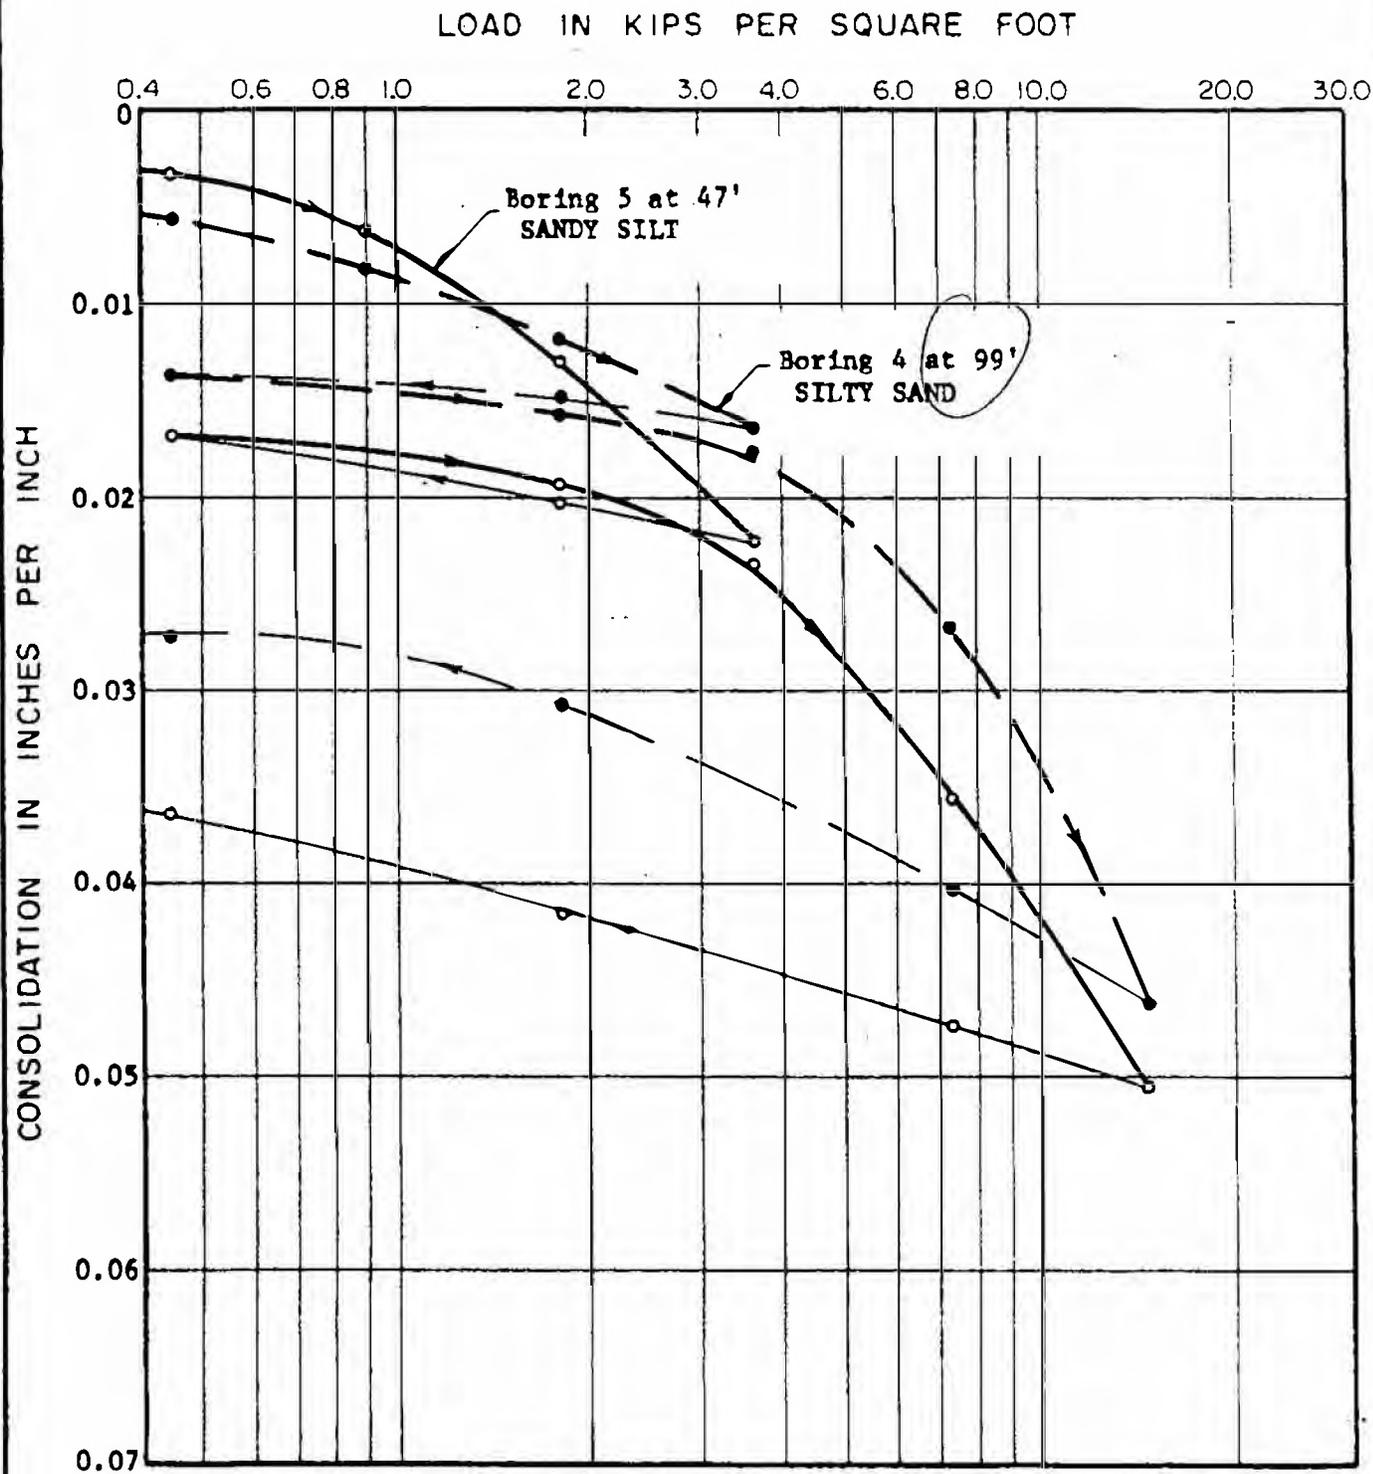
NOTE: Samples tested at field moisture content.

CONSOLIDATION TEST DATA

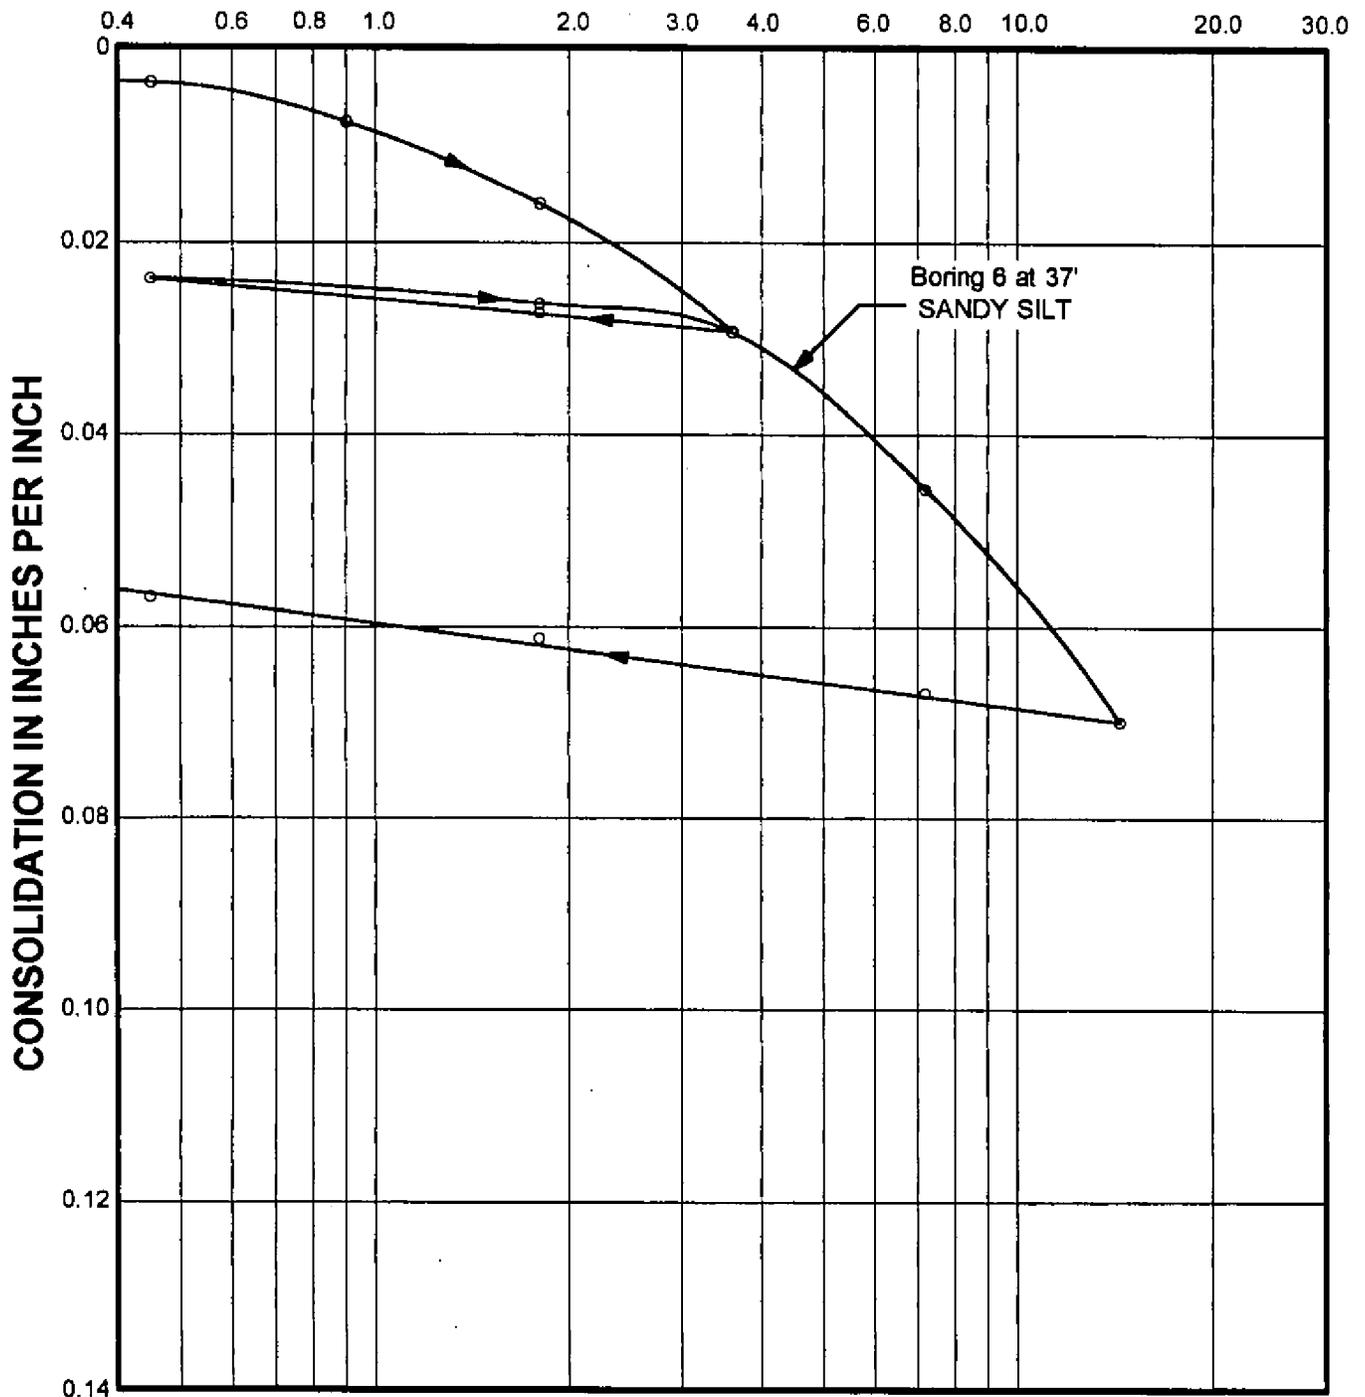
NOTE: Sample tested at field moisture content.

CONSOLIDATION TEST DATA
