Geotechnical Report and LADBS Approval Letter

GEOLOGY AND SOILS REPORT APPROVAL LETTER

This report provides an assessment of geologic conditions as well as foundation design information and geotechnical recommendations for the proposed Belmont Village project at the Westwood Presbyterian Church located at 10822 Wilshire Boulevard and the residential property at 10812 Ashton Avenue in the Westwood District of Los Angeles, California. The location of the project site is illustrated on Figure 1, Vicinity Map. The locations of the proposed project and our recent and relevant prior exploration borings are shown on Figure 2, Plot Plan.

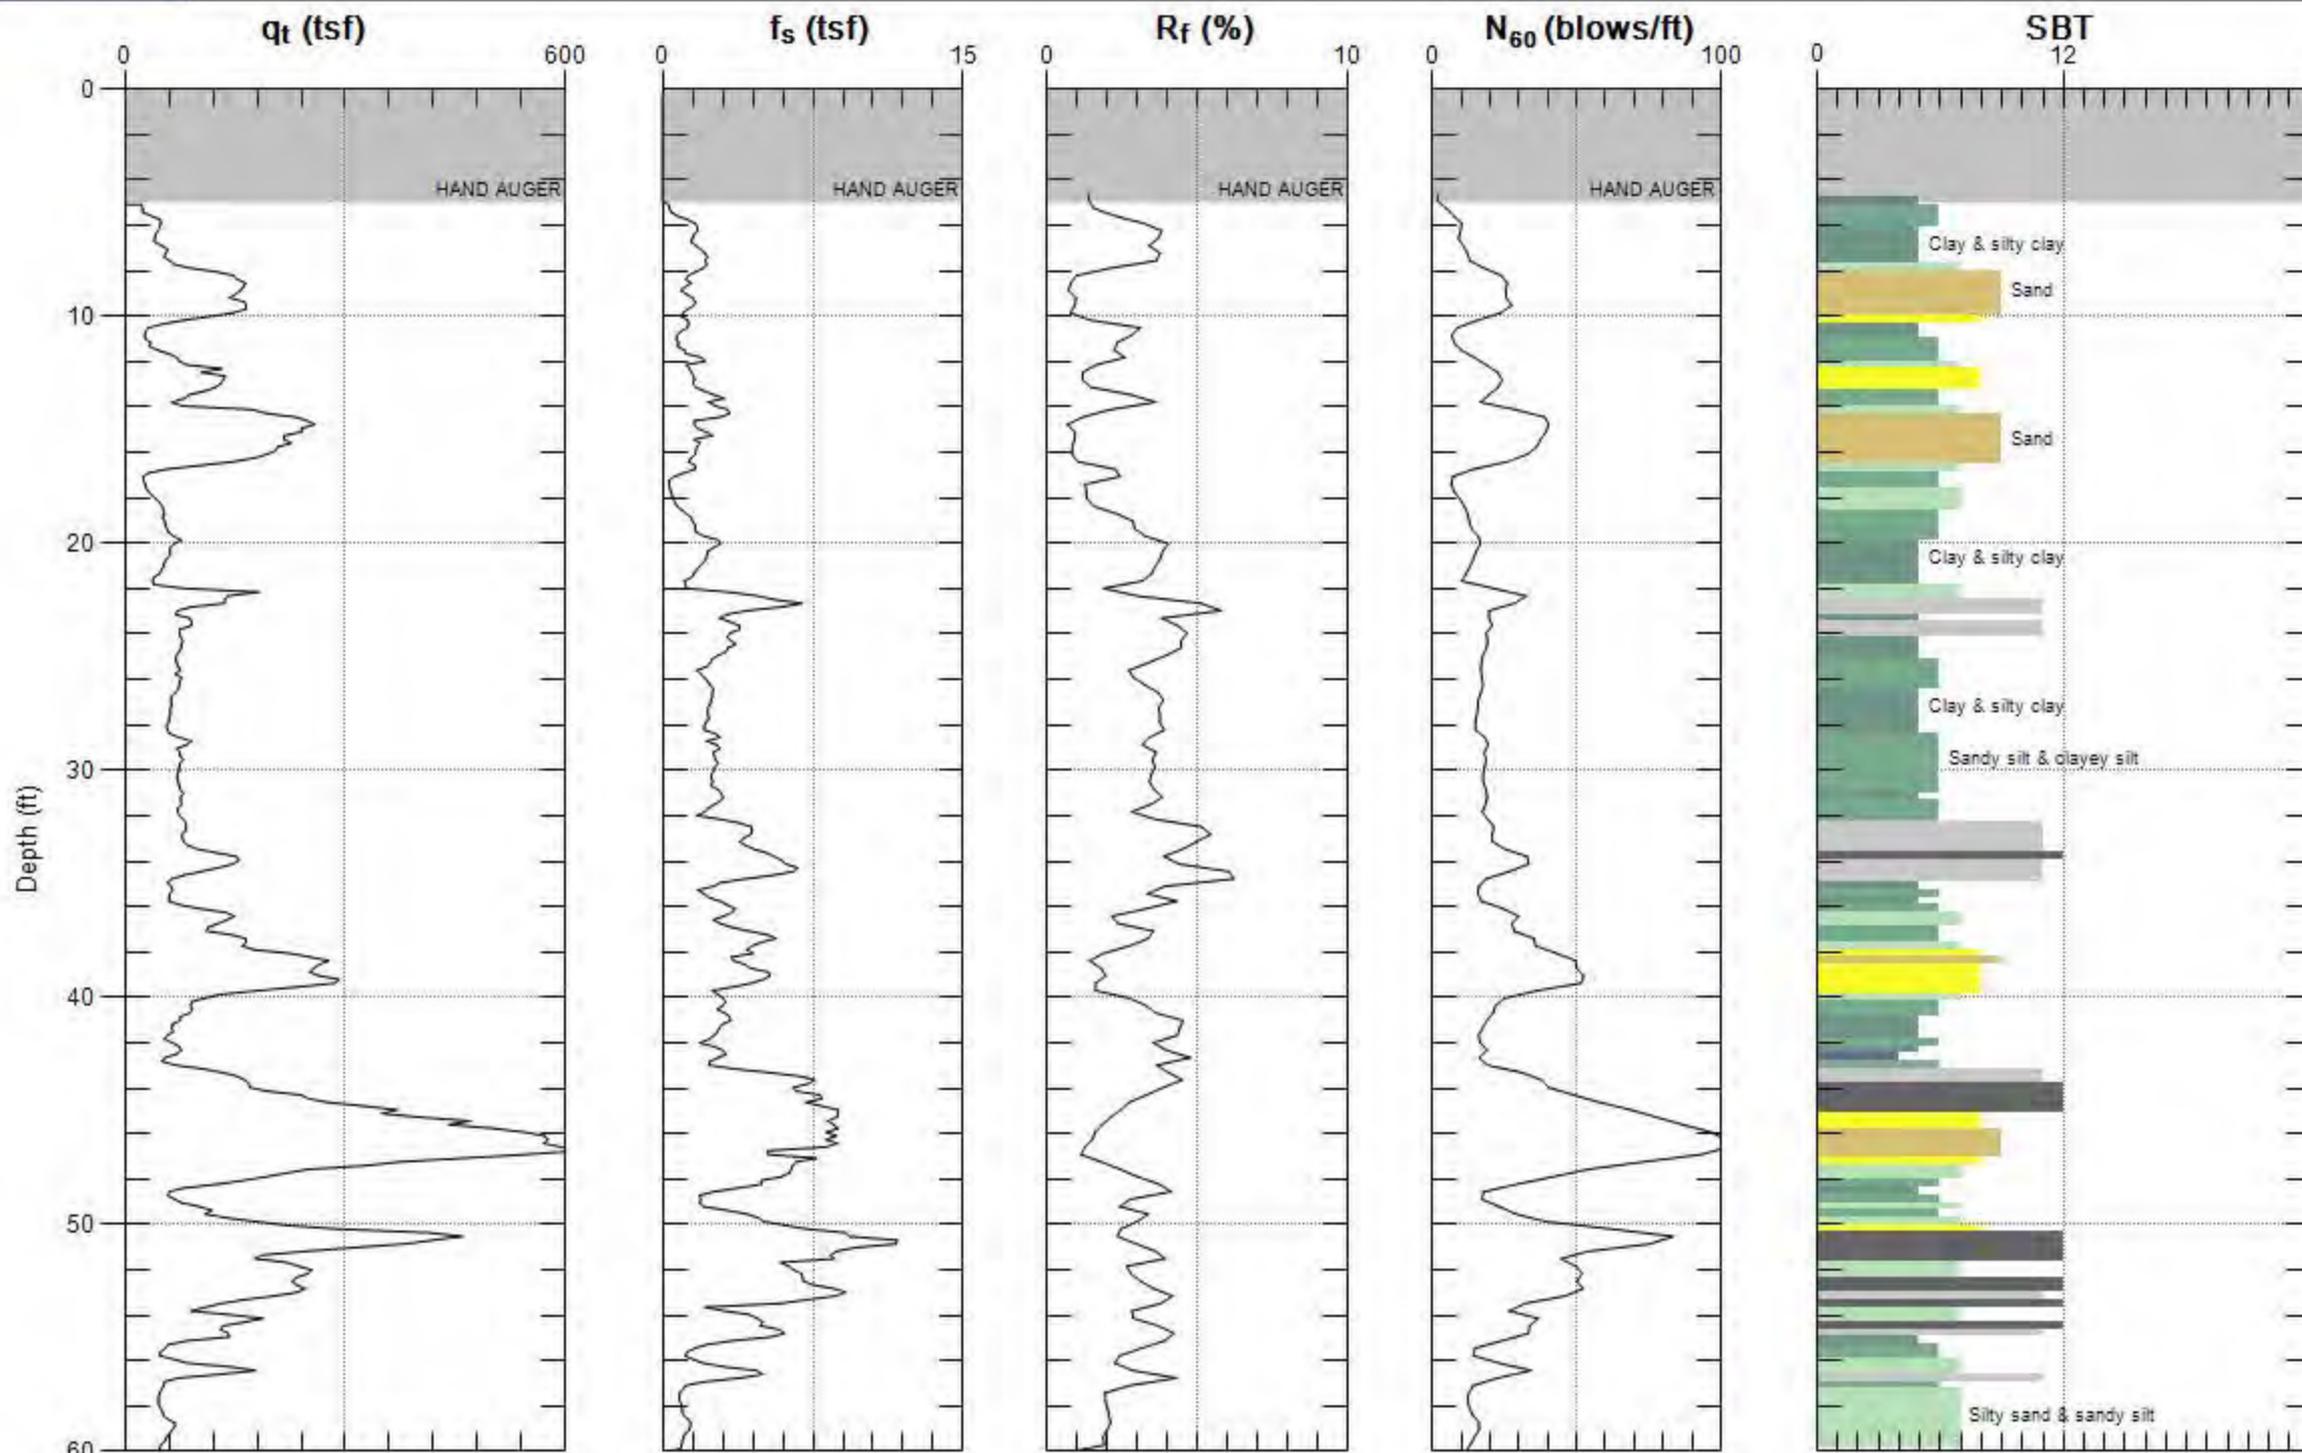
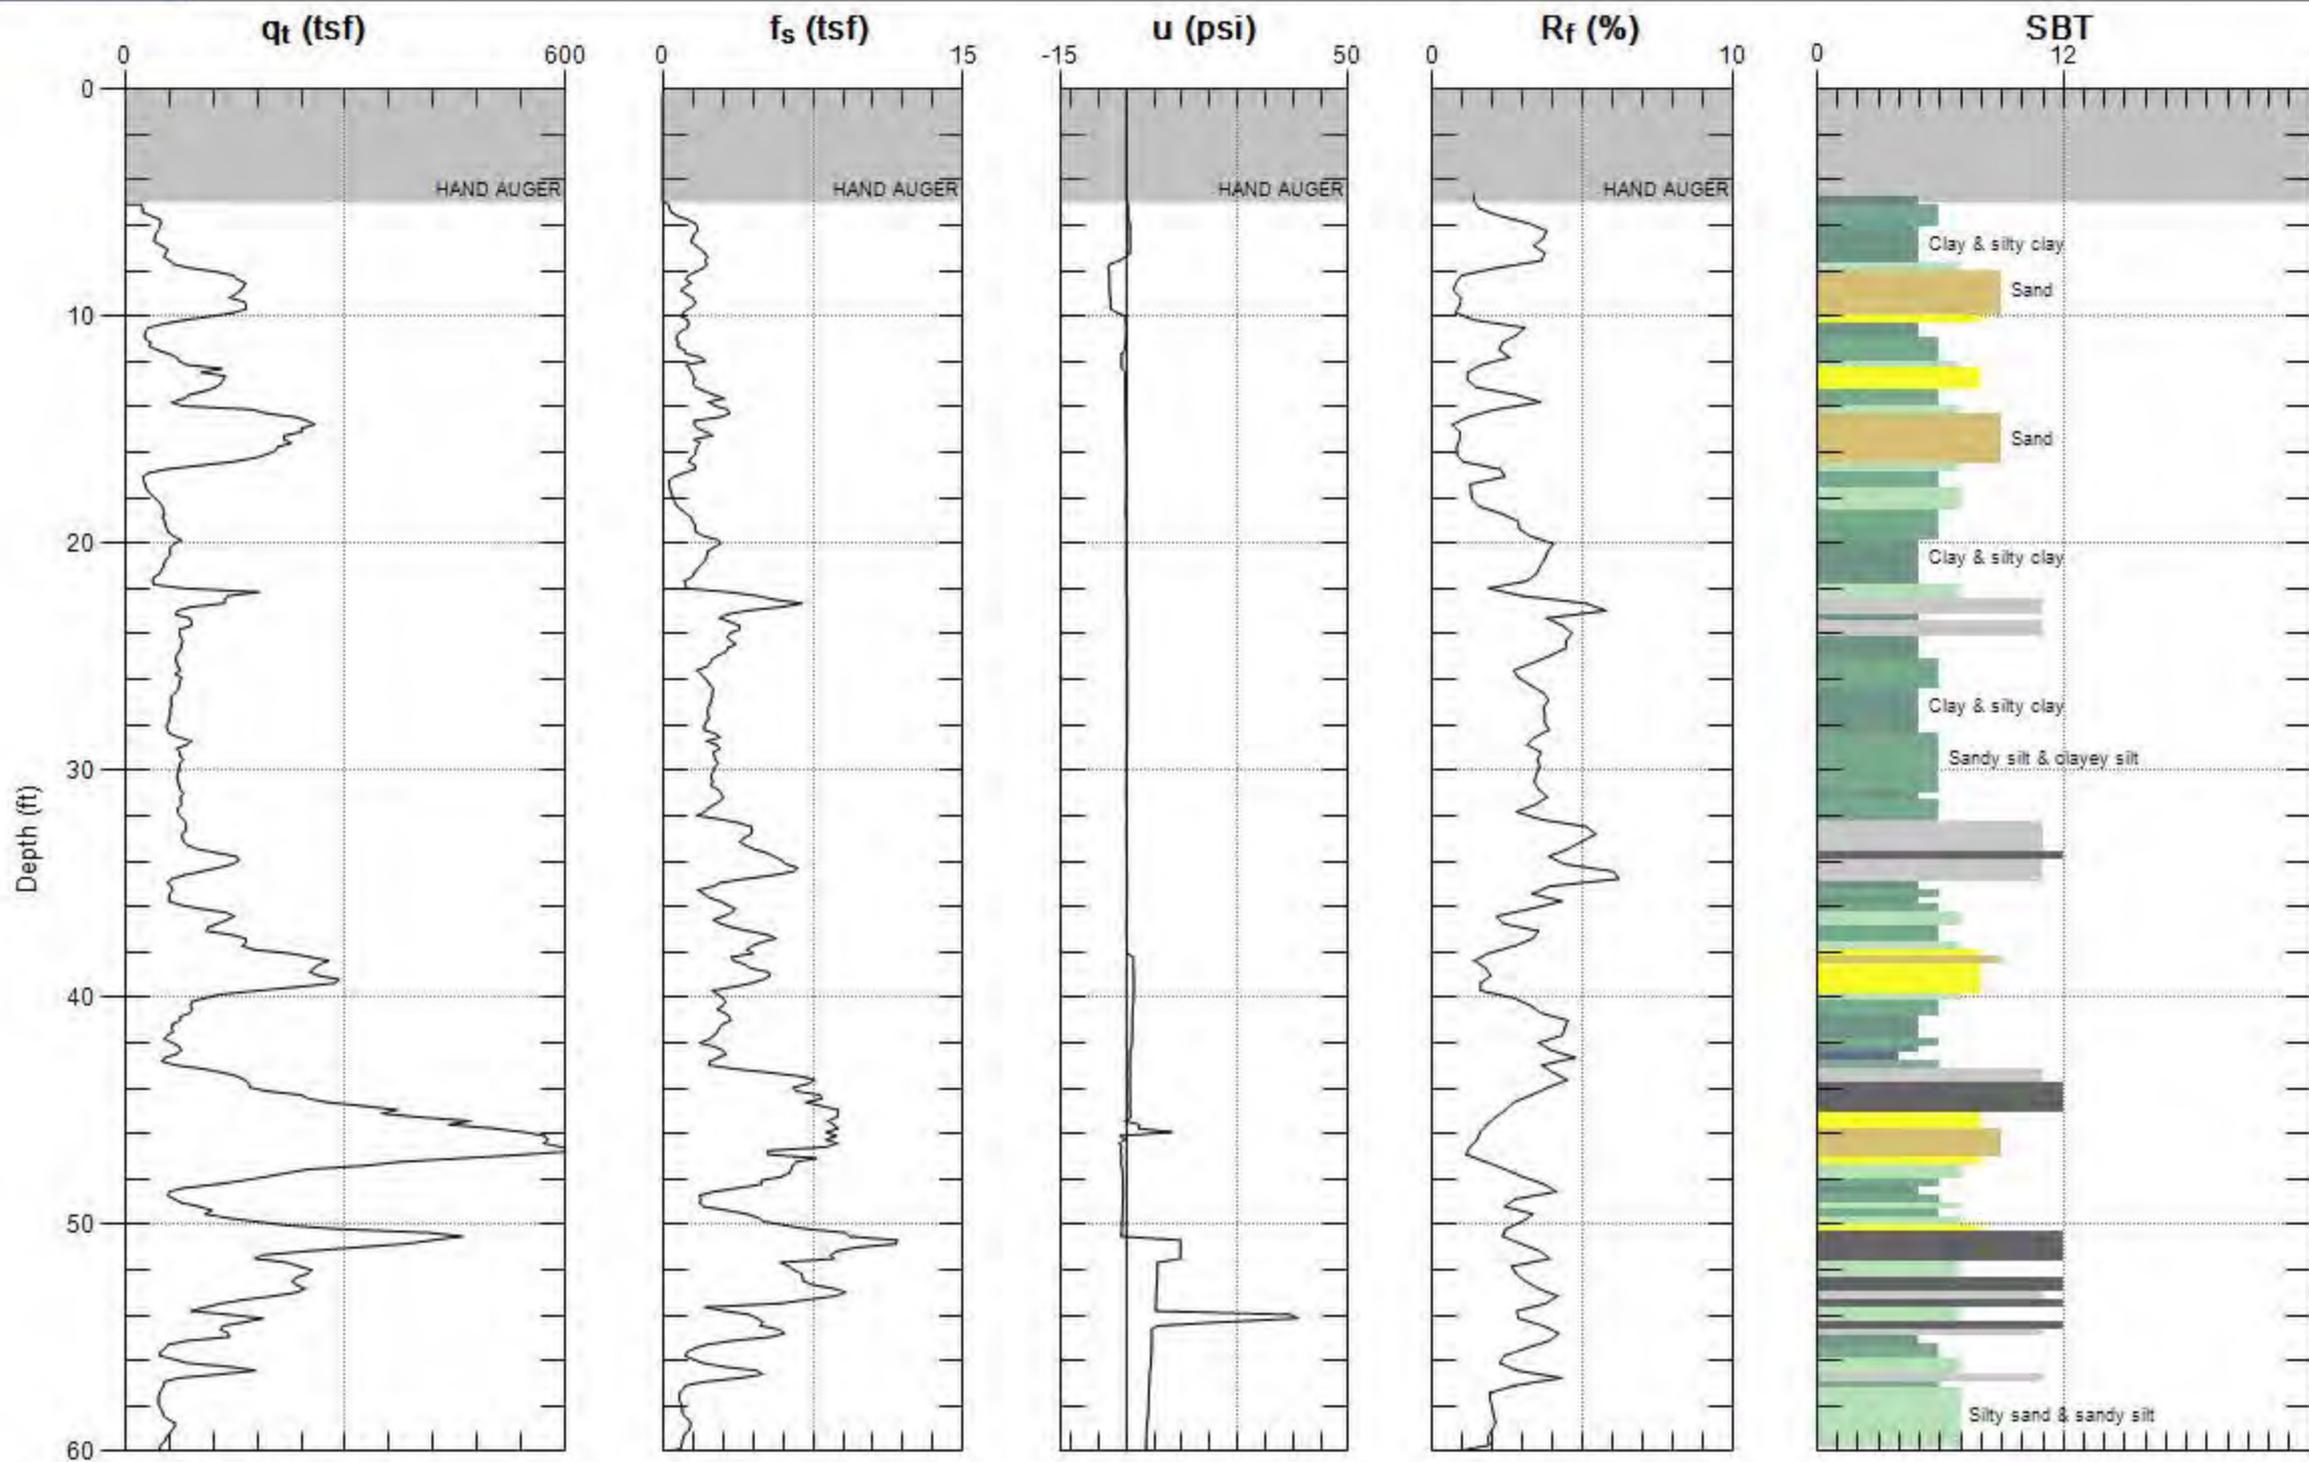
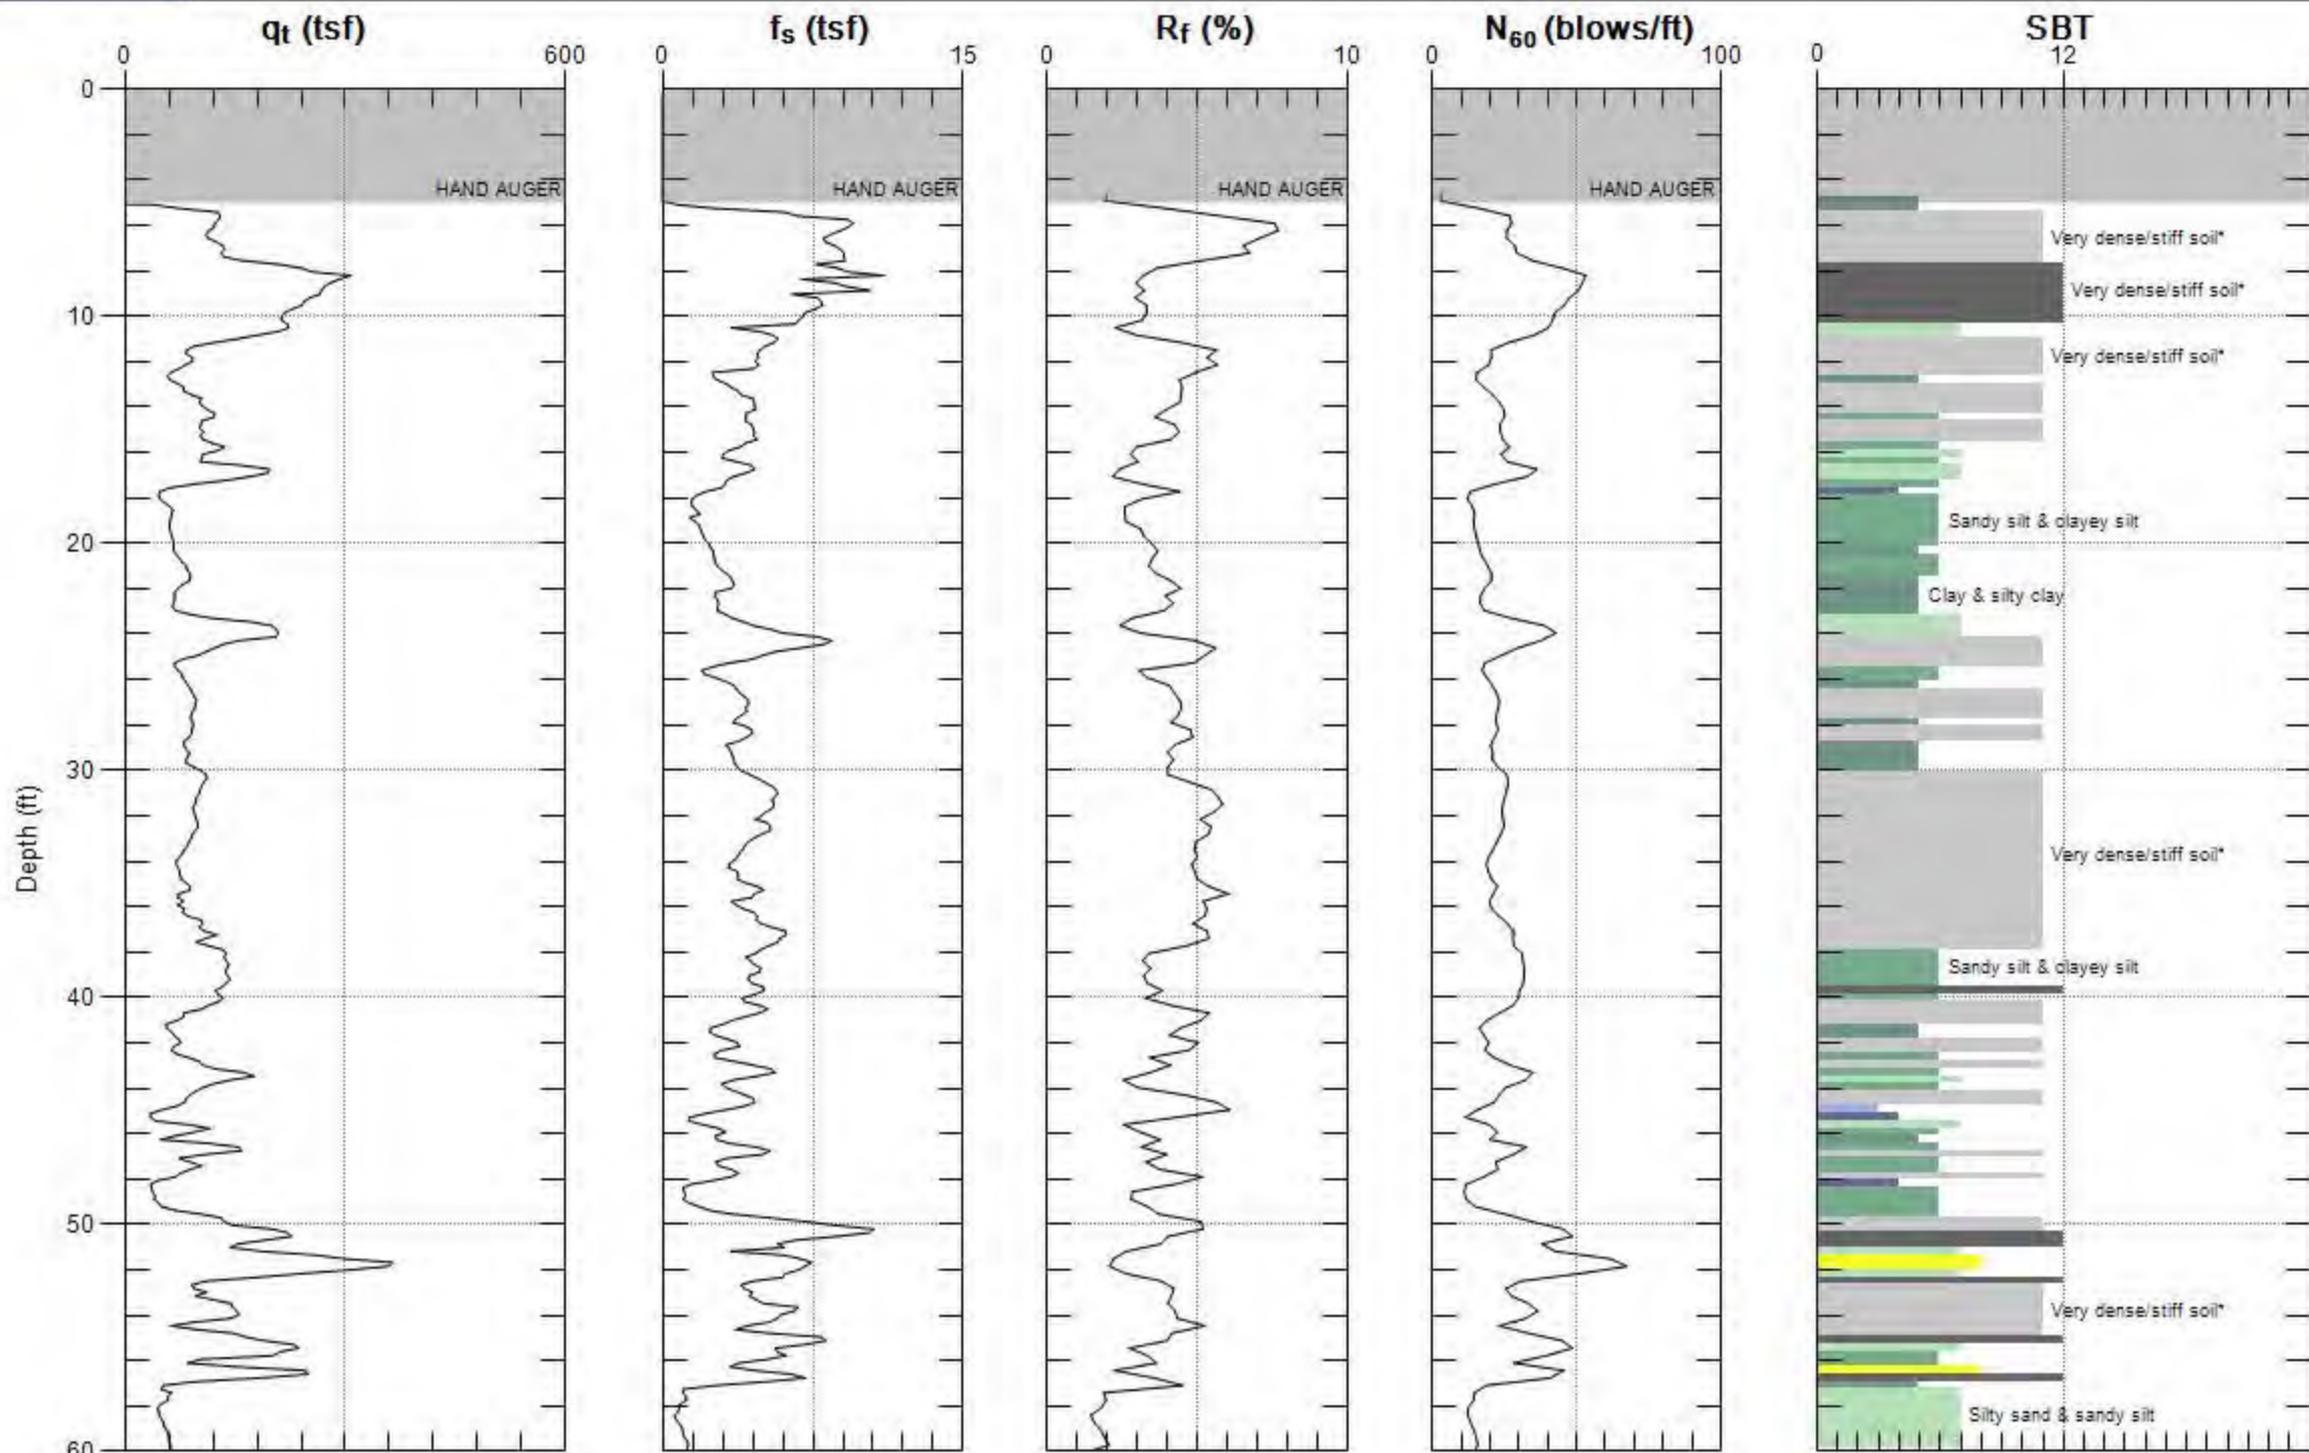
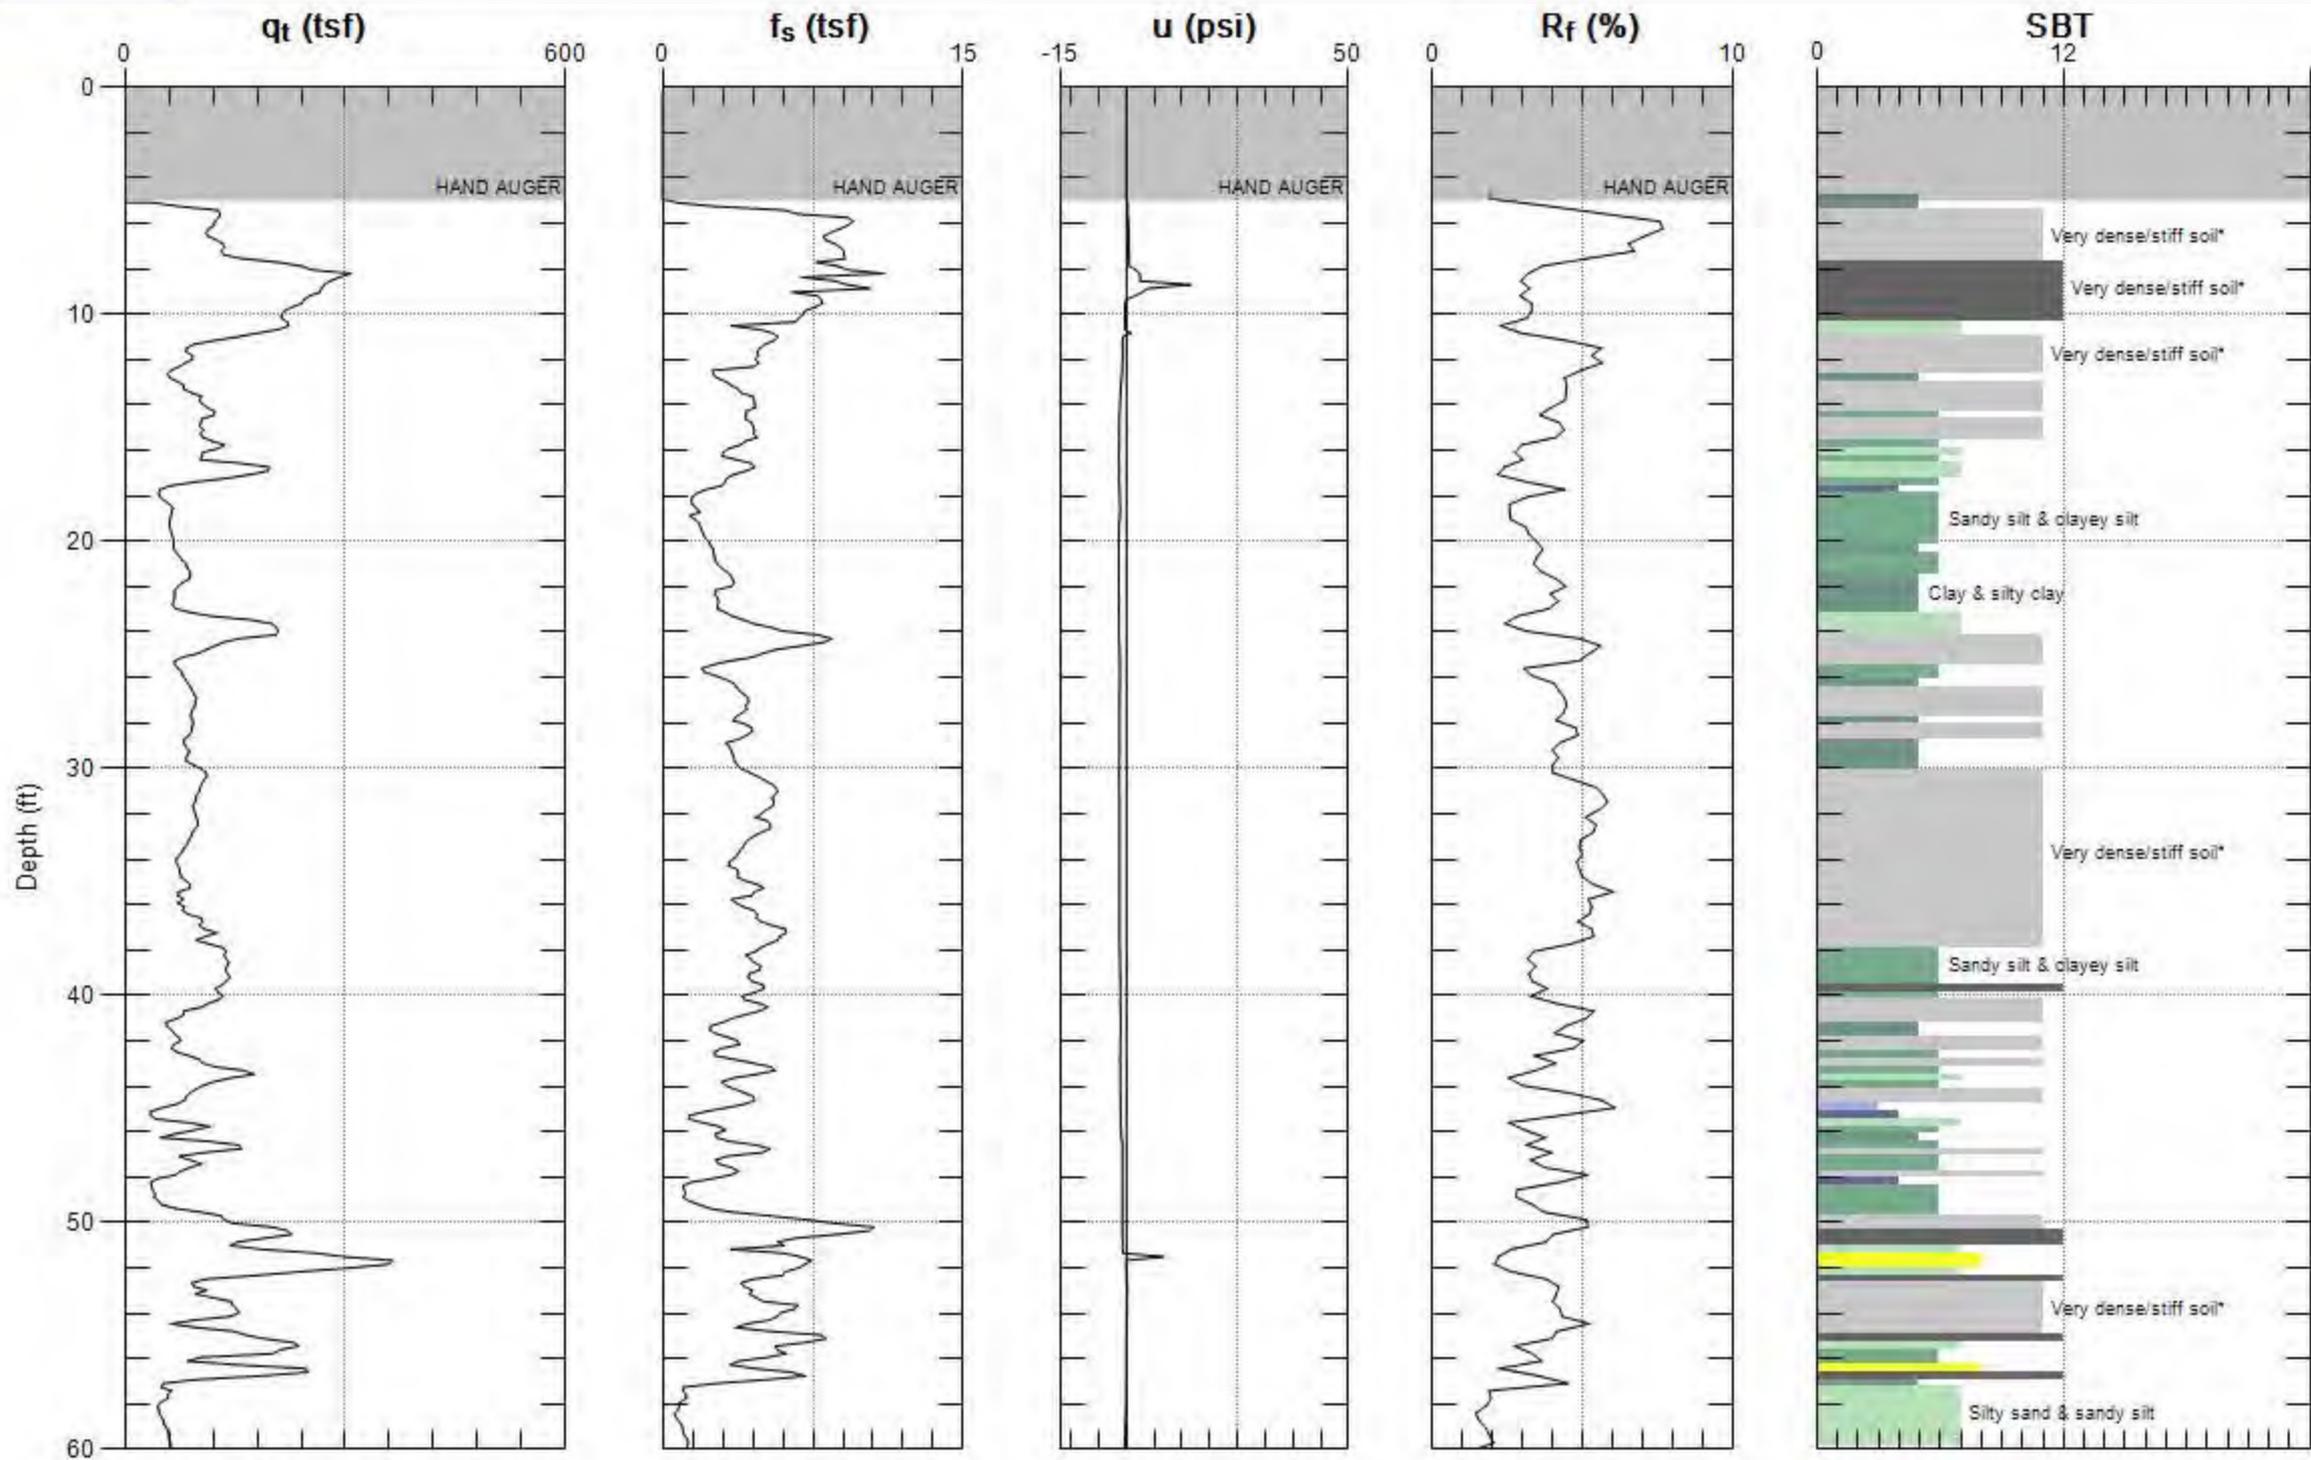
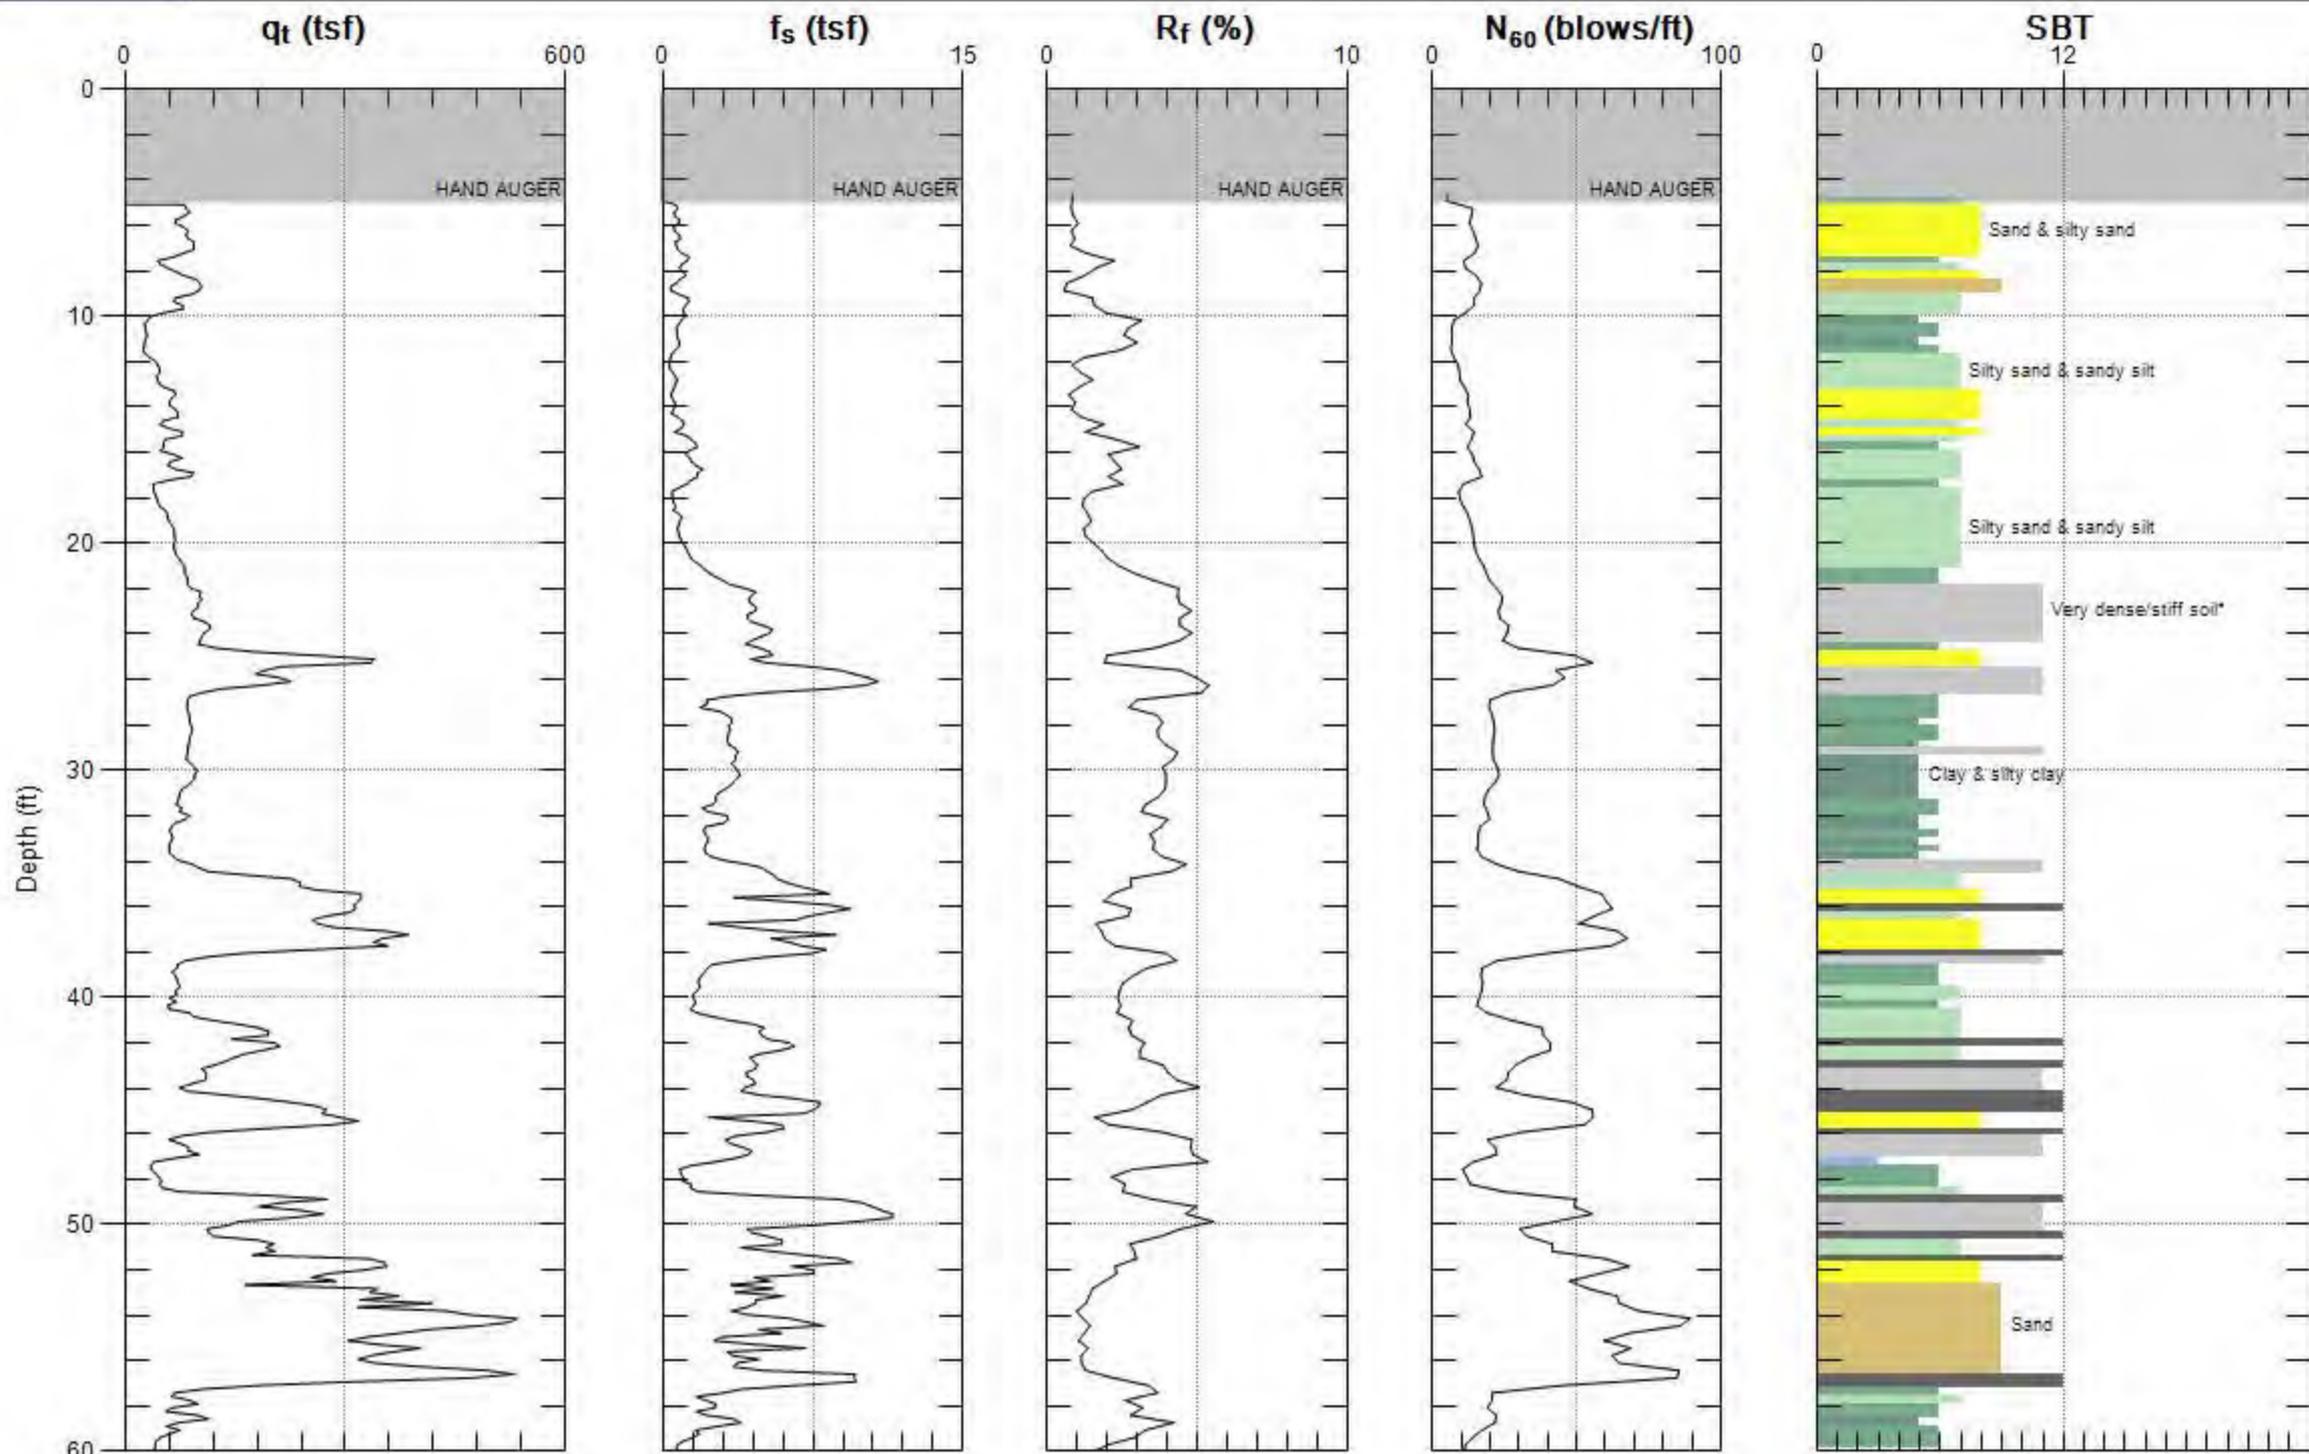
CONE PENETRATION TEST (CPT) RESULTS

Max. Depth: 60.203 (ft)
Avg. Interval: 0.328 (ft)

SBT: Soil Behavior Type (Robertson 1990)

The soil conditions beneath the site were explored by drilling four borings to depths of 51 to 61½ feet below the existing grade and performing four cone penetration tests (CPTs) to the depth of 60 feet below the existing grade. Data were also available from our prior investigation for the development of the existing condominium tower located immediately adjacent to the east of the project site. The boring locations of our recent and prior investigations as well as the CPT locations are illustrated on Figure 2. Details of the recent explorations and the logs of the borings are presented in Appendix A, the logs of the prior borings are presented in Appendix B, and the results of the recent CPTs are presented in Appendix C.

To supplement the exploratory borings, four cone penetration tests (CPTs) were performed to the depth of 60 feet below the existing grade. The locations of the CPTs are presented on Figures 2. The results of the CPTs are presented in Appendix C.
