Geotechnical Report and LADBS Approval Letter

GEOLOGY AND SOILS REPORT APPROVAL LETTER

This report provides an assessment of geologic conditions as well as foundation design information and geotechnical recommendations for the proposed Belmont Village project at the Westwood Presbyterian Church located at 10822 Wilshire Boulevard and the residential property at 10812 Ashton Avenue in the Westwood District of Los Angeles, California. The location of the project site is illustrated on Figure 1, Vicinity Map. The locations of the proposed project and our recent and relevant prior exploration borings are shown on Figure 2, Plot Plan.

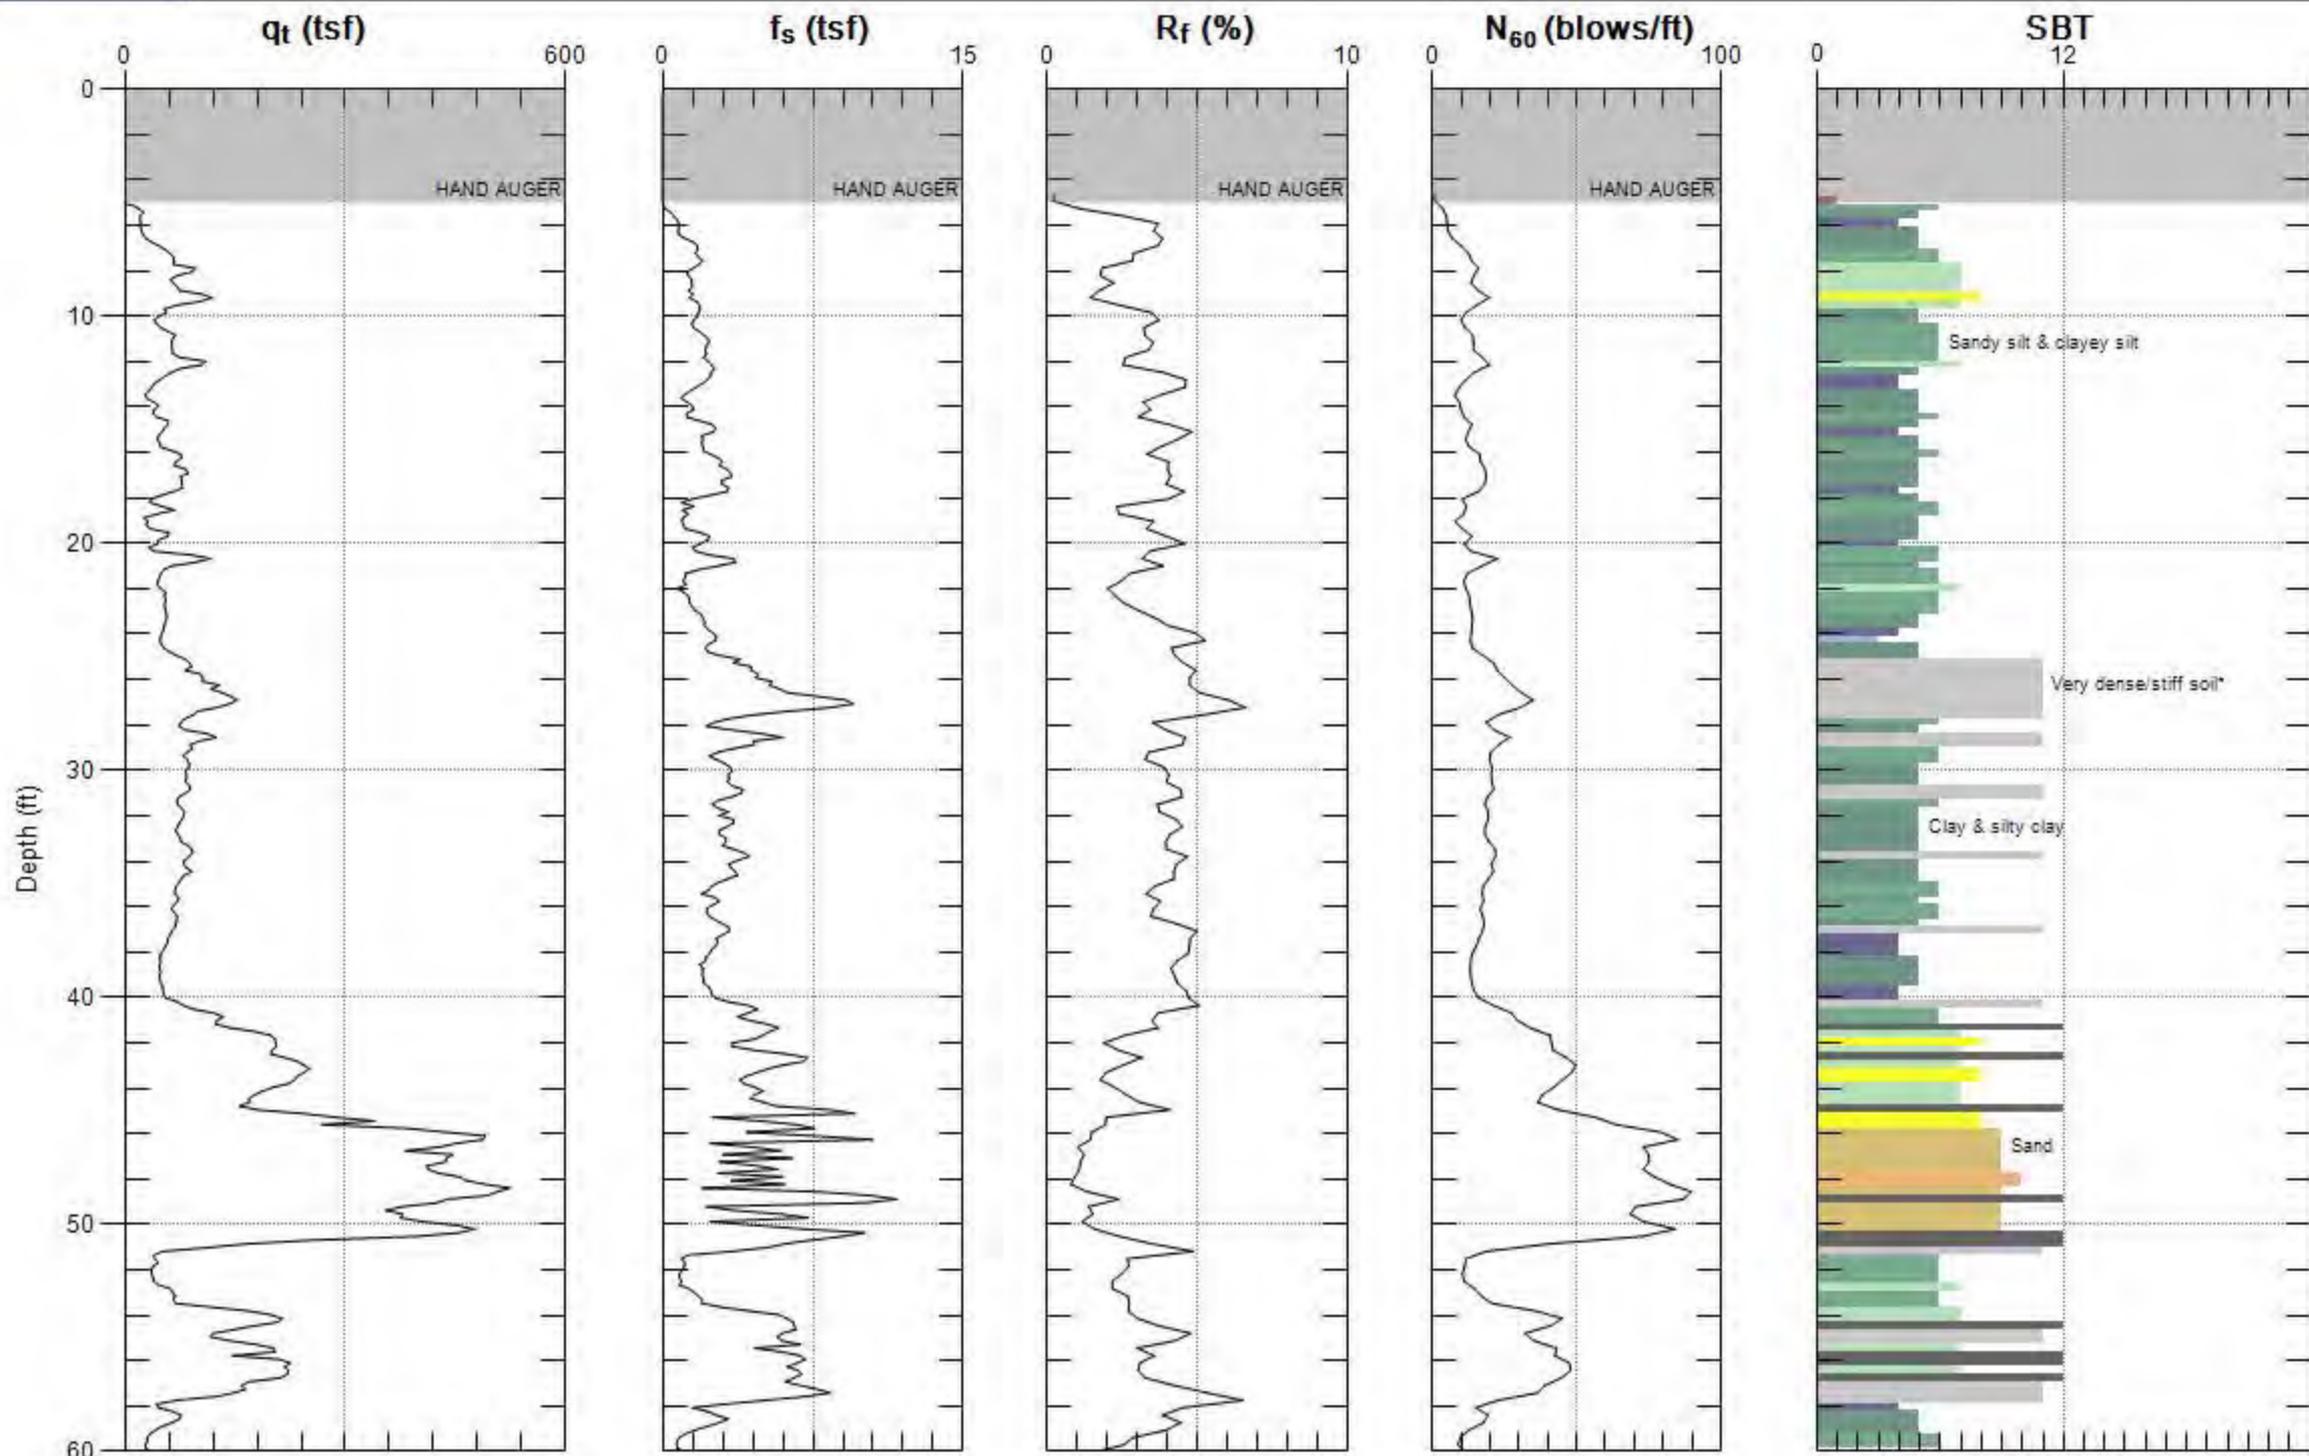
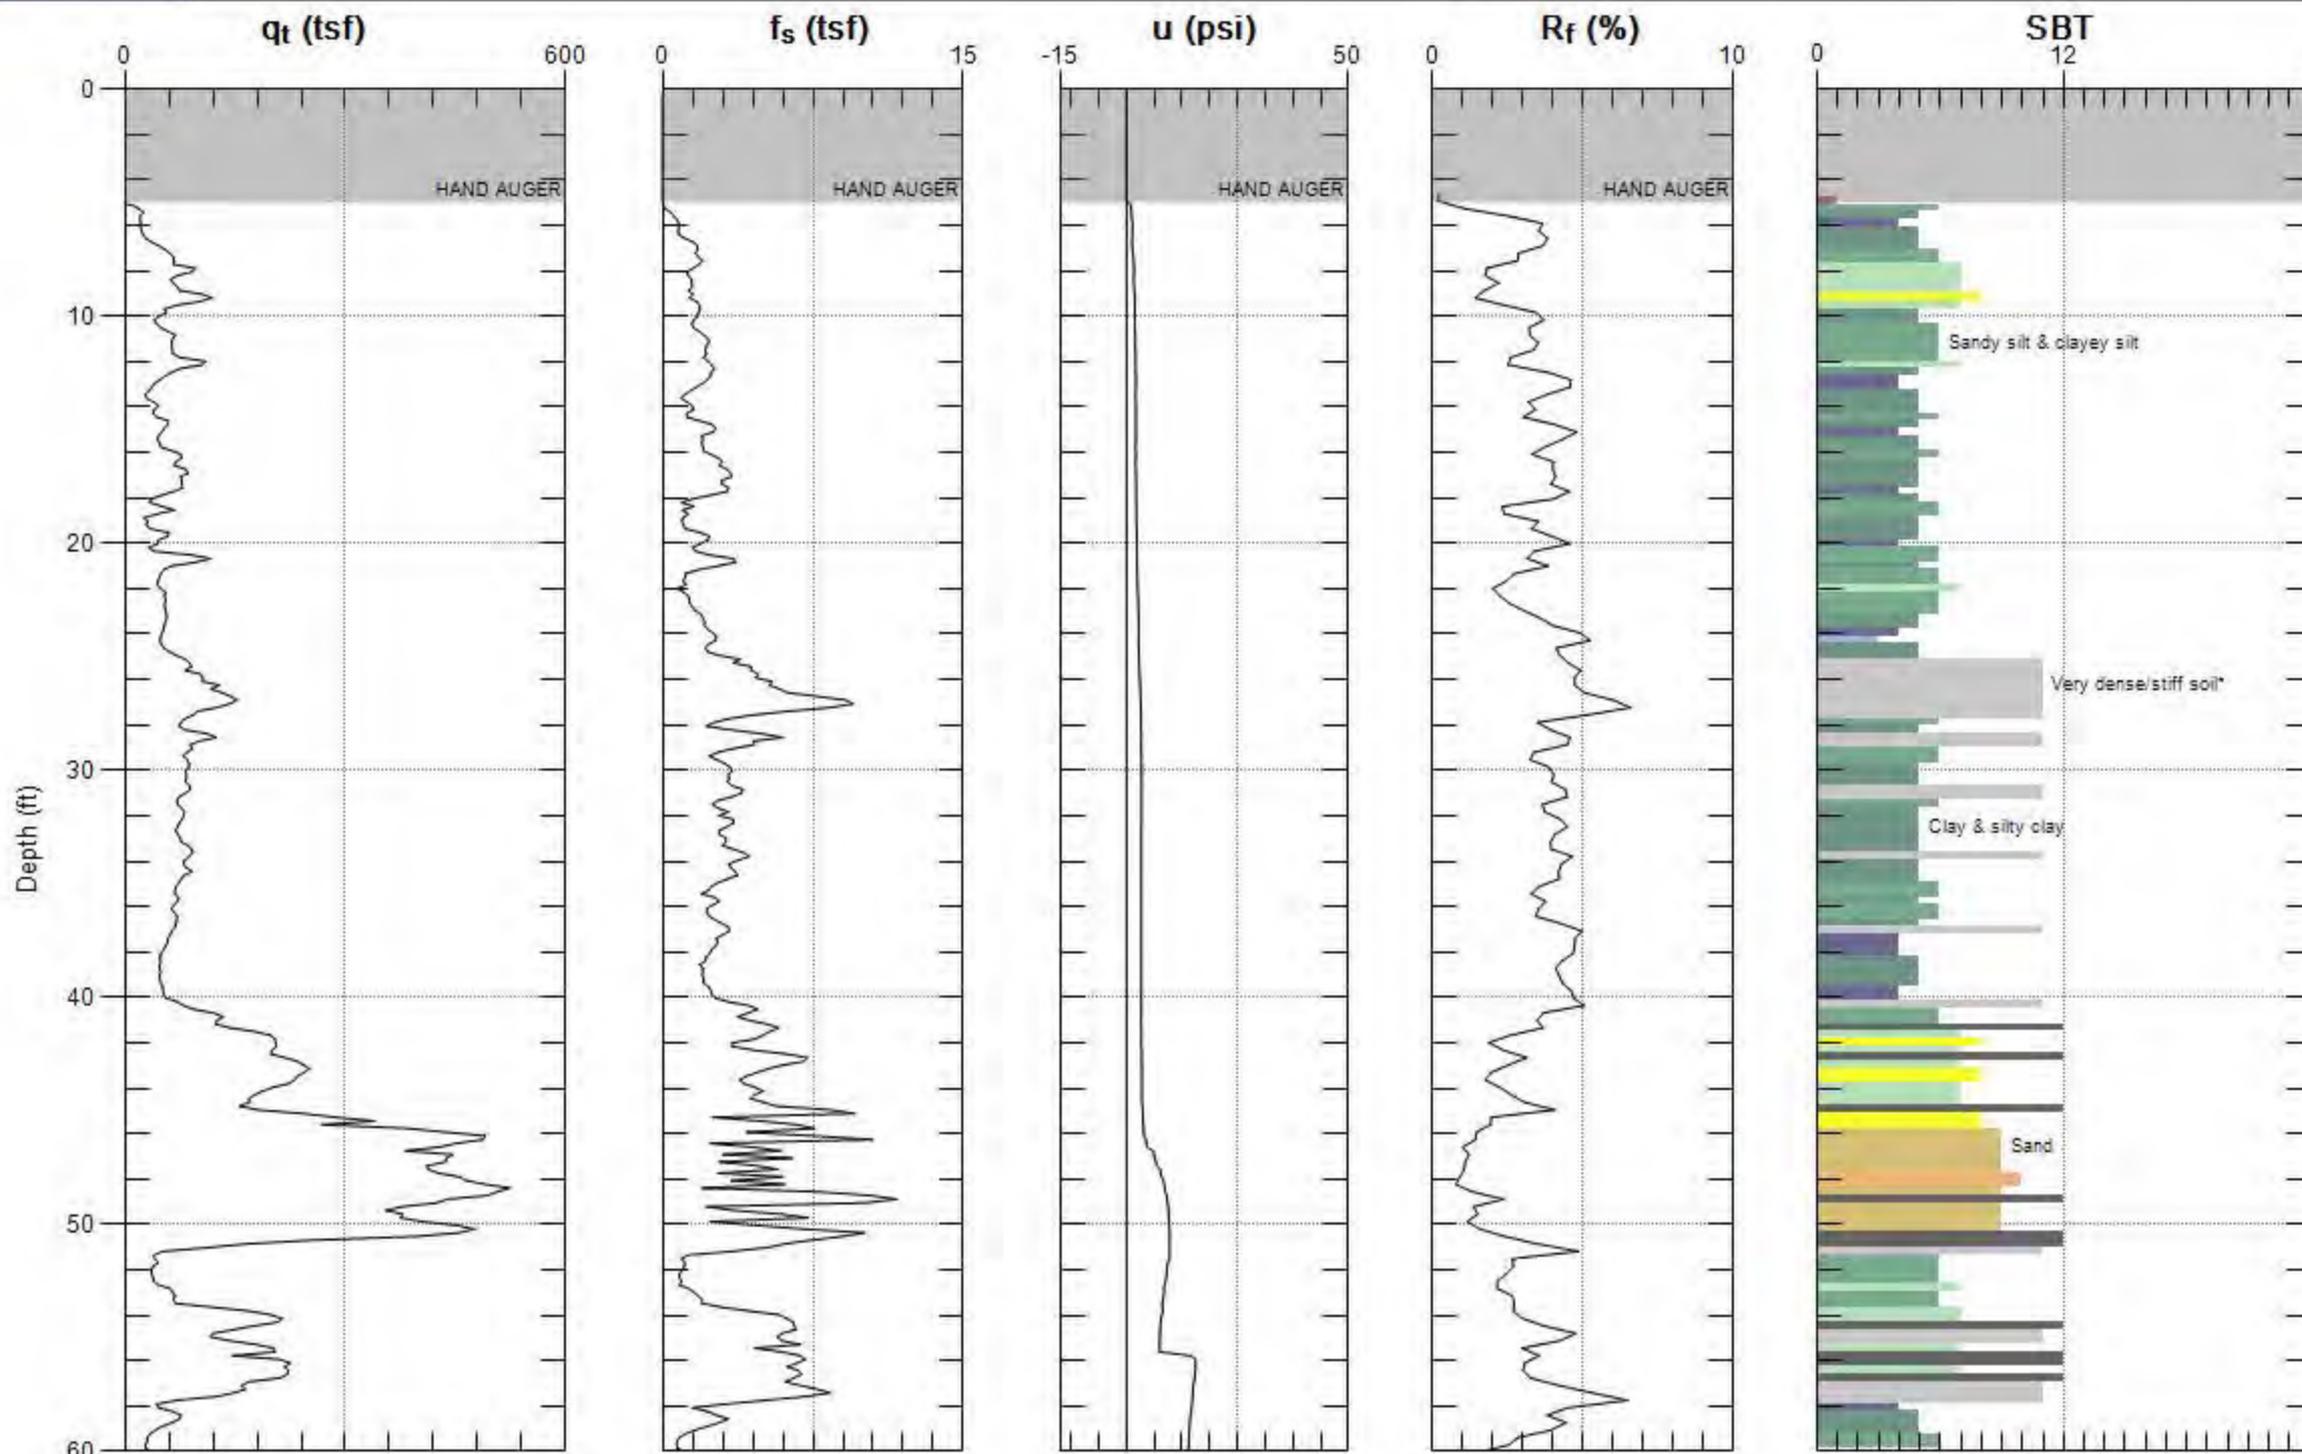
Max. Depth: 60.367 (ft)
Avg. Interval: 0.328 (ft)

SBT: Soil Behavior Type (Robertson 1990)

To supplement the exploratory borings, four cone penetration tests (CPTs) were performed to the depth of 60 feet below the existing grade. The locations of the CPTs are presented on Figures 2. The results of the CPTs are presented in Appendix C.
