RAP Response to CF 25-0006-S23 Status of RAP owned facilities that were impacted by the City Wildfires in January 2025.

Site Assessment Report

Facility Name: Palisades Recreation Center
Facility Address: 851 Alma Real Drive, Palisades, CA 90272
Inspection Date: January 30, 2025
Inspection Time: 11:30 AM (Pacific Time)
Inspection Description: Fire Damage Visual Assessment
Prepared by: Bureau of Engineering

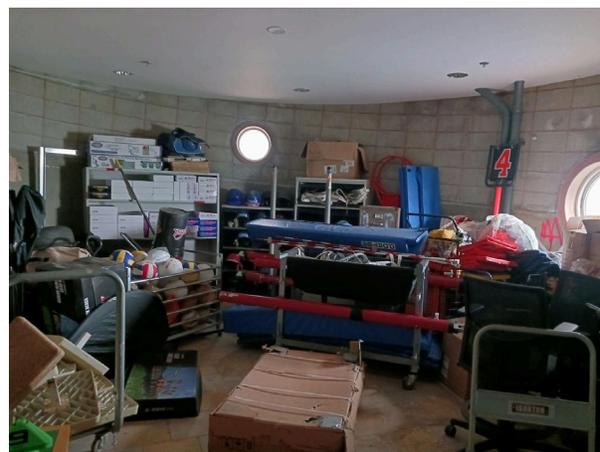
Photo of gym equipment storage at the southwest corner of the building.

This room has no evidence of damage from the fire. Further investigation of the ceiling attic is required to confirm if any fire or water damage.

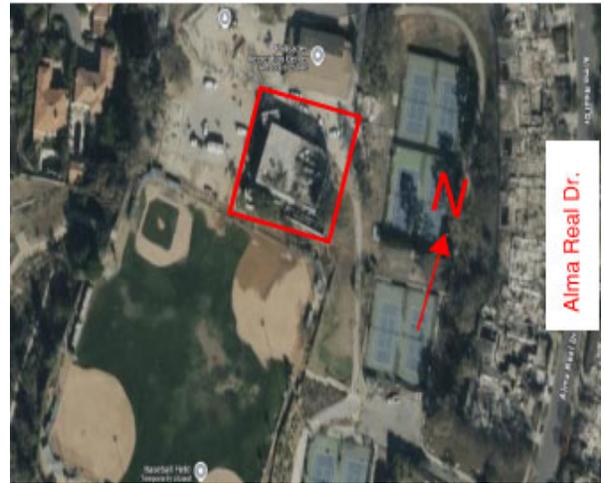
Figure-16a and Figure-16b

Photo of the northern side of the building:

The top steel wide-flanged beam (*Label 1*) along the roof perimeter and the cold-formed metal studs (*Label 2*) have been warped due to fire damage and will require in-kind replacement. Additional investigation is needed to evaluate the extent of damage to other structural elements.

Any structural steel components that are not distorted or bent do not need to be replaced.

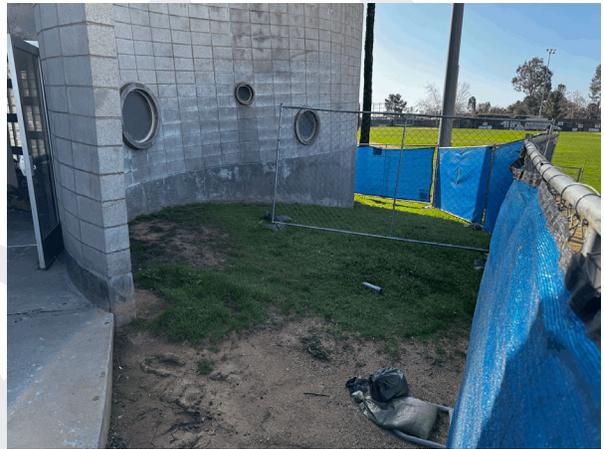
Figure-61

Photo of landscape area at west side of building

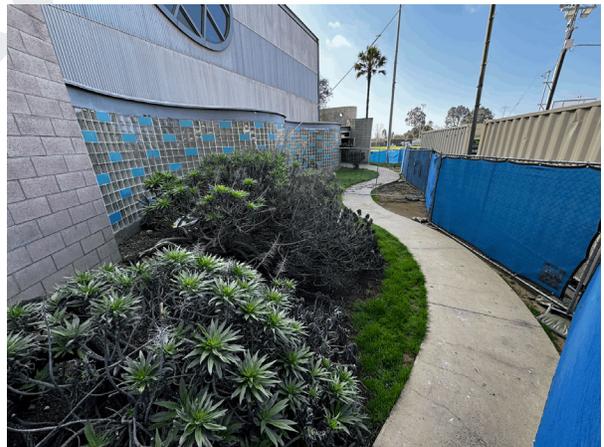
Figure-62

Photo of landscape area at north side of building

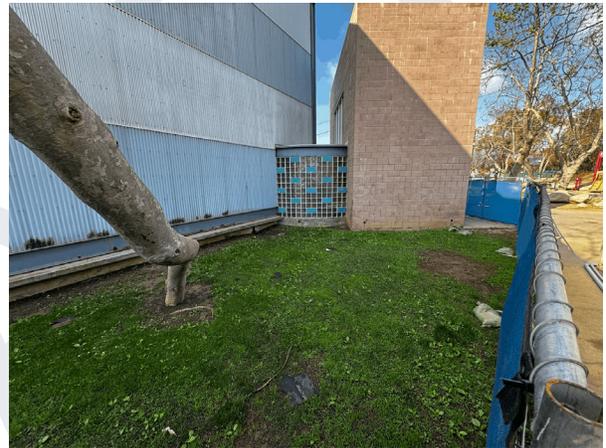
Figure-64

Photo of landscape area at north side of building

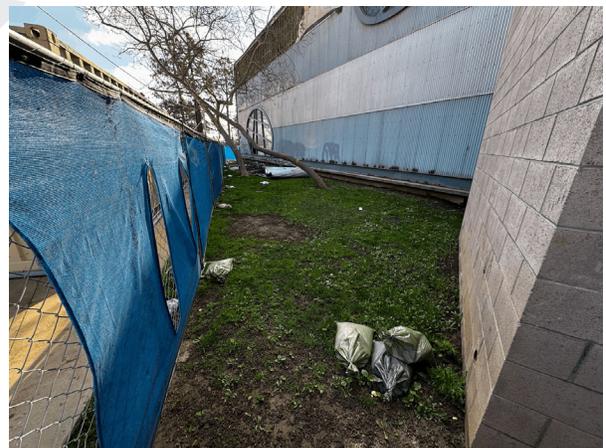
Figure-65

Photo of landscape area at east side of building

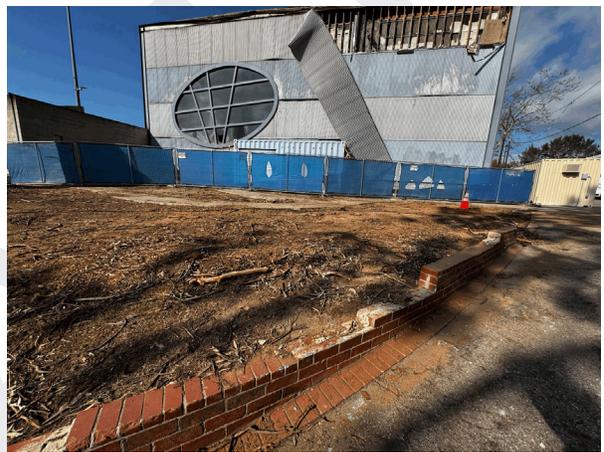
Figure-67

Photo of landscape area at east side of building

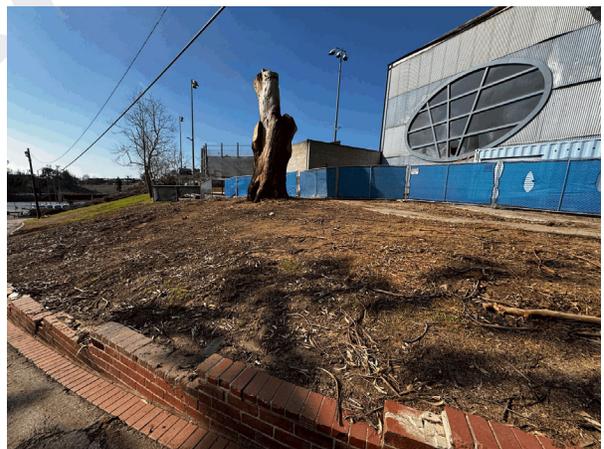
Figure-68

Photo of landscape area at south side of building

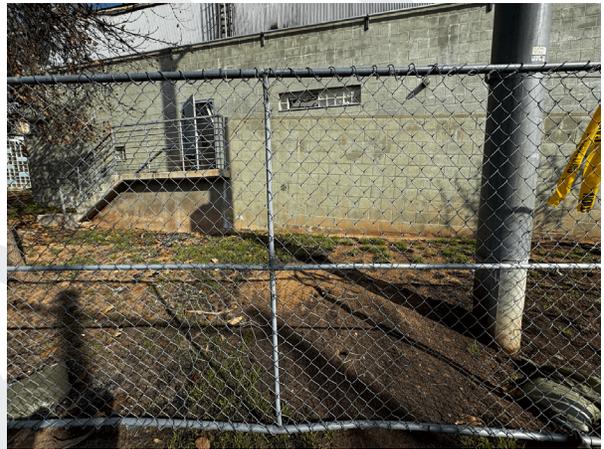
Figure-70

Photo of landscape area at south side of building

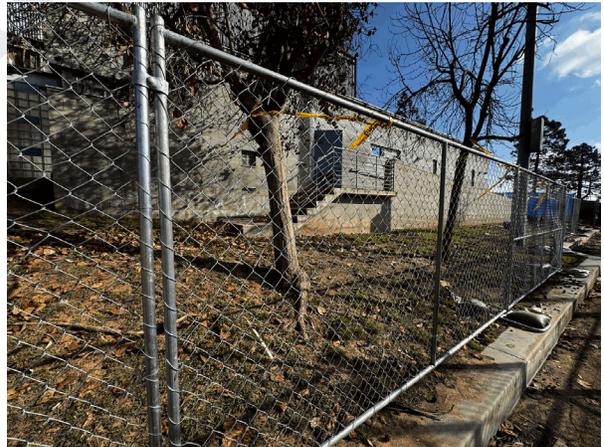
Figure-71

Photo of landscape area at south side of building
